Title: Auckland Regional Landfill					
Date	Version	Description	Prepared by:	Reviewed by:	Authorised by:
30/05/2019	1.0	Final	A. Naylor T. Coote	K. Hind	S. Eldridge

This Geotechnical Interpretive Report (GIR) describes the site geological and groundwater conditions and associated geotechnical model. This report is intended to support feasibility level design of the proposed landfill and access and application for resource consent. This report also identifies potential geotechnical risks to the project and recommends further investigation and/or analysis to avoid, remedy or mitigate these risks.

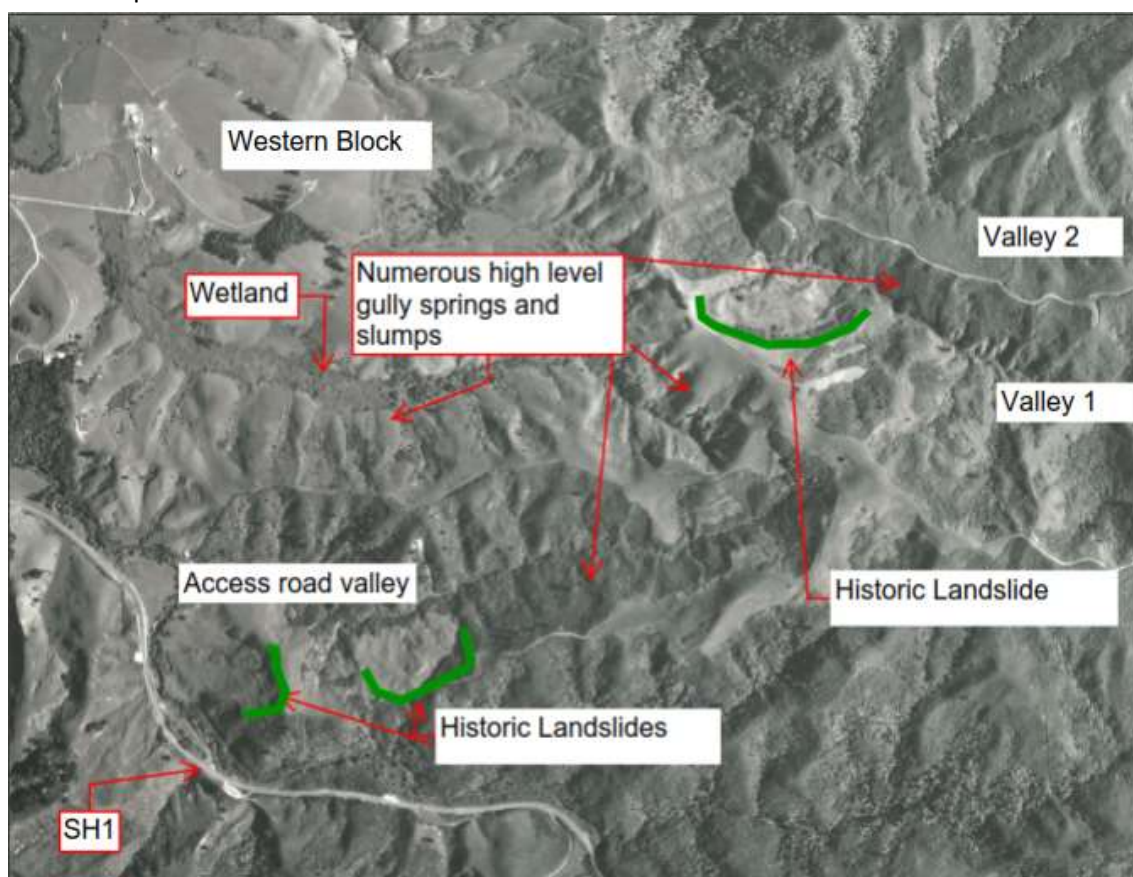
Figure 4.2: 1973 aerial image showing slope geomorphology. Selected identified historic landslides depicted.

The geomorphology of the proposed landfill site and access road is currently subdued by forest cover. We have assessed aerial photographs dated 1940 and 1973 (Figure 4.2), when the project area was devoid of vegetation and geomorphological features are more readily observed. Observed features on the aerial photographs include:

- There is a well-defined northeast (NE) / southwest (SW) structural lineation south of SH1, which appears to project through the valley of the Southern Block. Ridges and gullies are generally aligned NE-SW south of SH1 but are more variable north of SH1 and aligned E-W in the project area;
- Probable historic landslide features (Figure 1, Appendix A) in the vicinity of BH13 on the access road alignment, and below BH1 in the landfill footprint; and
- Numerous active shallow landslips within gully tributaries appearing to coincide with springs. Similar landslips and springs exist throughout Western Block slopes to the west of the landfill footprint.

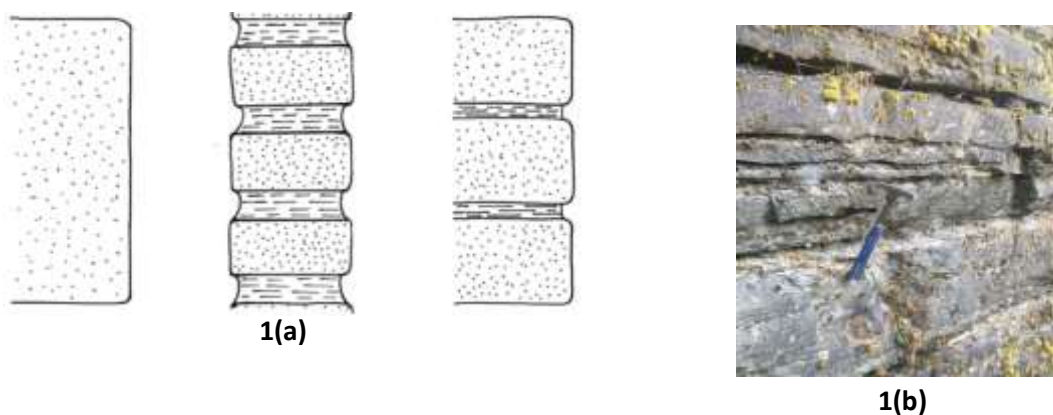
Figure 4.3: Pakiri Formation Rock Structure – a) Schematic showing typical interbedding of sandstone (dotted beds) and Siltstones (dashed beds) b) Typical Pakiri Formation interbedding

- The formation typically comprises interbedded weak to moderately strong sandstones and very weak to weak siltstone. Typical bedding sequences are shown in Figure 4.3 below;
- Pakiri Formation also contains moderately strong (20 to 50 MPa) massive volcanoclastic grit beds (gritstone) to conglomeritic coarse sandstones, with mixed source clasts;
- The siltstones and residually weathered soils contain considerable clay content;
- Volcanoclastic sandstones and conglomerates commonly weather to thick residual soils that are known to comprise significant smectite (swelling clay) and some allophane (sensitive clay); and
- Typically the bedding is sub-horizontal to gently dipping with an orthogonal to conjugate jointing pattern. Soft sediment deformation can however result in large increases in bedding orientation over relatively short distances.

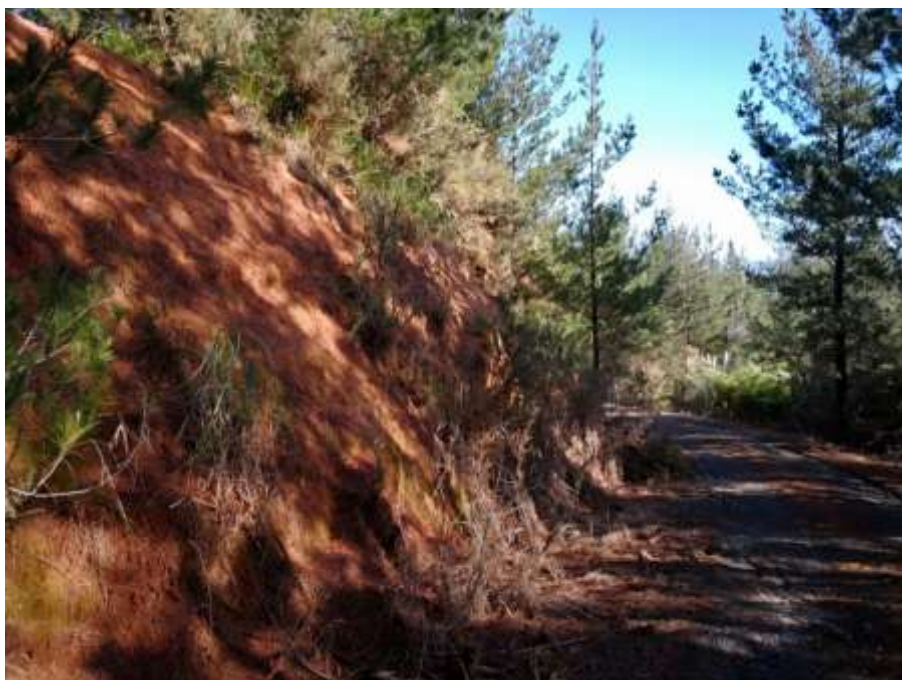
Photograph 4.1: Pakiri Formation residual soil

Residual Pakiri Formation soils were observed within forestry access road cuts in the project area. These generally consisted of reddish and orange brown silty sands with clay (Photograph 4.1). Limited outcrops of unweathered Pakiri Formation bedrock were observed on the cut slopes, and some bedrock was observed in the stream channels (Photograph 4.2). Bedding structures intersected within boreholes were typically dipping at shallow angles of between 0° and 15°.

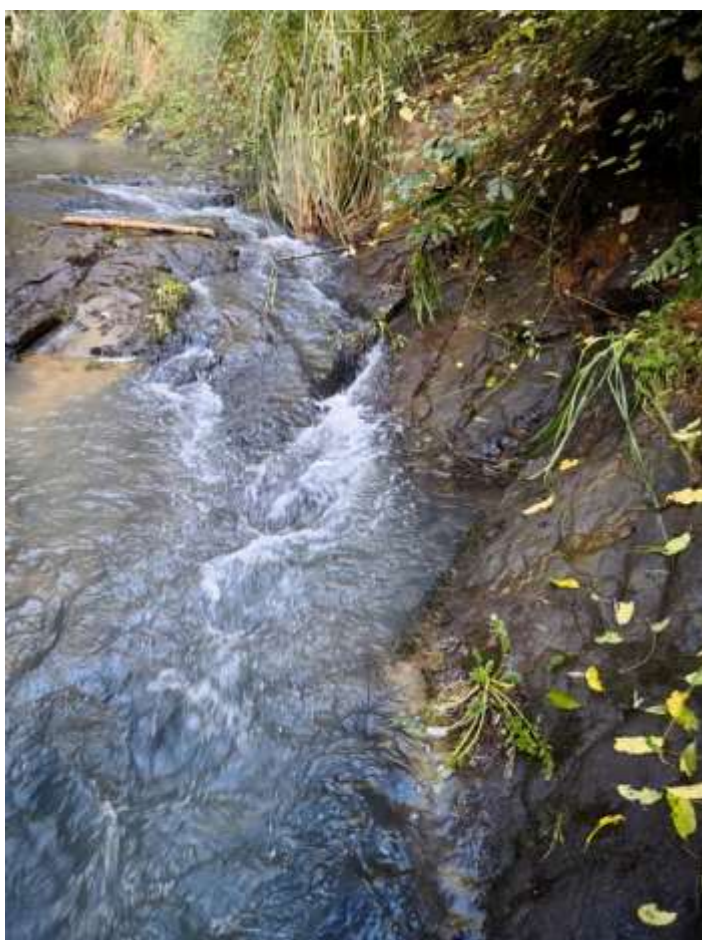
Photograph 4.2: Pakiri Formation sandstone bedrock observed at the north western end of the site

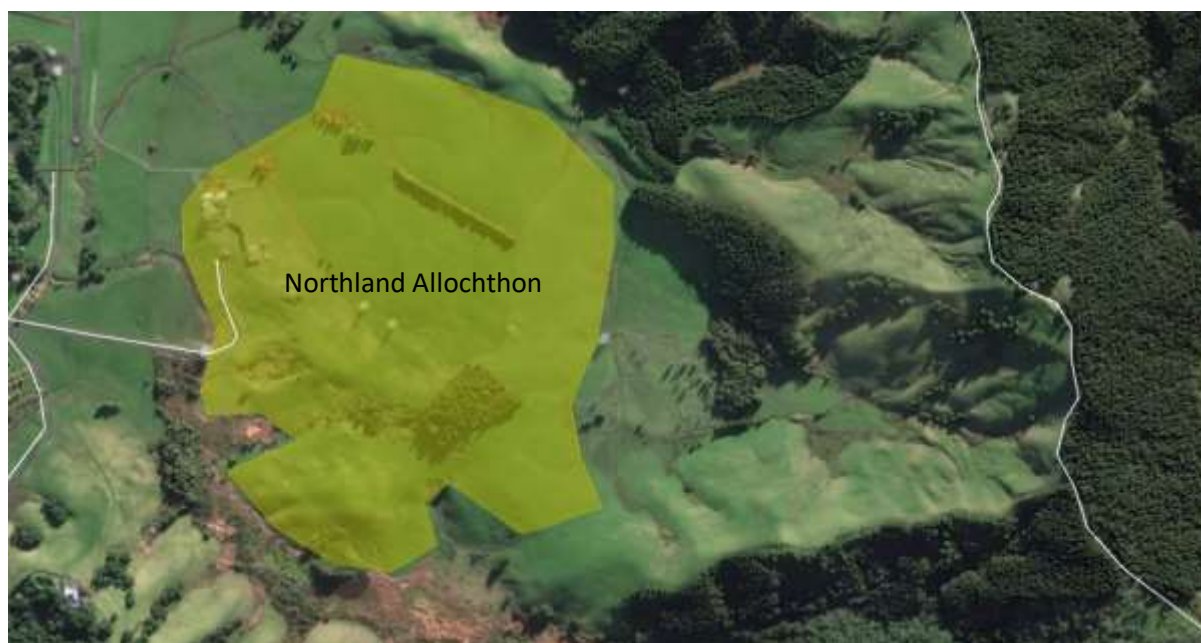
Figure 4.4: Inferred extent of the Northland Allochthon within the Western Block

Northland Allochthon typically comprises an upper residual clay soil overlying highly sheared and broken bedrock. Translational sliding in Northland Allochthon geology can occur on slopes as low as 8 to 10°, typically at the sheared contact at the base of the residual soil. Northland Allochthon was suspected of being present on the lowland west of the site in the Western Block, which was confirmed following the hand auger investigations for clay borrow material. The approximate extent of the Northland Allochthon in this area is shown in Figure 4.4.

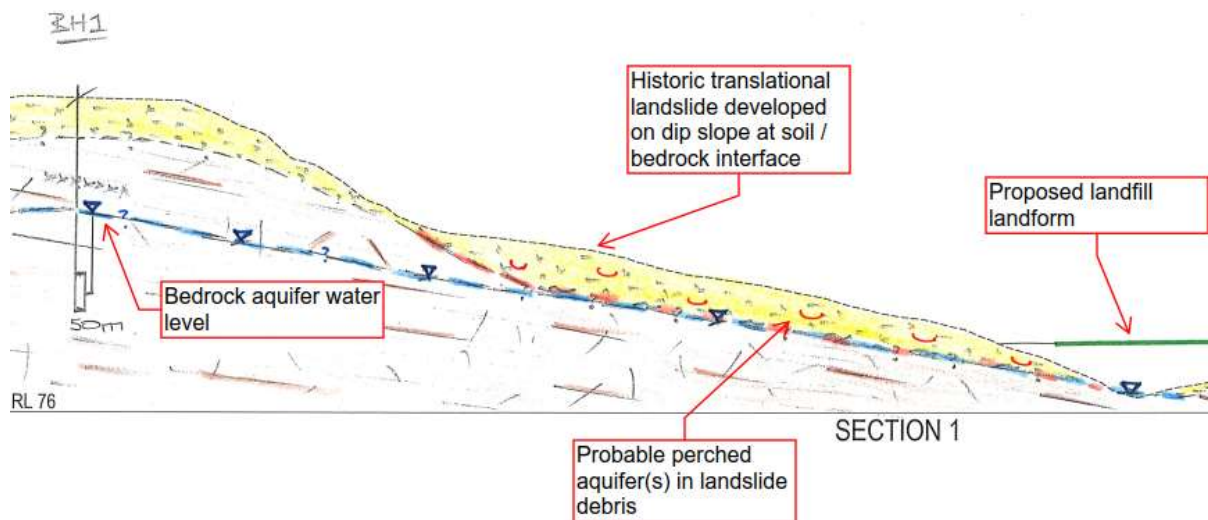
Figure 5.2: Conceptual ground model for historic translational landslide in lower southern flank of Valley 1

Probable historic landslide features are evident in the vicinity of BH13 on the access road alignment and below BH1 in the landfill footprint (Figures 5.1 and 5.2 below). These appear to be translational landslides located at, or in close proximity, to the soil / rock interface and in association with groundwater seepage. We have not observed any evidence of more deep seated slope instability within the Pakiri Formation bedrock. Clay seams and some polished defects were observed in boreholes BH12 and BH13 at, or near, the soil bedrock interface.

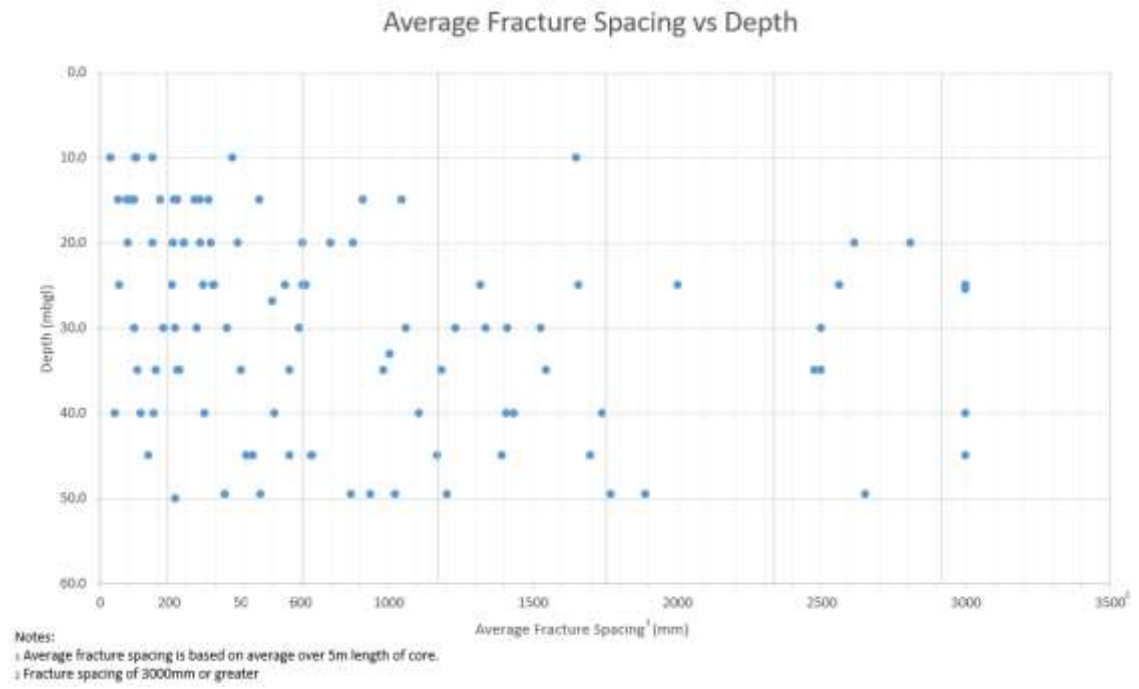
Figure 8.1: Average fracture spacing vs depth of in-situ rock

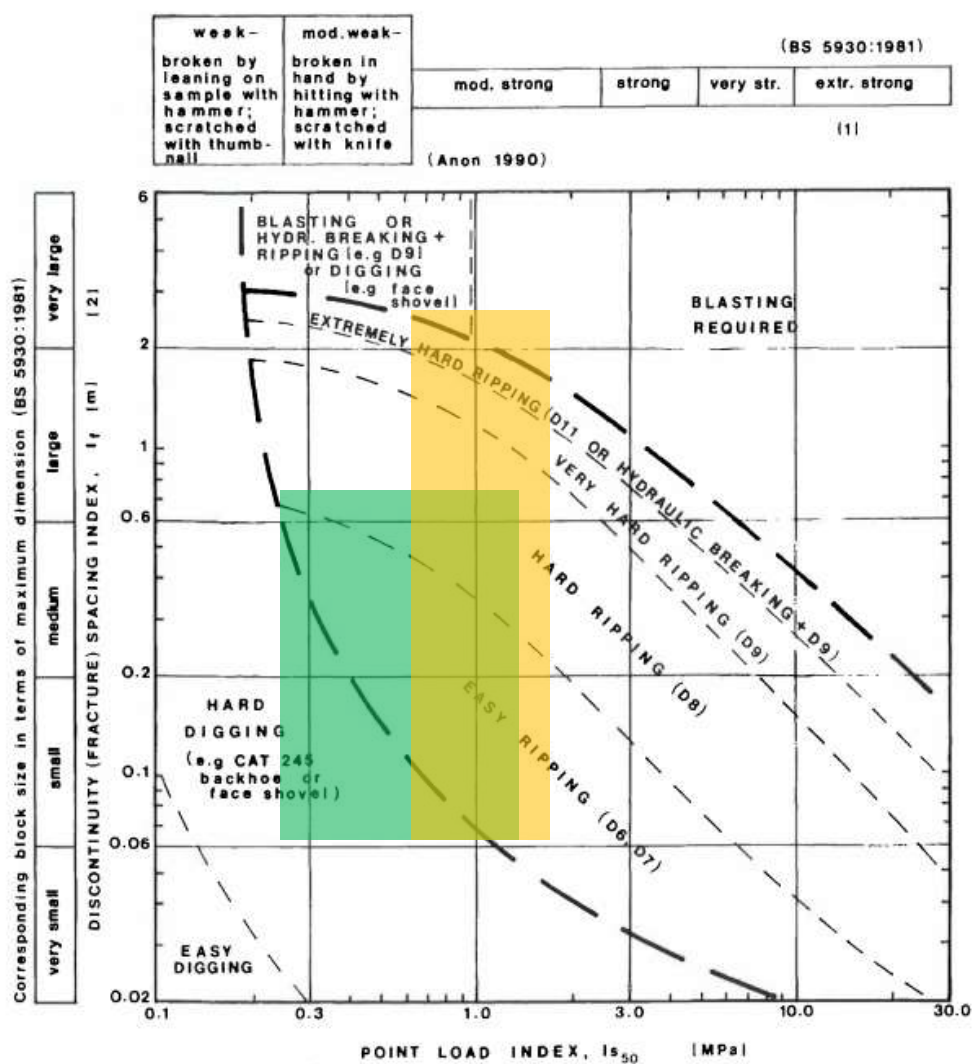
Figure 8.2: Ripability chart (Pettifer and Fookes, 1994)

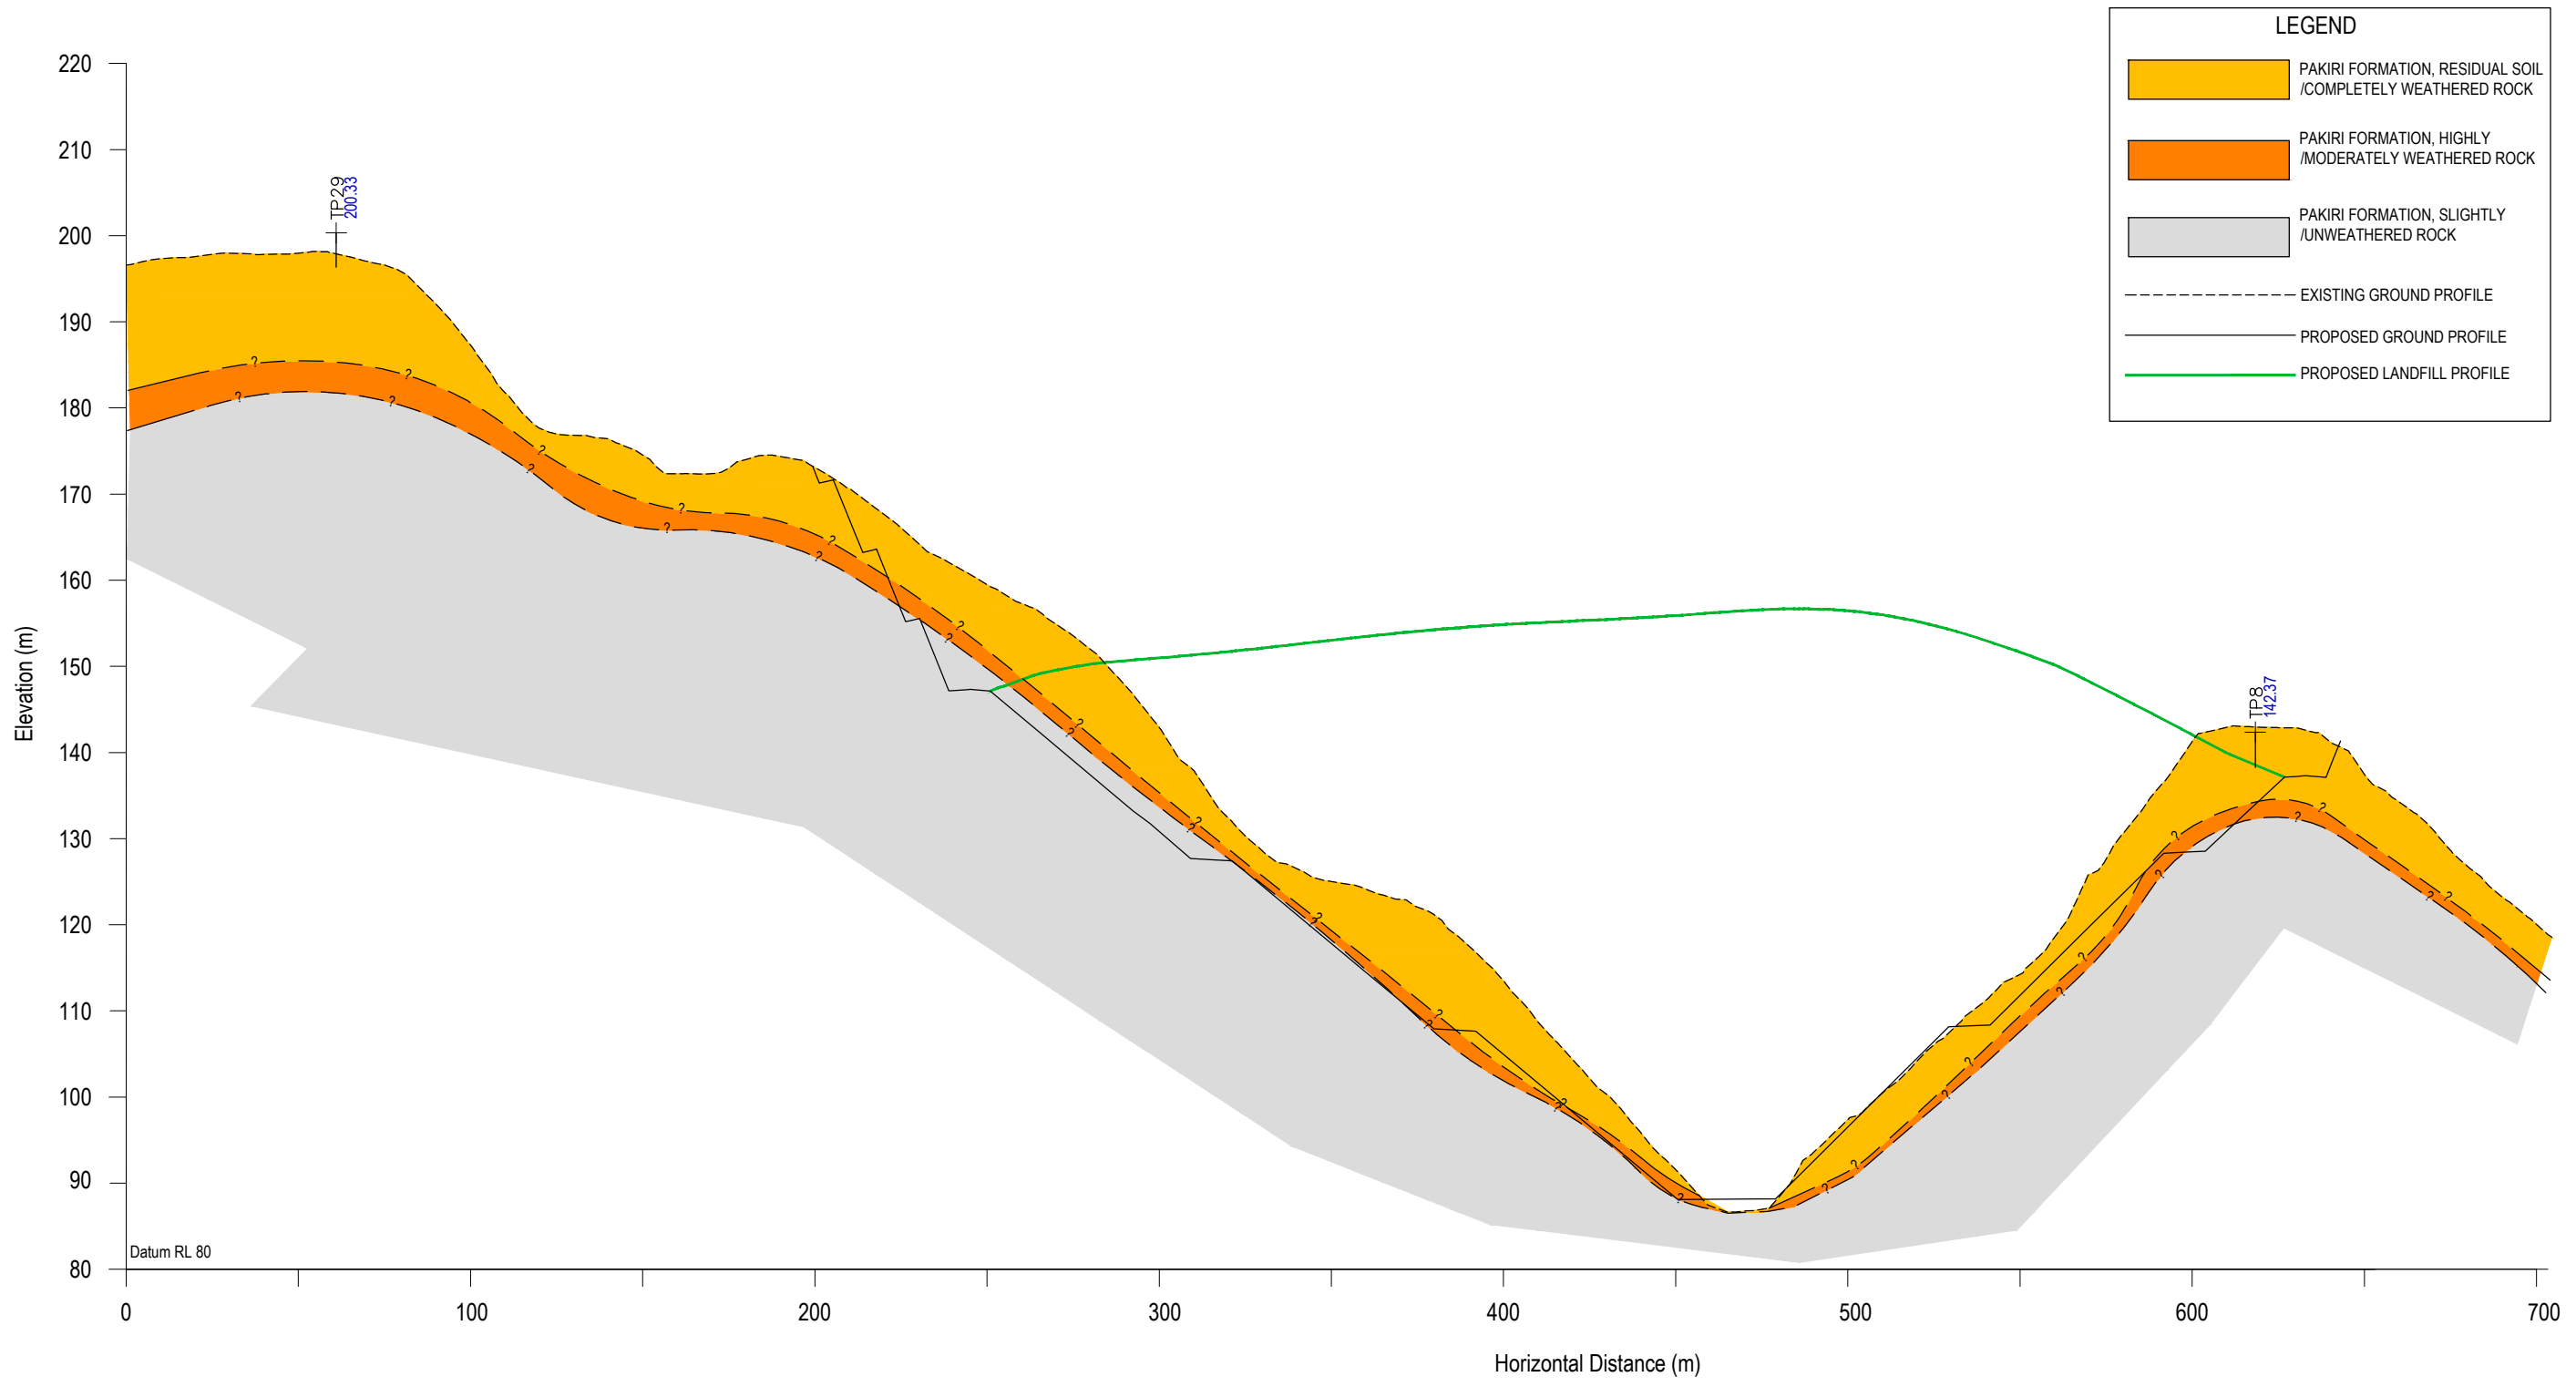
CLIENT	WASTE MANAGEMENT NZ Ltd
PROJECT	AUCKLAND REGIONAL LANDFILL PROJECT
TITLE	GEOLOGICAL SECTION Section 2
SCALE (A3)	1:2000 H (1:800V) FIG No. GM-F04
REV	1

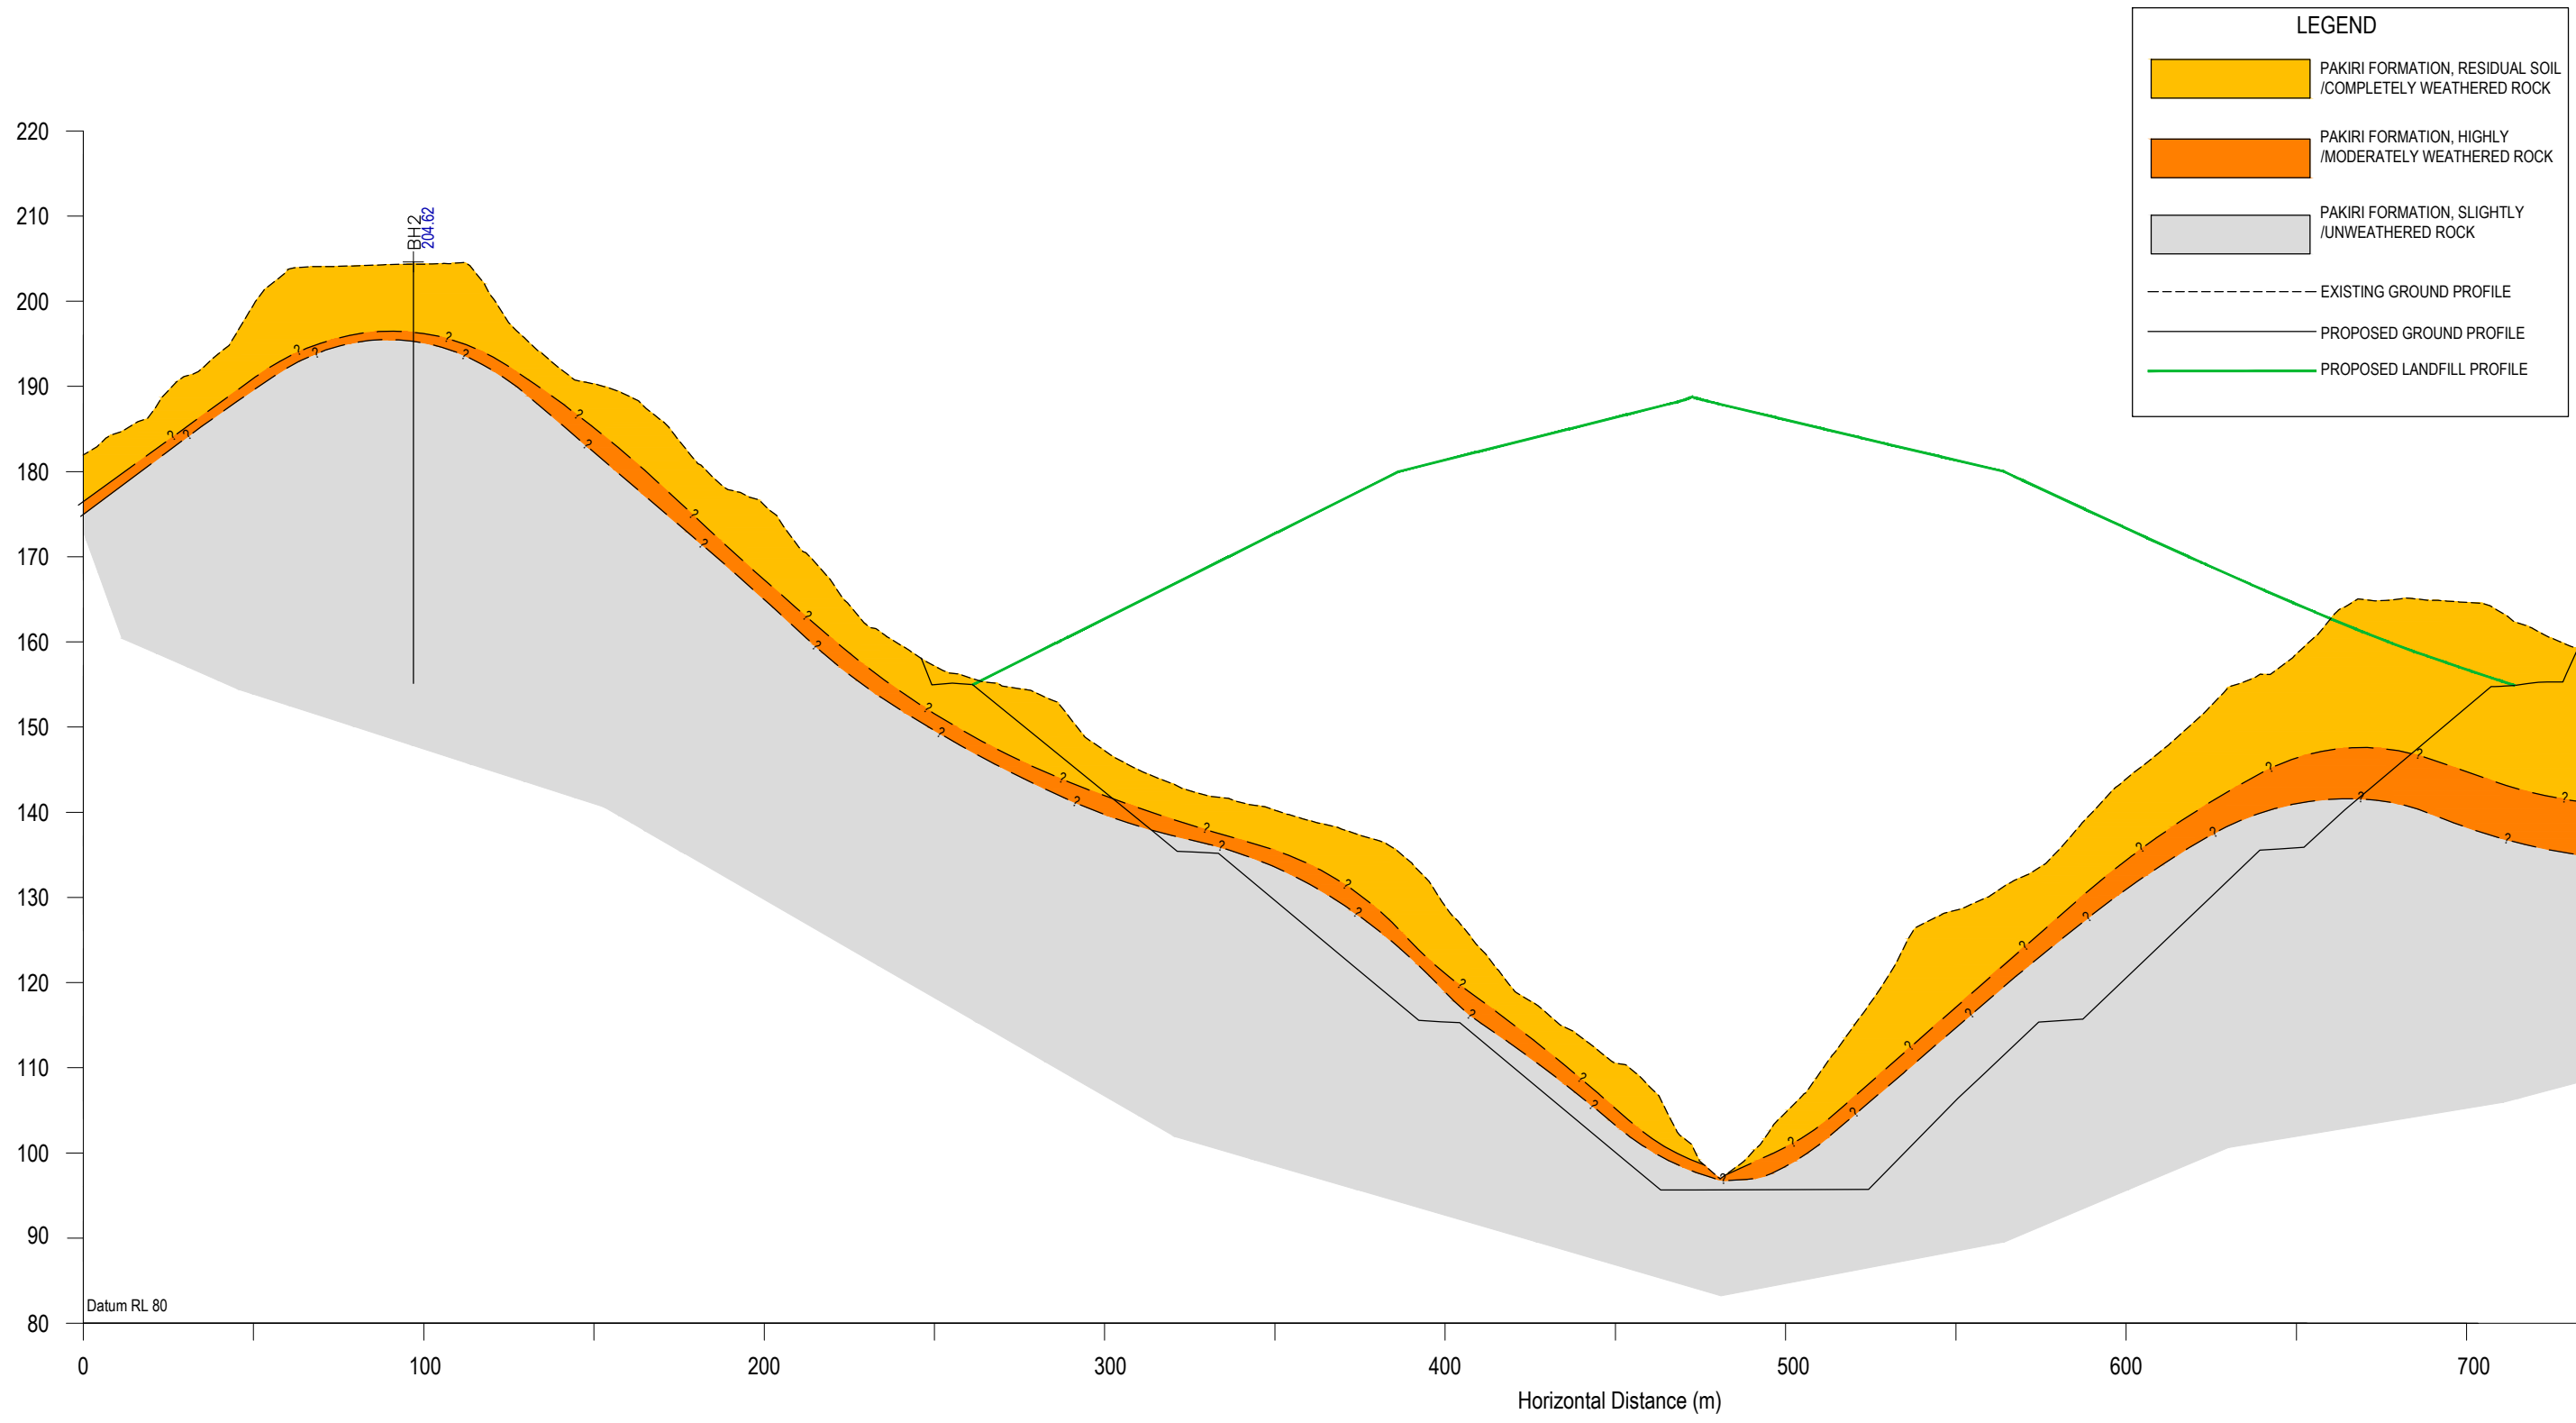
CLIENT	WASTE MANAGEMENT NZ Ltd
PROJECT	AUCKLAND REGIONAL LANDFILL PROJECT
TITLE	GEOLOGICAL SECTION Section 3
SCALE (A3)	1:2000 H (1:800V) FIG No. GM-F05
REV	1

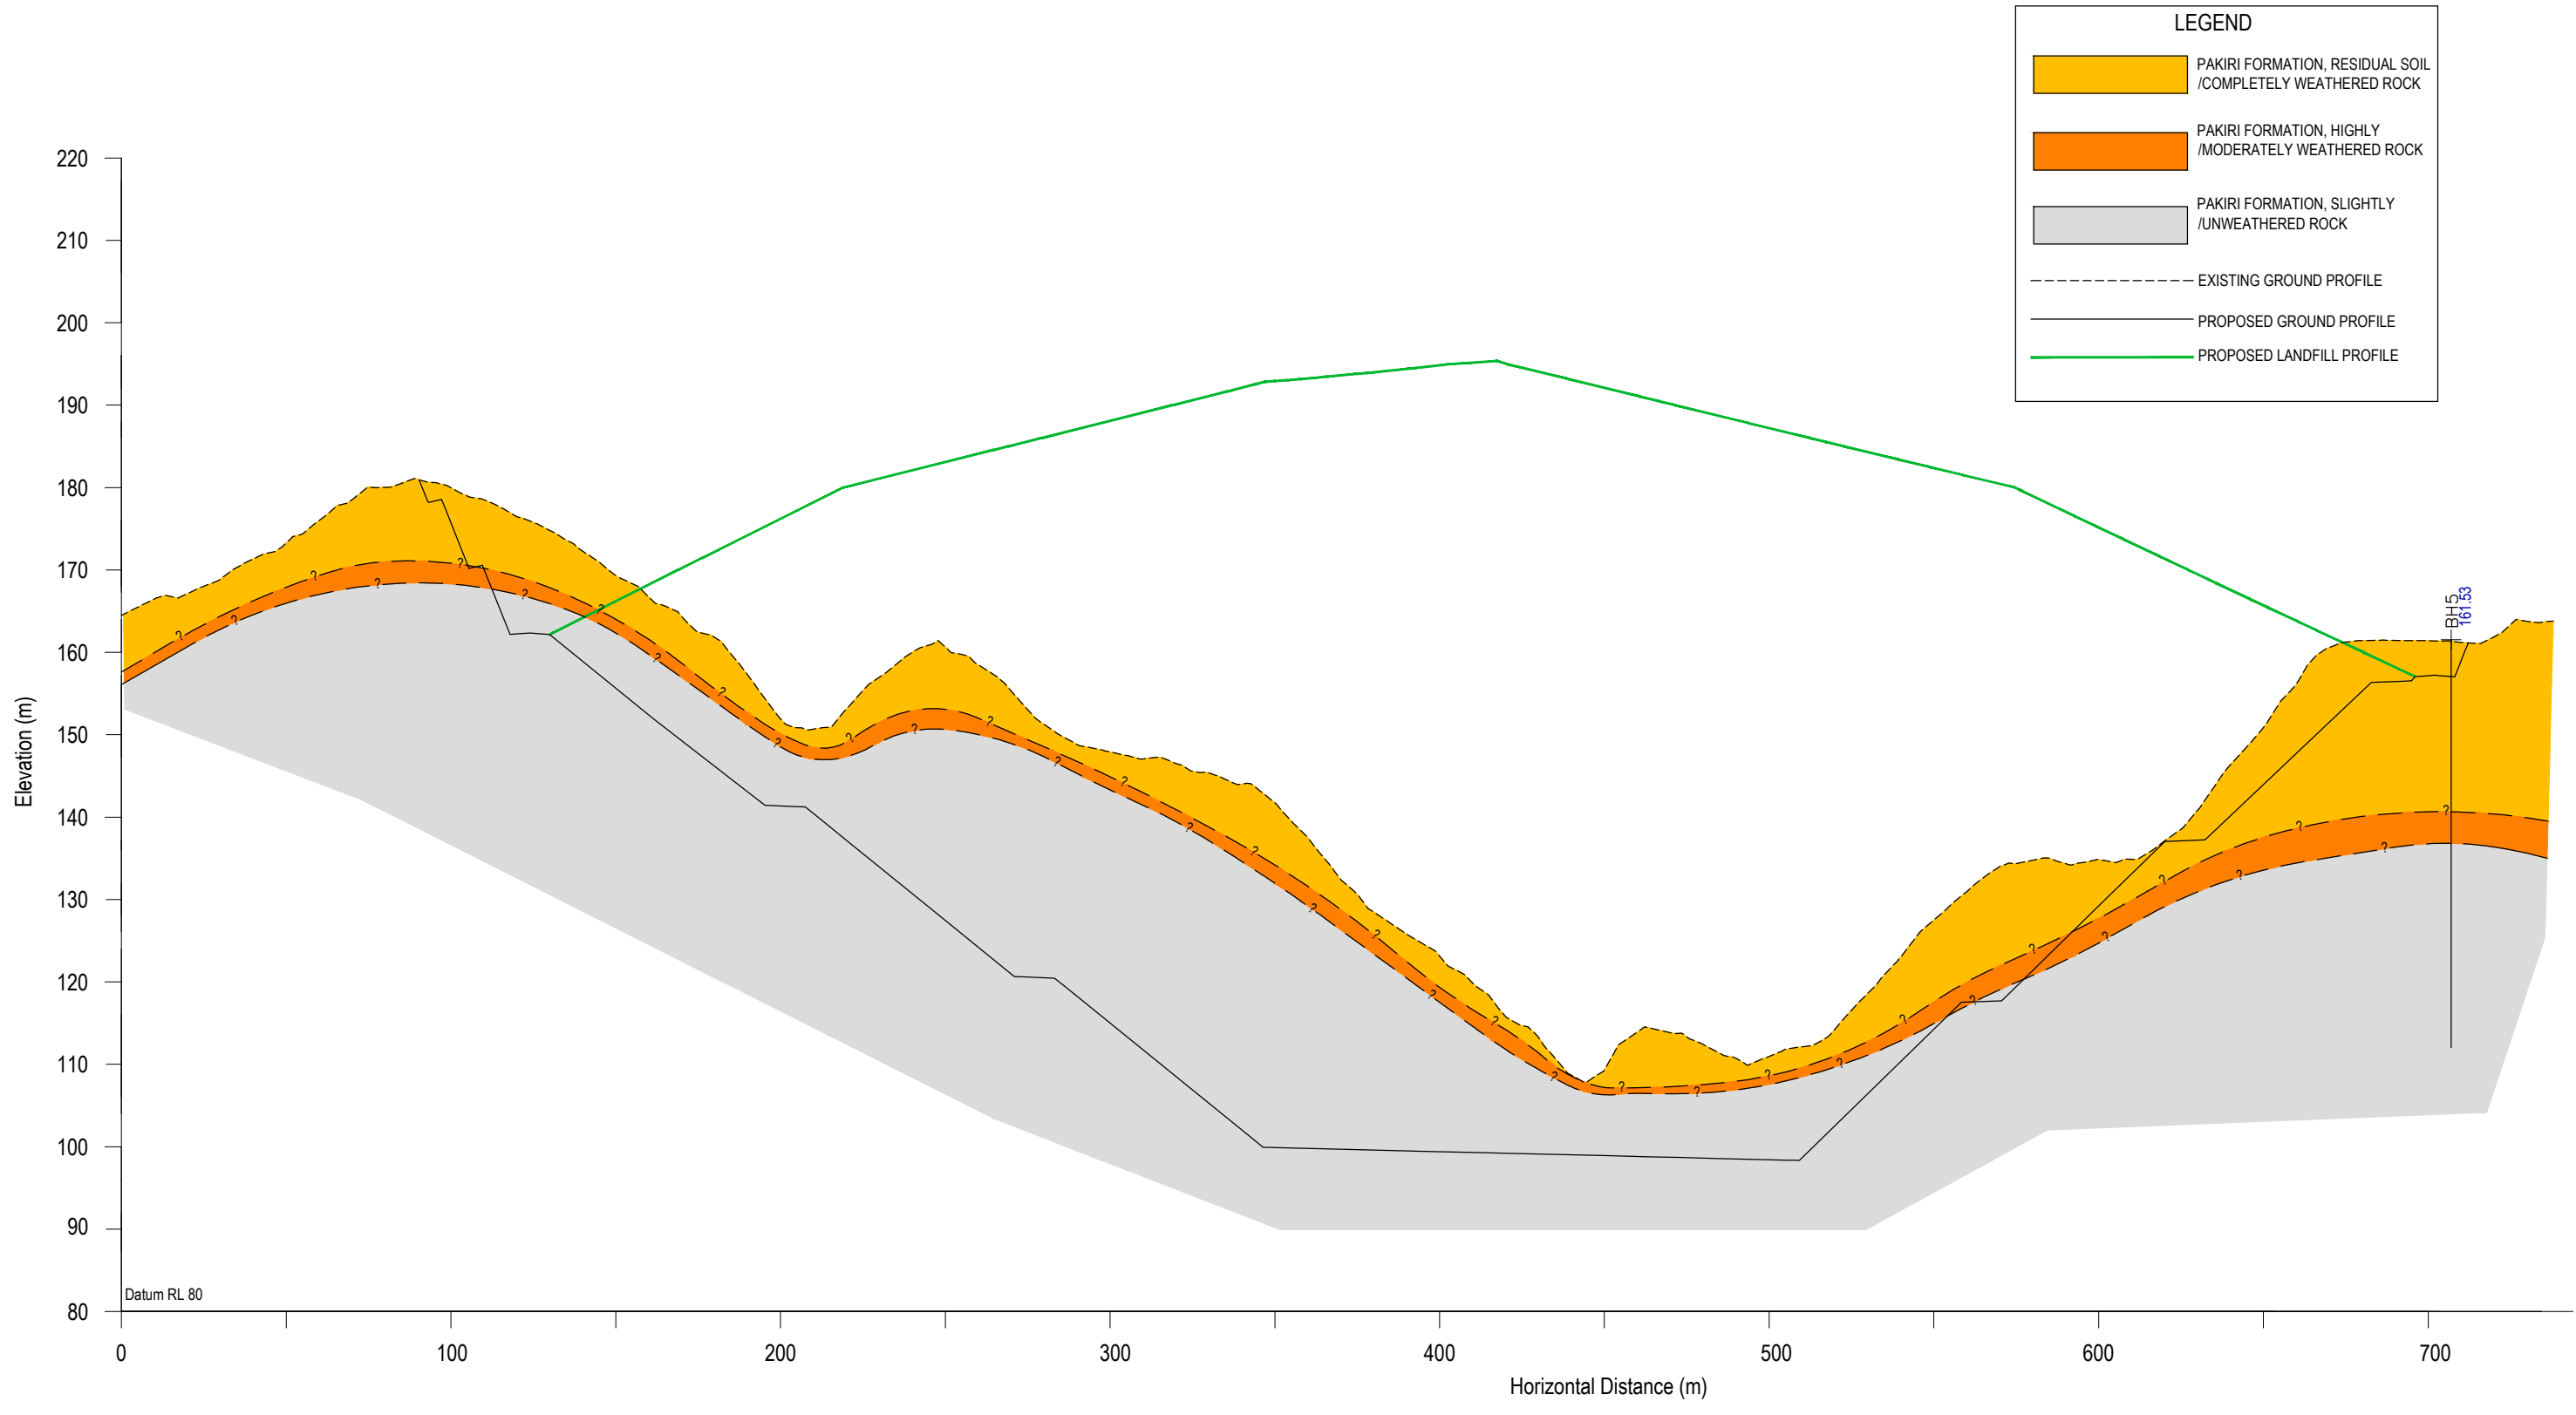
CLIENT	WASTE MANAGEMENT NZ Ltd
PROJECT	AUCKLAND REGIONAL LANDFILL PROJECT
TITLE	GEOLOGICAL SECTION Section 4
SCALE (A3)	1:2000 H (1:800V) FIG No. GM-F06
REV	1

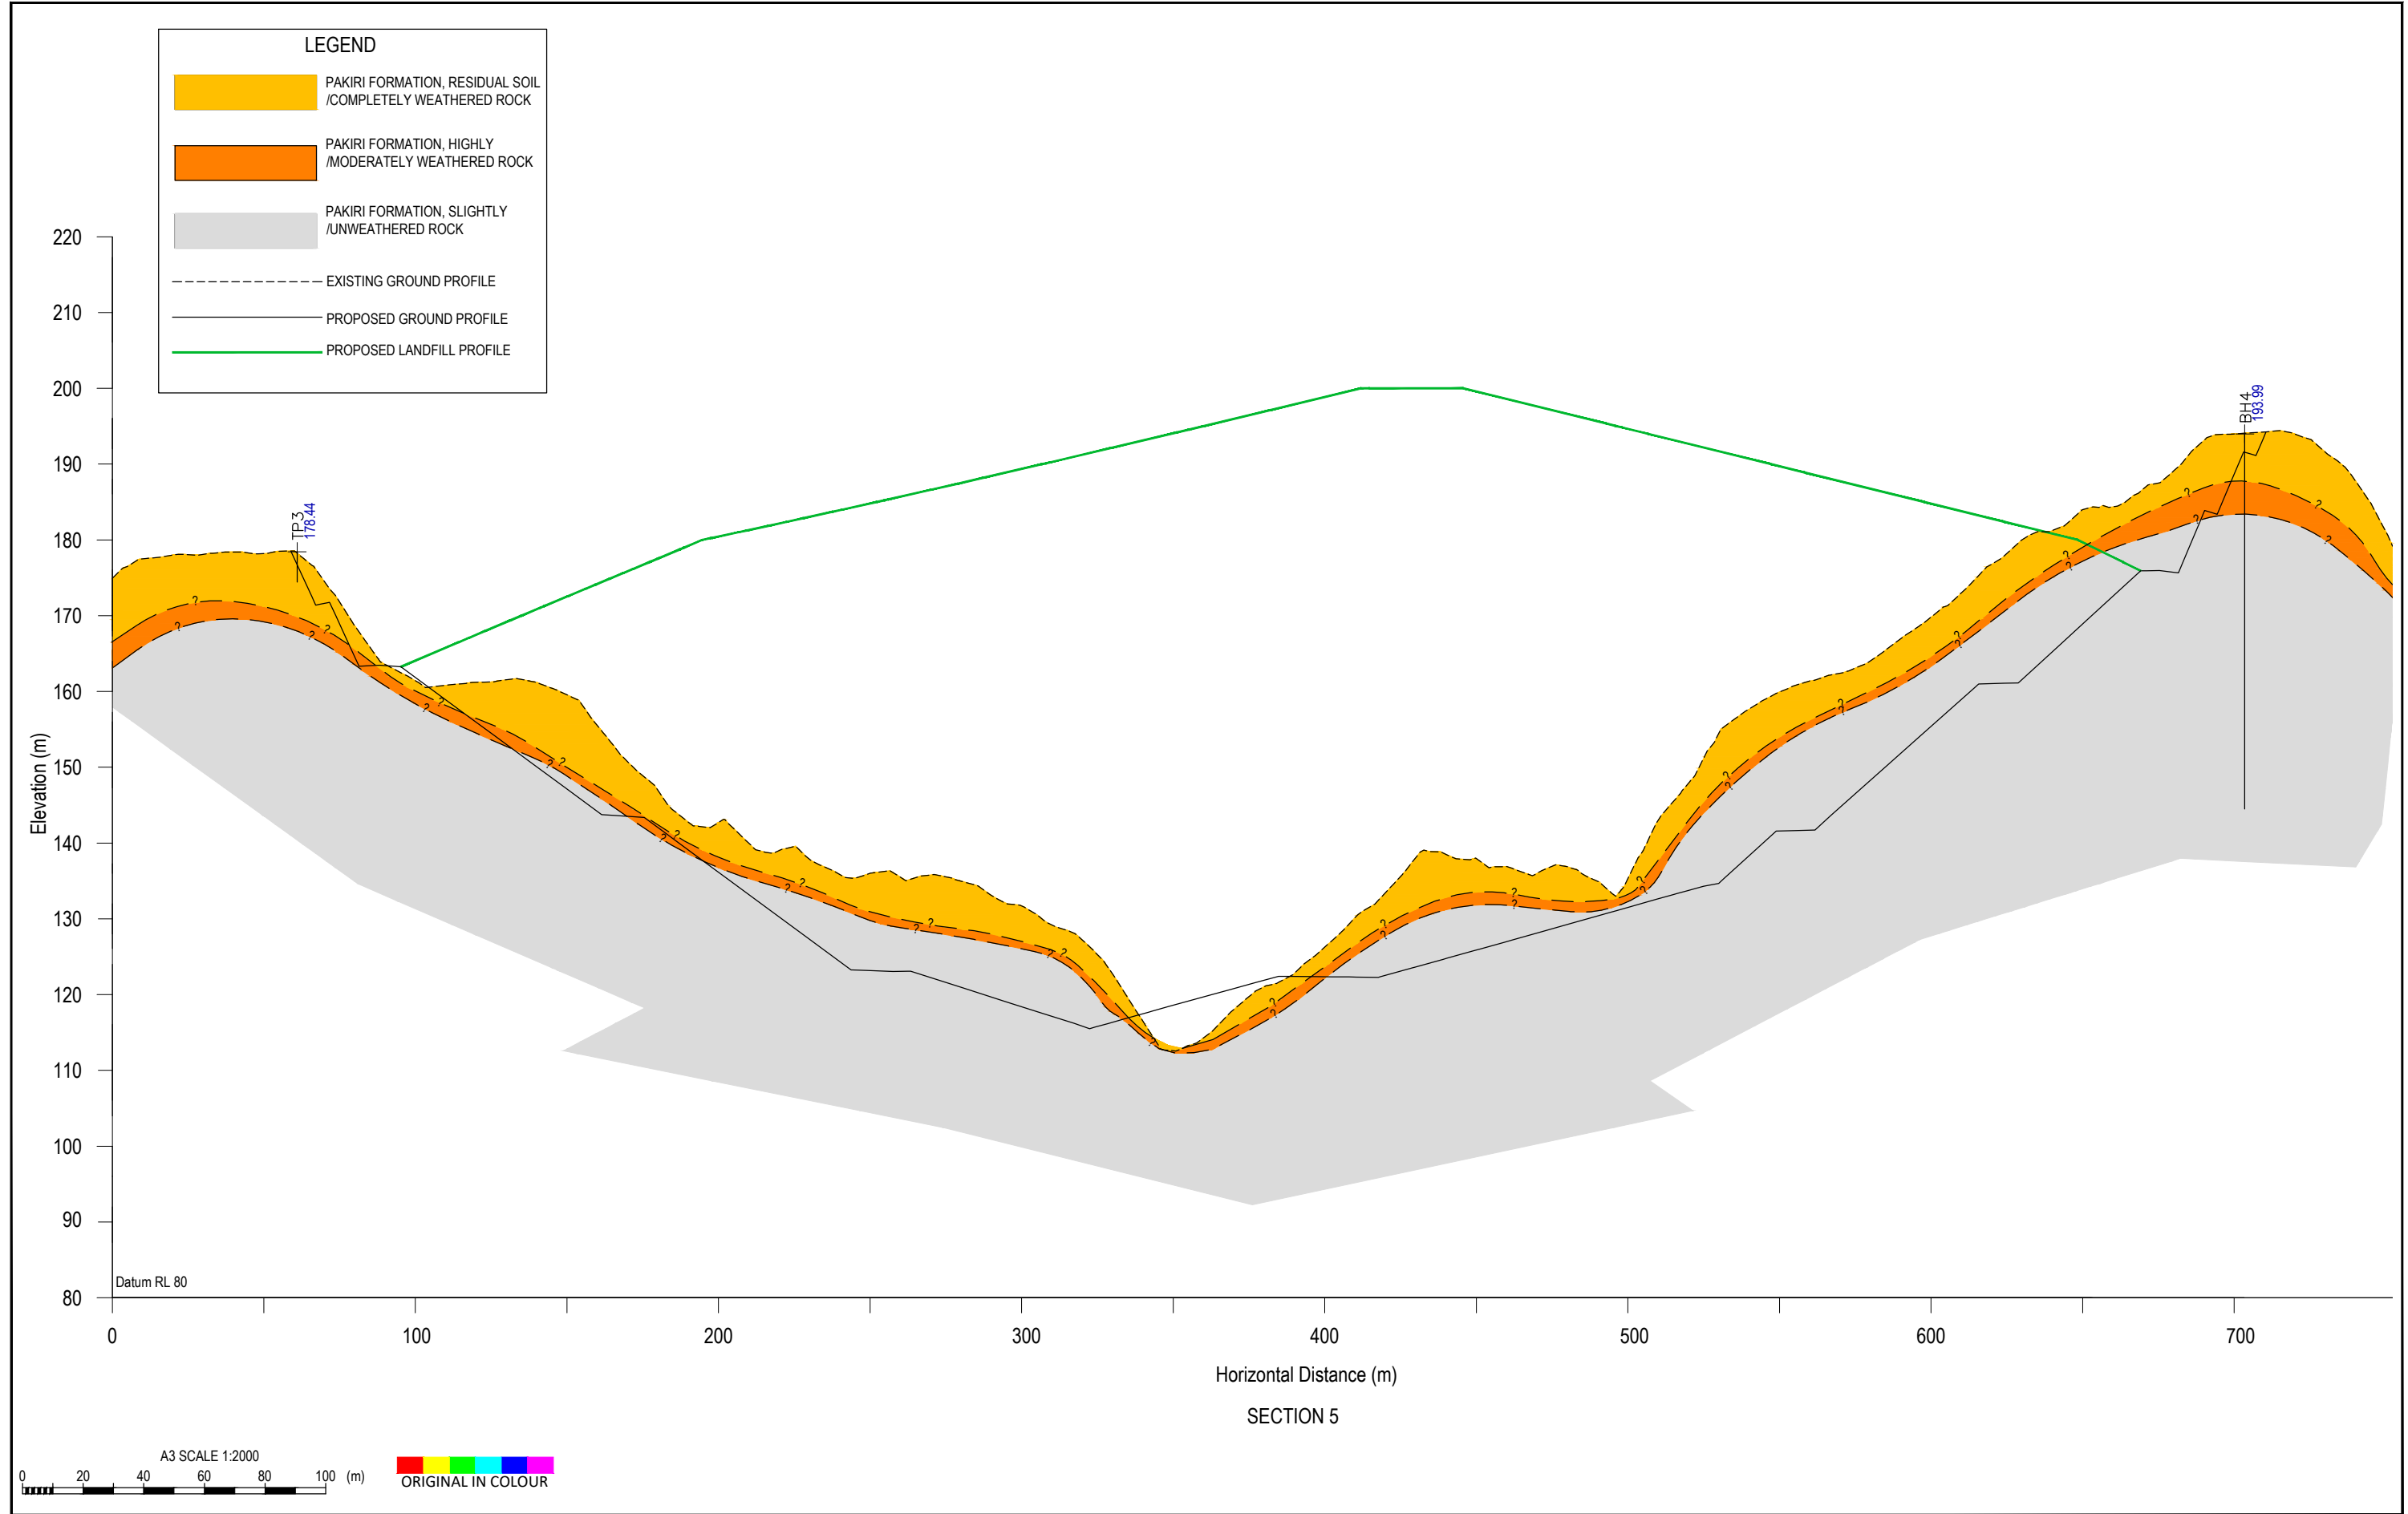
CLIENT	WASTE MANAGEMENT NZ Ltd
PROJECT	AUCKLAND REGIONAL LANDFILL PROJECT
TITLE	GEOLOGICAL SECTION Section 5
SCALE (A3)	1:2000 H (1:800V) FIG No. GM-F07
REV	1
