Title: Auckland Regional Landfill					
Date	Version	Description	Prepared by:	Reviewed by:	Authorised by:
30/05/2019	1.0	Final	A. Naylor T. Coote	K. Hind	S. Eldridge

This Geotechnical Interpretive Report (GIR) describes the site geological and groundwater conditions and associated geotechnical model. This report is intended to support feasibility level design of the proposed landfill and access and application for resource consent. This report also identifies potential geotechnical risks to the project and recommends further investigation and/or analysis to avoid, remedy or mitigate these risks.

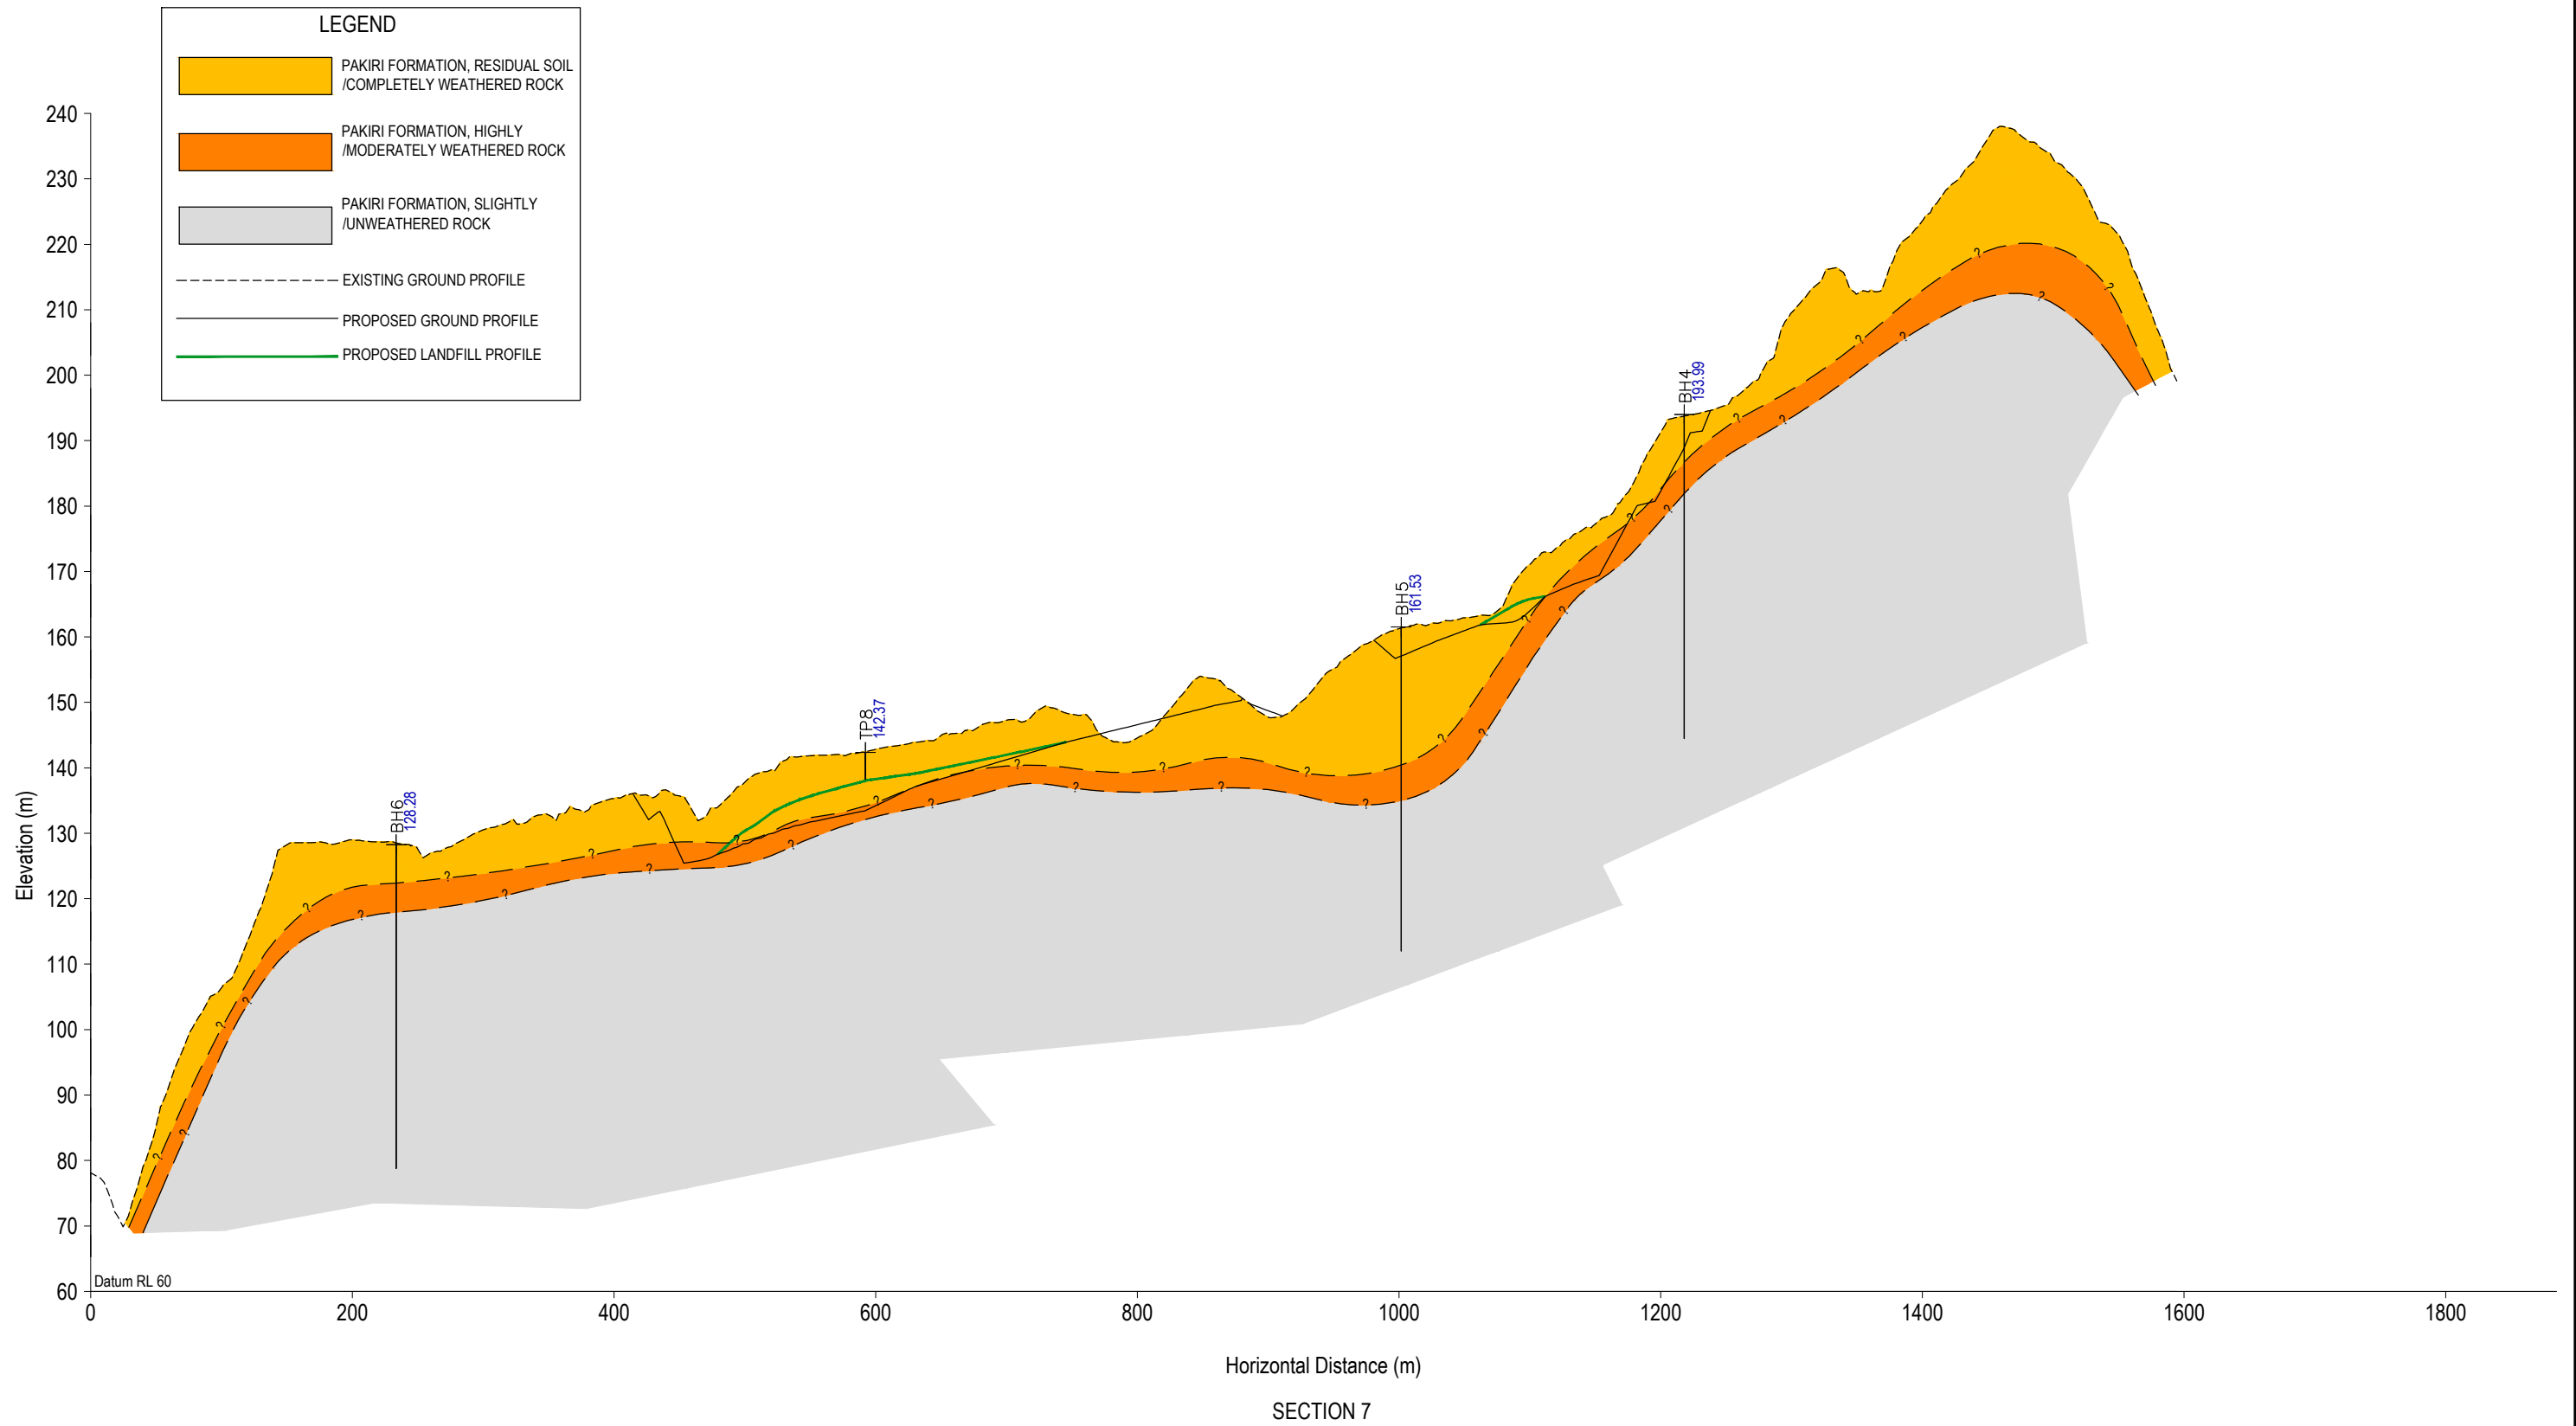
CLIENT	WASTE MANAGEMENT NZ Ltd
PROJECT	AUCKLAND REGIONAL LANDFILL PROJECT
TITLE	GEOLOGICAL SECTION Section 7
SCALE (A3)	1:5000 H (1:1000V) FIG No. GM-F09
REV	1

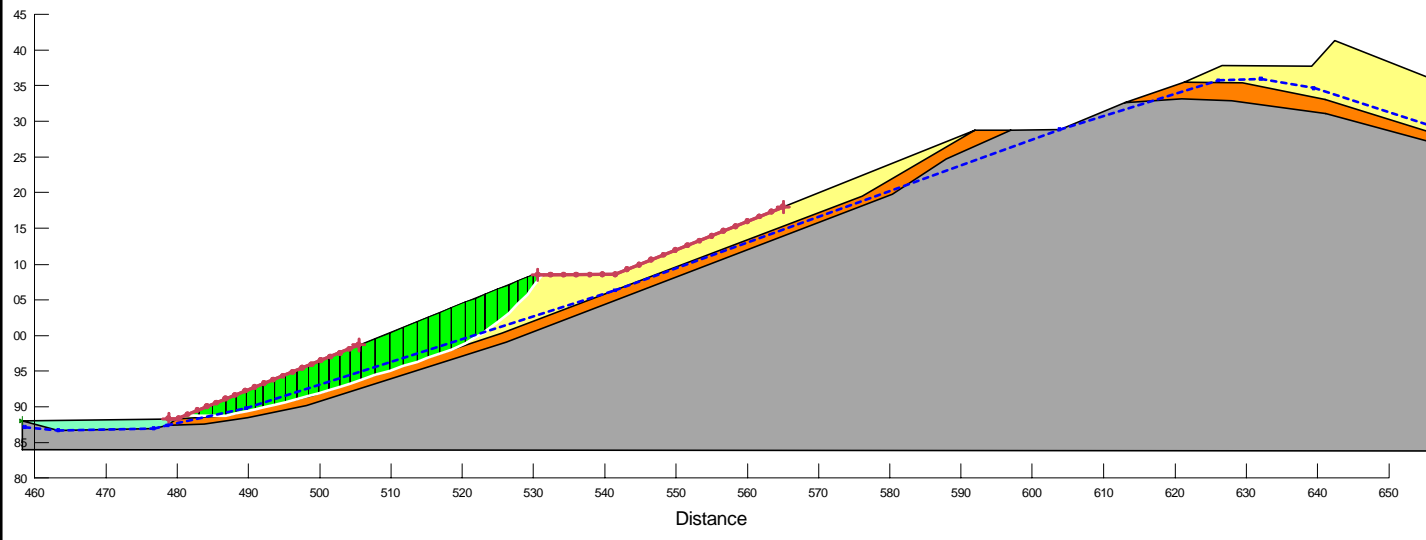
Title: Section 2 northern slope appendix.gsz	DWP Number:
		Analysis: Static long term Northern slope	Analysed by: ALNA
		Comments:	Scale: 1:750 @ A4

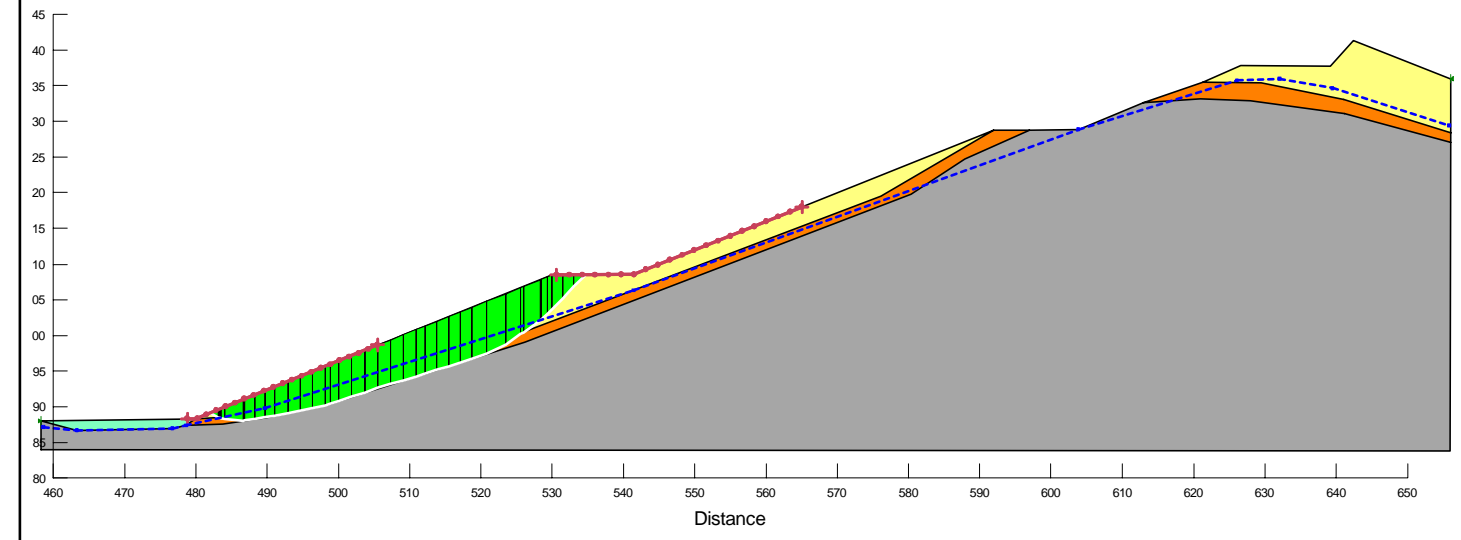
Title: Section 2 northern slope appendix.gsz	DWP Number:
		Analysis: Static short term Northern slope	Analysed by: ALNA
		Comments:	Scale: 1:750 @ A4

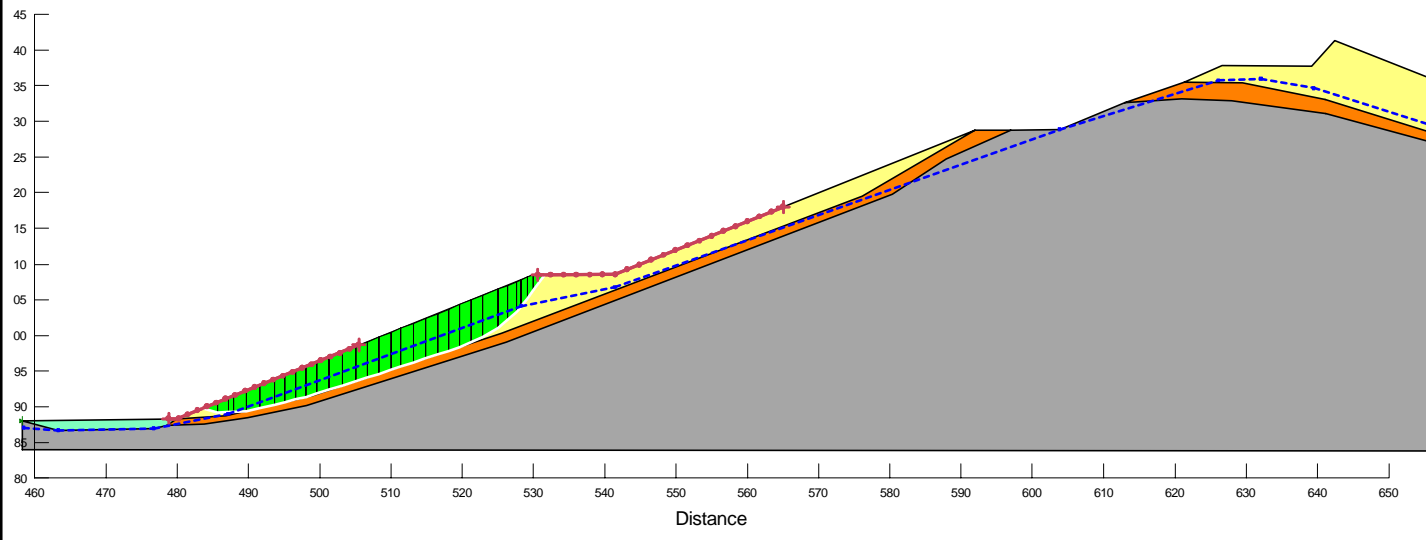
Title: Section 2 northern slope appendix.gsz	DWP Number:
		Analysis: Static elevated groundwater Northern slope	Analysed by: ALNA
		Comments:	Scale: 1:750 @ A4

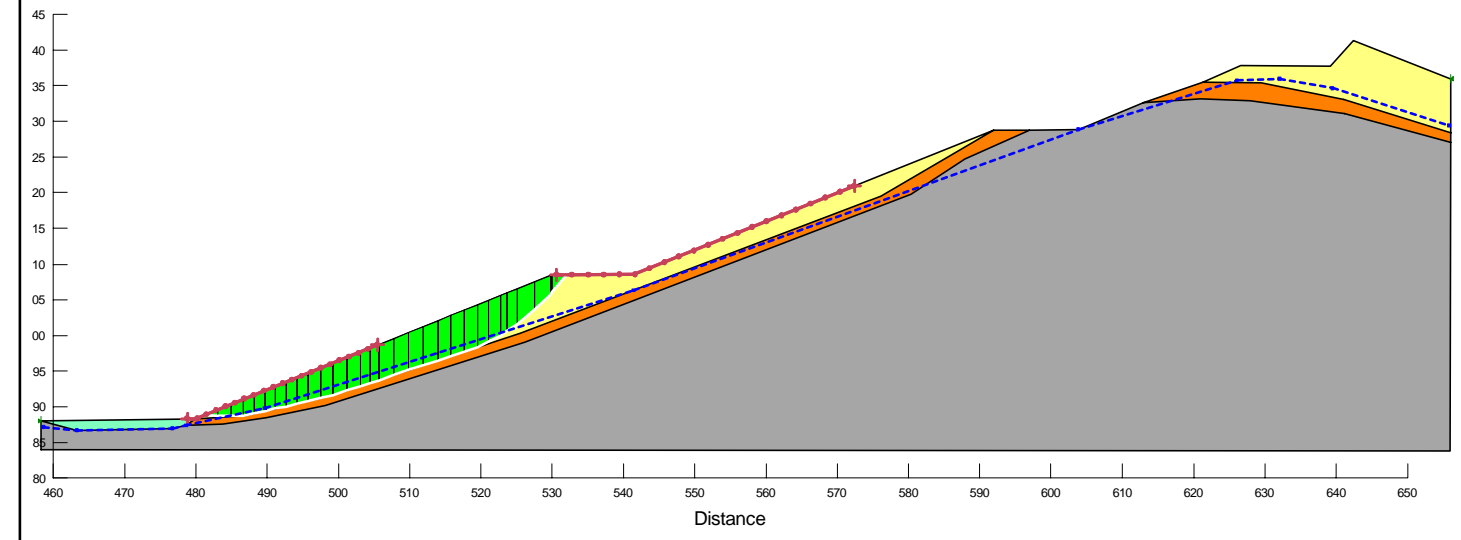
Title: Section 2 northern slope appendix.gsz	DWP Number:
		Analysis: Seismic ULS Northern slope	Analysed by: ALNA
		Comments:	Scale: 1:750 @ A4

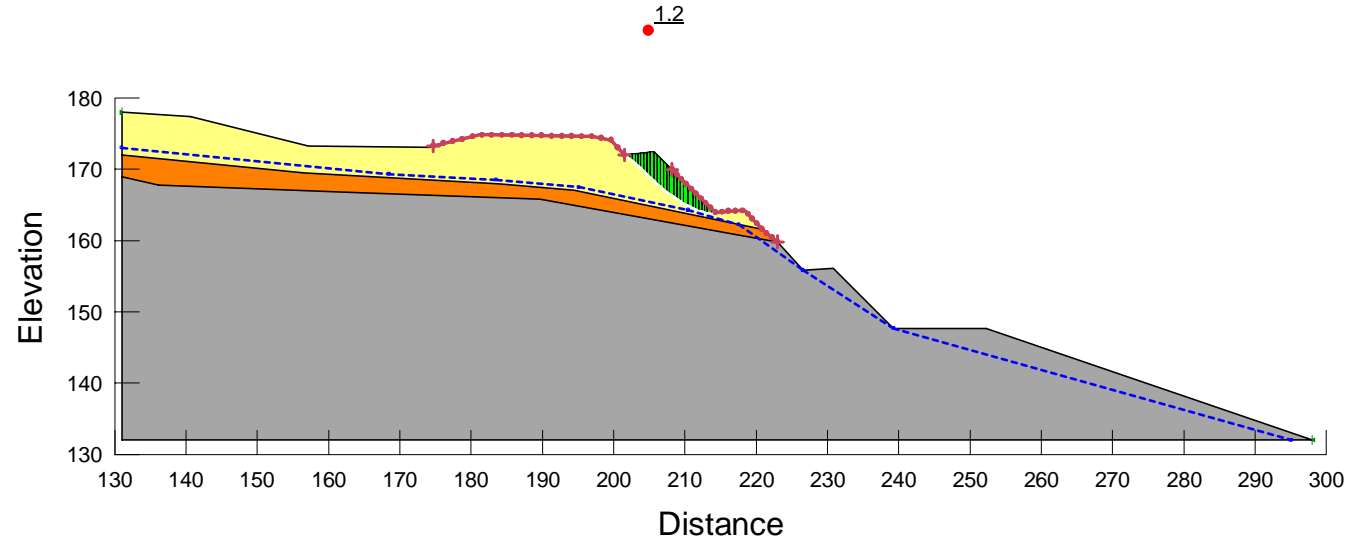
Title: Section 2 southern slope appendix.gsz	DWP Number:
		Analysis: Static long term Southern slope	Analysed by: ALNA
		Comments:	Scale: 1:750 @ A4

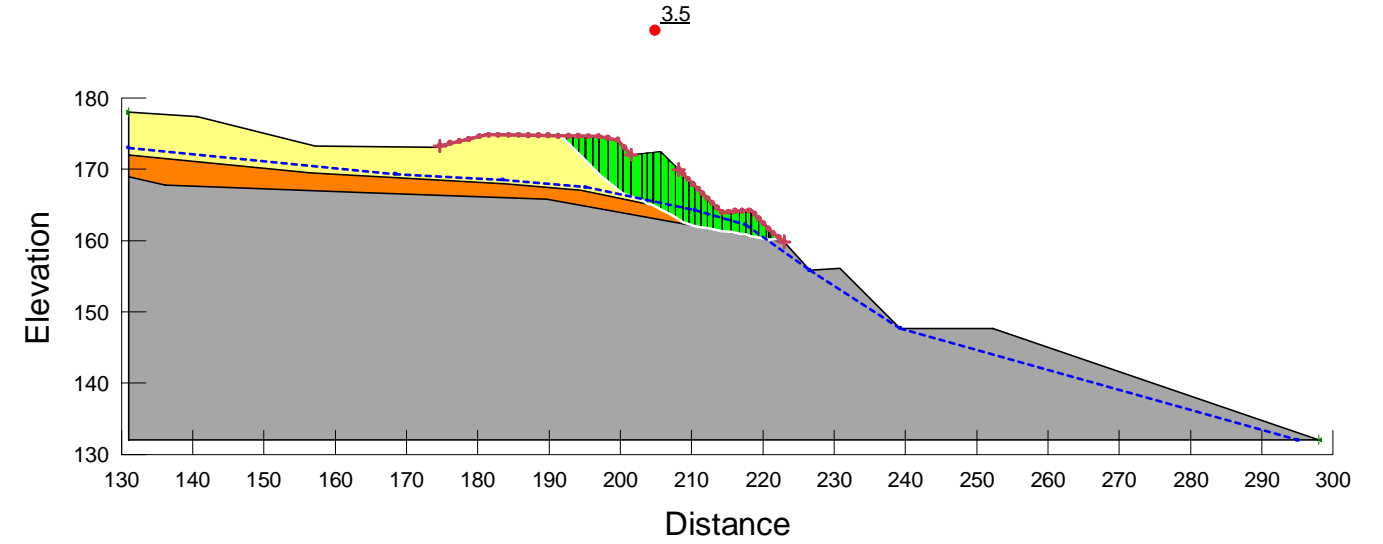
Title: Section 2 southern slope appendix.gsz	DWP Number:
		Analysis: Static short term Southern slope	Analysed by: ALNA
		Comments:	Scale: 1:750 @ A4

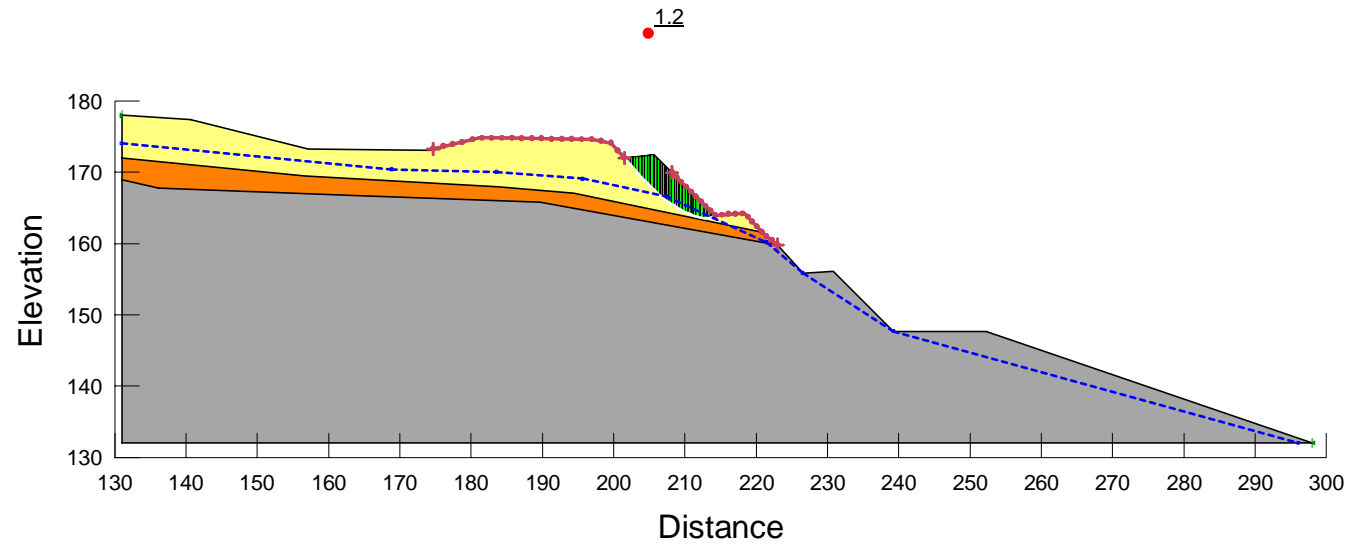
Title: Section 2 southern slope appendix.gsz	DWP Number:
		Analysis: Static elevated groundwater Southern slope	Analysed by: ALNA
		Comments:	Scale: 1:750 @ A4

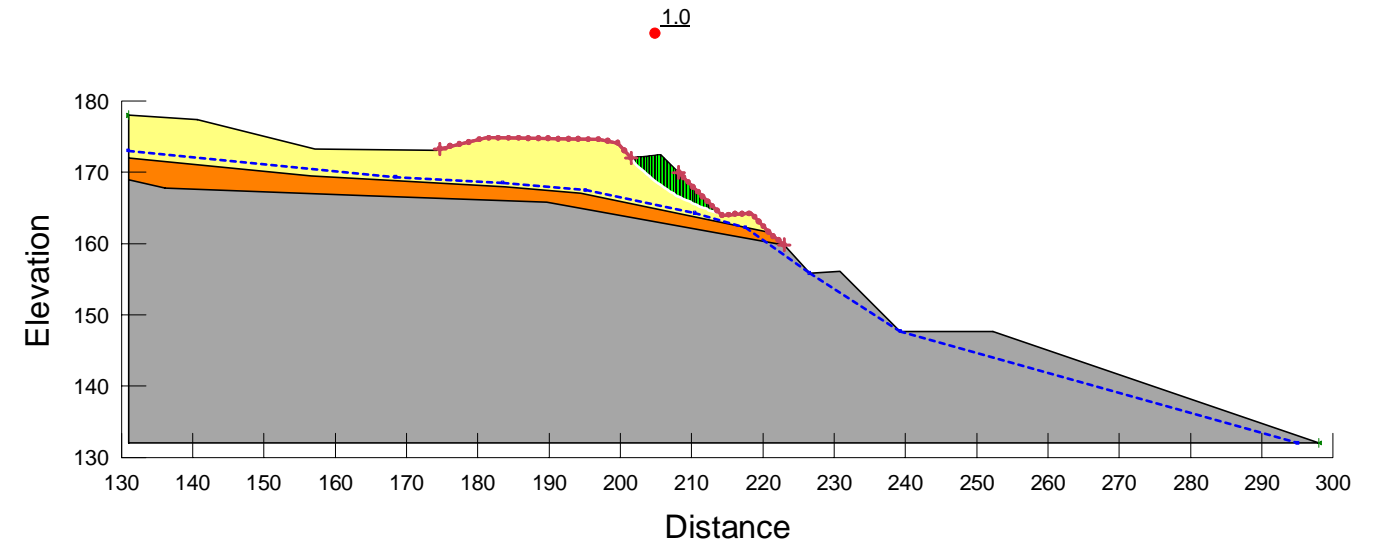
Title: Section 2 southern slope appendix.gsz	DWP Number:
		Analysis: Seismic ULS Southern slope	Analysed by: ALNA
		Comments:	Scale: 1:750 @ A4

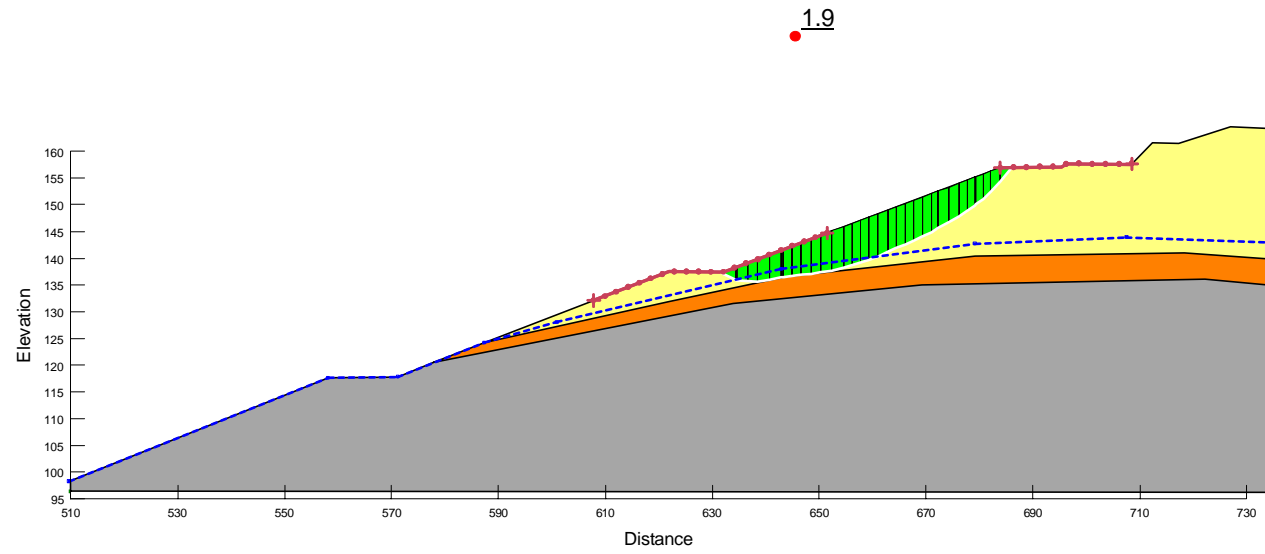
Title: Section 4 Northern slope.gsz
 Analysis: Static (long term) Northern Slope
 Comments:

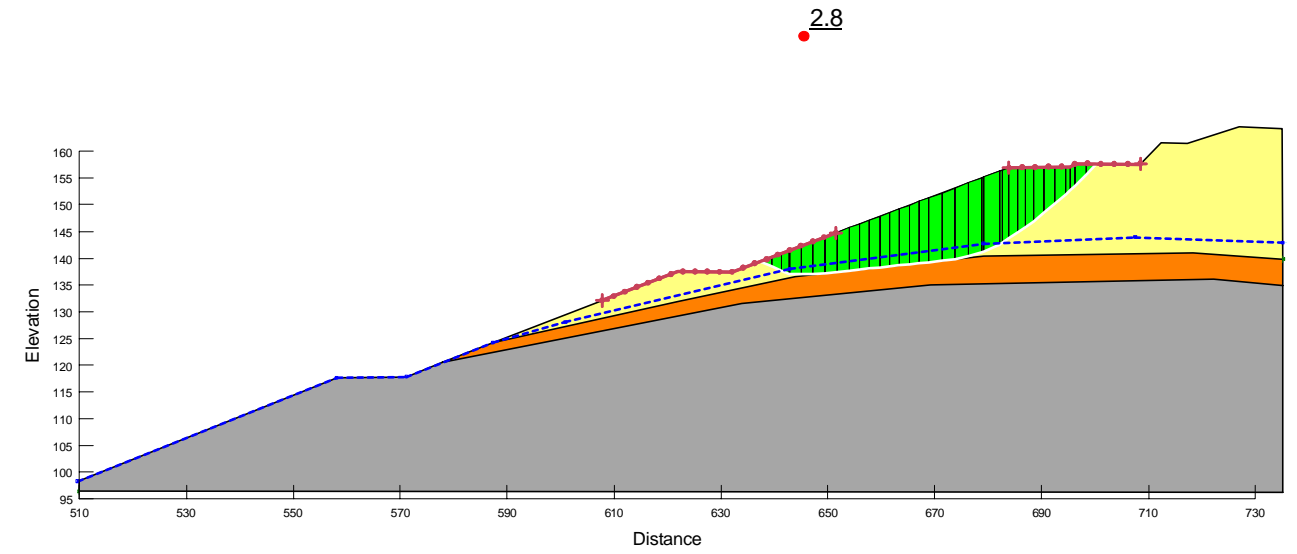
Title: Section 4 Northern slope.gsz
 Analysis: Static (short term) Northern Slope
 Comments:

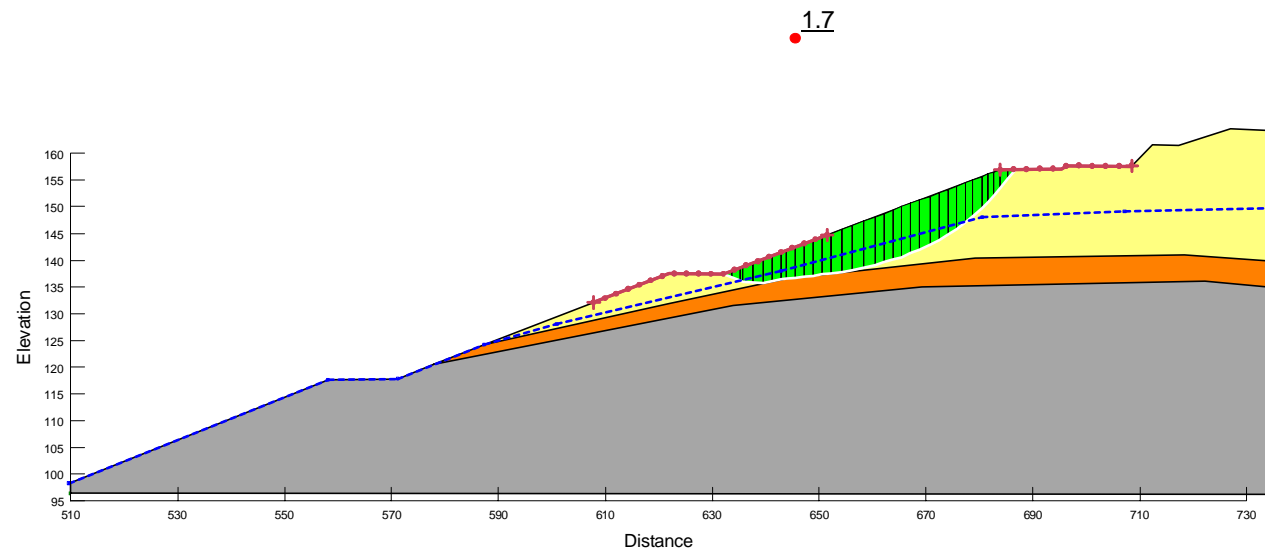
Title: Section 4 Northern slope.gsz
 Analysis: Static (elevated groundwater) Northern Slope
 Comments:

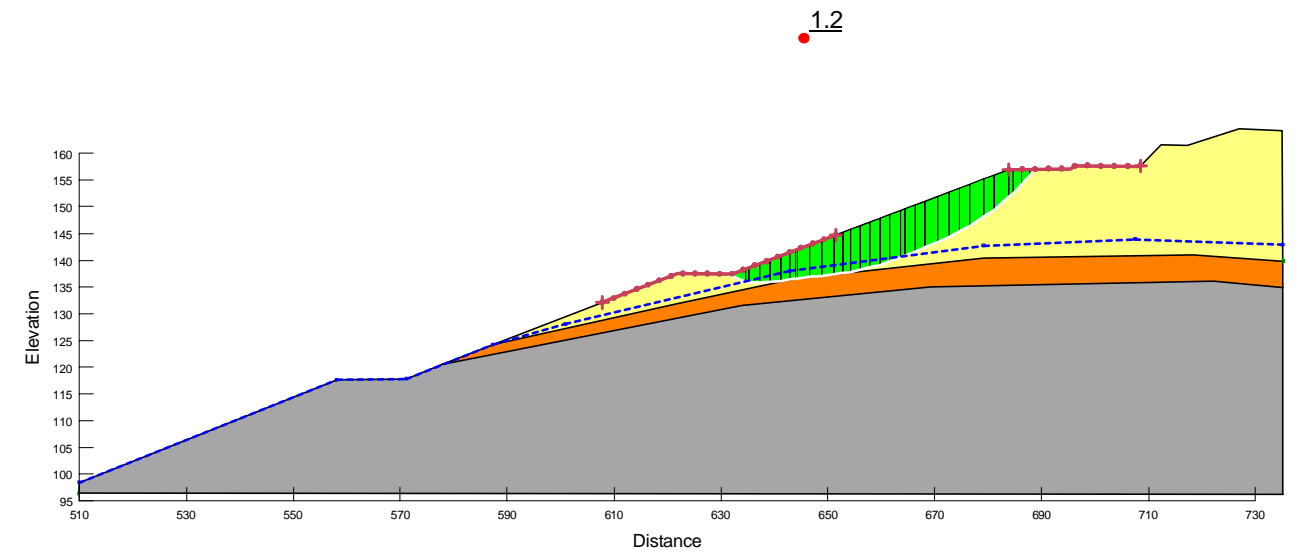
Title: Section 4 Northern slope.gsz
 Analysis: Seismic ULS Northern Slope
 Comments:

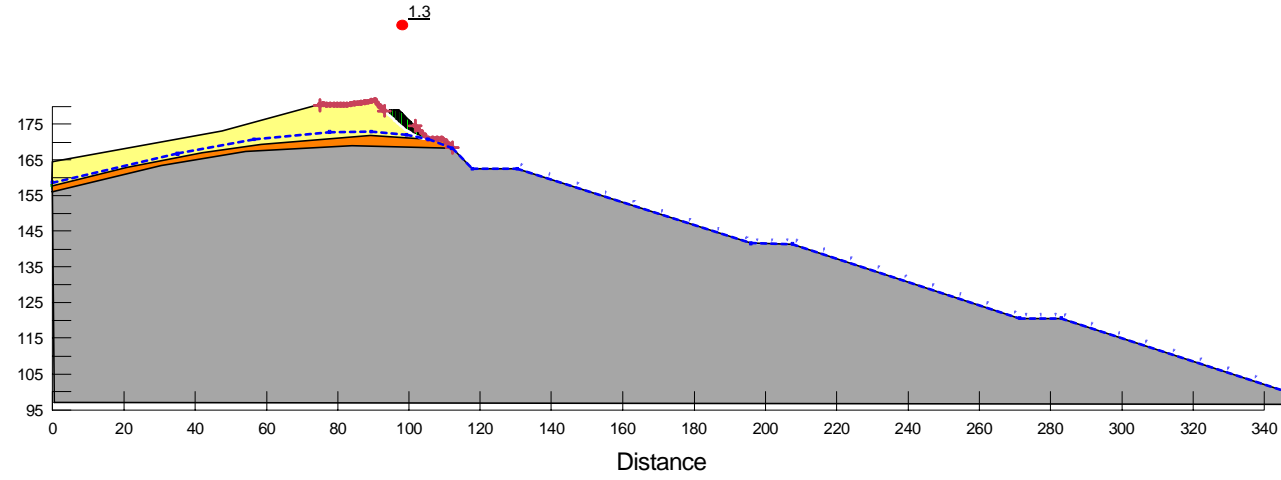
Title: Section 4 Southern slope.gsz	DWP Number:
		Analysis: Static (long term) Southern Slope	Analysed by: ALNA
		Comments:	Scale: 1:1,500 @ A4

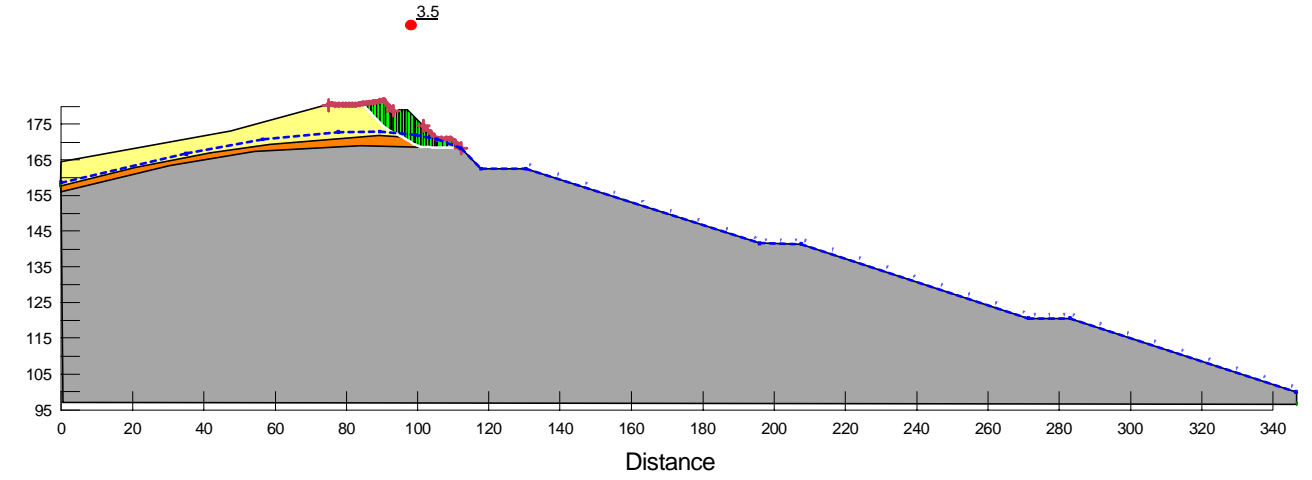
Title: Section 4 Southern slope.gsz	DWP Number:
		Analysis: Static (short term) Southern Slope	Analysed by: ALNA
		Comments:	Scale: 1:1,500 @ A4

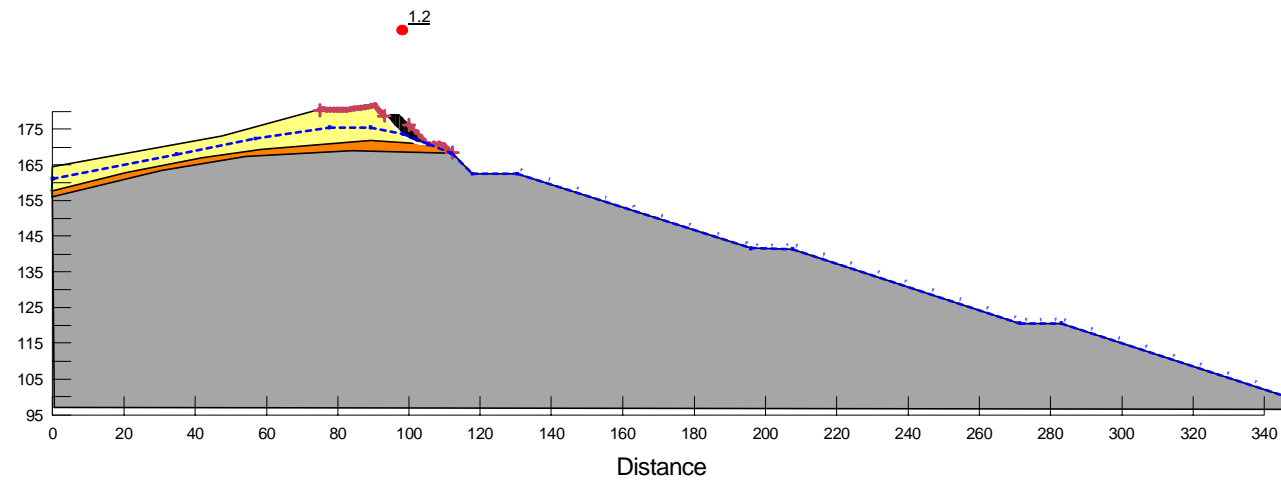
Title: Section 4 Southern slope.gsz	DWP Number:
		Analysis: Static (elevated groundwater) Southern Slope	Analysed by: ALNA
		Comments:	Scale: 1:1,500 @ A4

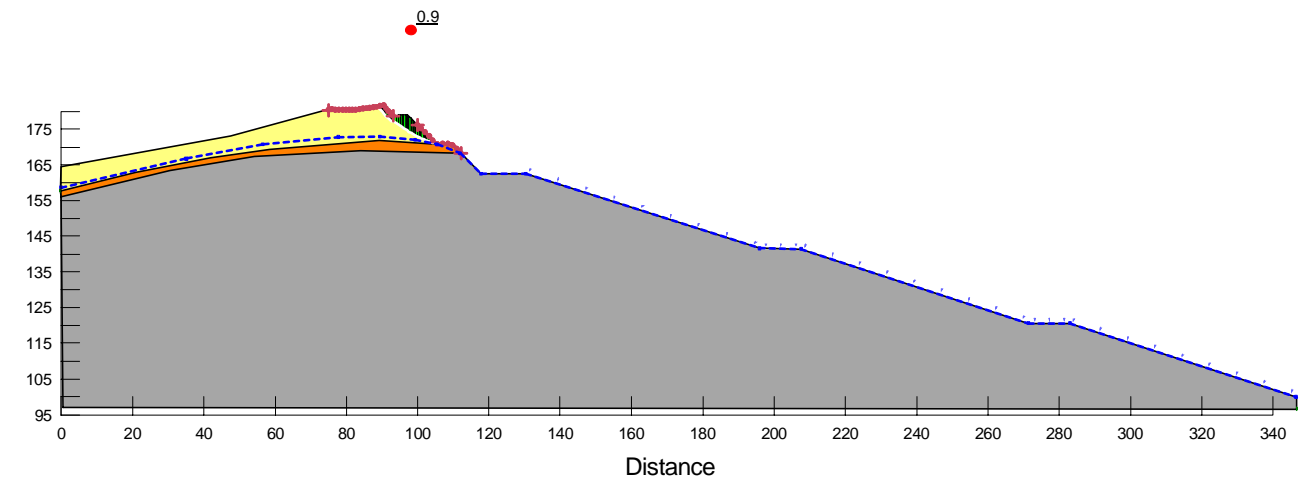
Title: Section 4 Southern slope.gsz	DWP Number:
		Analysis: Seismic ULS Southern Slope	Analysed by: ALNA
		Comments:	Scale: 1:1,500 @ A4

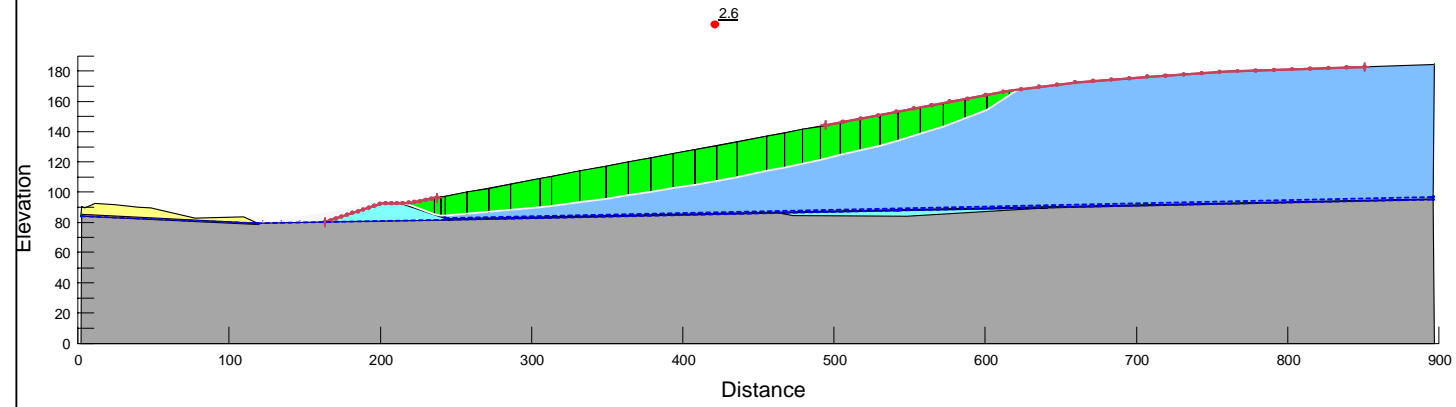
Title: Landfill Stability longsection.gsz	DWP Number:
Analysis: Static long term	Analysed by: ALNA
Comments:	Scale: 1:2,500 @ A3
	Checked by:

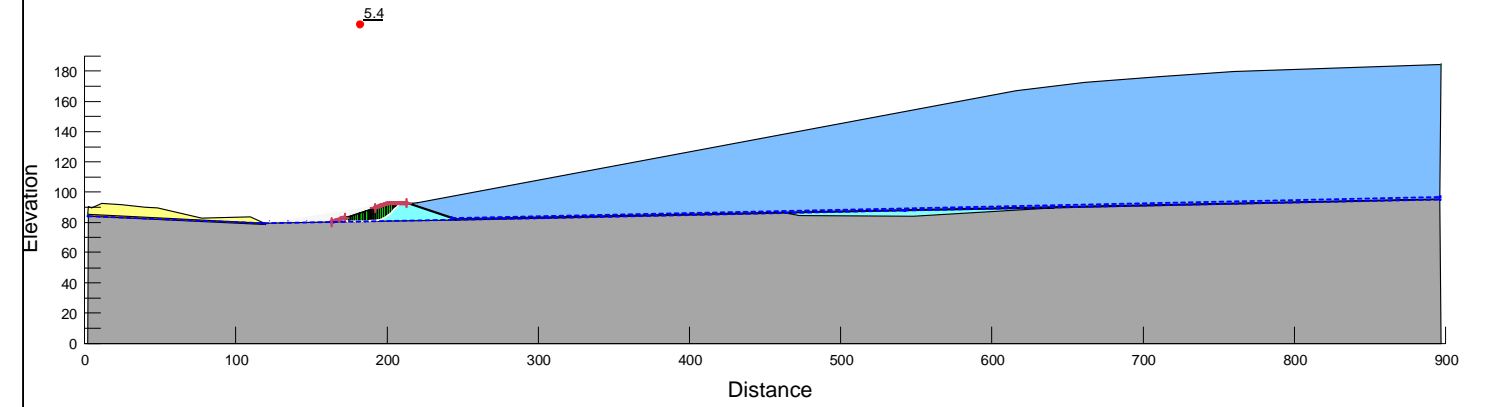
Title: Landfill Stability longsection.gsz	DWP Number:
Analysis: Static short term	Analysed by: ALNA
Comments:	Scale: 1:2,500 @ A3
	Checked by:

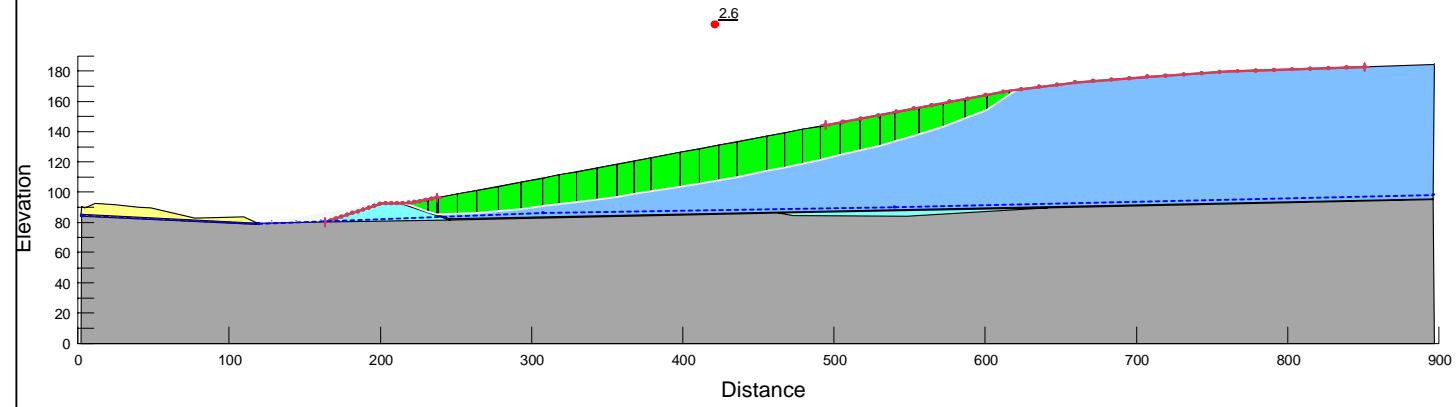
Title: Landfill Stability longsection.gsz	DWP Number:
Analysis: Static elevated groundwater	Analysed by: ALNA
Comments:	Scale: 1:2,500 @ A3
	Checked by:

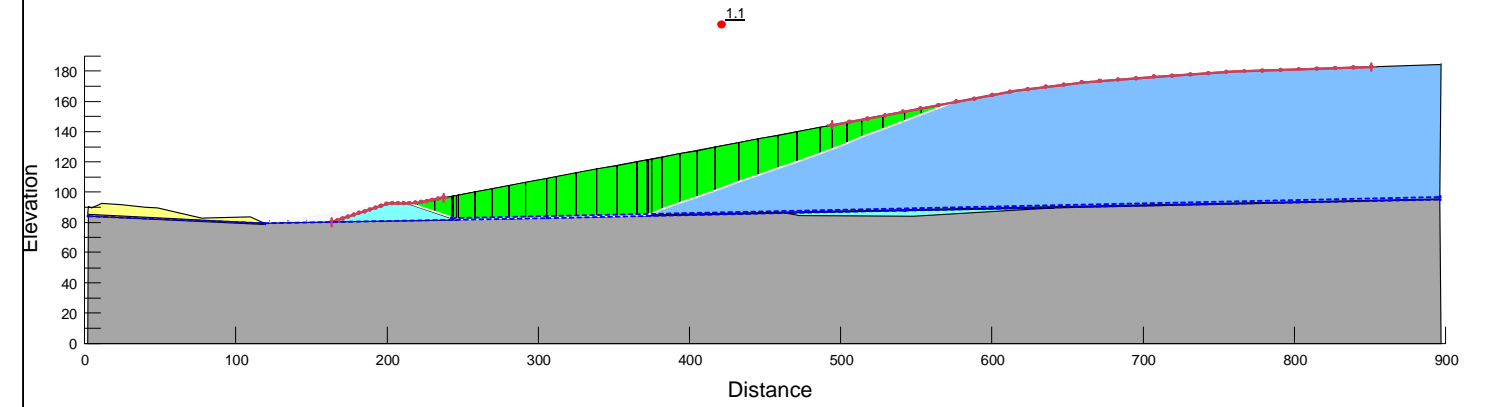
Title: Landfill Stability longsection.gsz	DWP Number:
Analysis: Seismic ULS	Analysed by: ALNA
Comments:	Scale: 1:2,500 @ A3
	Checked by:

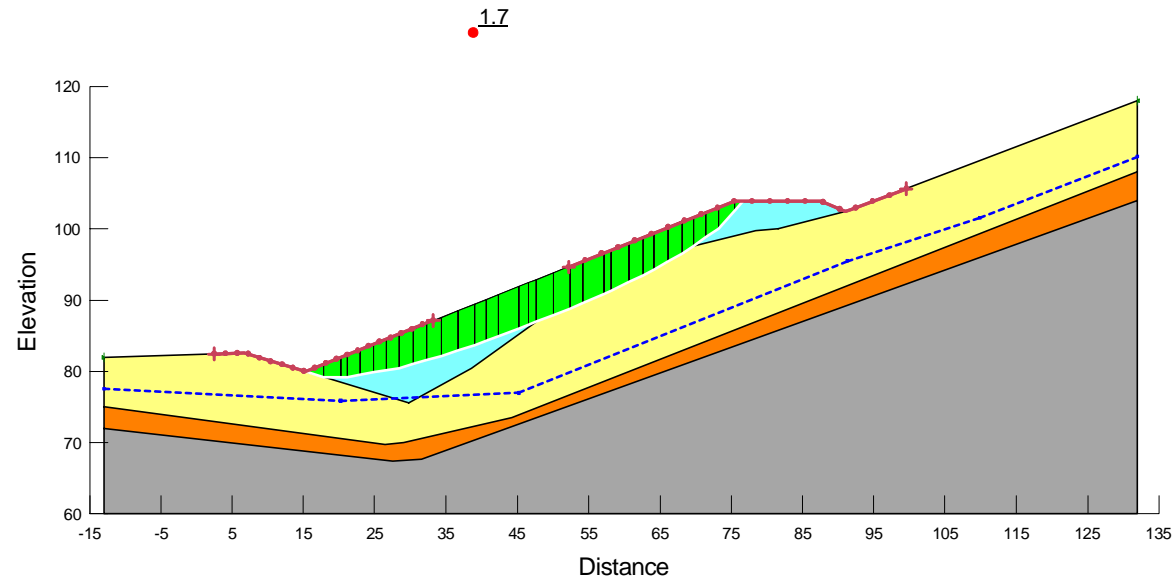
Title: Access Road CH1450 fill slope stability.gsz
 Analysis: Static long term
 Comments:

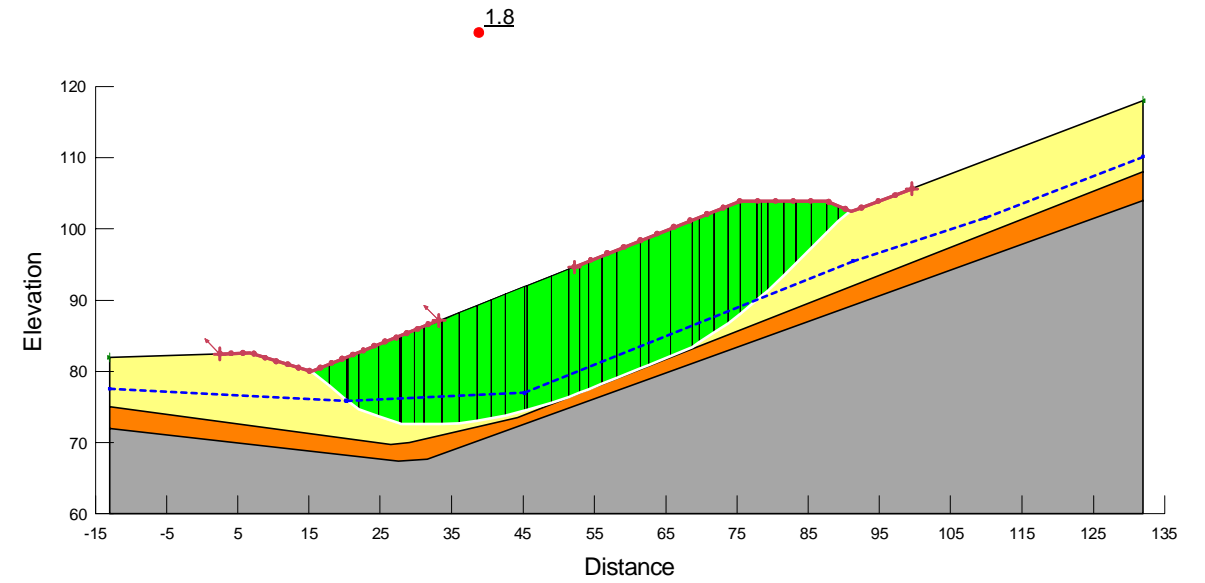
Title: Access Road CH1450 fill slope stability.gsz
 Analysis: Static short term
 Comments:

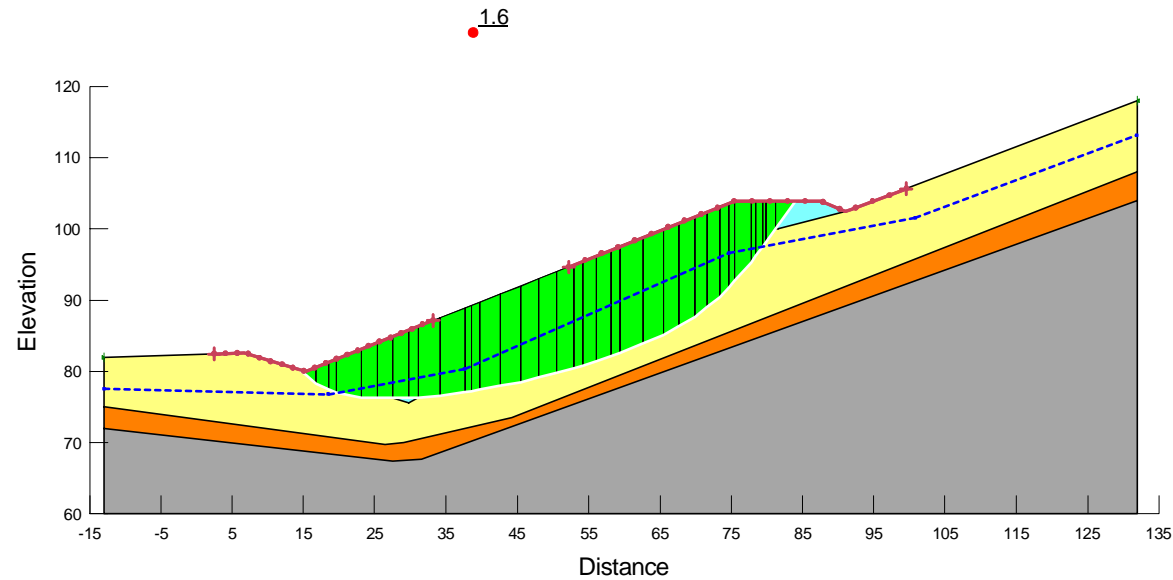
Title: Access Road CH1450 fill slope stability.gsz
 Analysis: static elevated groundwater
 Comments:

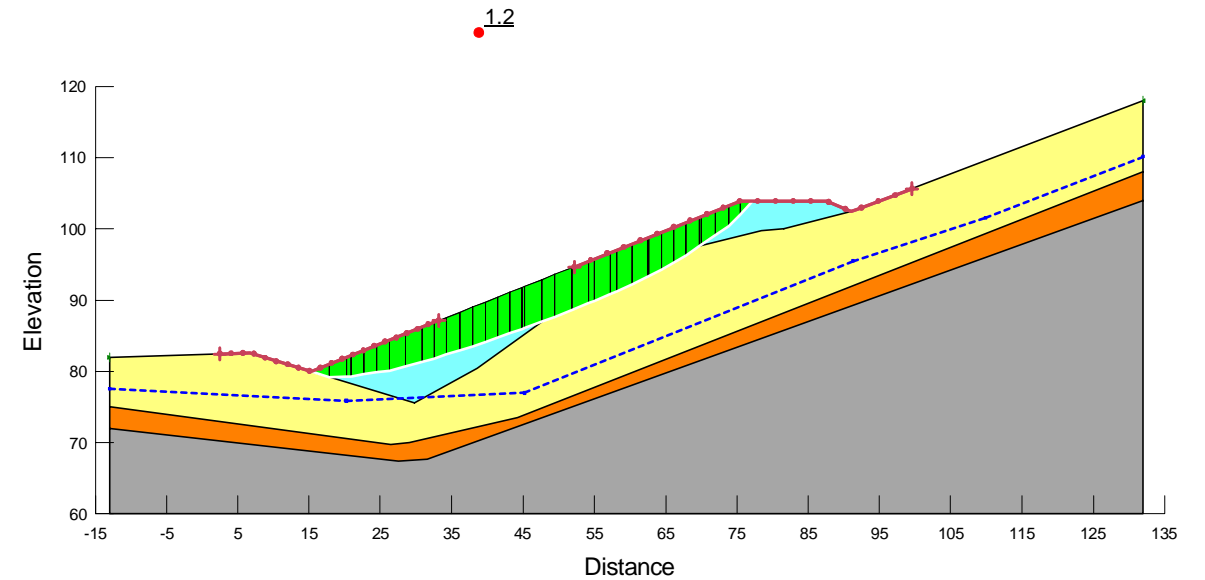
Title: Access Road CH1450 fill slope stability.gsz
 Analysis: Seismic ULS
 Comments:

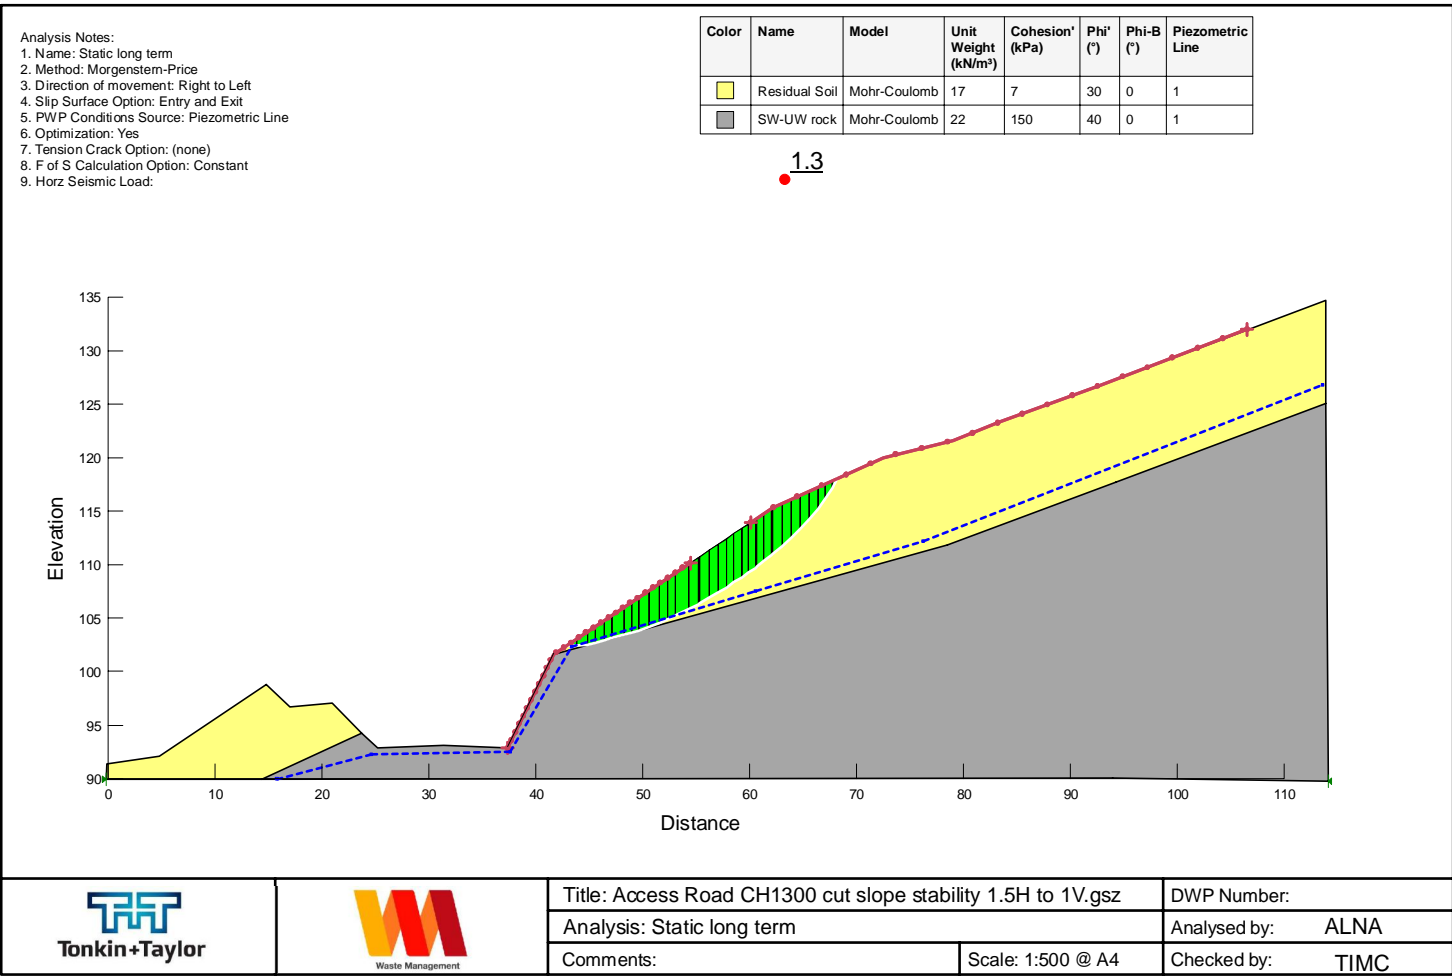
Analysis Notes:
 1. Name: Static long term
 2. Method: Morgenstern-Price
 3. Direction of movement: Right to Left
 4. Slip Surface Option: Entry and Exit
 5. PWP Conditions Source: Piezometric Line
 6. Optimization: Yes
 7. Tension Crack Option: (none)
 8. F of S Calculation Option: Constant
 9. Horiz Seismic Load:
