Title: Auckland Regional Landfill					
Date	Version	Description	Prepared by:	Reviewed by:	Authorised by:
30/05/2019	1.0	Final	A. Naylor T. Coote	K. Hind	S. Eldridge

This Geotechnical Interpretive Report (GIR) describes the site geological and groundwater conditions and associated geotechnical model. This report is intended to support feasibility level design of the proposed landfill and access and application for resource consent. This report also identifies potential geotechnical risks to the project and recommends further investigation and/or analysis to avoid, remedy or mitigate these risks.

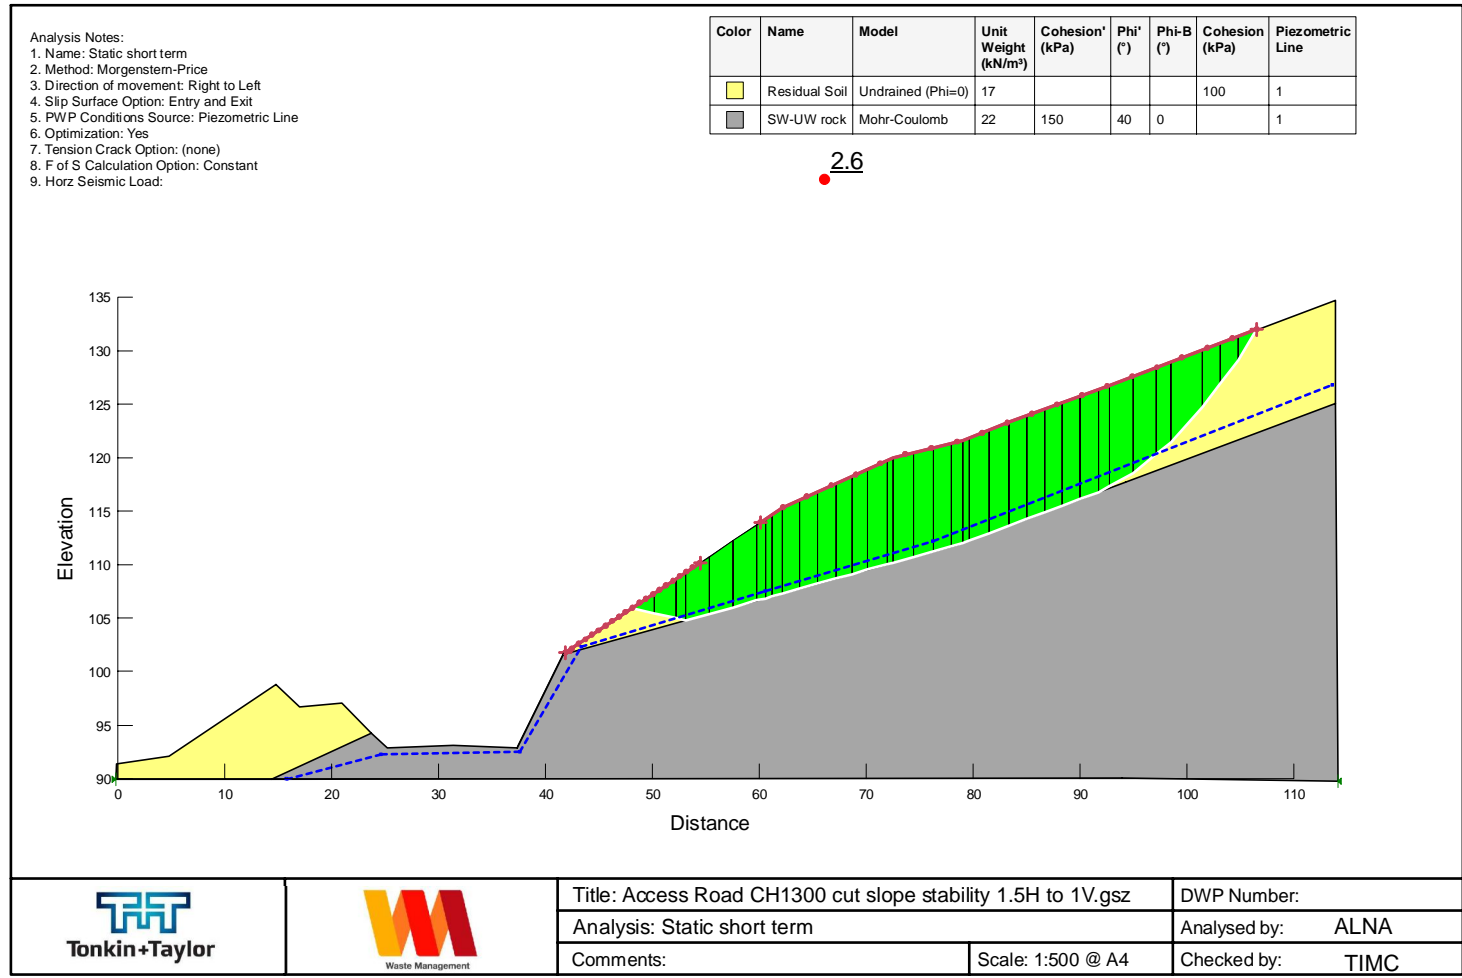
Analysis Notes:
 1. Name: Static short term
 2. Method: Morgenstern-Price
 3. Direction of movement: Right to Left
 4. Slip Surface Option: Entry and Exit
 5. PWP Conditions Source: Piezometric Line
 6. Optimization: Yes
 7. Tension Crack Option: (none)
 8. F of S Calculation Option: Constant
 9. Horiz Seismic Load:

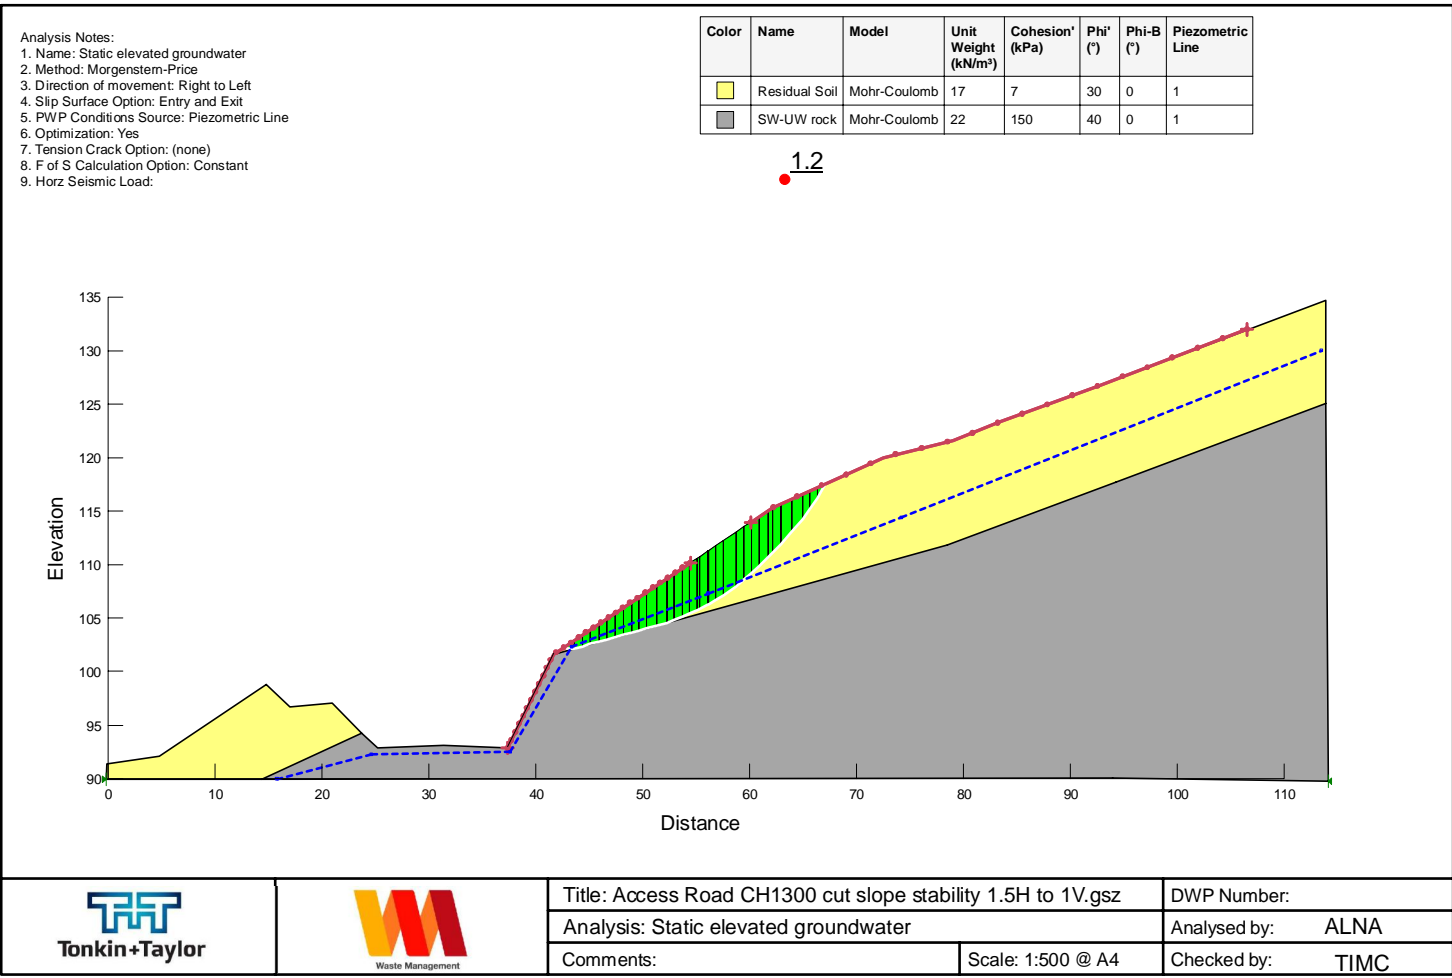
Analysis Notes:
 1. Name: Static elevated groundwater
 2. Method: Morgenstern-Price
 3. Direction of movement: Right to Left
 4. Slip Surface Option: Entry and Exit
 5. PWP Conditions Source: Piezometric Line
 6. Optimization: Yes
 7. Tension Crack Option: (none)
 8. F of S Calculation Option: Constant
 9. Horiz Seismic Load:

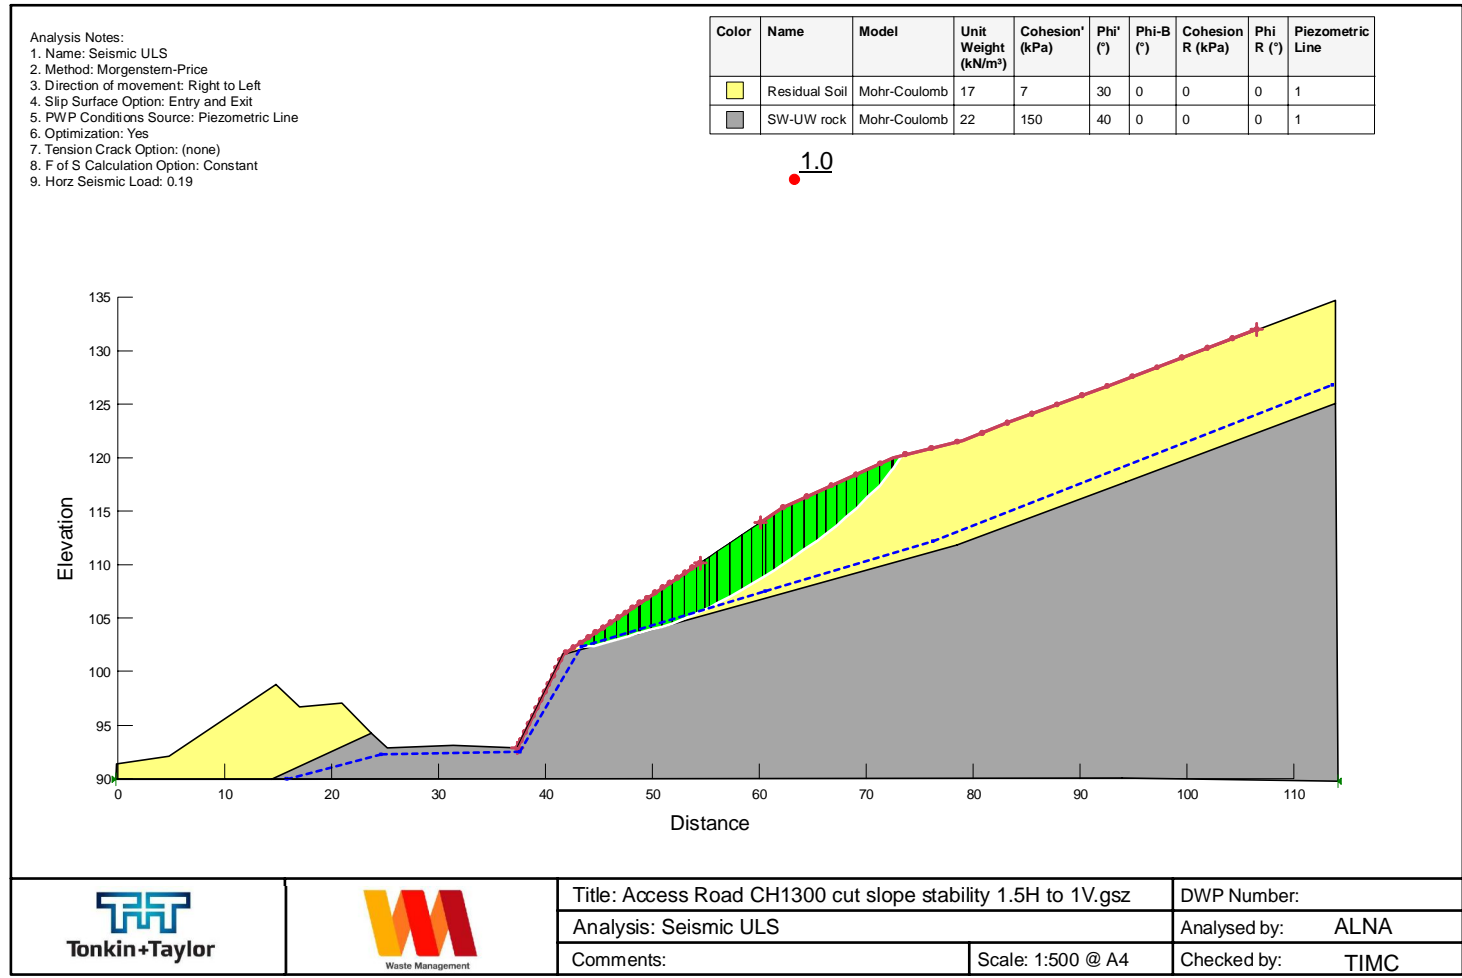
Analysis Notes:
 1. Name: Seismic ULS
 2. Method: Morgenstern-Price
 3. Direction of movement: Right to Left
 4. Slip Surface Option: Entry and Exit
 5. PWP Conditions Source: Piezometric Line
 6. Optimization: Yes
 7. Tension Crack Option: (none)
 8. F of S Calculation Option: Constant
 9. Horiz Seismic Load: 0.19

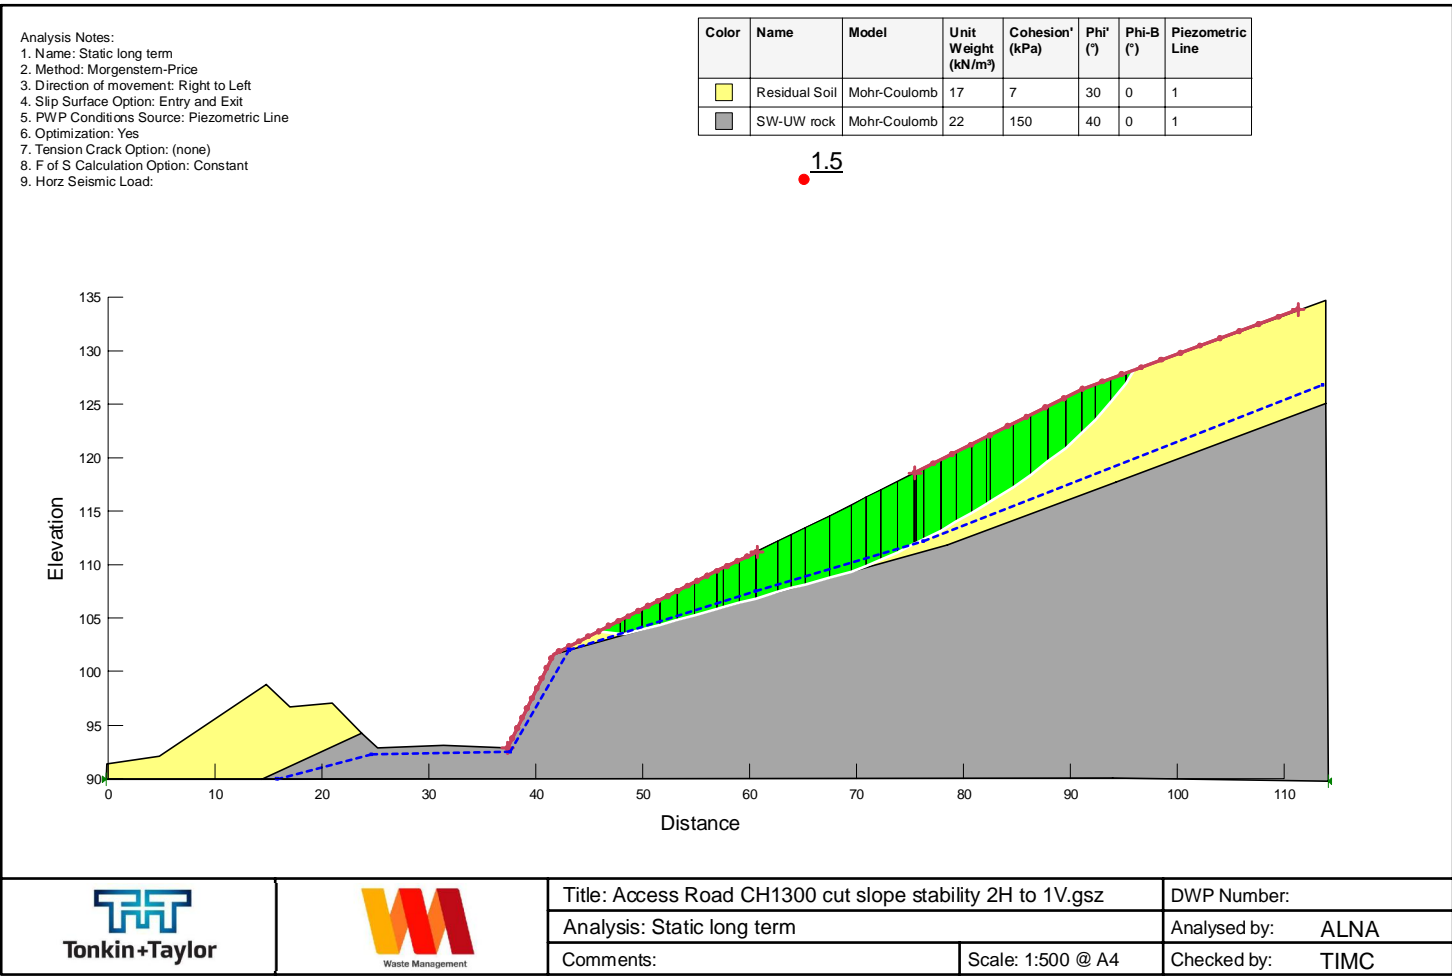
Analysis Notes:
 1. Name: Static long term
 2. Method: Morgenstern-Price
 3. Direction of movement: Right to Left
 4. Slip Surface Option: Entry and Exit
 5. PWP Conditions Source: Piezometric Line
 6. Optimization: Yes
 7. Tension Crack Option: (none)
 8. F of S Calculation Option: Constant
 9. Horz Seismic Load:

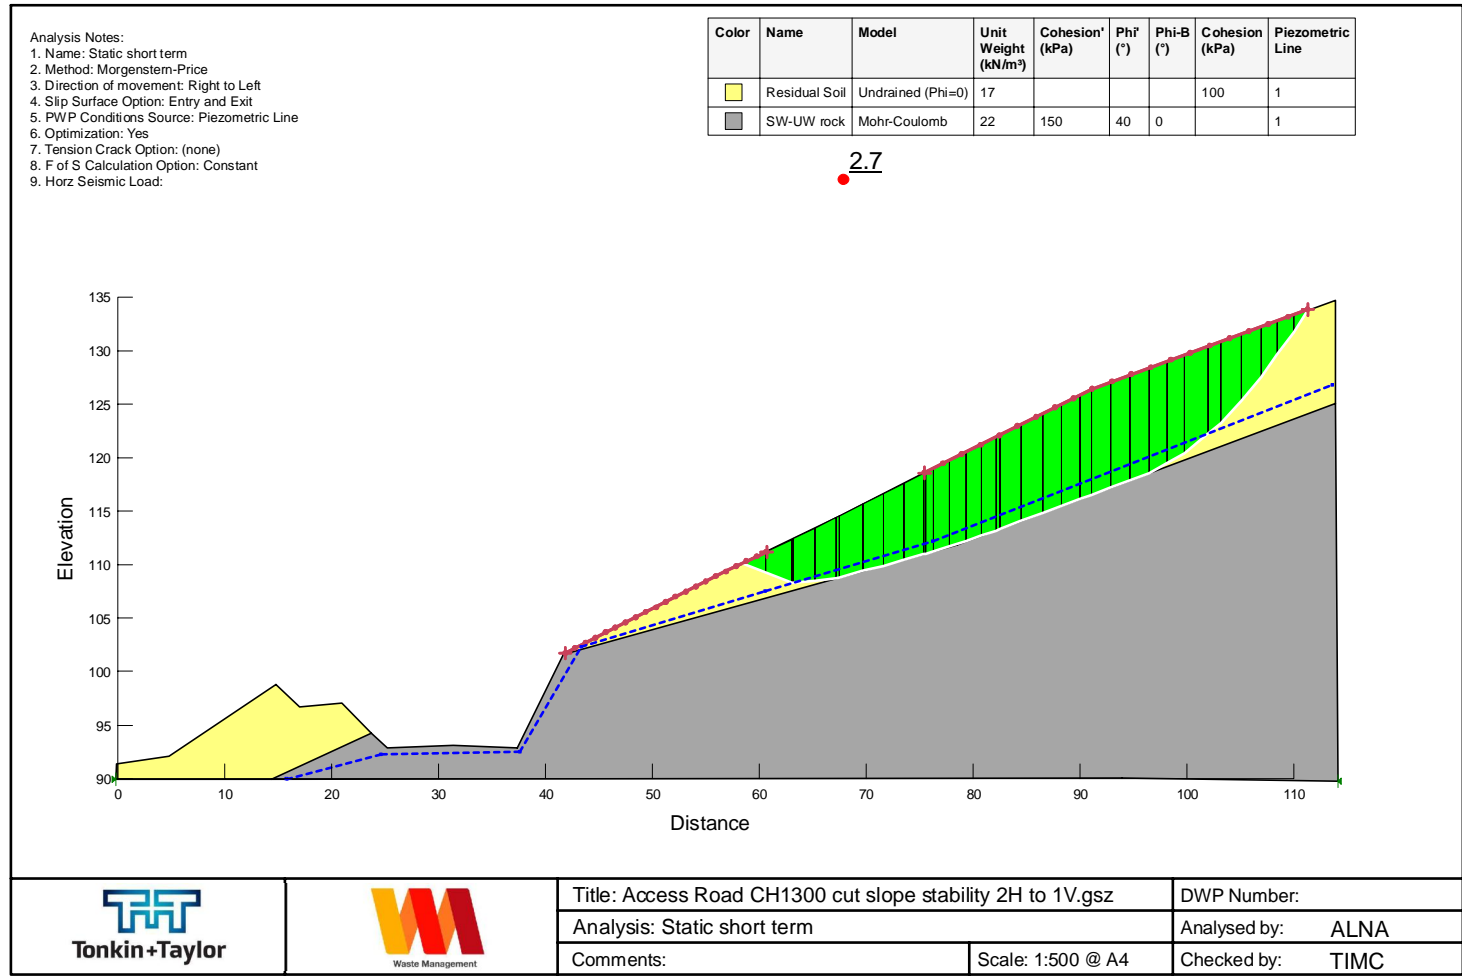
Analysis Notes:
 1. Name: Static short term
 2. Method: Morgenstern-Price
 3. Direction of movement: Right to Left
 4. Slip Surface Option: Entry and Exit
 5. PWP Conditions Source: Piezometric Line
 6. Optimization: Yes
 7. Tension Crack Option: (none)
 8. F of S Calculation Option: Constant
 9. Horz Seismic Load:

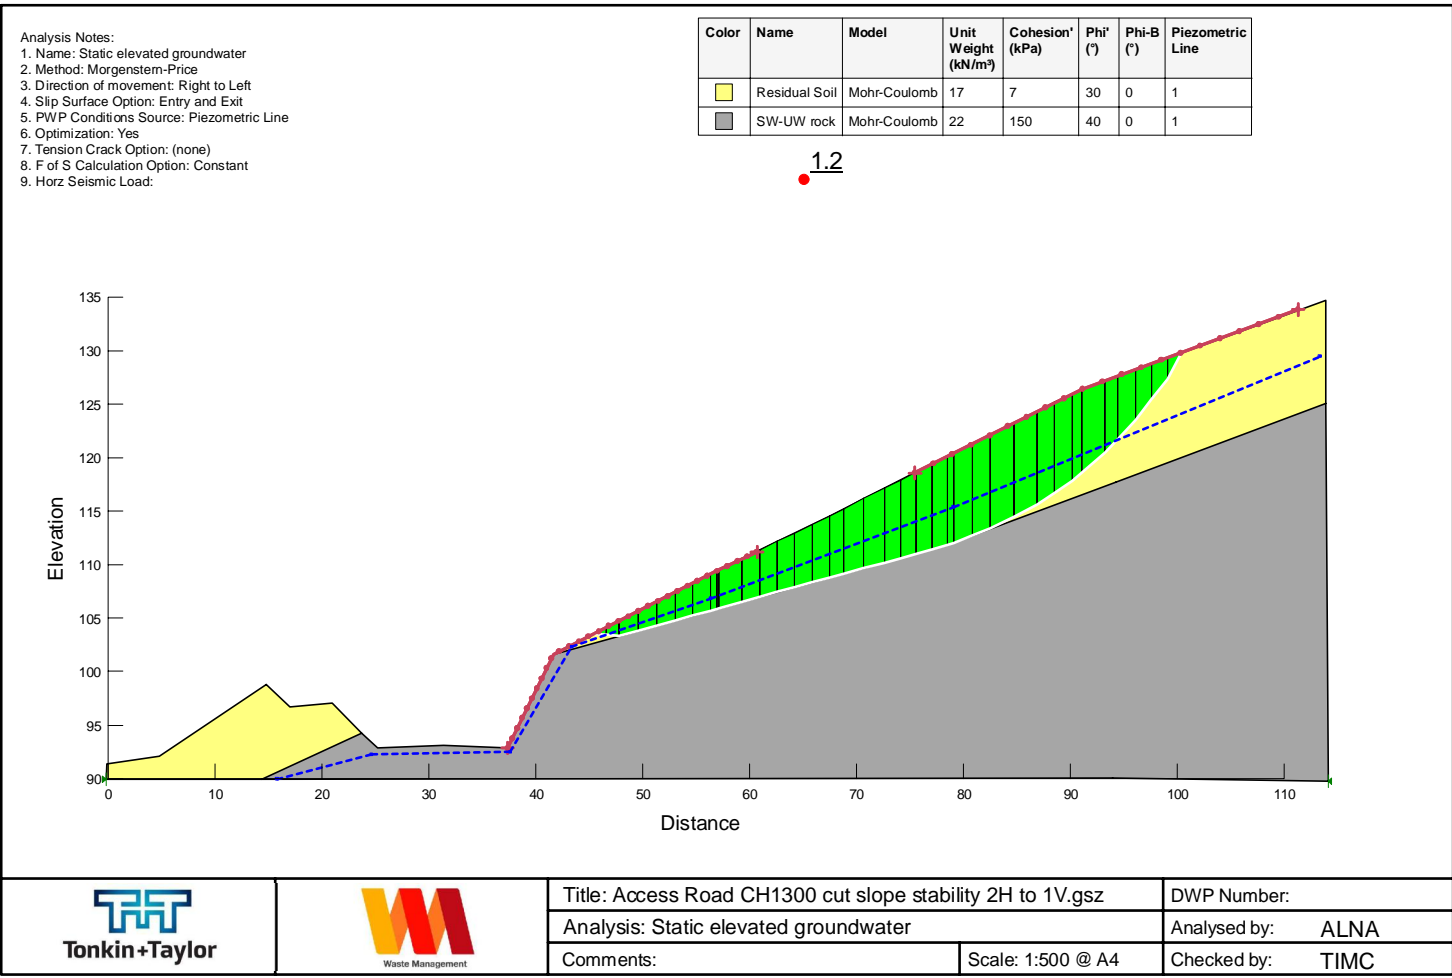
Analysis Notes:
 1. Name: static elevated groundwater
 2. Method: Morgenstern-Price
 3. Direction of movement: Right to Left
 4. Slip Surface Option: Entry and Exit
 5. PWP Conditions Source: Piezometric Line
 6. Optimization: Yes
 7. Tension Crack Option: (none)
 8. F of S Calculation Option: Constant
 9. Horz Seismic Load:

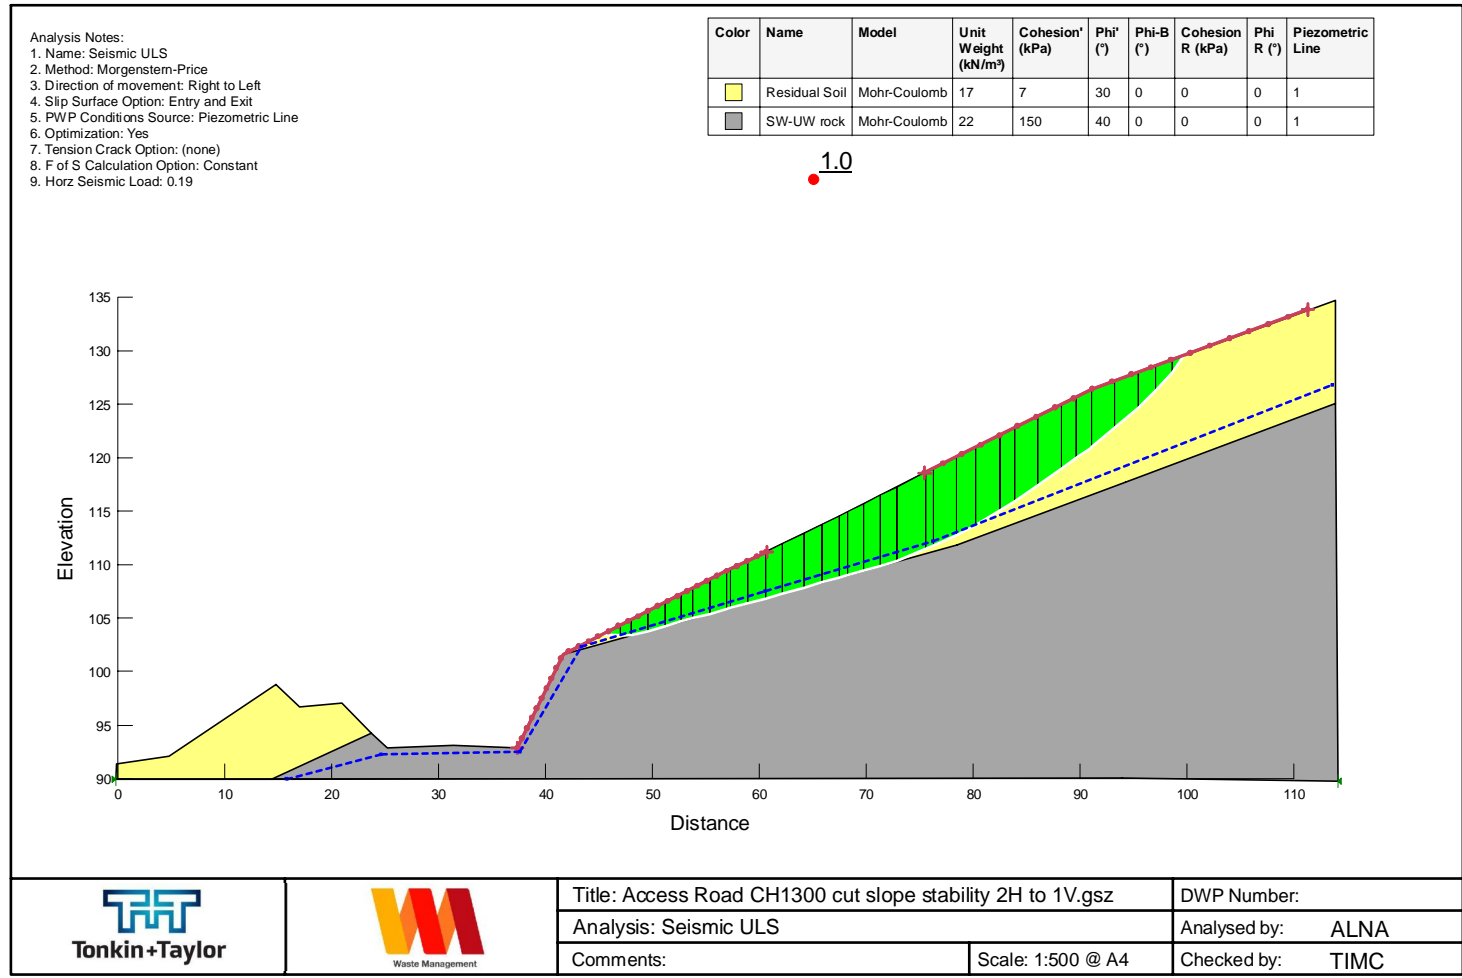
Analysis Notes:
 1. Name: Seismic ULS
 2. Method: Morgenstern-Price
 3. Direction of movement: Right to Left
 4. Slip Surface Option: Entry and Exit
 5. PWP Conditions Source: Piezometric Line
 6. Optimization: Yes
 7. Tension Crack Option: (none)
 8. F of S Calculation Option: Constant
 9. Horz Seismic Load: 0.19
