# Coastal Hazard Assessment Whenuapai Plan Change

Stage 1

Prepared for  
Auckland Council  
Prepared by  
Tonkin & Taylor Ltd

**Date**  
August 2017  
**Job Number**  
1003234.v2

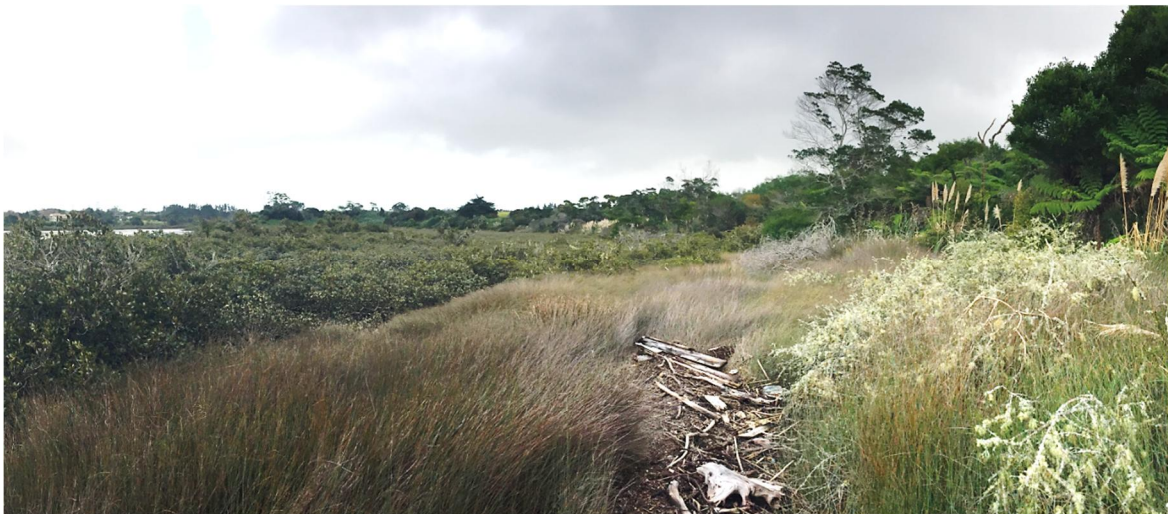
*Figure 3-5 View south from Cell A where an established mangrove forest exists and other forms of vegetation have colonised weathered material at the base of these cliffs*

In areas such as Figure 3-4 within the southern end of Cell A where an established mangrove forest exists, other forms of vegetation have colonised weathered material at the base of these cliffs. With the majority of these areas typically inundated every high tide the increased vegetation provides an areas for debris and beach sediment to collect.

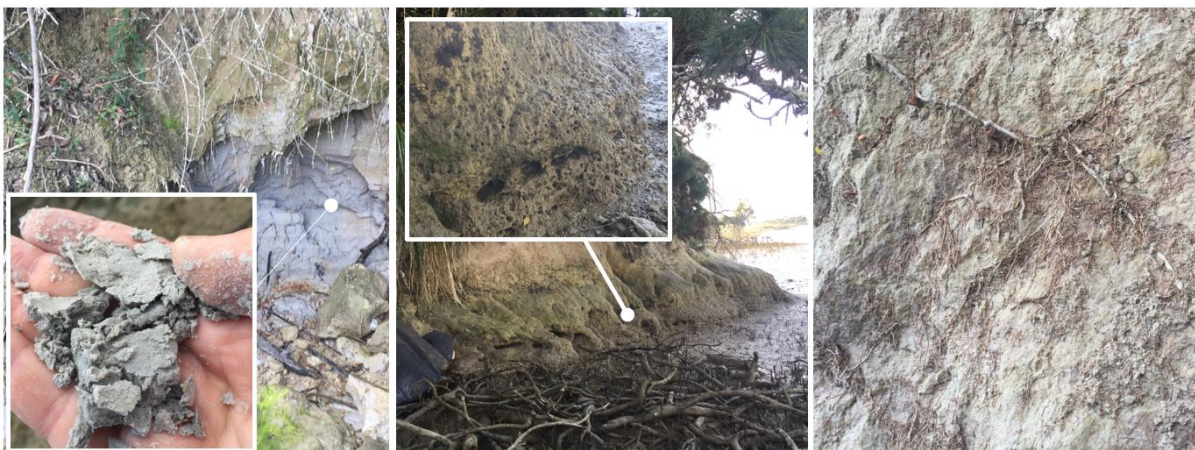
Figure 3-6 Surface weathering, bio-erosion and root pressure

During our walkover inspection signs of erosion in exposed areas included surface weathering (Figure 3-6 left), bio-erosion (Figure 3-6 centre) and root pressure (Figure 3-6 right).

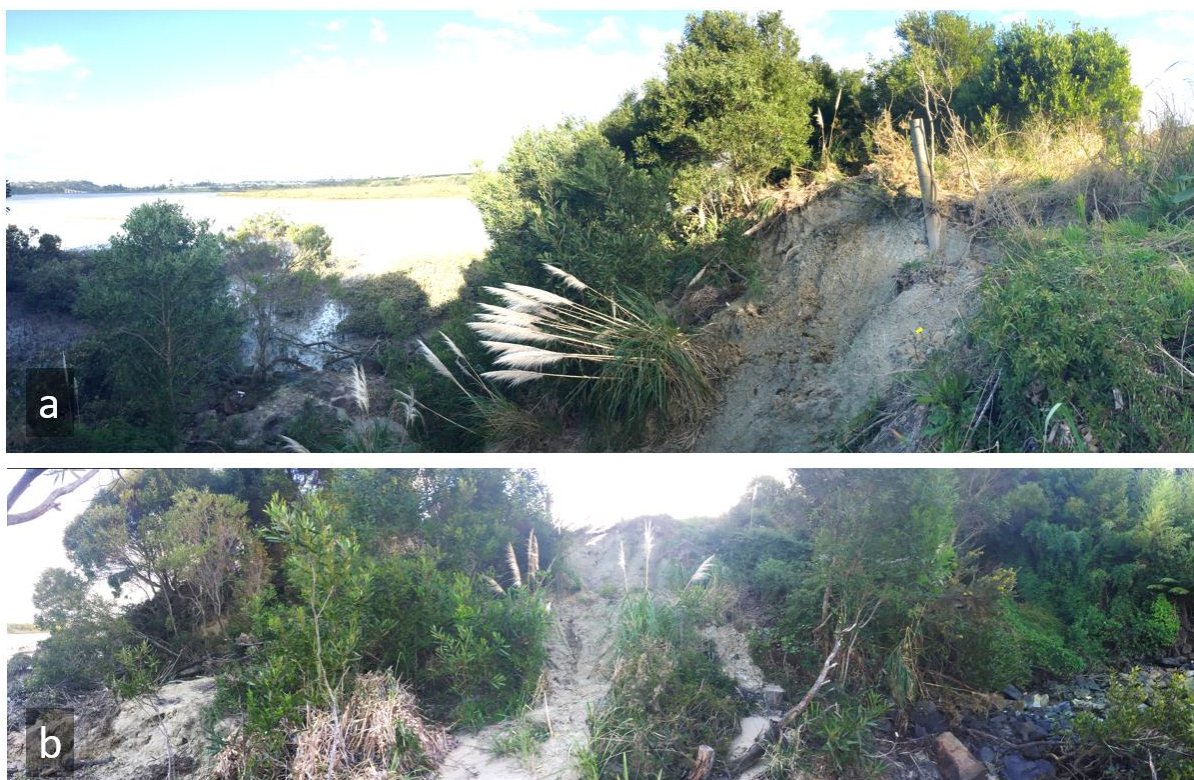
Figure 3-7 Instability within Cell A PF exposures (Photo top and bottom taken at the same location)

Slopes in Cell A with less mangrove protection were less densely vegetated, with shallow landslips and related instability being more common in these areas (Figure 3-7). Exposures in ECBF or fill material were less visible due to vegetation cover and lack of access.

Our site observations confirmed the presence of PF coastal cliff outcrops within the section of coast denoted as Cell A in Figure 3-1 (photographs of outcrops in Figure 3-2 and Figure 3-7).

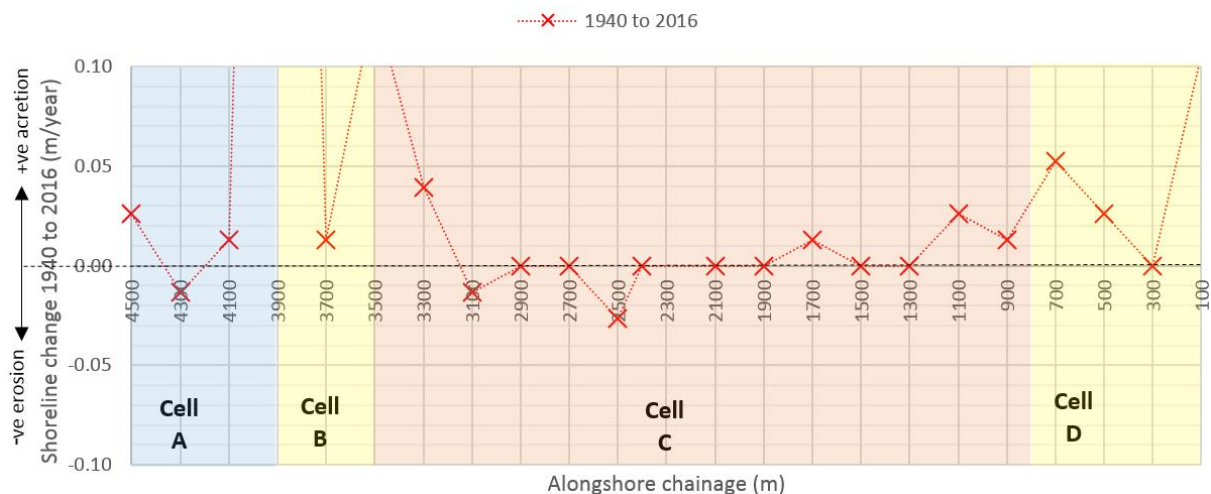
Figure 3-8 Horizontal cliff toe change rate between 1940 and 2016, alongshore chainage (m) measured from the south-eastern end of the site

Digitised shoreline positions have been mapped in the 1940, 1972, 2004, 2016 photographs. Due to the lower resolution of many of these images, comparison of the historical shoreline position has been limited to the 1940 and 2016 photographs (Refer Appendix A). Horizontal offsets between these two shoreline positions have been measured and plotted at 200 m intervals (Figure 3-8).

From digitised cliff toe positions in Figure 3-8 changes in shoreline position indicate:

- 1 Cell A - accumulation of weathered material, and up to -0.02 m/year of erosion
- 2 Cell B – significant land reclamation between 1940 and 1972
- 3 Cell C - accumulation of weathered material and in some areas land reclamation, and up to -0.03 m/year of erosion.
- 4 Cell D - accumulation of weathered material and in some areas land reclamation.

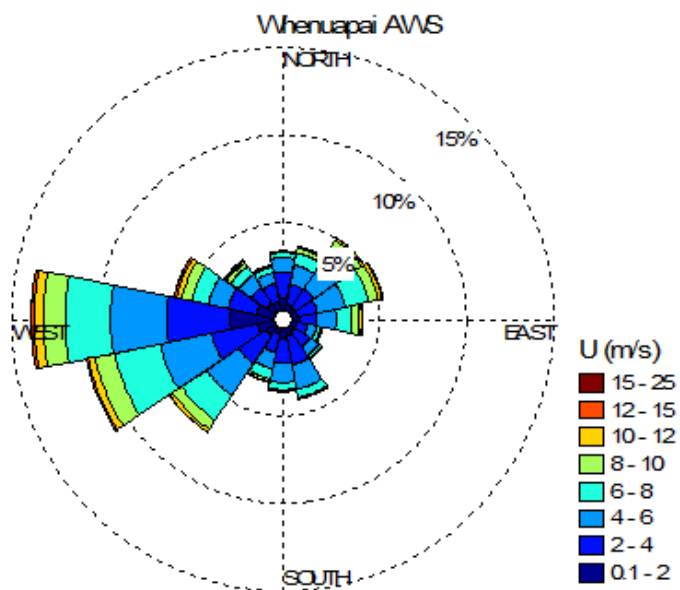
Figure 4-1 Wind Rose and monthly mean wind speed for Whenuapai (NIWA, 2013).

Wind data was available from the National Institute of Water and Atmospheric Research (NIWA) weather gauging station at Whenuapai (NIWA Cliflo data point A64761). The wind data used was collected on an hourly basis from January 1960 to October 2013. The wind rose comprising wind speeds (m/s) and probability of occurrence per direction have been presented in Figure 4-1.

The site is located in the north-western extent of the inner Waitemata Harbour, exposed to wind-waves from the east and to a lesser extent the north east. Figure 4-1 shows winds from north east and east directions only occur approximately 15% of the time. In summer the proportion of winds from the northeast increases. Due to the changing location of the high pressure belt which is further south in summer and early autumn than it is in winter and spring (Chappell, nd).

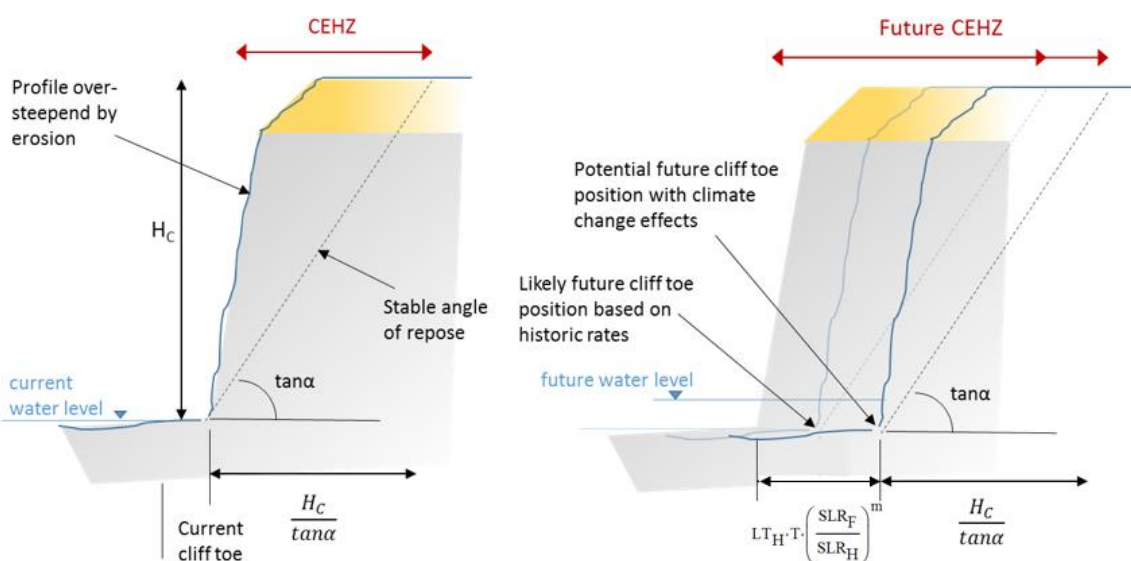
Figure 5-1 Definition sketch for cliff shore coastal erosion hazard zones for the present day (left) and future (right)

The historic long-term retreat rate above relates to erosion of the cliff slope itself and not weathered material that has collected at the base of it. A coastal baseline that best follows the base of existing sea cliffs from which future Coastal Erosion Hazard Zones (CEHZ) can be measured generally follows the 1940 aerial photograph where the base of cliffs are less obscured by vegetation. Where erosion can be seen in the 2016 photograph (i.e. since 1940), the baseline follows the 2016 shoreline.

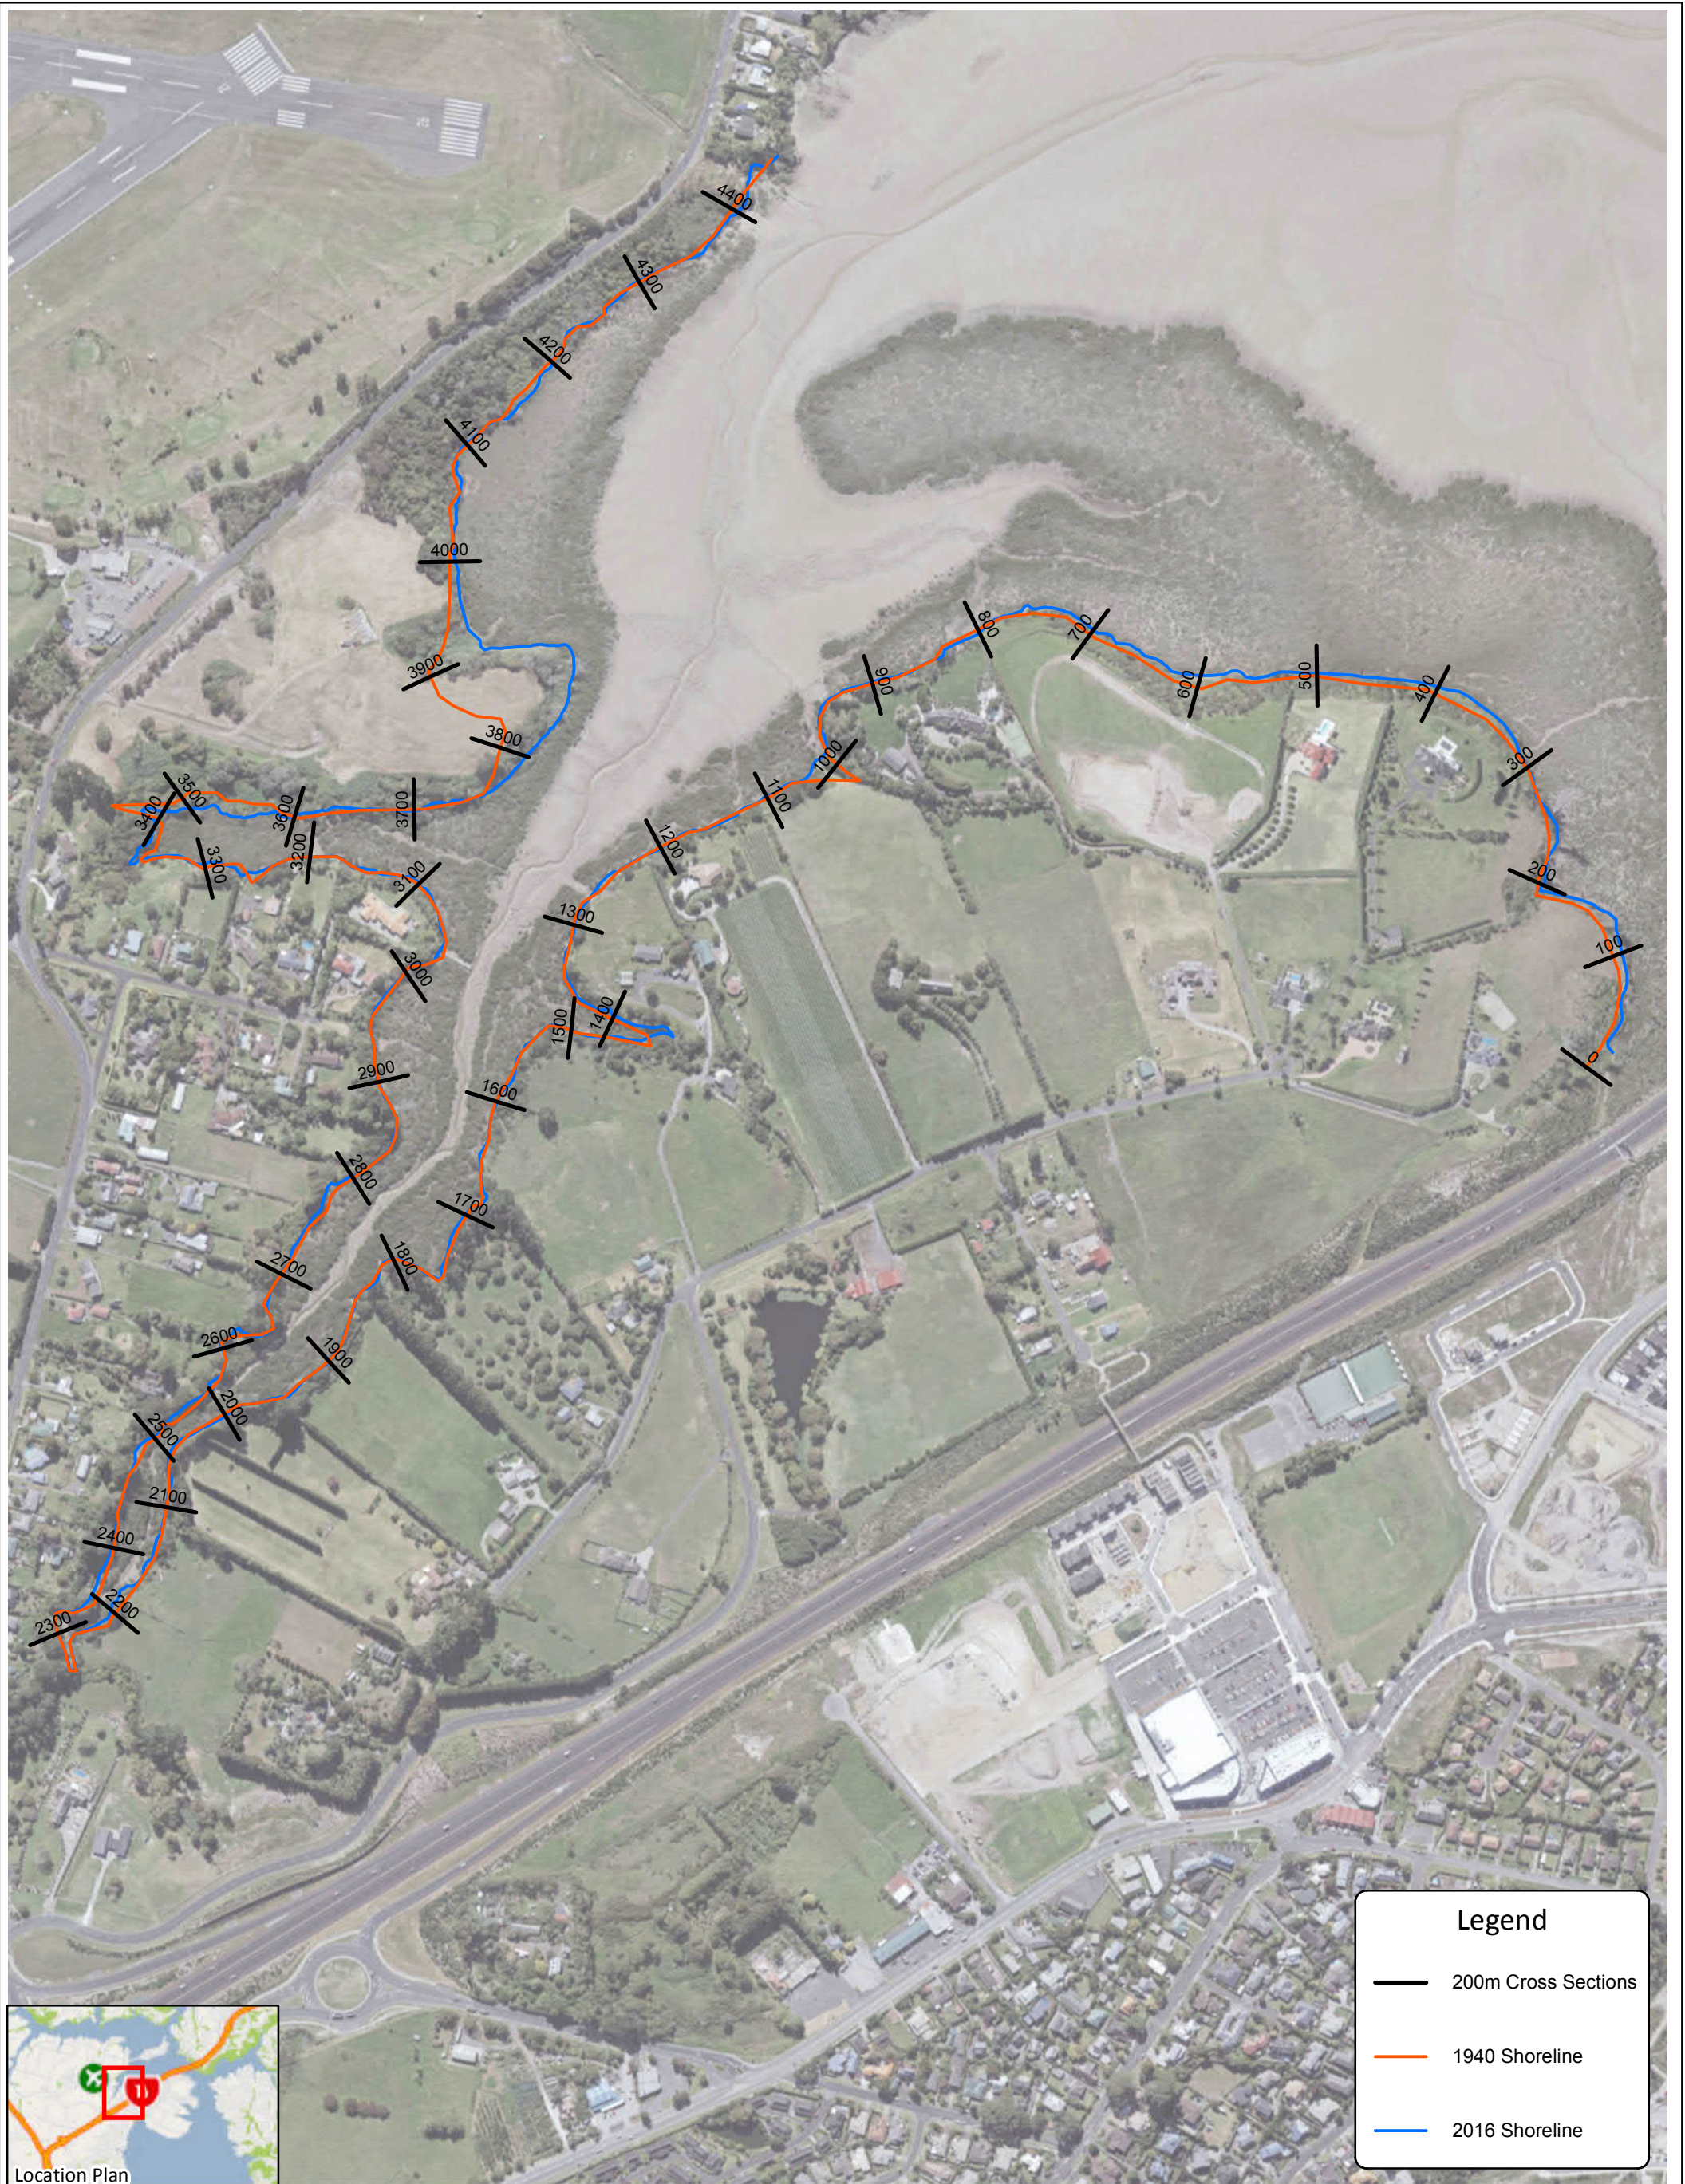
**AUCKLAND COUNCIL**  
**WHENUAPAI**  
Coastal Hazard Assessment  
1940 and 2016 Shoreline Positions

- 200m Cross Sections
- 1940 Shoreline
- 2016 Shoreline

Appendix A : Historic shorelines
