## **Appendix D: Historical geotechnical investigations**

- **Sketch plan, historical geotechnical investigations**
- **Statement of Evidence by Shane Gareth Lander**
- **Fraser Thomas, Geotechnical Investigation Report, 650 Whitford-Maraetai Road**
- **Partial records, Foundation Engineering, Pavilion Building**
- **New Zealand Geotechnical Database, various nearby borehole logs**

BEACHLANDS SOUTH LIMITED PARTNERSHIP  
 STRUCTURE PLAN  
 KNOWN GEOTECHNICAL INVESTIGATIONS  
 SKETCH PLAN

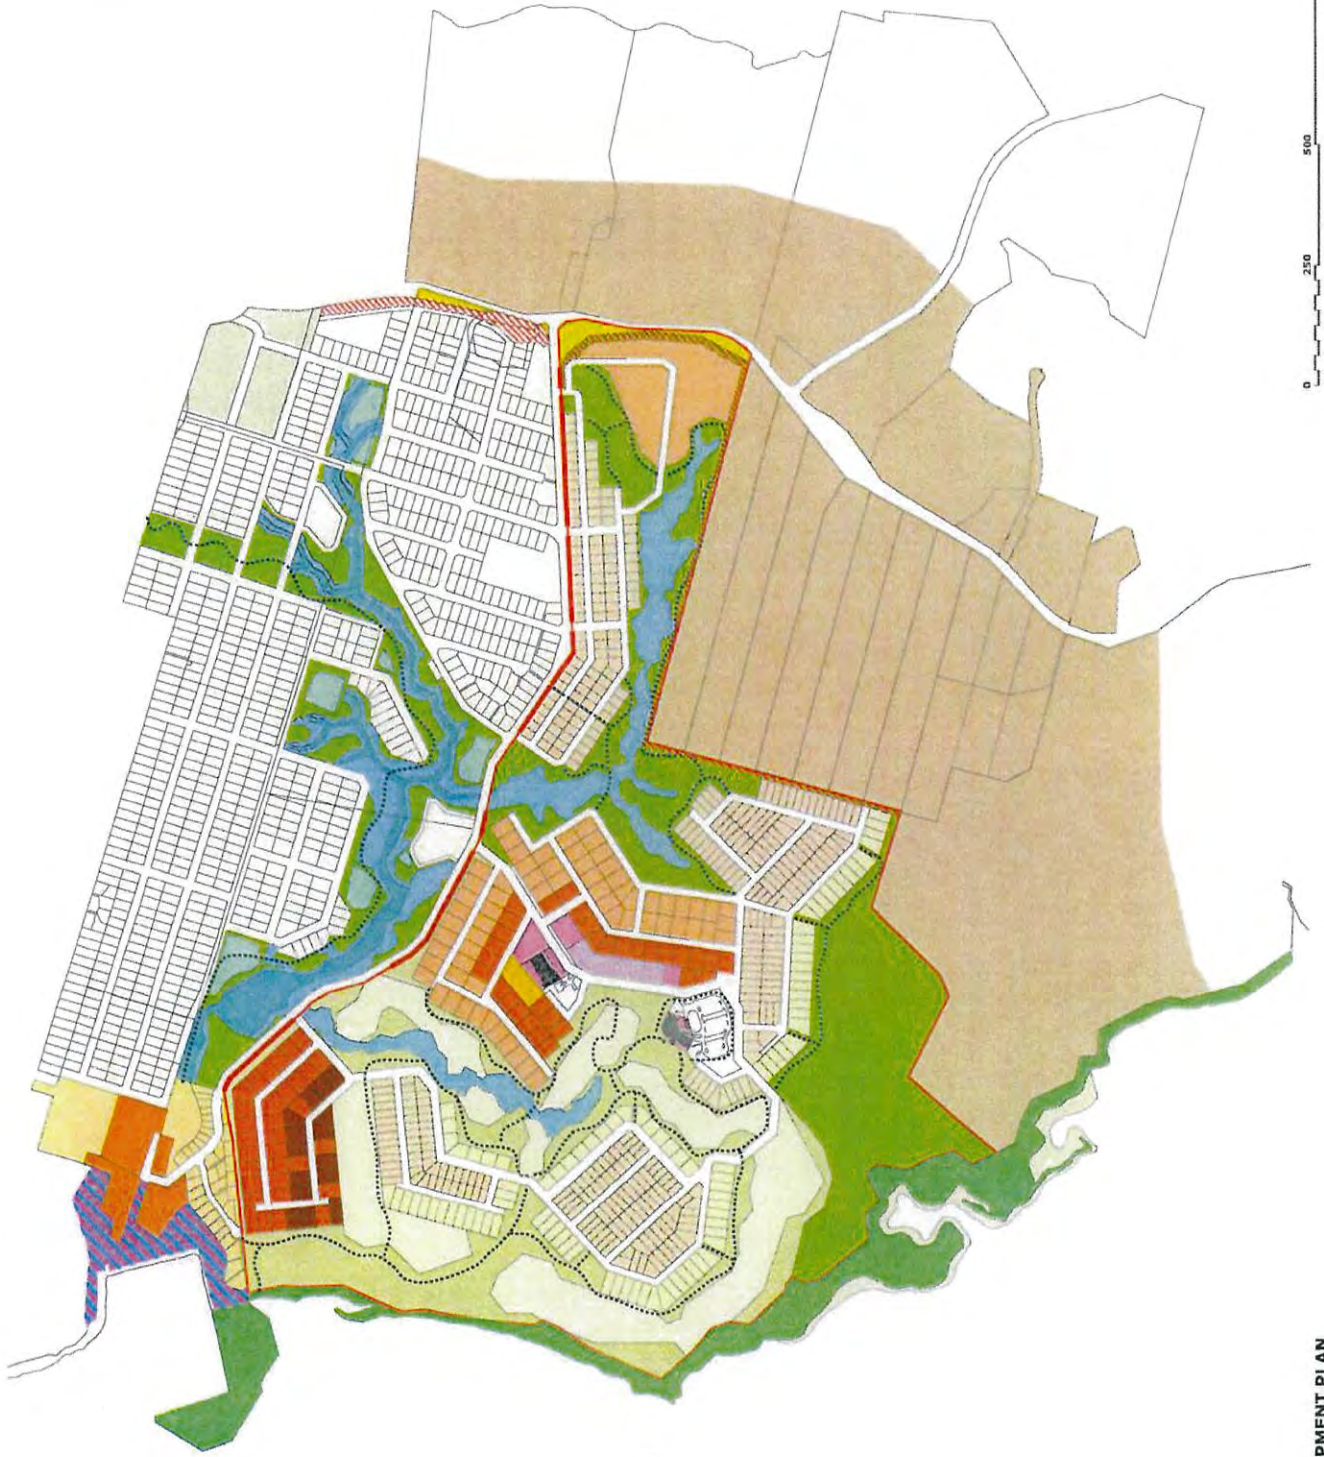
**BEACHLANDS 2: CONCEPT DEVELOPMENT PLAN**

- Single Family House (1 or 2 storey)
- Single Family House (2 storey)
- Detached Court (2 storey)
- Street Facing Terrace / Terraced Laneway (2 storey)
- Apartment (3 storey)
- Live/Work (3 storey)
- Hotel (3 storey)
- Retail/Commercial
- Open Space
- Private Open Space - Golf Course
- Public Open Space - Conservation
- Public Open Space
- Floodplain
- Stormwater Management Area
- Indicative Stormwater Pond
- Designation 291
- No Direct Site Access Permitted - 2m Hedge
- Existing Buildings
- Beachlands 2 Structure Plan Area
- Landscape Buffer Area
- Indicative Walkway
- Countryside Living Zone
- Single House Zone
- Terrace Housing and Apartment Buildings Zone
- Marina Zone
- Rural Production Zone

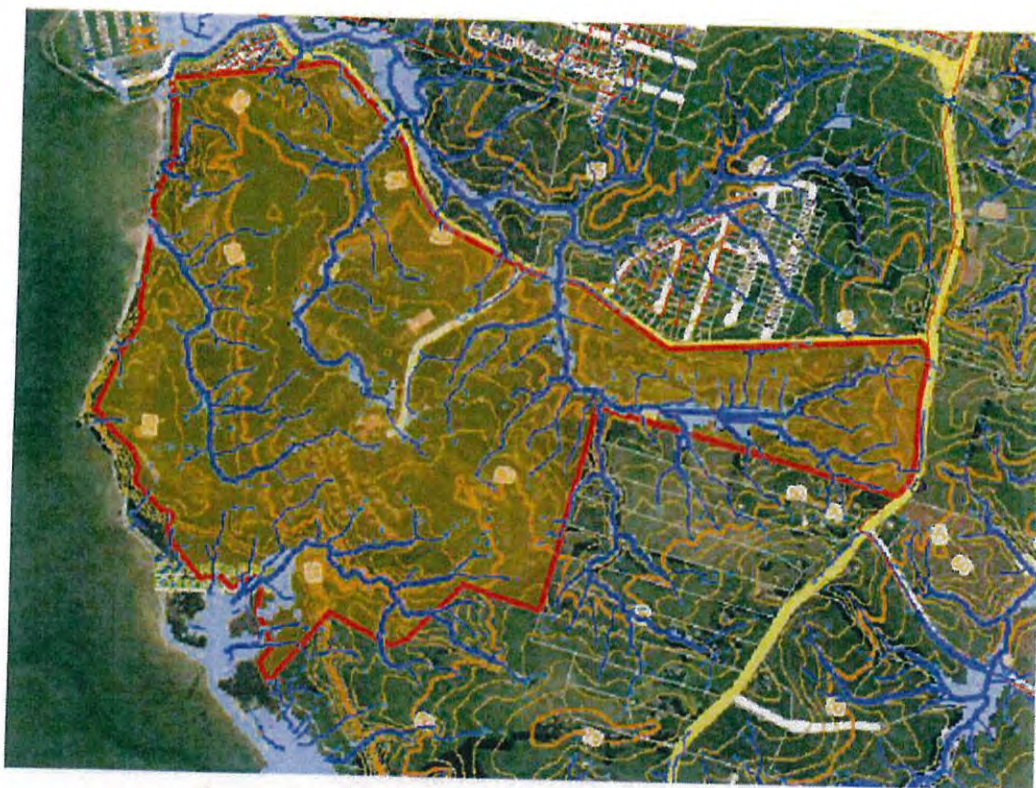
Figure 2: Overland Flow and Flood Hazards as modelled on Council GIS

As indicated on Council's GIS system, and further confirmed through a review of GIS contour information, the site contains a number of overland flow paths, with Council's rough-order LIDAR modelling also showing rapid hazard flooding resulting from the overland flow. While the major overland flows are generally correct – following existing water courses onsite, some of the smaller ones are likely modelled incorrectly and could be considered as minor sheet flow having less bearing on future development.

The major overland flow paths have been considered as part of the master-plan development with neighbourhood precincts drawn to accommodate the paths wherever practical. Some of the minor flow paths will need to be diverted or piped as part of development works onsite; this would be readily achievable with little or no effect on the catchment as a whole. As part of detailed design for a development form for the site, minimum floor levels may need to be considered for some of the major flow paths, such reporting forming part of a Resource Consent and Building Consent for any such future development design.

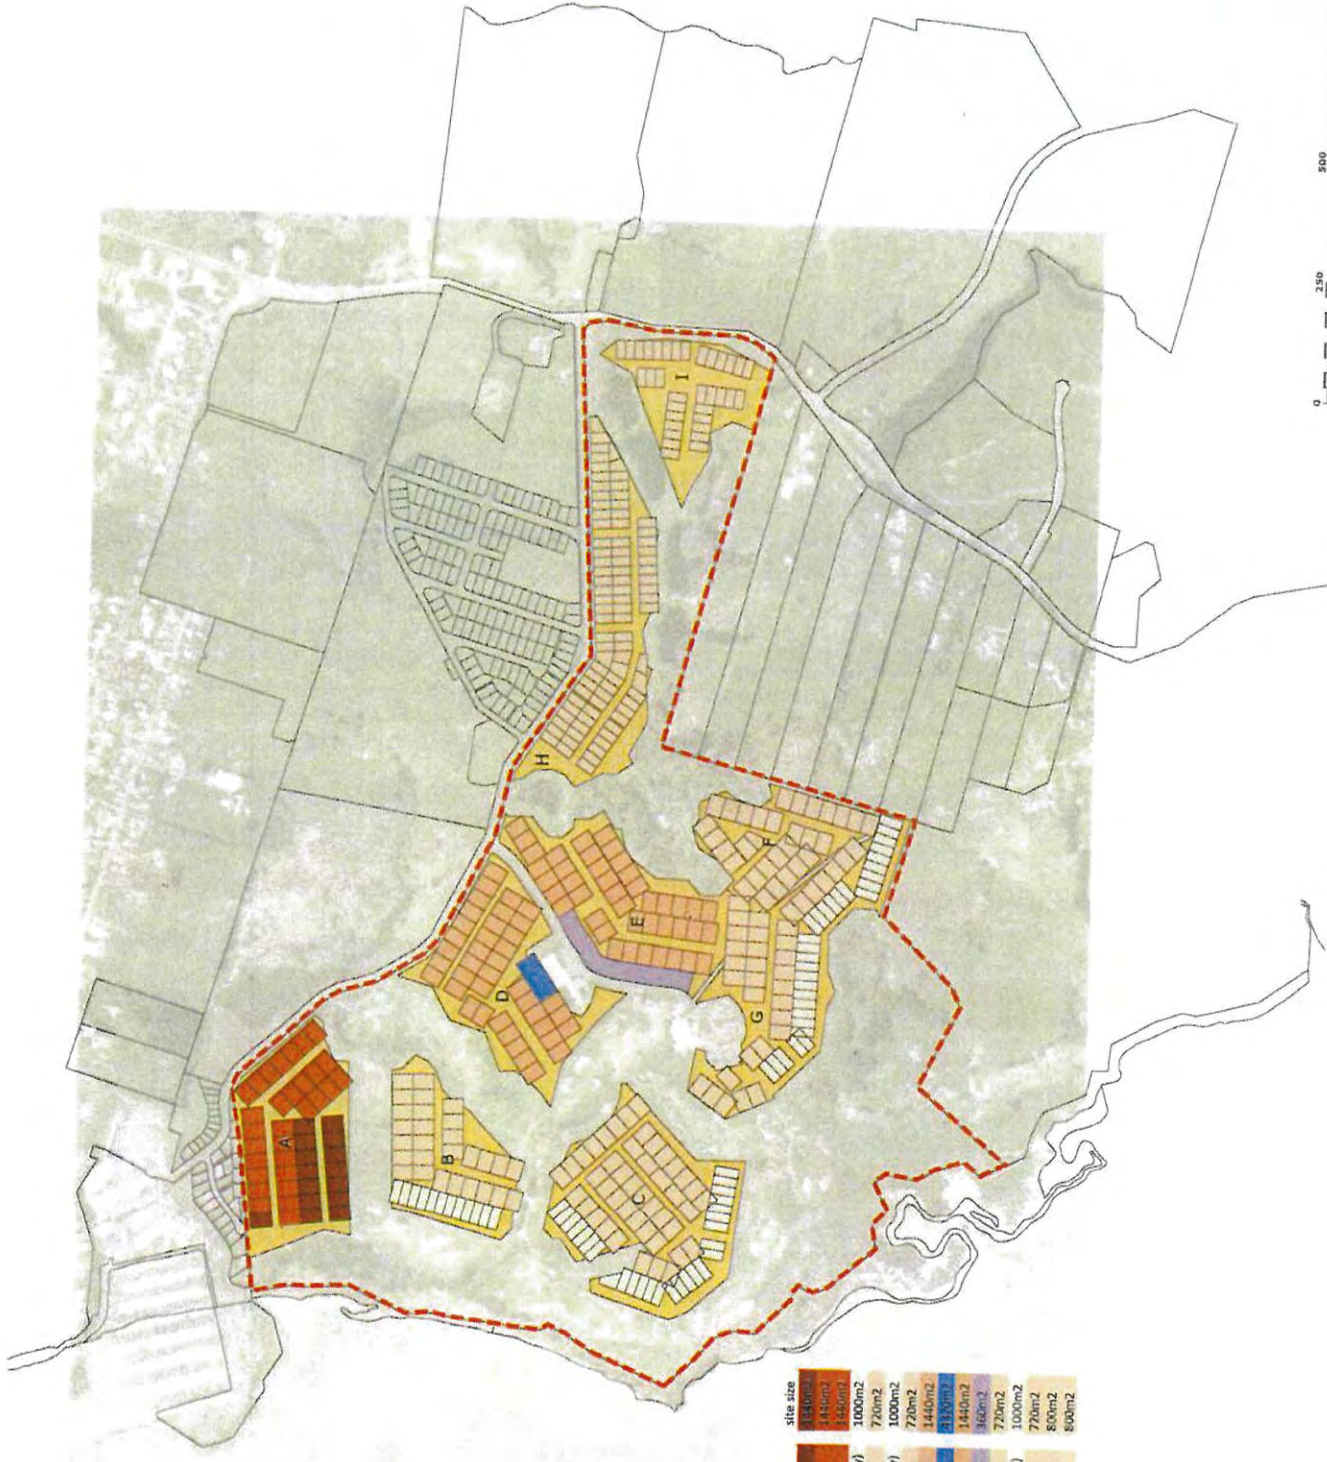
LOT ARRANGEMENT PLAN

Lot	Type	Site size
A	apartments (2, 3 or 4 storey)	11400m <sup>2</sup>
B part (sea view)	duplex (long terrace) (2 storey)	11400m <sup>2</sup>
B part	apartment (long terrace) (2 storey)	11400m <sup>2</sup>
C part (sea view)	single family house (1 or 2 storey)	1000m <sup>2</sup>
D1	single family house (2 storey)	720m <sup>2</sup>
D2	single family house (1 or 2 storey)	1000m <sup>2</sup>
E1	detached court (2 storey)	720m <sup>2</sup>
E2	detached court (2 storey)	1440m <sup>2</sup>
F	live/work (3 storey)	1440m <sup>2</sup>
G part (estuary view)	single family house (2 storey)	720m <sup>2</sup>
G part	single family house (1 or 2 storey)	1000m <sup>2</sup>
H	single family house (2 storey)	720m <sup>2</sup>
I	single family house (2 storey)	800m <sup>2</sup>

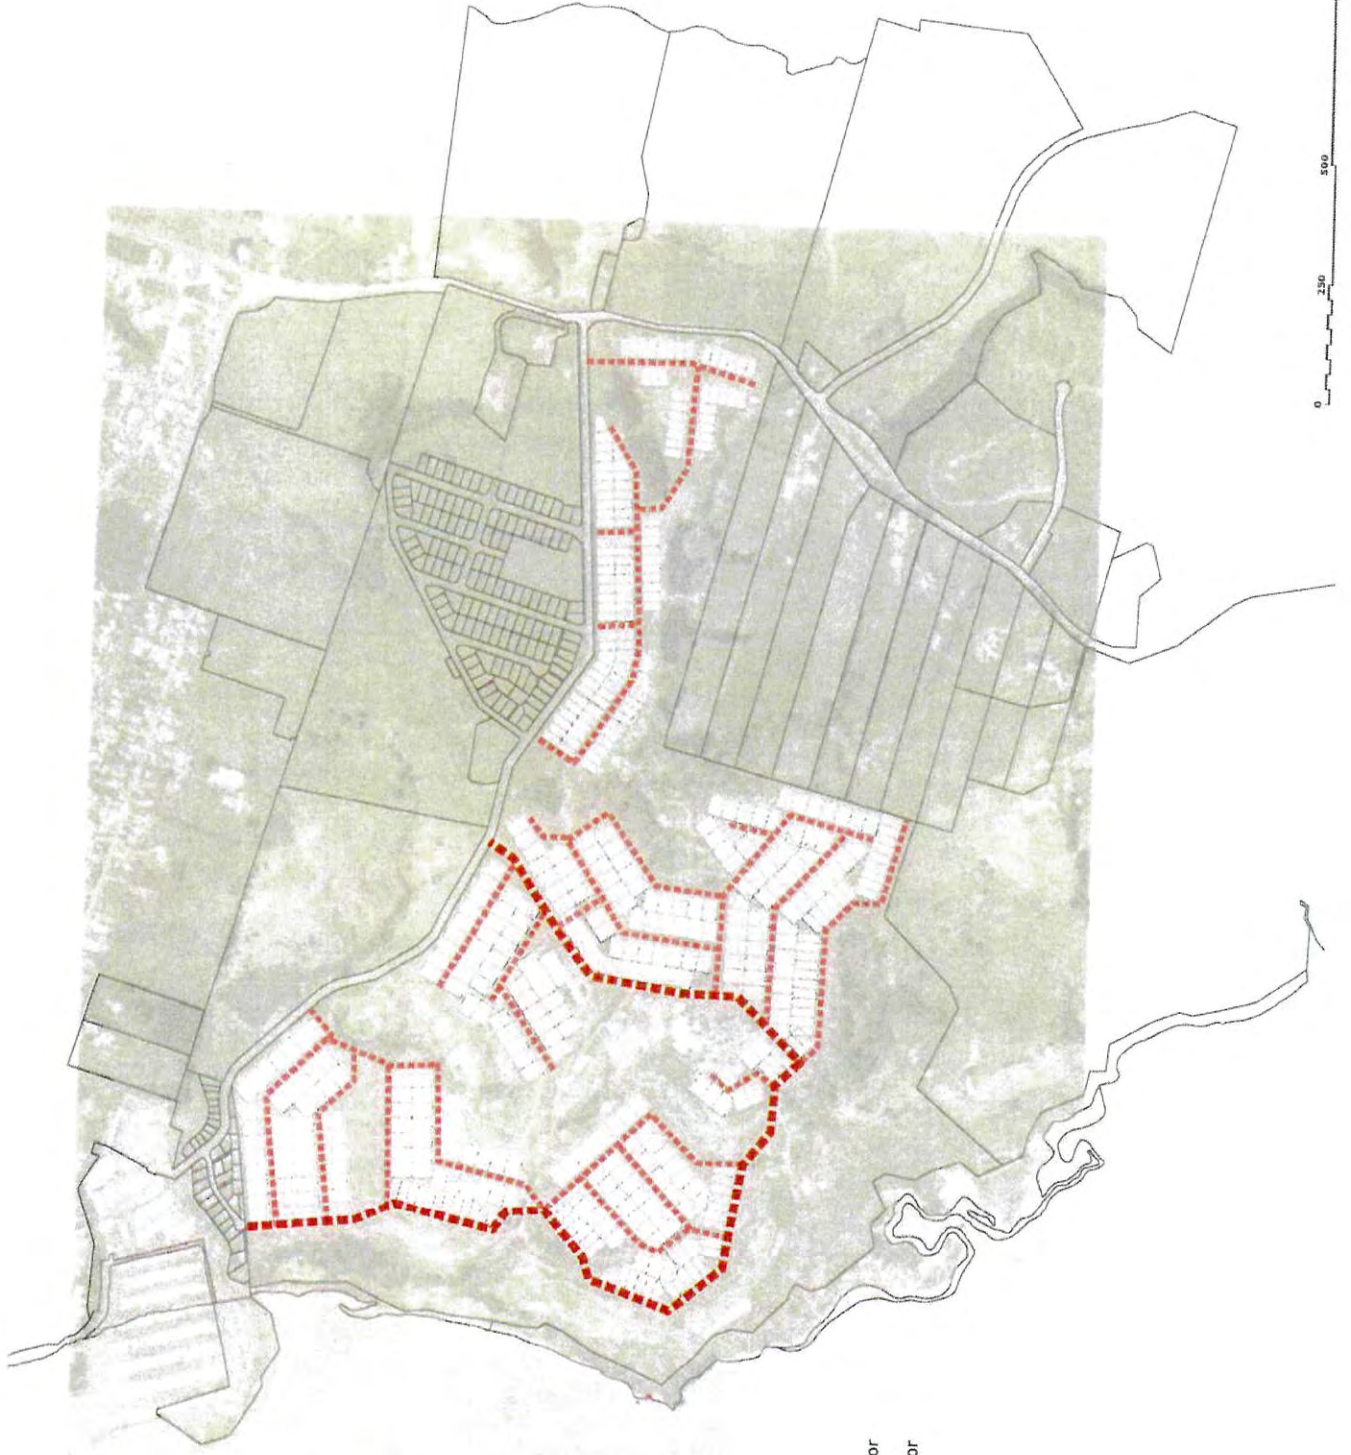
CIRCULATION PLAN

- KEY
- 20m wide road corridor
  - 16m wide road corridor
