Project **TE AUAUNGA**

Responses to Auckland Council RMA cl 23 Requests | E1-E9 | 11

Notification determination and resource consent decision report for a discretionary activity under the Resource Management Act 1991

Subject: To authorise the damming of water with and use of an existing dam on the bed of a tributary of Oakley Creek, Mt Albert for stormwater treatment.

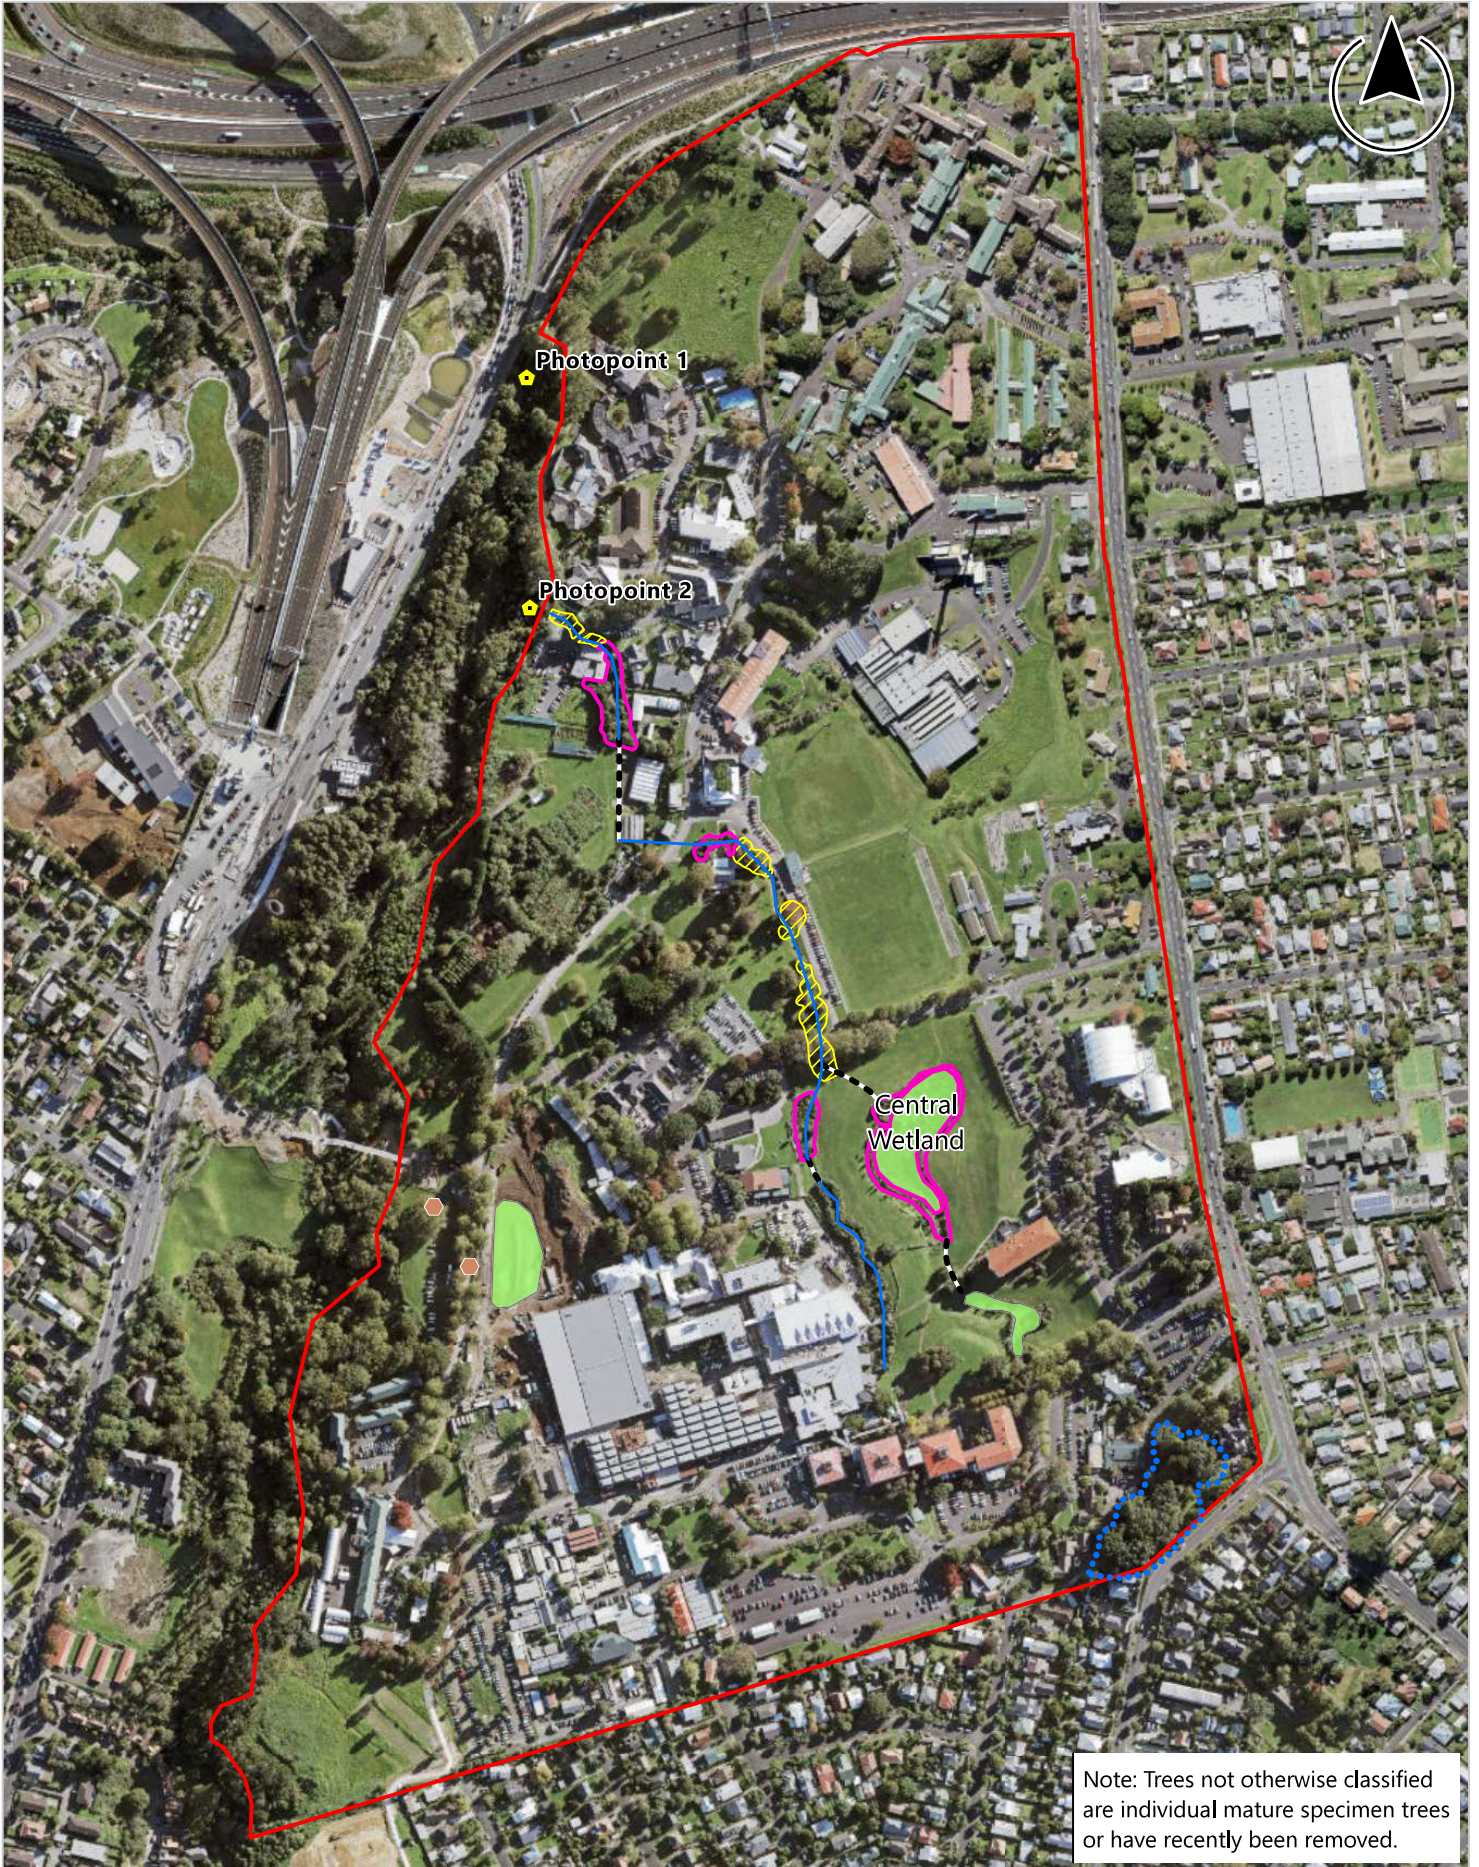
Appendix 1: Map

Note: Trees not otherwise classified are individual mature specimen trees or have recently been removed.

- Rock Outcrop
- Vegetation Area**
 - ▨ Exotic riparian vegetation (2,605 m²)
 - ▨ Native riparian vegetation (3,085 m²)
 - Mature mixed canopy (5,807 m²)
- Watercourses**
 - Piped Section
 - Wairaka Stream
 - Stormwater Management Device
 - ▭ Wairaka Precinct

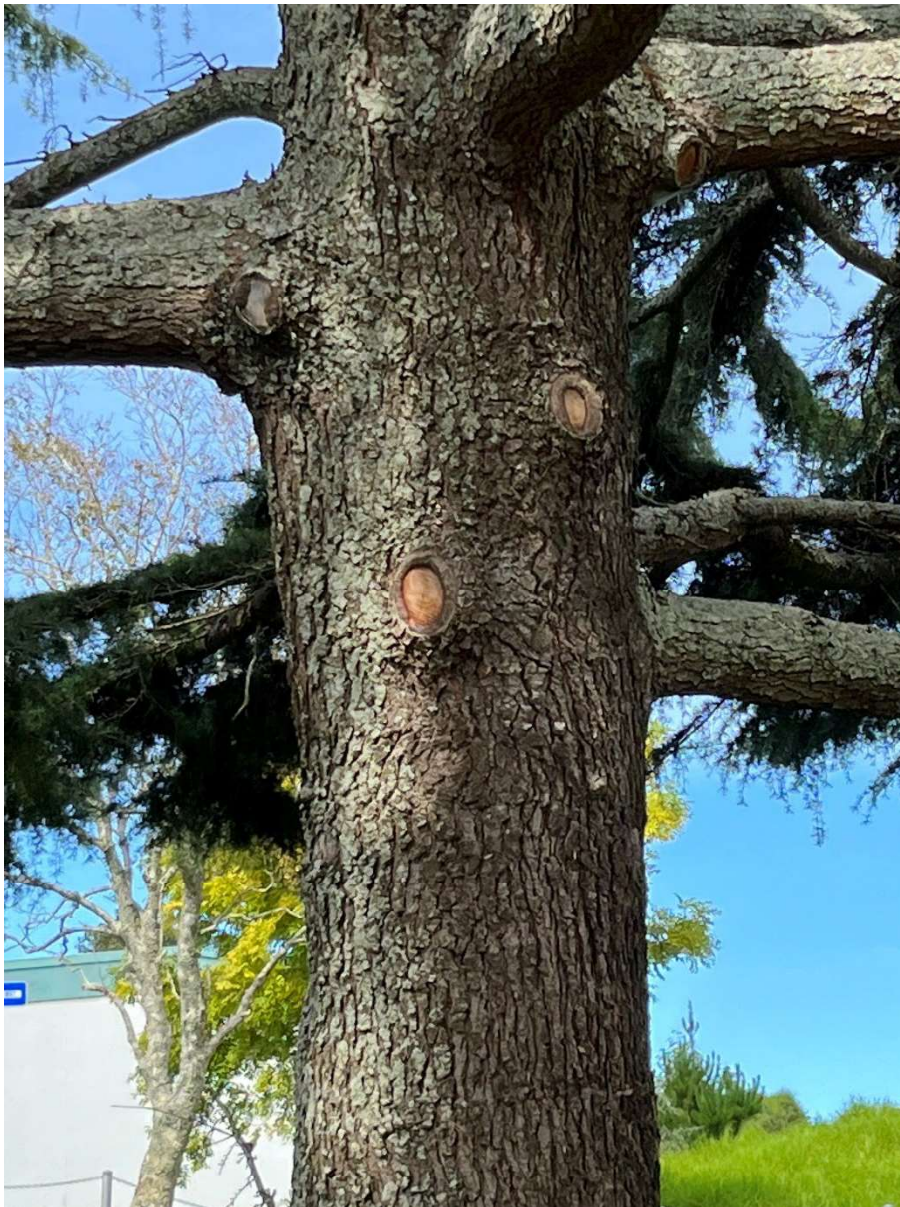
Figure 1: Pine that would otherwise be considered potential roosts, note scars that have healed over where lower vegetation has been removed.

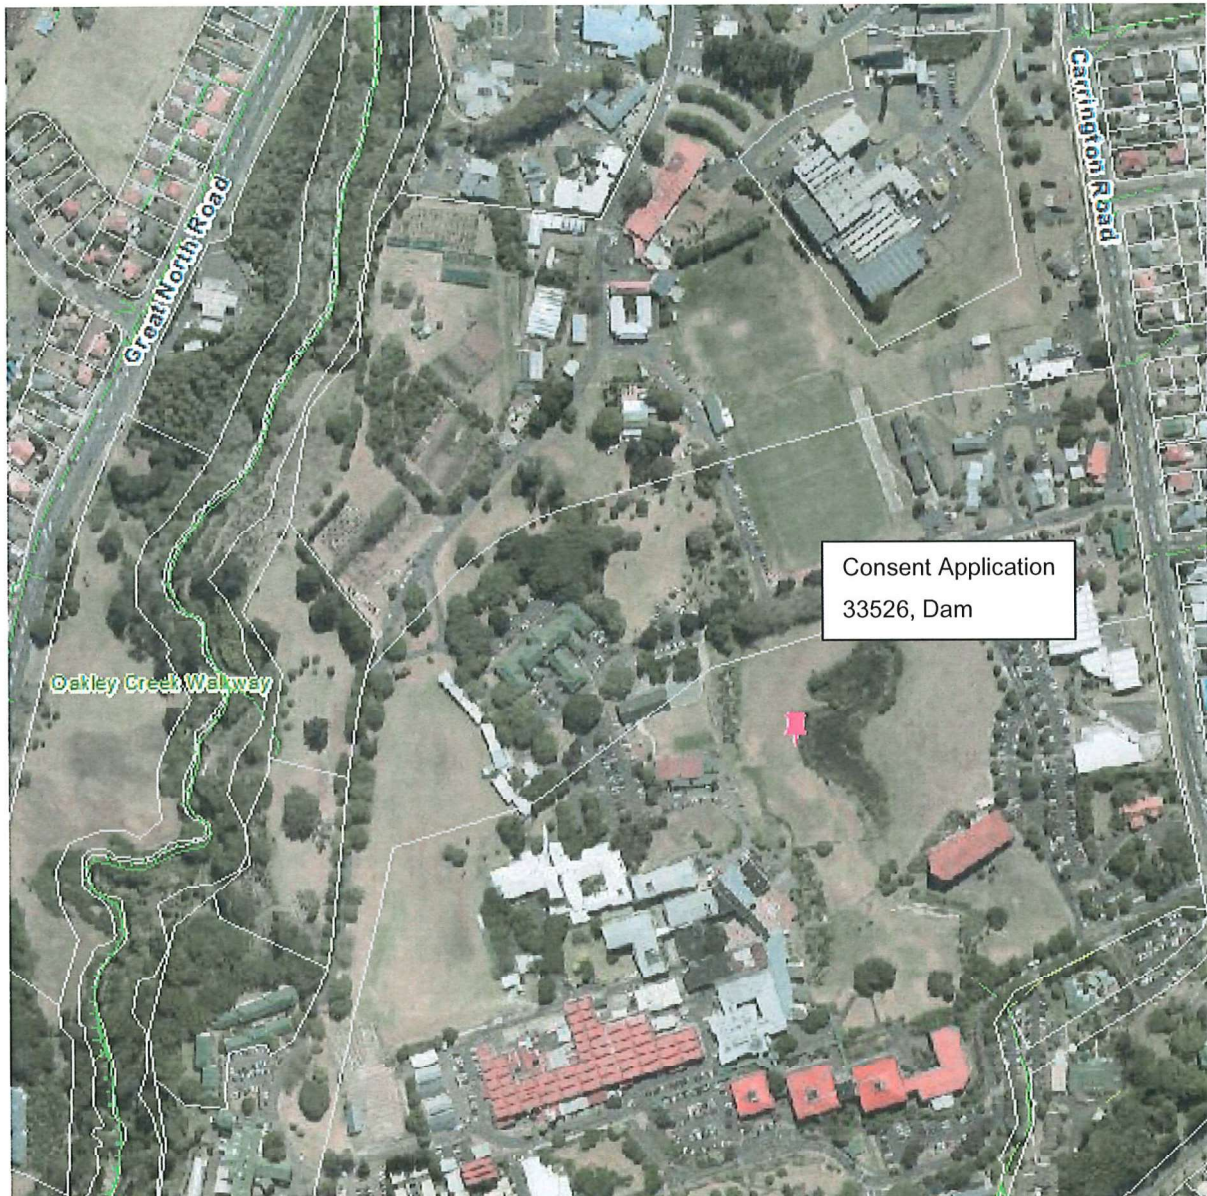
Fig 1 Oakley Creek and Dam site

1752255mE 5917000mN adjacent to Building #180. The spring fed stream discharges into the dammed stream about 200m downstream of the spring source.

The applicant owns a 51.5 ha property, on the west side of Carrington Road, Mt Albert. The applicant has made an application no. 33526 to replace existing consent no. 8256 (file Kr 928256) to dam water with a 5m high on-stream dam located on a

tributary of Oakley Creek, 530m upstream of the confluence with the main stem, granted in April 1992, and expiring on 31 December 2006. The dam is for a stormwater detention / quality pond and located on Lot 2 DP 406935 (CT 424414).

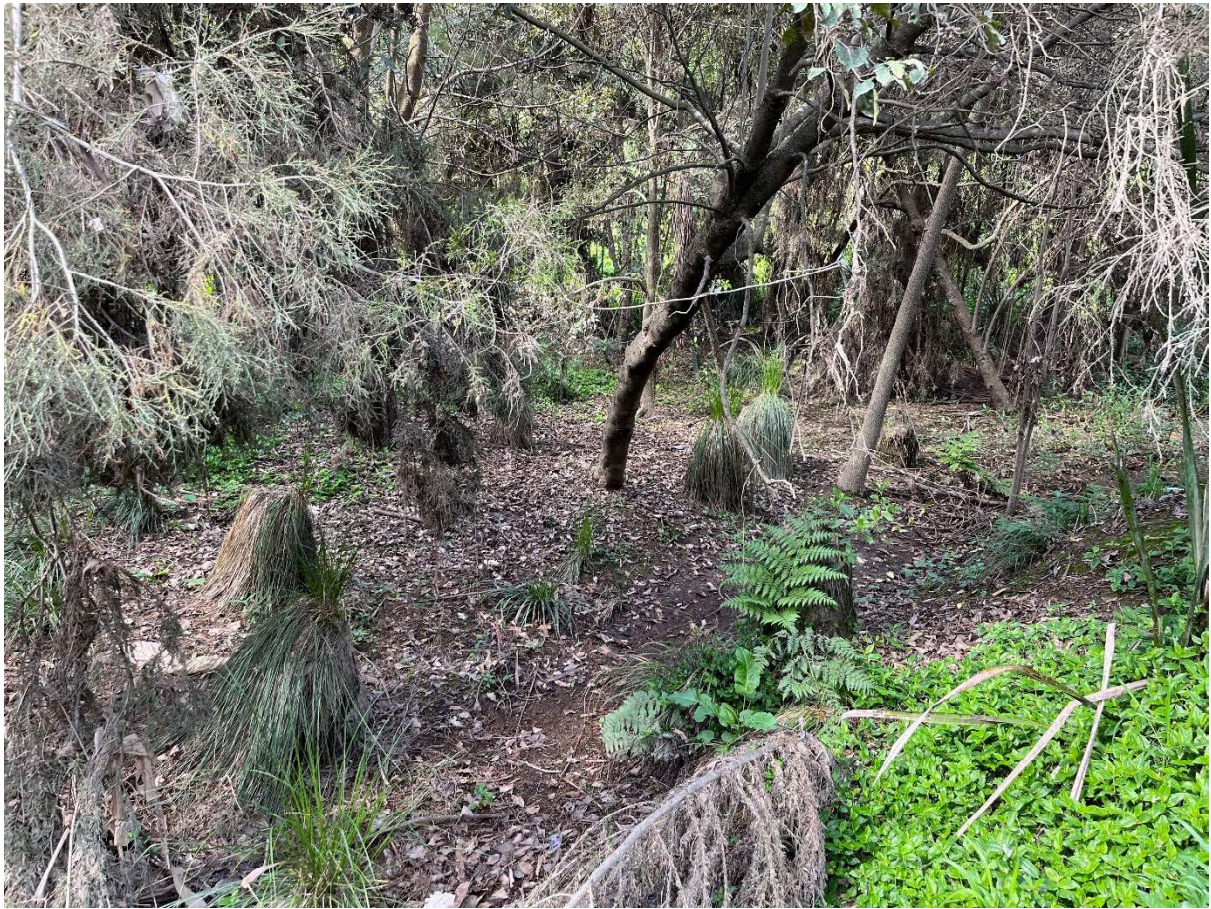
Figure 2: Wairaka Stream through the Mason Clinic

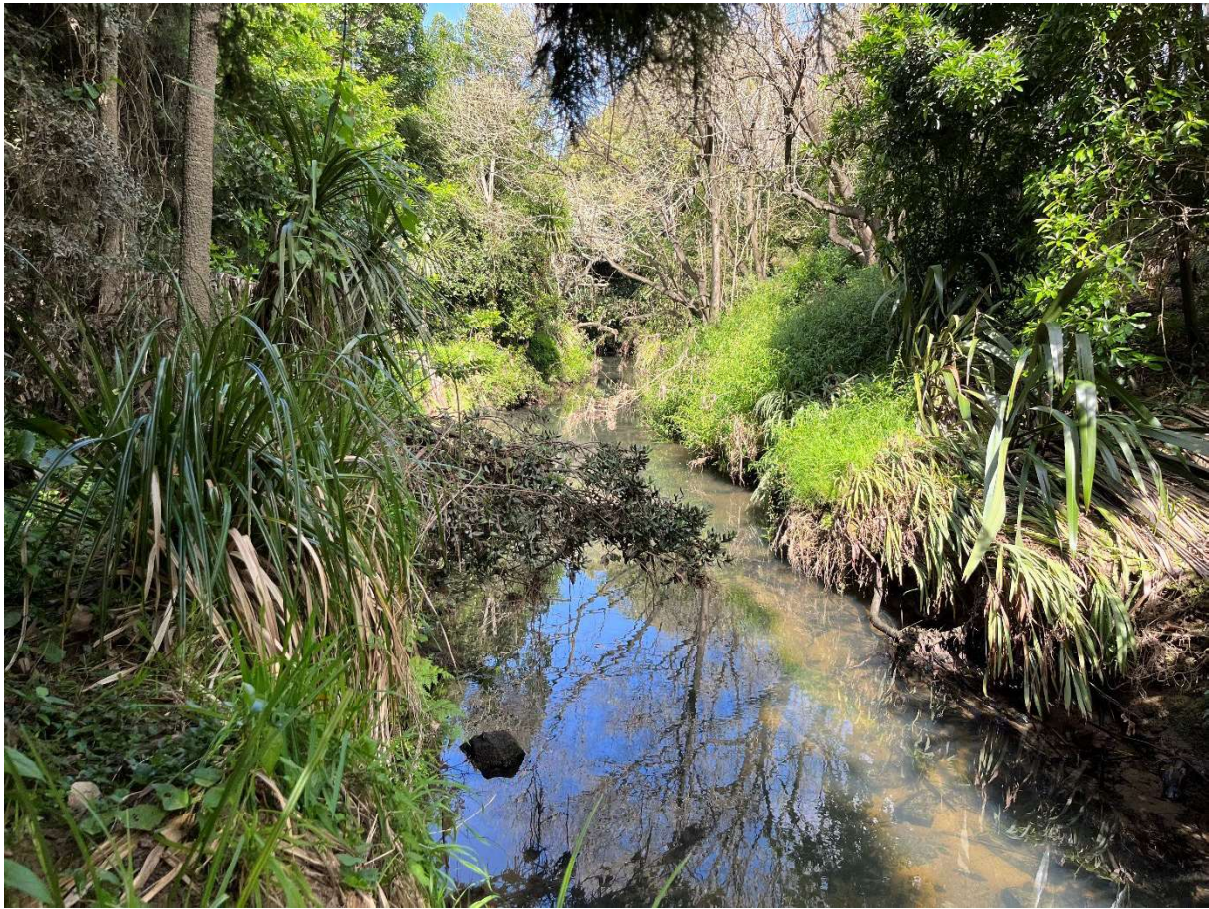
Figure 3: Te Auaunga immediately upstream of Great North Road culvert.

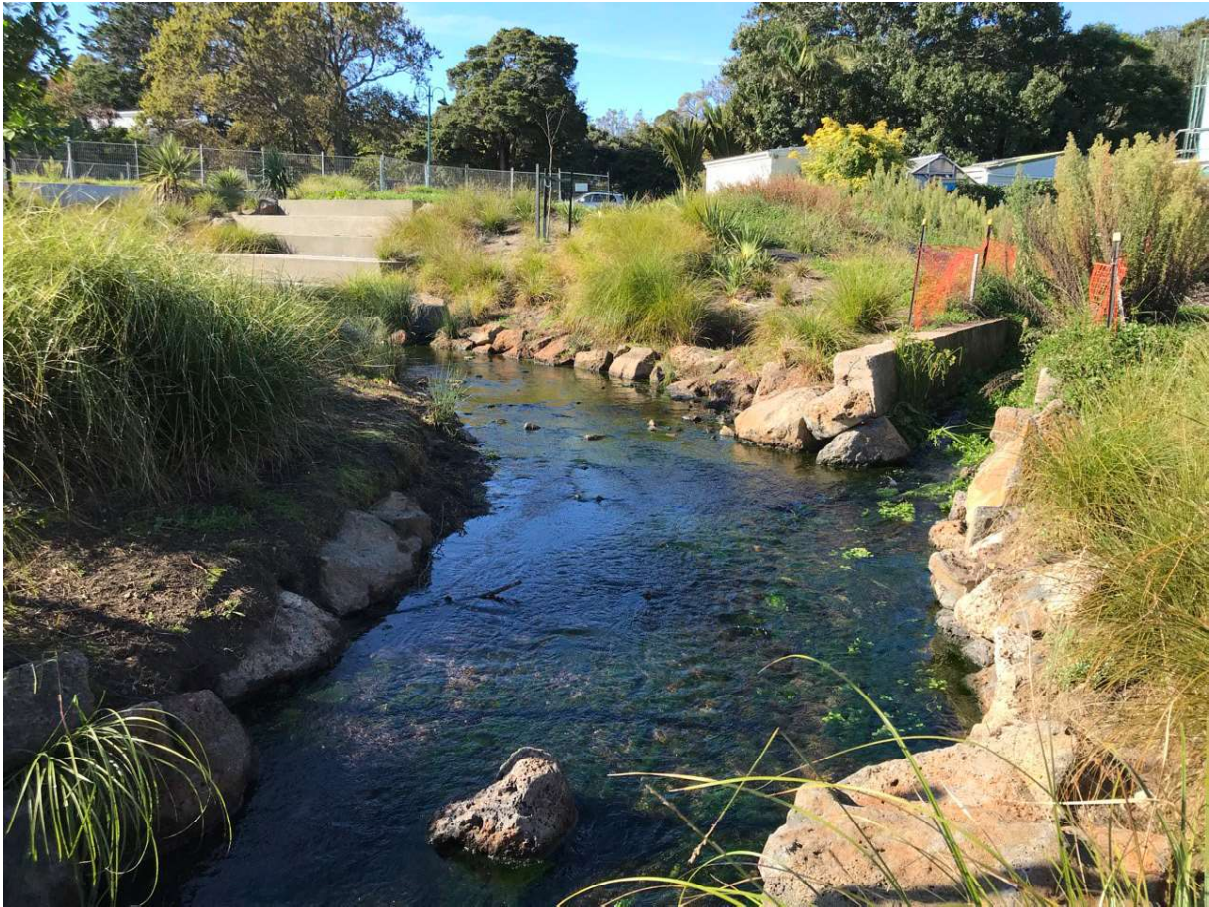
Figure 4: Recently (post-March 2021) daylight reach of Wairaka

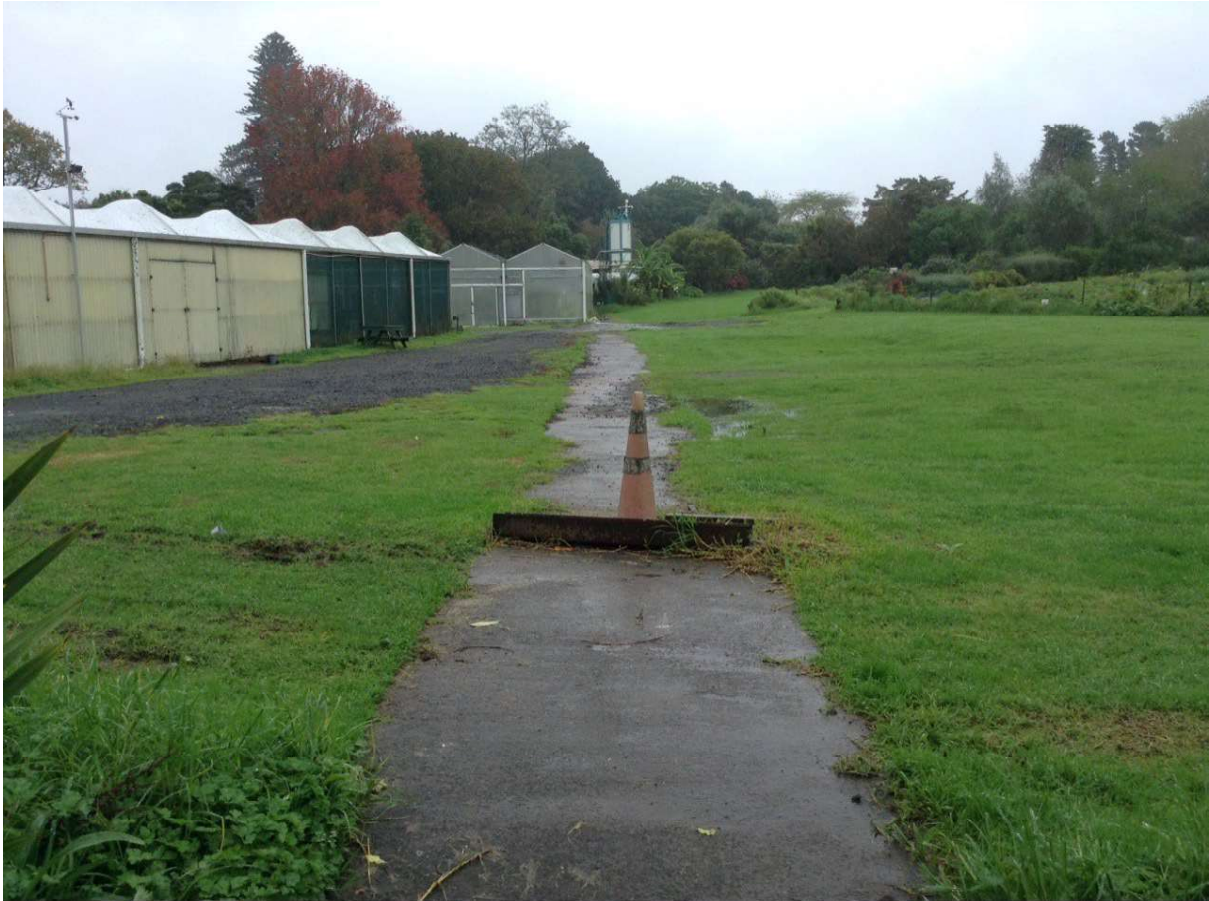
Figure 5: Remaining daylighting opportunity
