Hibiscus and Bays Local Board Workshop Programme

Hibiscus and Bays – Remediate Storm and Cyclone affected Assets

Freyberg Park - Amenities Block Removal

Infrastructure Funding Agreements (IFAs)

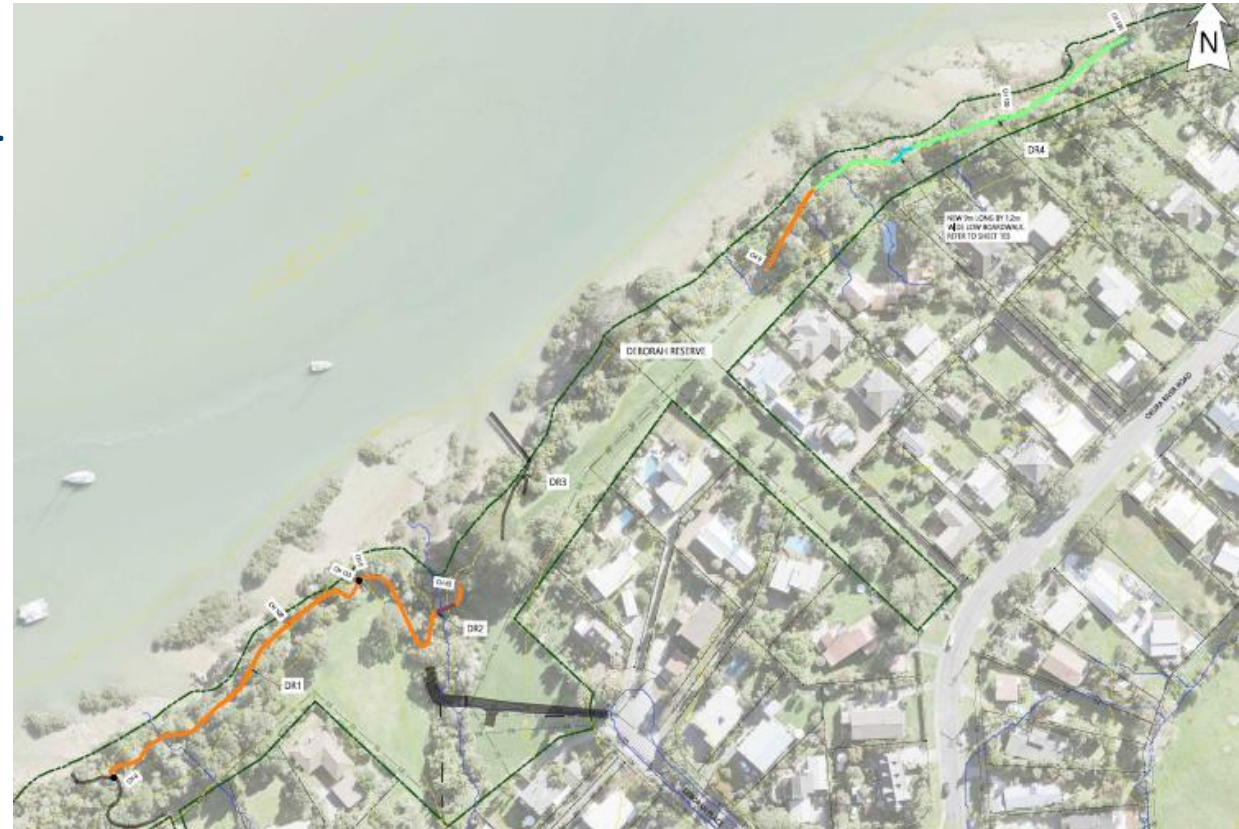
Landslips in 3 locations, track, boardwalk, and boat ramp.

- Design complete.
- Contractor award in process.
- Expected delivery by May 2024.

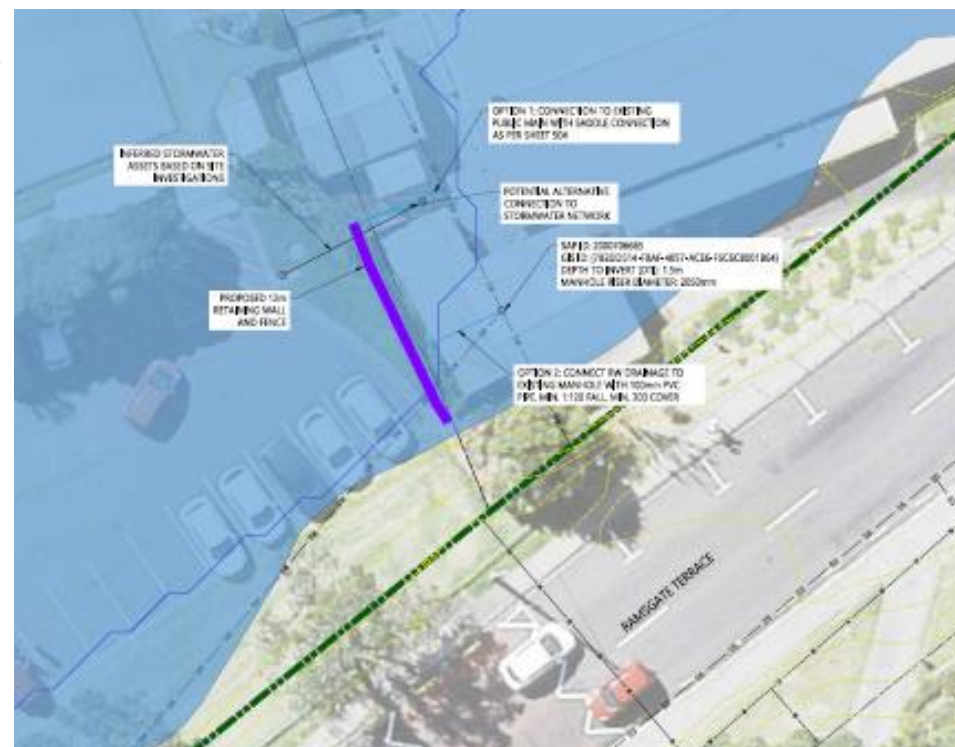
Fence and retaining wall failing by the bowling club.

- Design completed.
- Stakeholders have been involved in design process.
- Engineering Approval for stormwater connection obtained.
- Building Consent/ Resource Consent in progress.
- Contractor award in progress.
- Expected delivery by April/ May 2024.

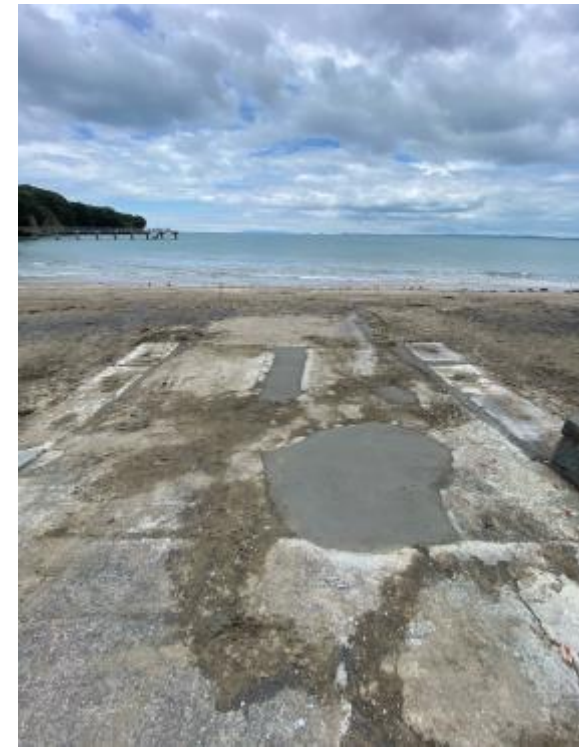
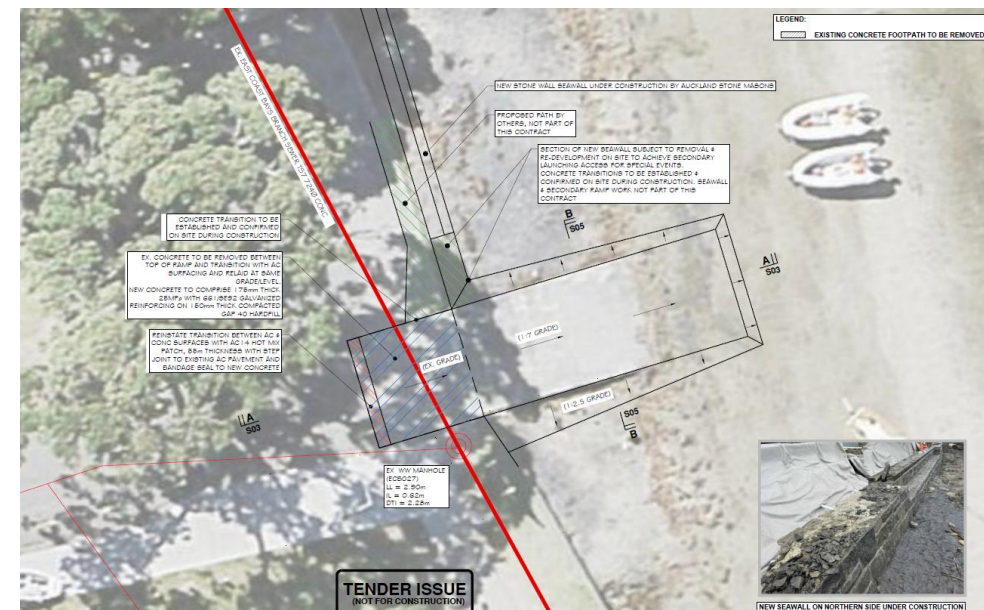
Undermining of the boat ramp, wash out of sand etc.

- Design complete. The boat ramp has existing consent and renewal works are planned within permitted activity.
- Temporary measures applied to carry ramp through until end of April.
- Due to busy season requirements the renewal works have been pushed out to commence late April 2024 .

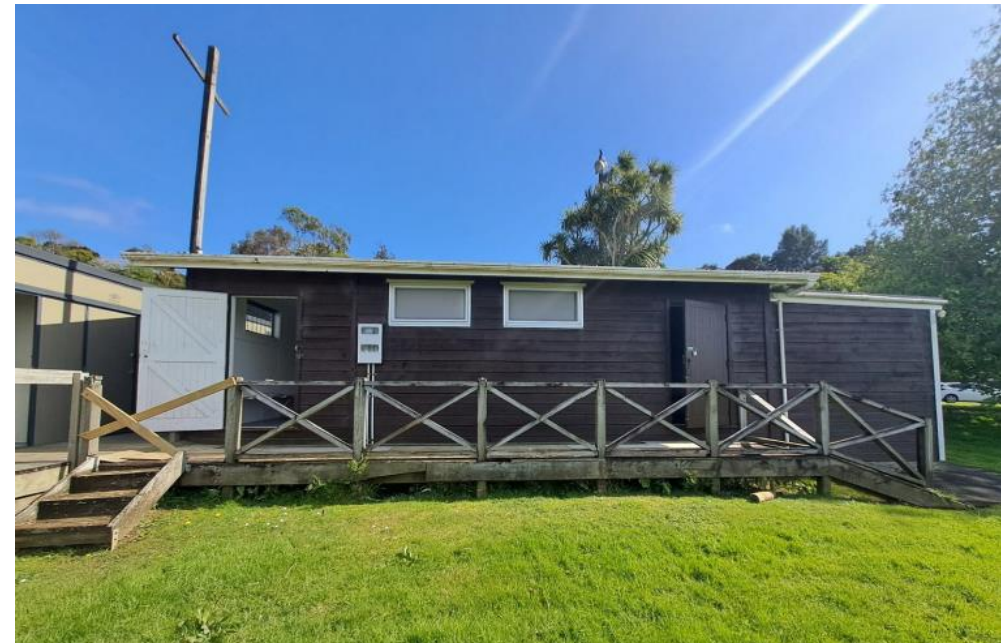
Freyberg toilet and changing room facility has been completed in 2022 under project #24497 Freyberg Park - demolish and rebuild main park building.

The toilet block and temporary changing rooms are now redundant and require removal.

A condition assessment has been requested and completed to identify if the building is salvageable for reuse or must be demolished.

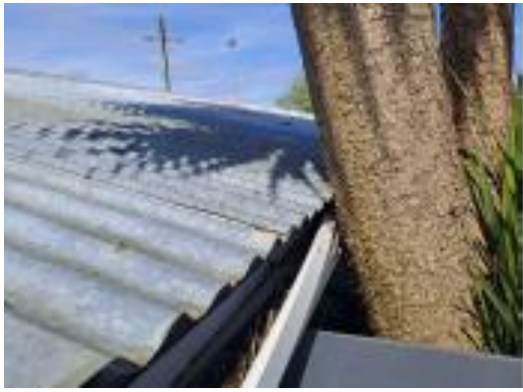
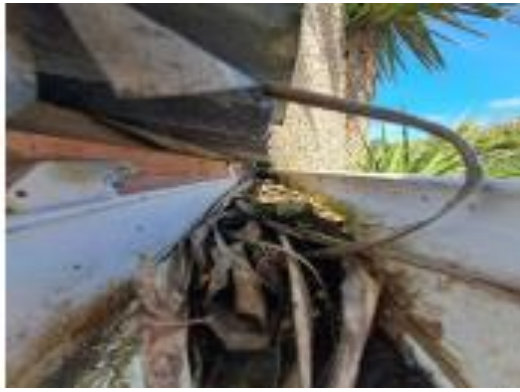
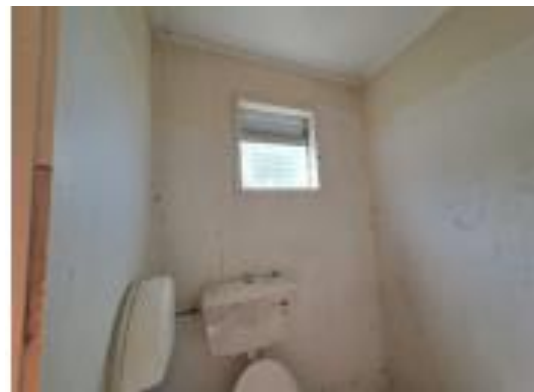
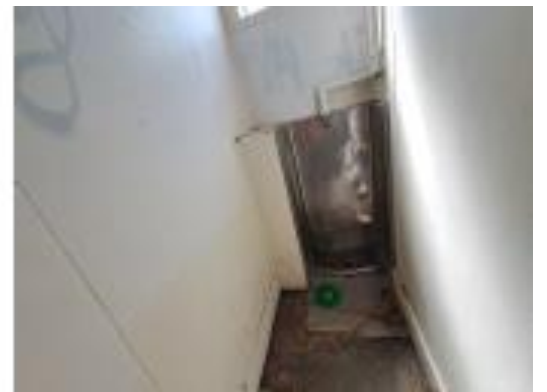
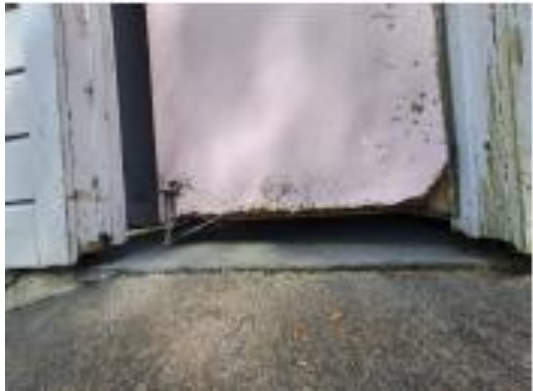
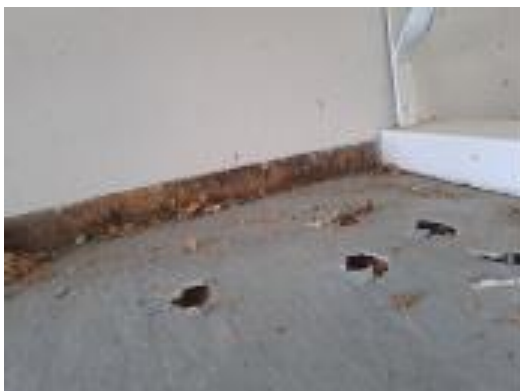
- Roof cladding and fixtures corrosion.
- Dry rot in floor plate. Failed wet area floor covering.
- Deferred maintenance of Toilet roof cladding, barge board fascia at roof apex and flashing.
- Rotten rusticated timber weatherboard cladding, reduced ground clearance affecting exterior elements.
- Blocked, and failed spouting system and exterior light fittings.
- Changing room corroded interior window bars, window fittings and openings not operational.
- Tree causing damage to spouting.

- Poor condition (Condition Grade 4- CG4), functional with limited serviceability remaining, extensive deterioration and minimal life expectancy remaining, maintenance costs inefficient.

- Very poor condition (Condition Grade 5- CG5), limited functionality and potentially hazardous to remain in service, extensive deterioration, generally not suitable to occupy and use.

Schedule the demolition of the toilet block and changing rooms used as temporary facilities.

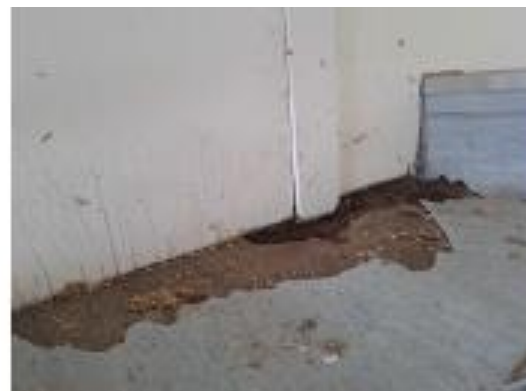
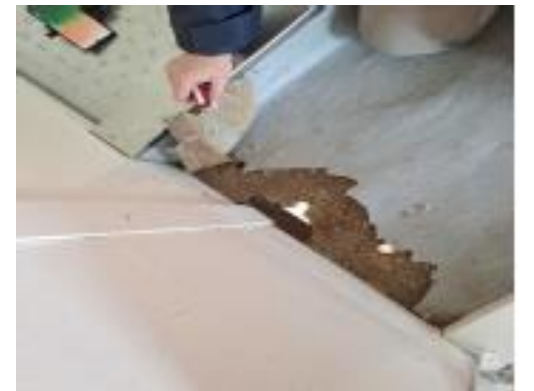
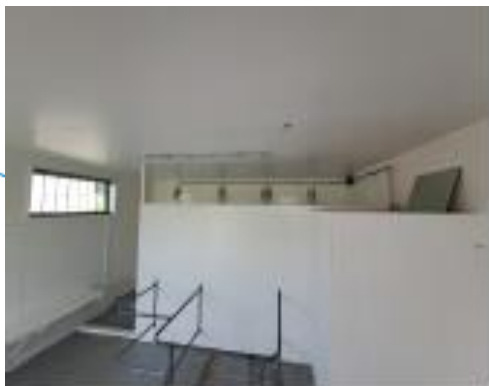
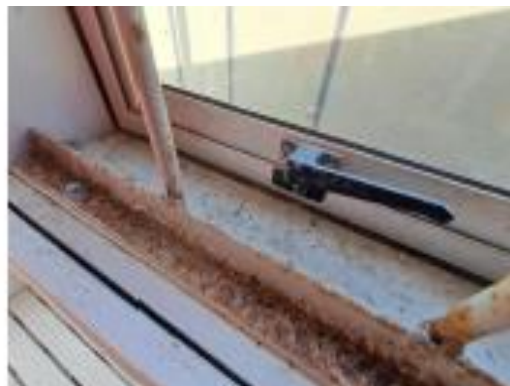
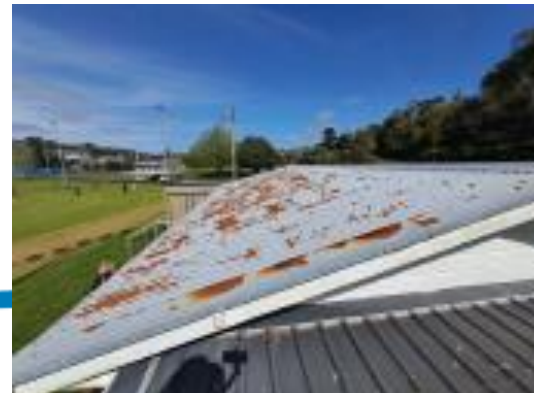
Freyberg Park - Toilet Block and Change Rooms

The overall condition of the building is in poor to very poor condition.

The remediation required to achieve acceptable condition under NZ building code are not economical considering the life and age of the toilet block and changing rooms.

The condition assessment has concluded that due to the severity of the asset's overall safety and performance features, a renewal of the changing rooms is not recommended.

Relocation/ Reuse of the building is not recommended.
