Hibiscus and Bays Local Board Inanga Spawning Project Report 2018 – 2019

Sophie Tweddle, Whitebait Connection Auckland Regional Coordinator

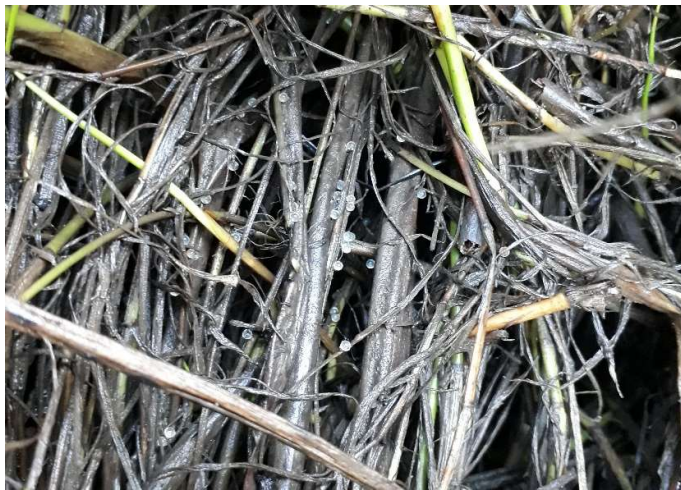
Photo: Inanga eggs in dense root mat (Sophie Tweddle, WBC)

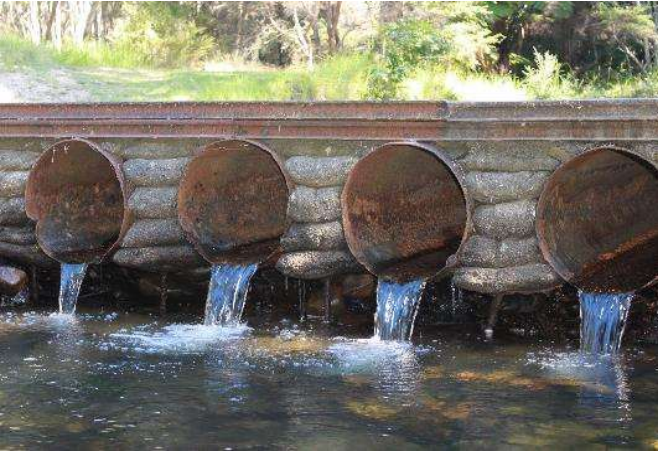
Photo: Instream barriers, such as perched culvert, can prevent inanga migration

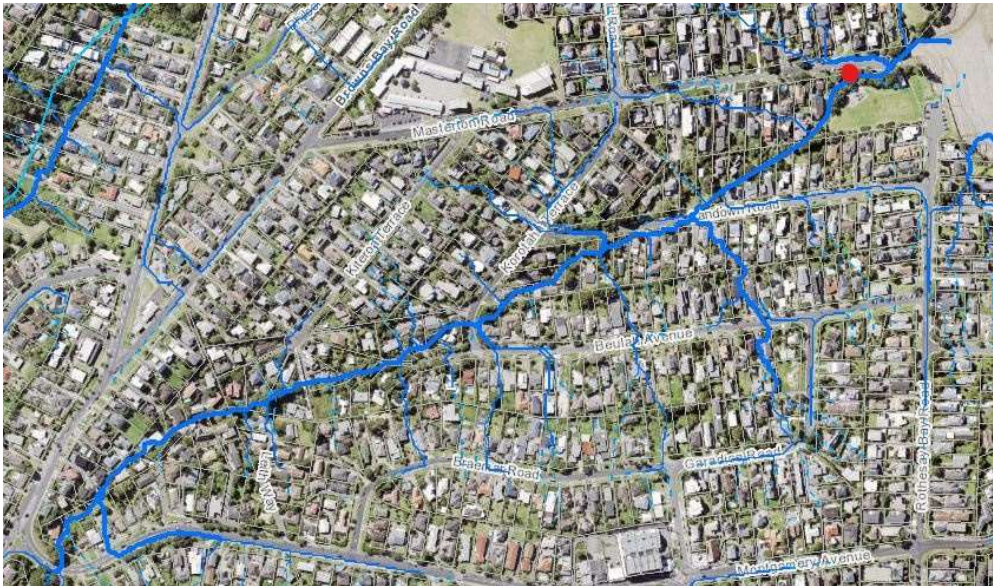
Photo: Rothesay Bay Stream. Red dot indicates the study site. (Auckland Council GeoMaps)

Rothesay Bay Stream is a small, coastal stream that runs from Browns Bay Road to Masterton Road in Rothesay Bay. The upstream channel appears to be largely culverted, although there may be some small areas of open channel on private land. The open channel studied as part of this project begins just off Sandown Road, where it flows behind private property and into the Rothesay Bay Reserve.

The catchment is urban, comprising a mix of residential dwellings, gardens and roads. The stream runs through a reserve at the bottom of the catchment. Several stormwater pipes/outlets drain into the stream from the catchment.

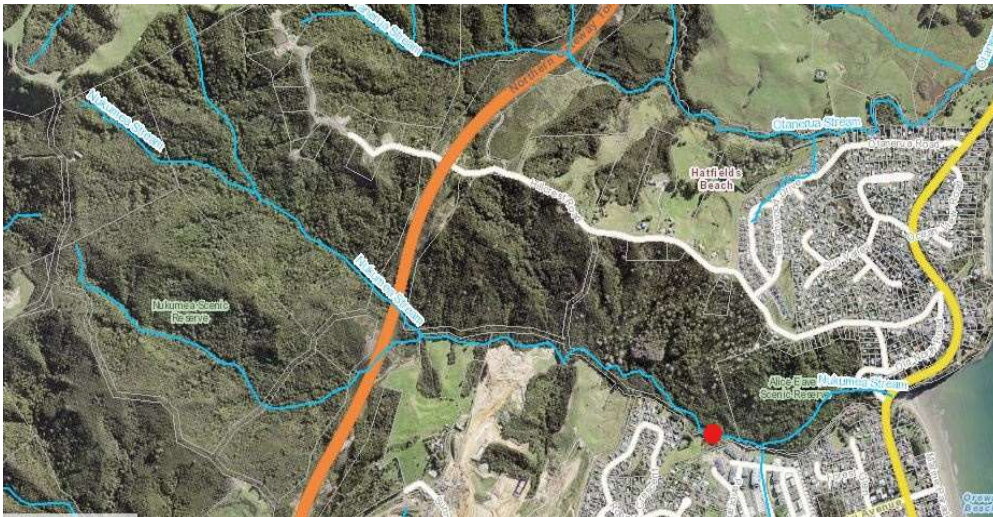
Photo: Nukumea stream catchment. Red dot indicates study site. (Auckland Council GeoMaps)

The Nukumea Stream is located at the northern end of Orewa. It is one of the last, largely natural streams in the Auckland Region and has high biodiversity values. The stream was chosen by NIWA for release of giant kōkopu (another whitebait species) in 2009 and again in 2019, due to its natural state and good instream habitat.

The upper catchment of the stream (west of State Highway 1) is largely forested (Nukumea Scenic Reserve). The catchment east of SH1, is bordered by a large area of privately owned, native bush, and Alice Eaves Scenic Reserve on the true left bank. The true right bank is bordered by new development and residential areas. Much of the new development is in close proximity to the stream.

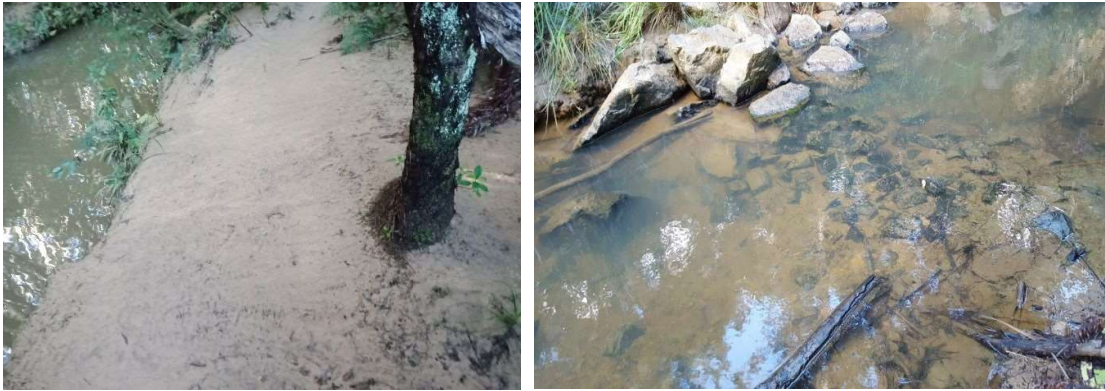
sediment, particularly by the saline wedge, is deep and easily disturbed. There has been a noticeable increase in sediment in the stream, and on riparian vegetation, in the last year.

Photo: Sediment deposition on the stream banks and on in-stream vegetation

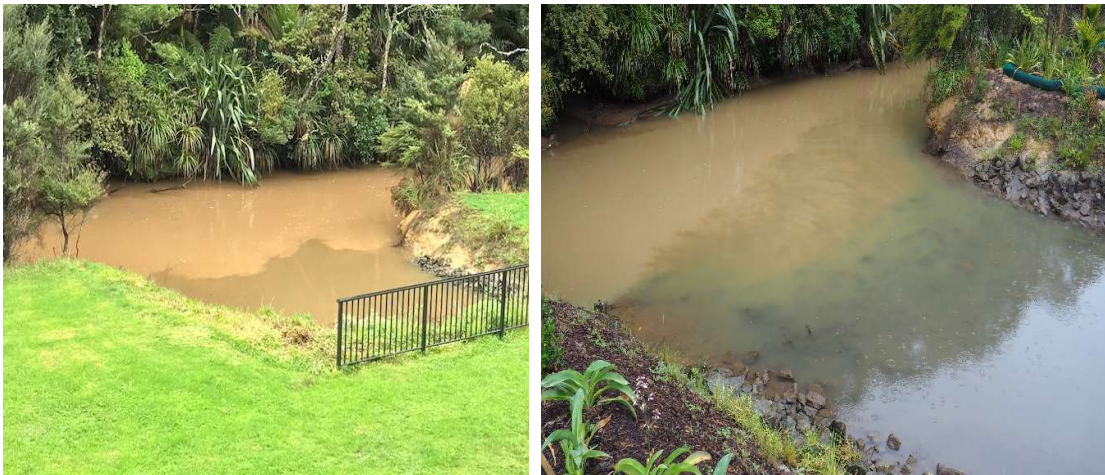
Photo: Sediment in the stream after rainfall, on two different occasions.

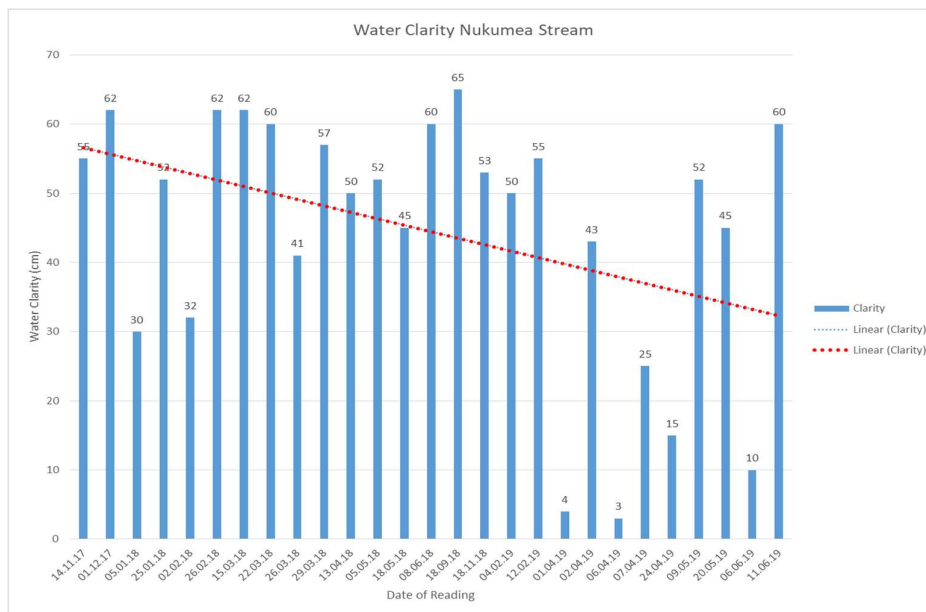
The most interesting results for the year have been those for water clarity. Previously, clarity was only measured as part of regular monitoring (not in response to rainfall). Observations and photos taken by concerned residents did, however, show that clarity was greatly affected by rain. In 2019, volunteers managed to take samples during or directly after heavy rainfall events and the results show how heavily impacted the stream is by sediment. In total, 10 incidents of heavy sediment in the stream have been recorded in the last 18 months.

Graph: Water clarity measurements on the Nukumea Stream over a 19 month period

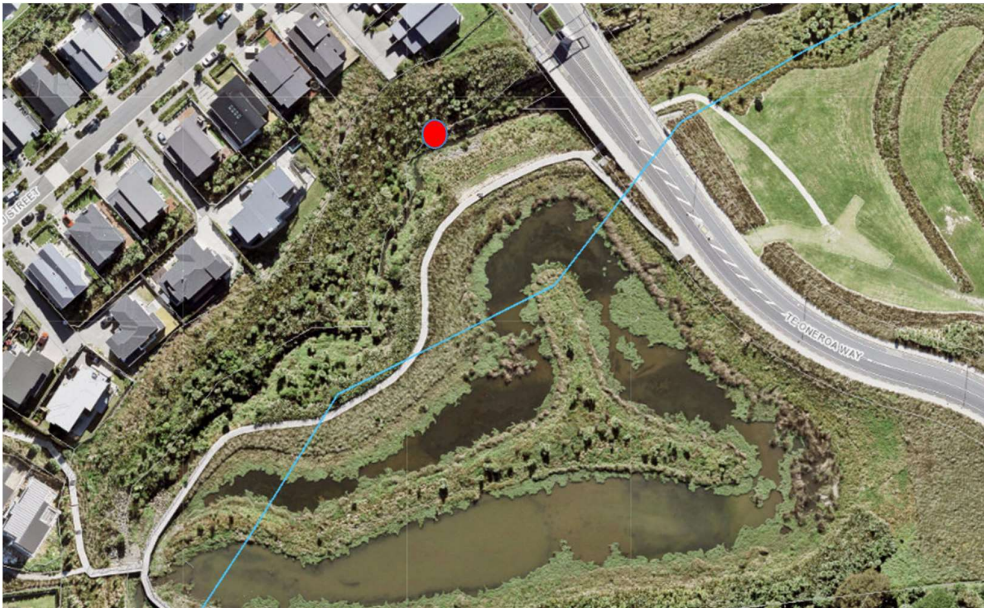
Photo: Awaruku Creek at the stormwater ponds. Red dot indicates study site. (Auckland Council GeoMaps)

Awaruku Creek is a small, coastal stream that runs from the top of Glenvar Road, through Torbay and out into the Hauraki Gulf at Long Bay. The stream is largely open (not culverted) but there are some sections that have been culverted and channelized.

The catchment is urban, comprising a mix of residential dwellings, gardens, reserves and roads. The stream runs through several reserves at the top and middle of the catchment, and a large stormwater pond/wetland at the bottom of the catchment. Several stormwater pipes/outlets drain into the stream from the catchment.

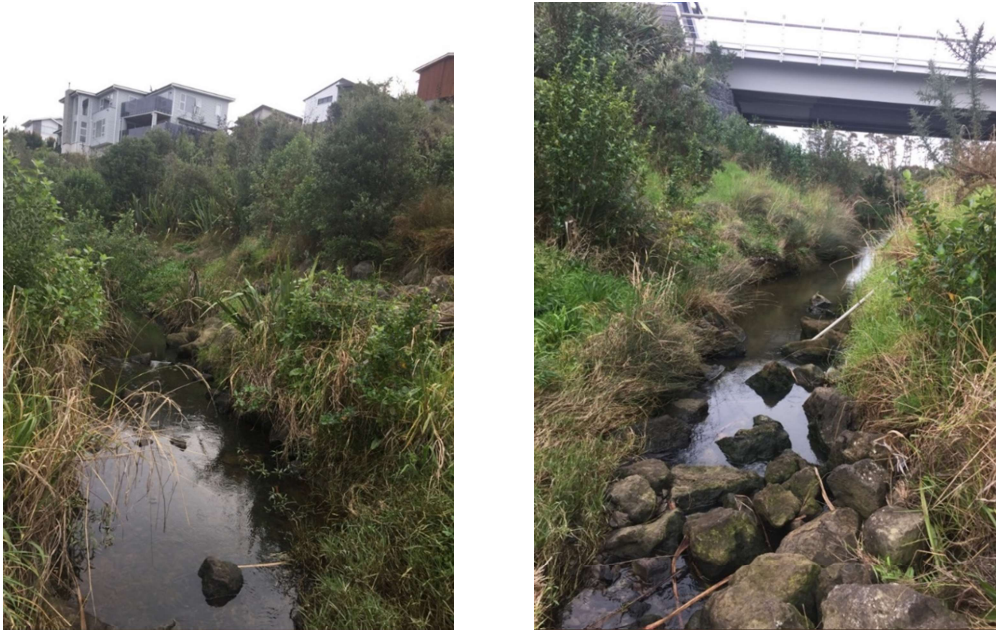
Photo: Awaruku Creek at the saline wedge – upstream (left) and downstream (right)

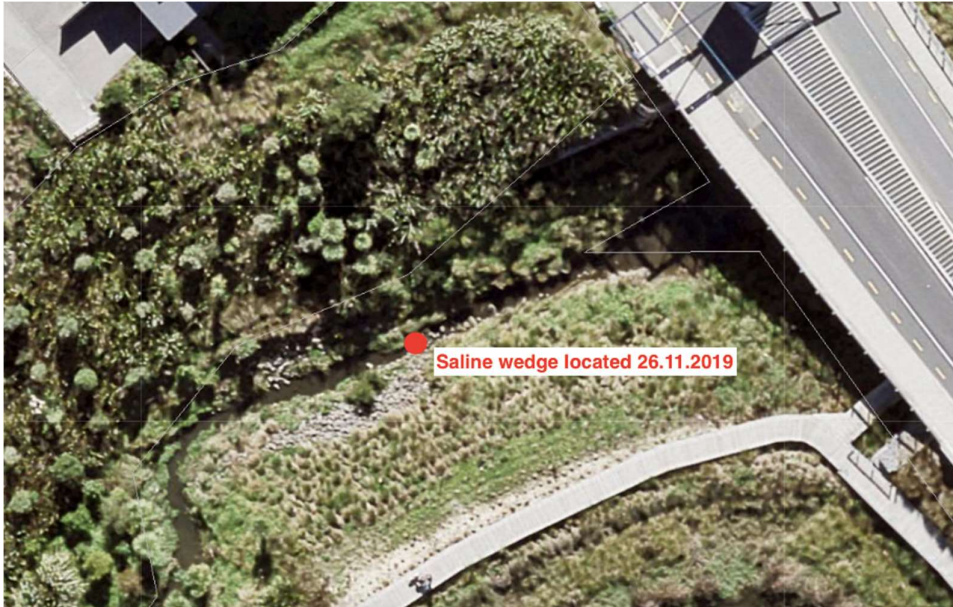
Whitebait Connection also undertook a saline wedge survey of the stream, and an assessment of habitat around the saline wedge, to check the sites suitability for inanga spawning. The saline wedge was found at NZTM 1756093, 5938051 on the 26.11.2019. Flow conditions were low.

Photo: saline wedge on the Awaruku Creek (Auckland Council GeoMaps)

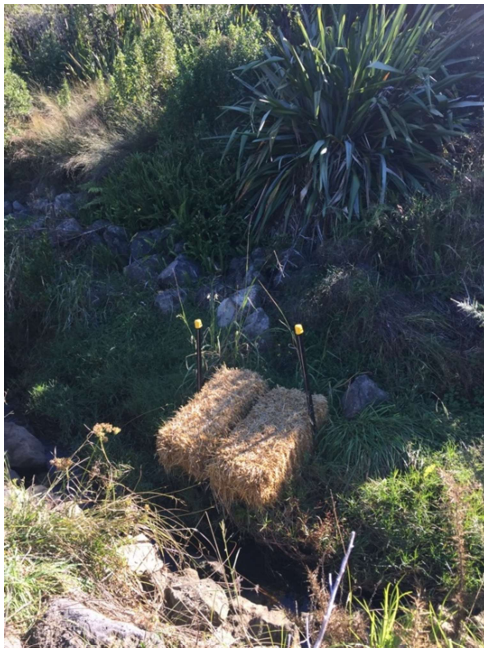
A small area of suitable habitat was found at the saline wedge however, as this habitat was limited, artificial habitat was installed at the site.

Photo: Awaruku Creek hay bale installation

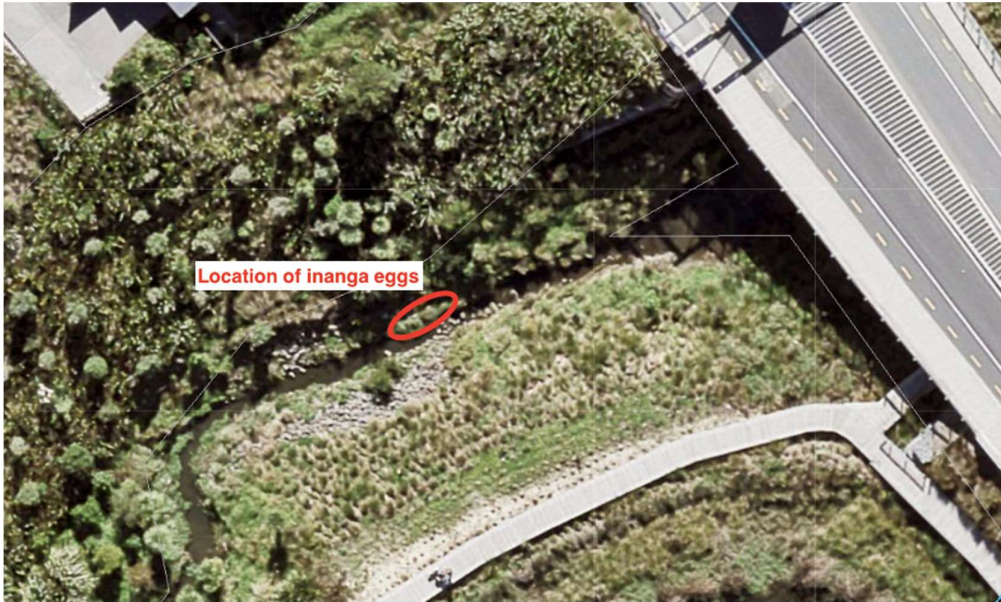
Three spawning surveys and egg checks were undertaken at suitable locations on the stream during the spawning season. Eggs were found during two of the three surveys, however no spawning activity was seen.

The map below shows the location of eggs. Eggs were found in both the hay bales and the natural habitat surrounding the hay bales.

Photo: Location of inanga eggs on the Awaruku Creek

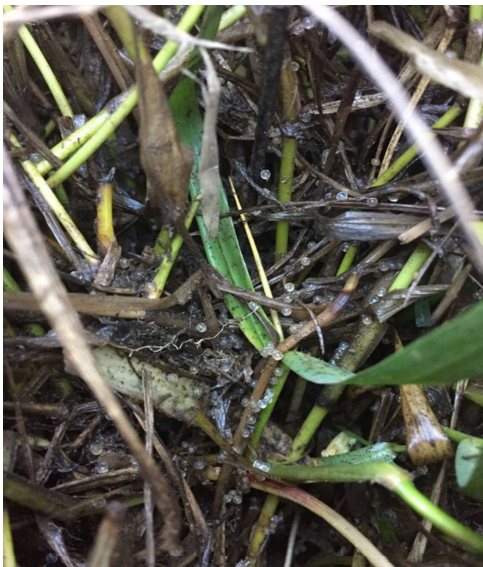
Photo: Inanga eggs found in natural habitat surrounding the hay bales

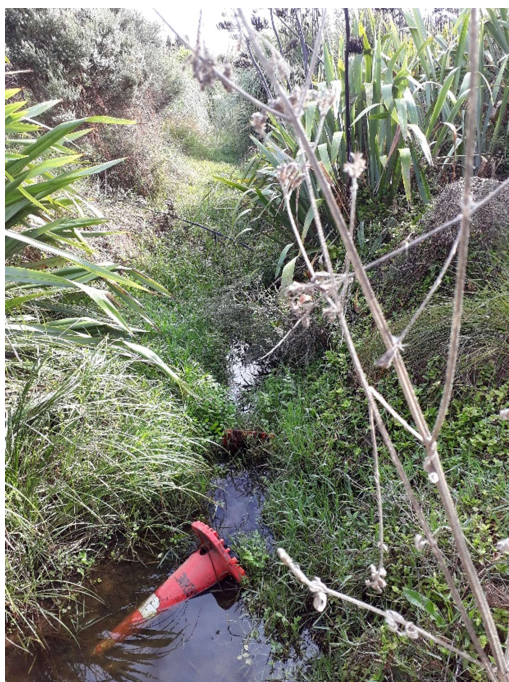
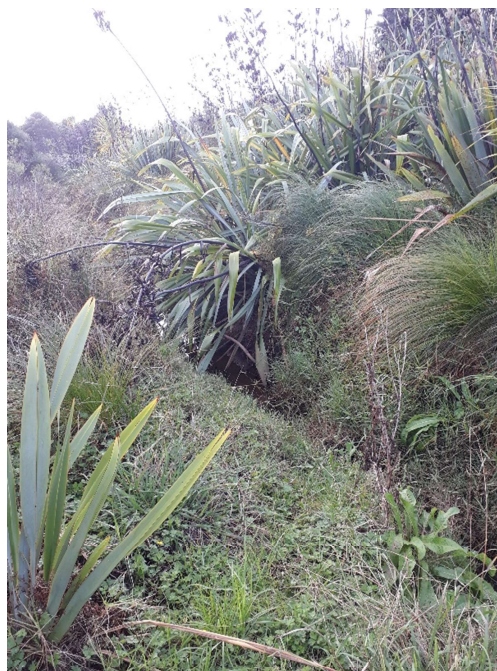
The stream is soft bottomed with reasonable instream habitat on both branches and areas of good riparian habitat within the reserves. A long stretch of the northern branch has recently been naturalised, which has added to its ecological value.

Photo: Riparian habitat along the southern branch, close to the saline wedge

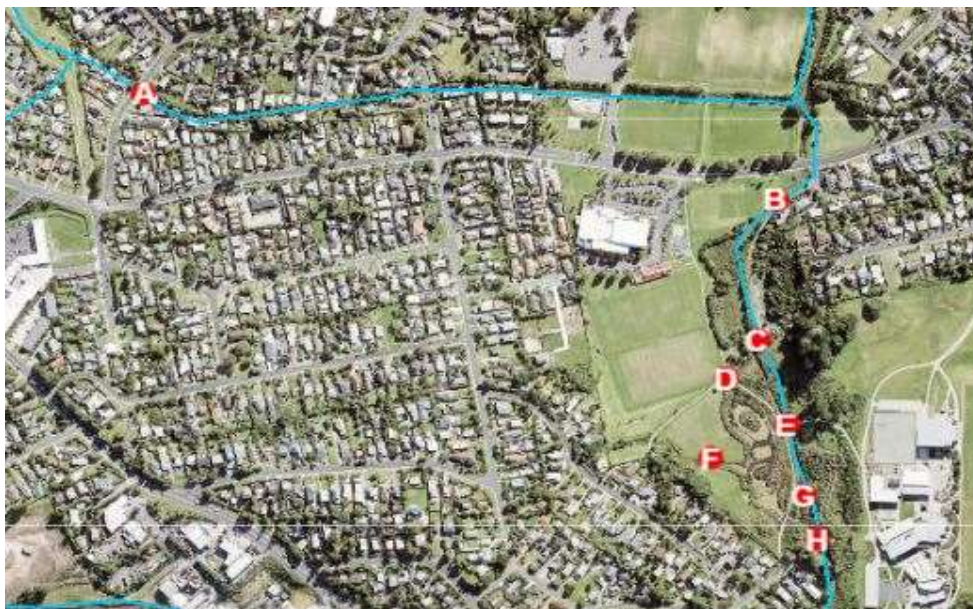
Photo: Location of fish traps on Stanmore Bay stream (Auckland Council GeoMaps)

Fish surveys were undertaken on five occasions. Traps were placed at various locations on the southern branch and at one site on the northern branch (see map below for numbering). Traps were set in the evening and checked the following morning.

Results from these surveys can be seen in the table below. Only traps which recorded a result are listed. Traps not present in the table recorded a zero result (no fish caught).

The saline wedge was found at Point A (NZTM 1755111, 5945192) on the northern branch and Point B (NZTM 175859, 5944853) on the southern branch on the 12/11/19. Flow conditions were low. The habitat was found to be suitable for inanga to spawn on the southern branch but vegetation cover was limited on the northern branch.

A further saline wedge survey was undertaken on the southern branch after low tide observations at point B of crab holes. On this occasion, the wedge was found to be further upstream at Point C. Habitat at this point is marginal. The banks of the stream are steeper and it is not clear if a spring high tide would inundate vegetation at the top of the bank.

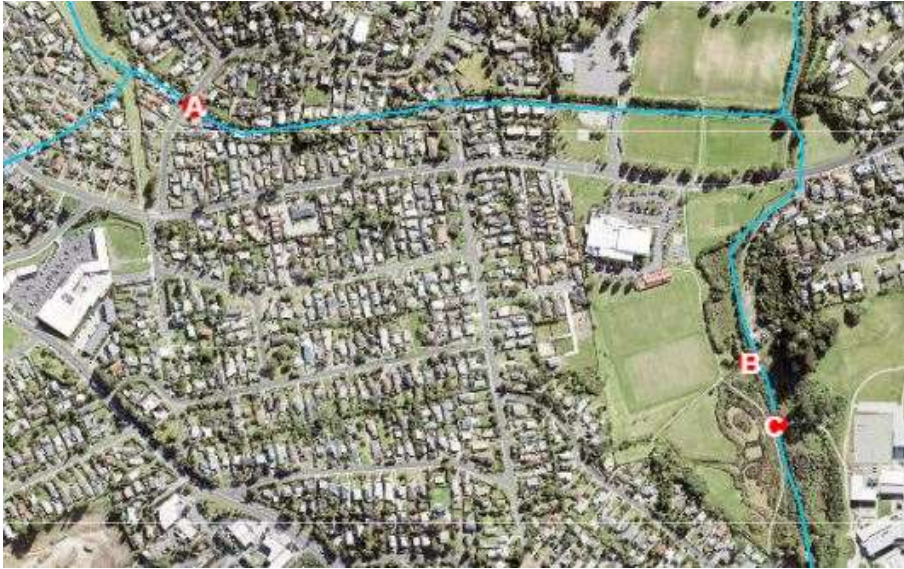
Photo: Location of saline wedge on both branches of Stanmore Bay

Unfortunately, despite finding inanga on both tributaries of the stream, no spawning activity has been observed to date and no eggs have been found on either branch. It may be worth installing artificial habitat on the stream in 2020, to confirm whether or not inanga would spawn if suitable habitat was present. If spawning is confirmed, WBC can then work with landowners to plant riparian vegetation that is suitable for inanga to spawn. It may also be possible to create some inanga 'benches' on the southern branch, in collaboration with Healthy Waters.

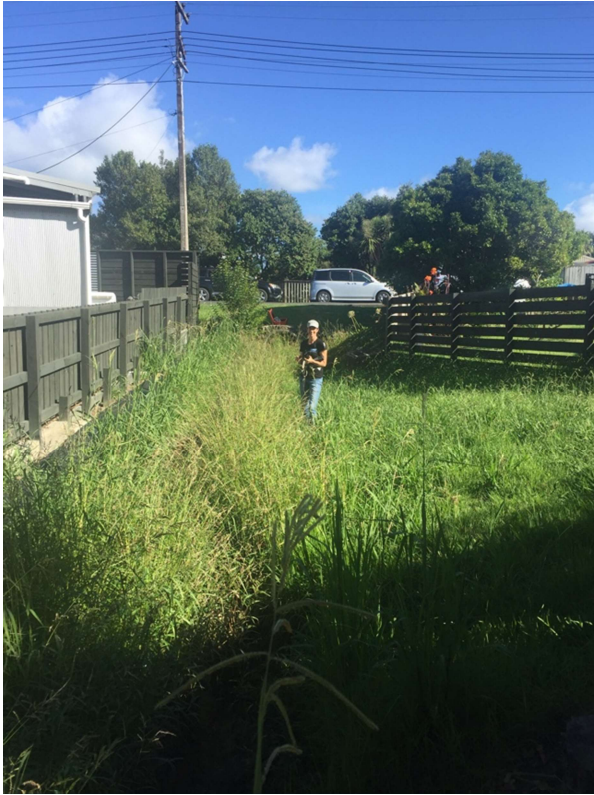
Photo: Location of saline wedge behind property at 7 Langton Road

On the northern branch of the stream, the landowner at 7 Langdon Road was contacted to arrange permission to access the stream behind their property. They are keen to see the land around the stream managed to avoid overgrowth of weeds and have requested help with planting the stream bank. The saline wedge was located at this site, along with several gravid inanga later in the season.

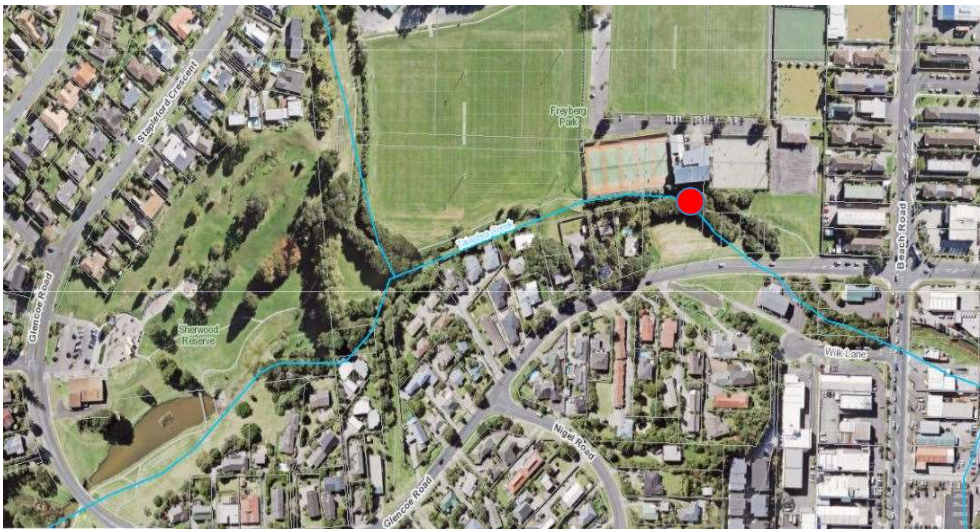
Photo: Taiaoatea Creek at Sherwood Reserve and Freyberg Park. Red dot indicates study site. (Auckland Council GeoMaps)

The Taiaoatea Creek is a small, coastal stream that runs from East Coast Road in the west, through residential development and out into the Hauraki Gulf at Browns Bay. The stream is stormwater fed and the upstream channel has been highly modified and culverted. A project is currently underway to open-up (daylight) and restore part of the stream that runs through Sherwood reserve to a more natural channel.

The catchment is urban, comprising a mix of residential dwellings, gardens and roads. The stream runs through several reserves at the bottom of the catchment – Sherwood Reserve, Freyberg Park and Browns Bay Creek Reserve. Several stormwater pipes/outlets drain into the stream from the catchment.

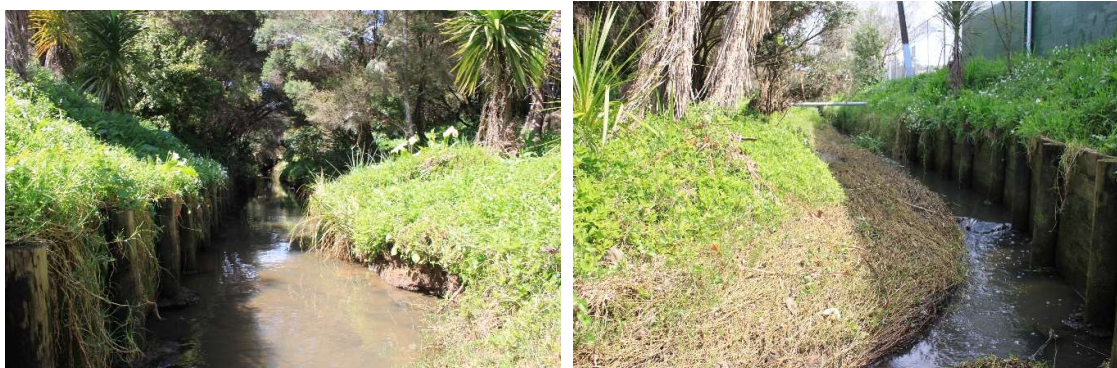
The stream is bedrock based below the limit of saltwater intrusion and soft bottomed upstream of the tennis courts in Freyberg Park. Riparian cover is patchy but there are small stretches of native vegetation within the reserves. There is limited instream habitat downstream of the saltwater limit but reasonable instream habitat within the freshwater.

Photo: Downstream (left) and upstream (right) view of Taiaotea Creek, Freyberg Park

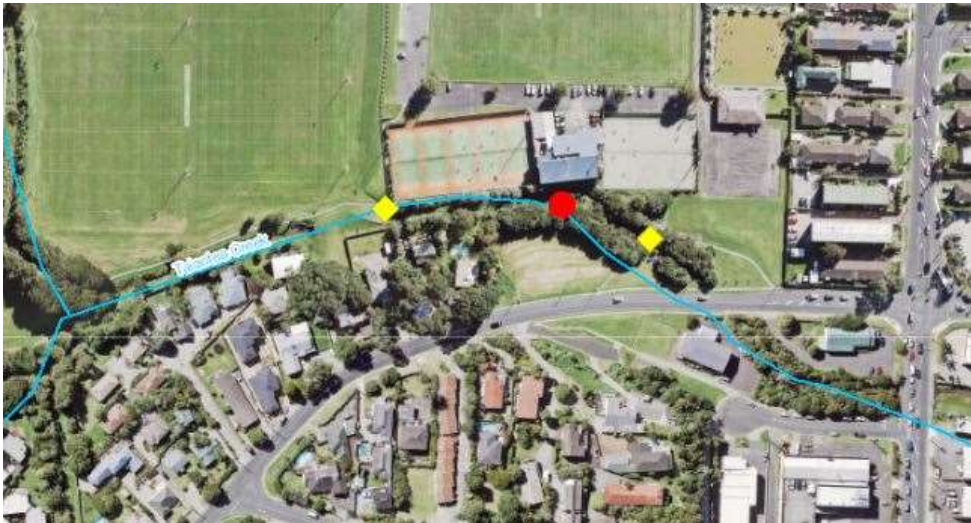
The saline wedge was found at NZTM 1755505, 5935186 on the 11.11.18. Flow conditions were normal at the time of survey. The habitat was found to be suitable for inanga to spawn around and upstream of the wedge, with dense, grassy habitat on the true right bank (looking downstream). There is, however, no suitable habitat on the true left bank as the bank has been retained with wooden boards.

Photo: Saline wedge (red dot) on the Taiāotea Creek and inanga caught during survey on 11.11.18 (diamond)

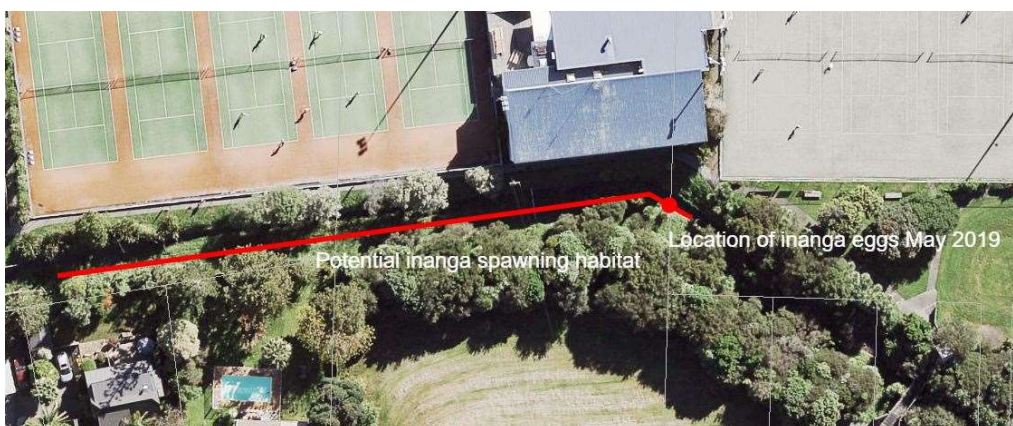
Two spawning surveys and egg checks were undertaken at suitable locations on the stream during the spawning season. No eggs or spawning was found on the 14.05.19. A small clump of eggs was, however, found on the 30.05.19. The map below shows the location of the spawning site.

Photo: Location of inanga spawning site on the Taiāotea Creek (Auckland Council GeoMaps)

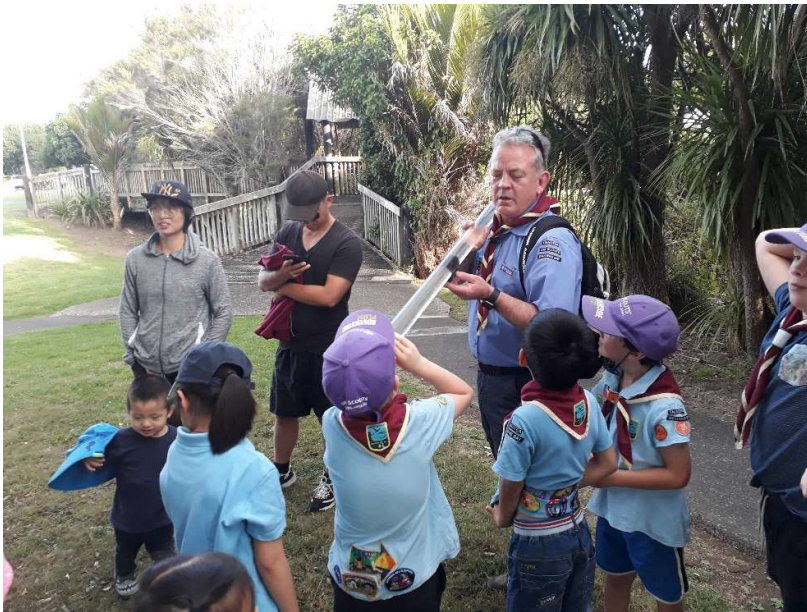
Photo: Browns Bay Keas testing water quality at the Taiatea Creek

The Brown Bays Keas group visited the stream in February 2019 to work towards their environment badge. A total of 15 keas and six adult helpers used simple equipment to test water quality. They then walked a short length of the stream looking for litter or other pollutants. They then took it in turns to 'fish' for macroinvertebrates in the stream, and to look for inanga.

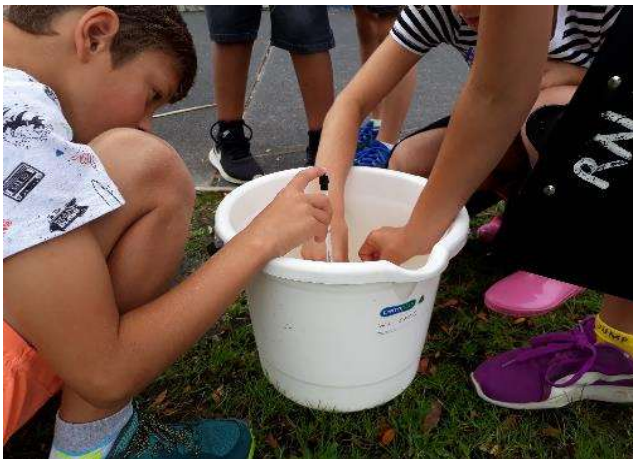
Photo: Students from Orewa North Primary test a water sample from the Nukumea Stream (Sophie Twedde, WBC)

Basic water quality testing was also undertaken at both project sites, by local volunteers and school students. Tests were undertaken using a Wai Care testing kit, which includes water clarity (using a clarity tube), water and air temperature (using a digital thermometer), dissolved oxygen (using a Chemets Kit), pH (using Fisherbrand test strips), Nitrates/nitrites (using Aquachek test strips) and Phosphates (using Microtest kit).

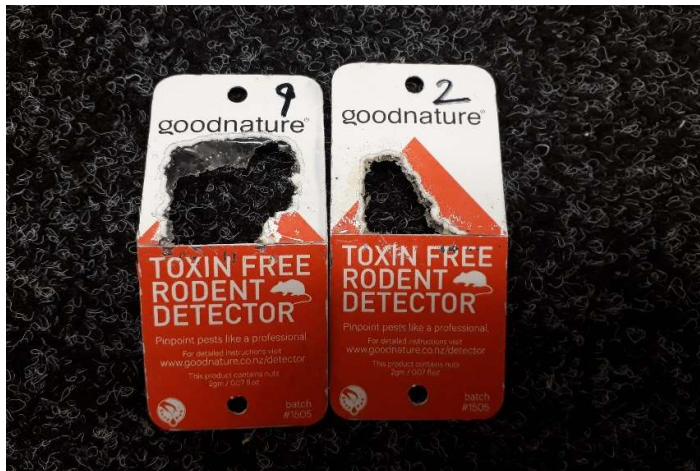
Chew cards and tracking tunnel cards were checked and replaced once a week over a 5 week period on Nukumea Stream and once a week for two weeks on the Rothesay Bay Stream. The results were recorded and analysed by the students. Results from pest monitoring can be used to guide pest control work.

Photo: Chew cards with evidence of rat activity (Sophie Tweddle, WBC)
