Job No: 615478.6240
18 February 2015

Clough and Associates
321 Forest Hill Road
Waiatarua
Auckland 0612

Quarry Road Site Report – Ground Penetrating Radar Survey

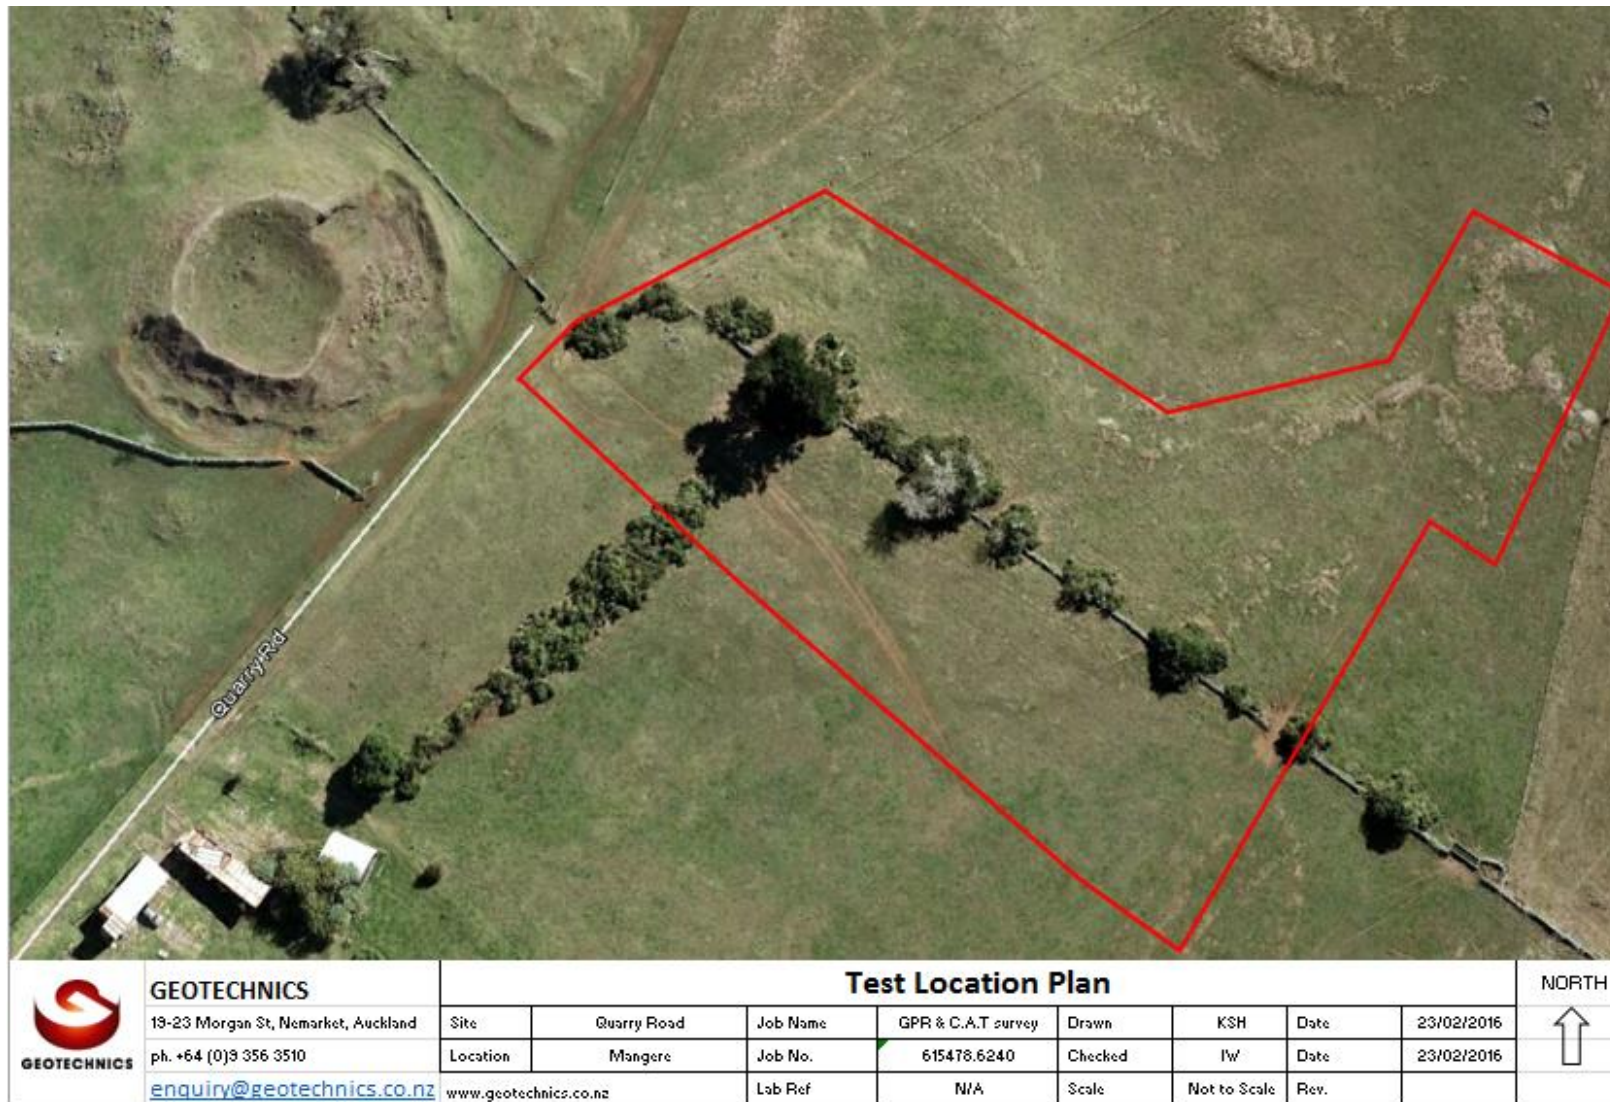
The extent of the flow is visible from the surface, the location and extent of the voids are indicated in this report.

Survey site plan showing voids
