PRELIMINARY SITE
INVESTIGATION -
CONTAMINATION

362 JONES ROAD, HUNUA

Project No.	33250	Approved for Issue	
Version No.	1	Name	Sean Finnigan
Status	Final	Signature	 
Authors	E Bish & A Field	Date	04/04/2024
Reviewer	S Finnigan

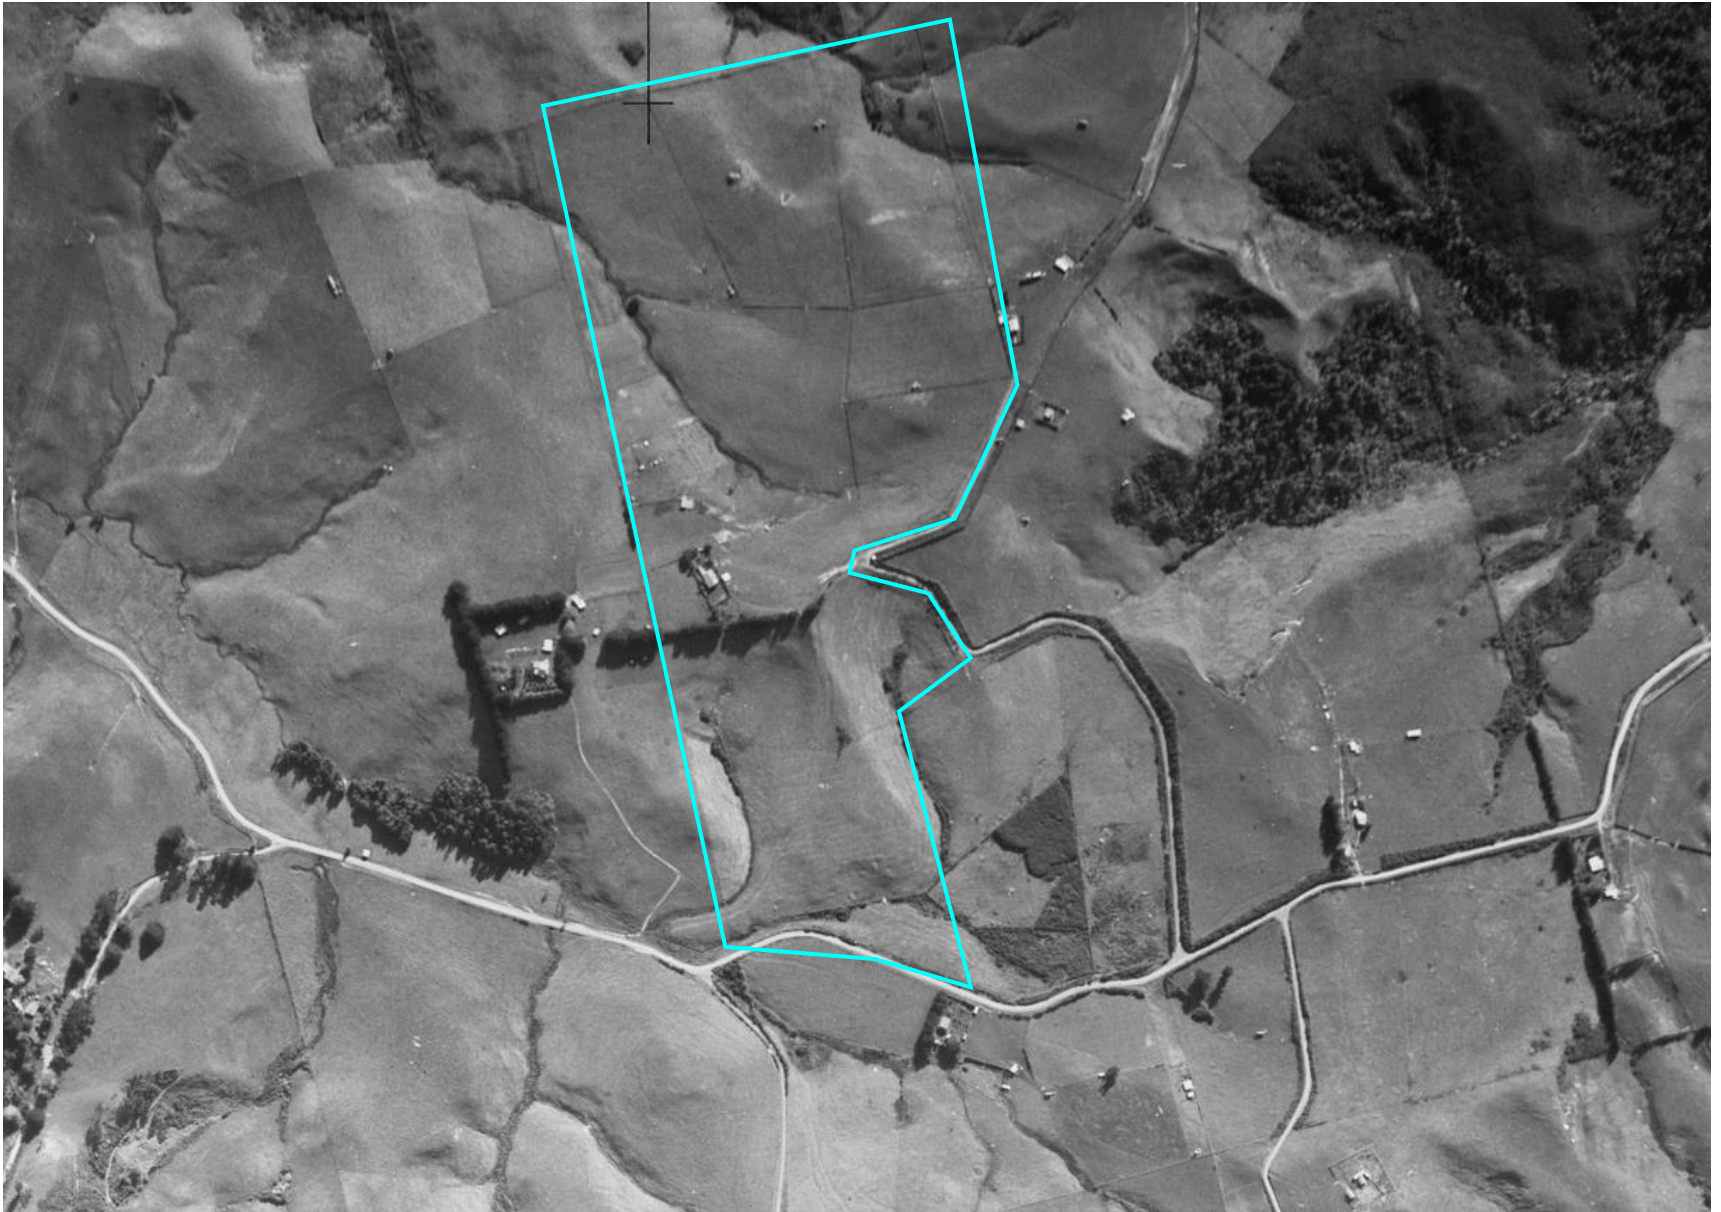
1944 Aerial: The subject site appears to have two main structures in the center of the site. One of the structures appears to be surrounded by planted trees, shrubs and hedges. A smaller standalone structure lies to the east of the main structure. South of the main structure, there is a hedgerow that spans the width of the subject site from west to east. Signs of culvert crossings in the northern and southern section of the site are observed. The subject site appears to be used for rural/pastoral purposes, with grass paddocks present. The site is bounded by Jones Rd to the east and Hunua Rd to the south. Part of Hunua road encompasses the southern portion of the subject site. Surrounding properties appear to be in use for a mix of rural, rural-residential, and pastoral purposes.

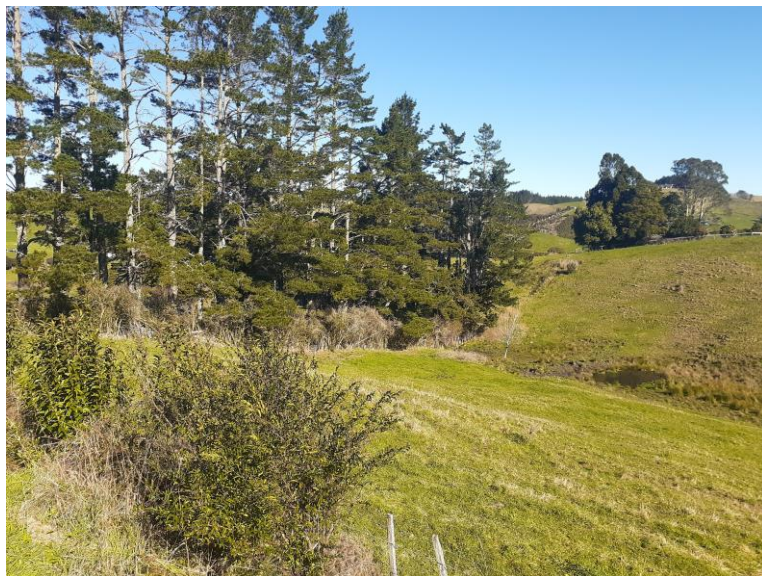
Further north on Jones Road, the northern portion of the site was observed to comprise mainly grassed paddocks on moderately steep hills. No signs of soil contamination were identified in this area of the site.

North paddock looking from East on Jones road

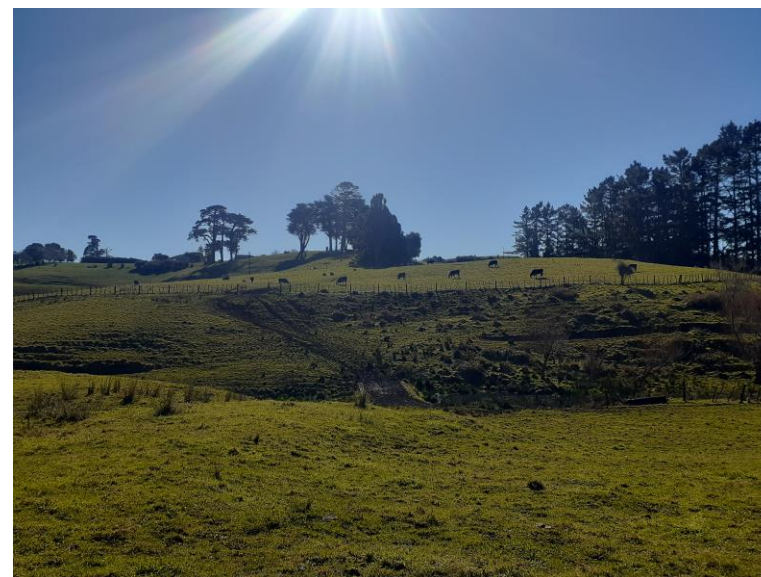
East gully and boundary line view from Jones road
