31 July 2024

WWLA1219

Dominion Road and Valley Road Apartments, Mt Eden – Ground Contamination Review

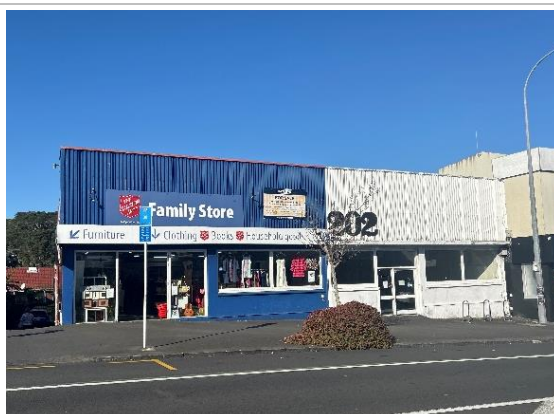
198-202 Dominion Road (Photographs 1-4)
<ul style="list-style-type: none"> • The property has three adjoining double-storey buildings, constructed of concrete block with some portions covered in texture plaster and fibrolite. Joinery is mixed timber and aluminium, and where flaking paint is noted there is a red primer (indicating potential use of lead-based paint). • Current occupants of the buildings include a boxing studio, Salvation Army store, and clothing manufacturer. A vacant space was most recently occupied by the Red Cross. • The driveway and carpark surrounding the buildings are asphalt, with only very minimal exposed soil for decorative planting. Asphalt is in moderate condition. • Our inspection of the location of an underground fuel storage tank (UST) described in the PSI and DSI as having been removed, suggest some of the associated structure such as the concrete lined pit may be present (Photo 4).

Photograph 1: 198-202 Dominion Road (street frontage).

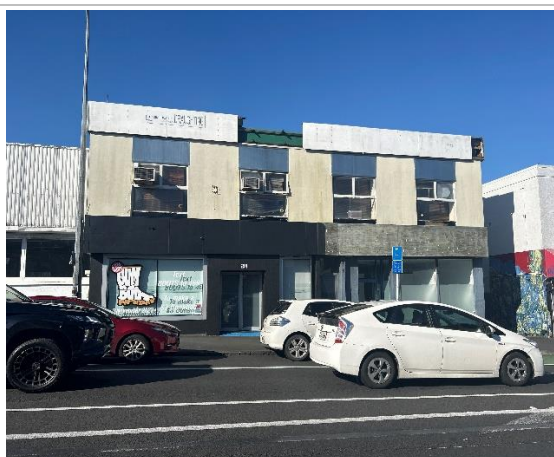
- This property contains four buildings, generally of brick or concrete block construction. Textured plaster cover and cladding repairs are frequent throughout all buildings. Repair materials include fibre cement sheeting and corrugated metal.
- Current and former (recently vacated) occupants include a café, tattoo shop, architect, coffee shop and cosmetics retailer. The coffee shop is located in the former automotive engineering building and contains a workshop at the eastern end of the building.
- Exposed soil is visible underneath the staircase at the rear of 214-216 Dominion Road. Fragments of potential ACM were observed at the ground surface.

Photograph 5: 214 Dominion Road (street frontage)

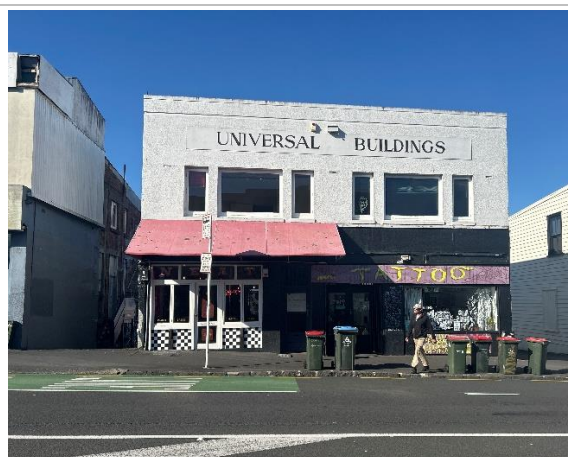
Photograph 6: 218 Dominion Road (street frontage).

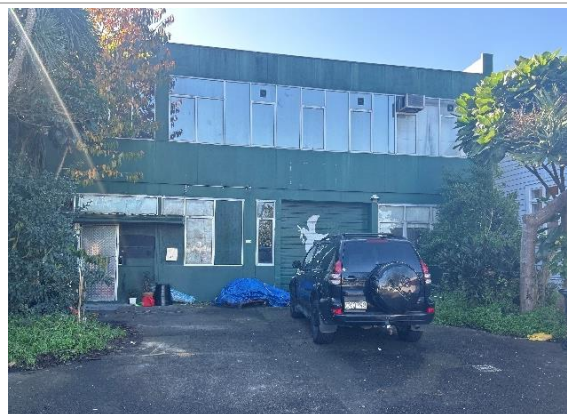
- This property contains a two-storey building which appeared to be used for residential purposes.
- The building is of concrete block construction clad in fibre cement board.
- Most of the site surfaces were covered with concrete excluding small decorative gardens. All vegetation was in good condition.

Photograph 10: Street frontage of 113 Valley Road (looking north).

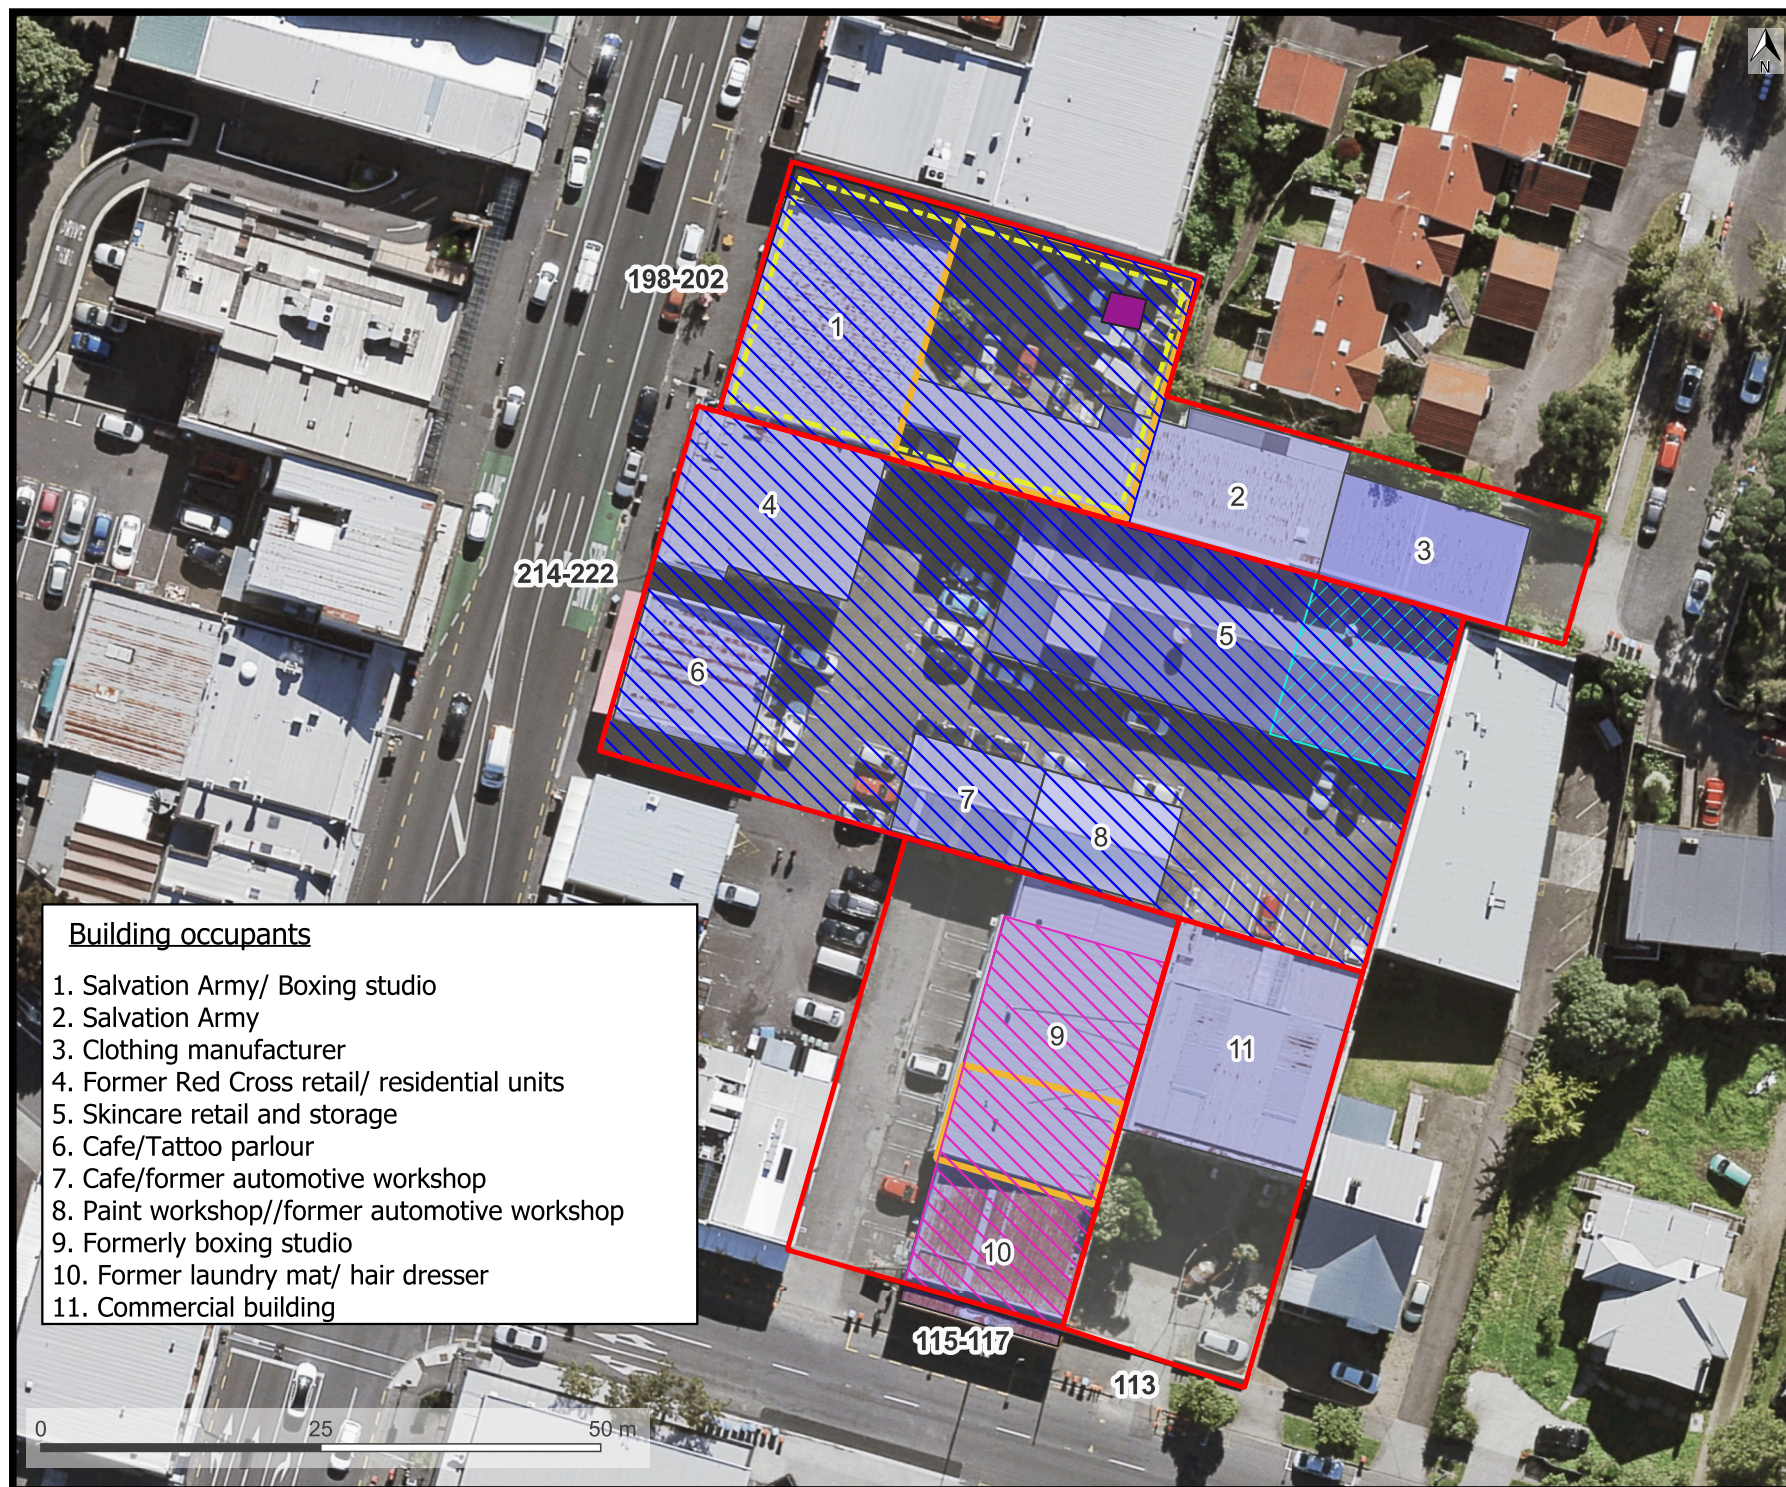
A summary of the findings of both the PSI and DSI are presented in **Table 3** along with our comment on the applicability of the findings. HAIL areas discussed in our review and shown on **Figure 2**.

1. Salvation Army/ Boxing studio
2. Salvation Army
3. Clothing manufacturer
4. Former Red Cross retail/ residential units
5. Skincare retail and storage
6. Cafe/Tattoo parlour
7. Cafe/former automotive workshop
8. Paint workshop//former automotive workshop
9. Formerly boxing studio
10. Former laundry mat/ hair dresser
11. Commercial building

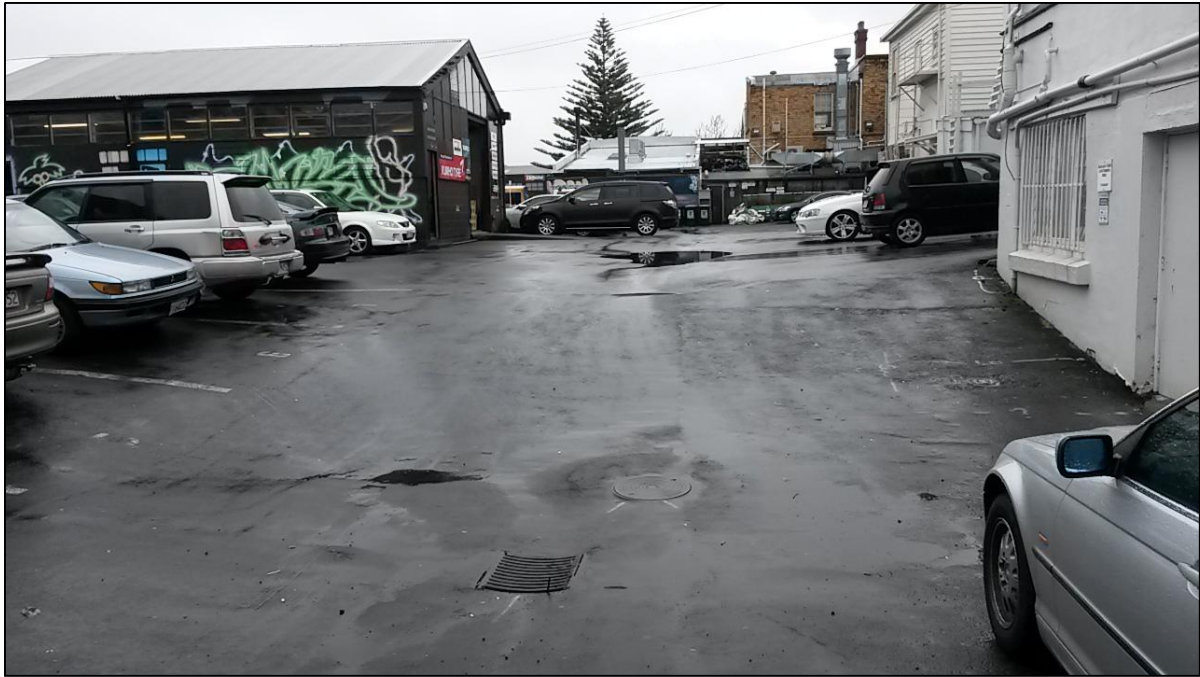
- 222 Dominion Road is occupied by an auto engineering business (Photograph 1). Access to the workshop was not available. The business' signage and website indicate that regular car servicing and warranting is carried out, along with specialist performance car builds and modifications. Operations appeared to be confined to the workshop, and there was no evidence of staining around the perimeter of the building.

Photograph 1: The central area of the site, looking south from the boundary of 216 and 218 Dominion Road. On the right, the site slopes upwards towards Dominion Road (west). The auto engineering workshop located at 222 Dominion Road is visible on the left. A stormwater drain and manhole are visible in the foreground.

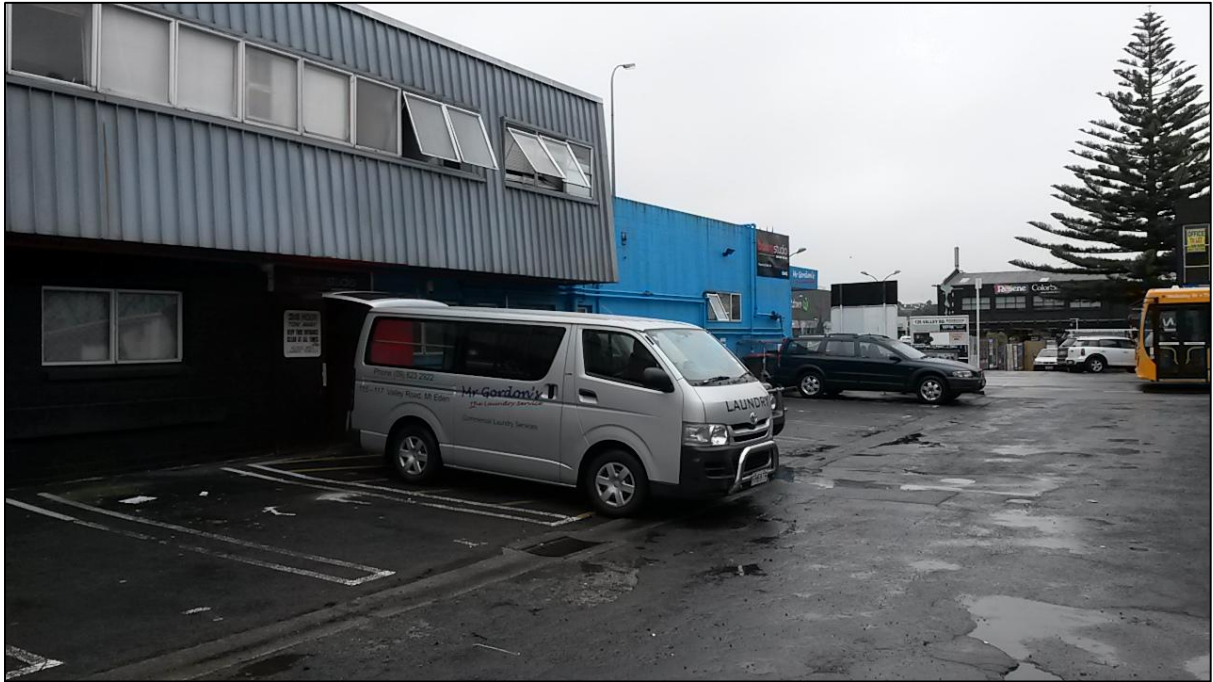
Photograph 4: The buildings on 115 and 117 Valley Road, occupied by a boxing studio (far left) and a commercial laundry (blue building on the road front).

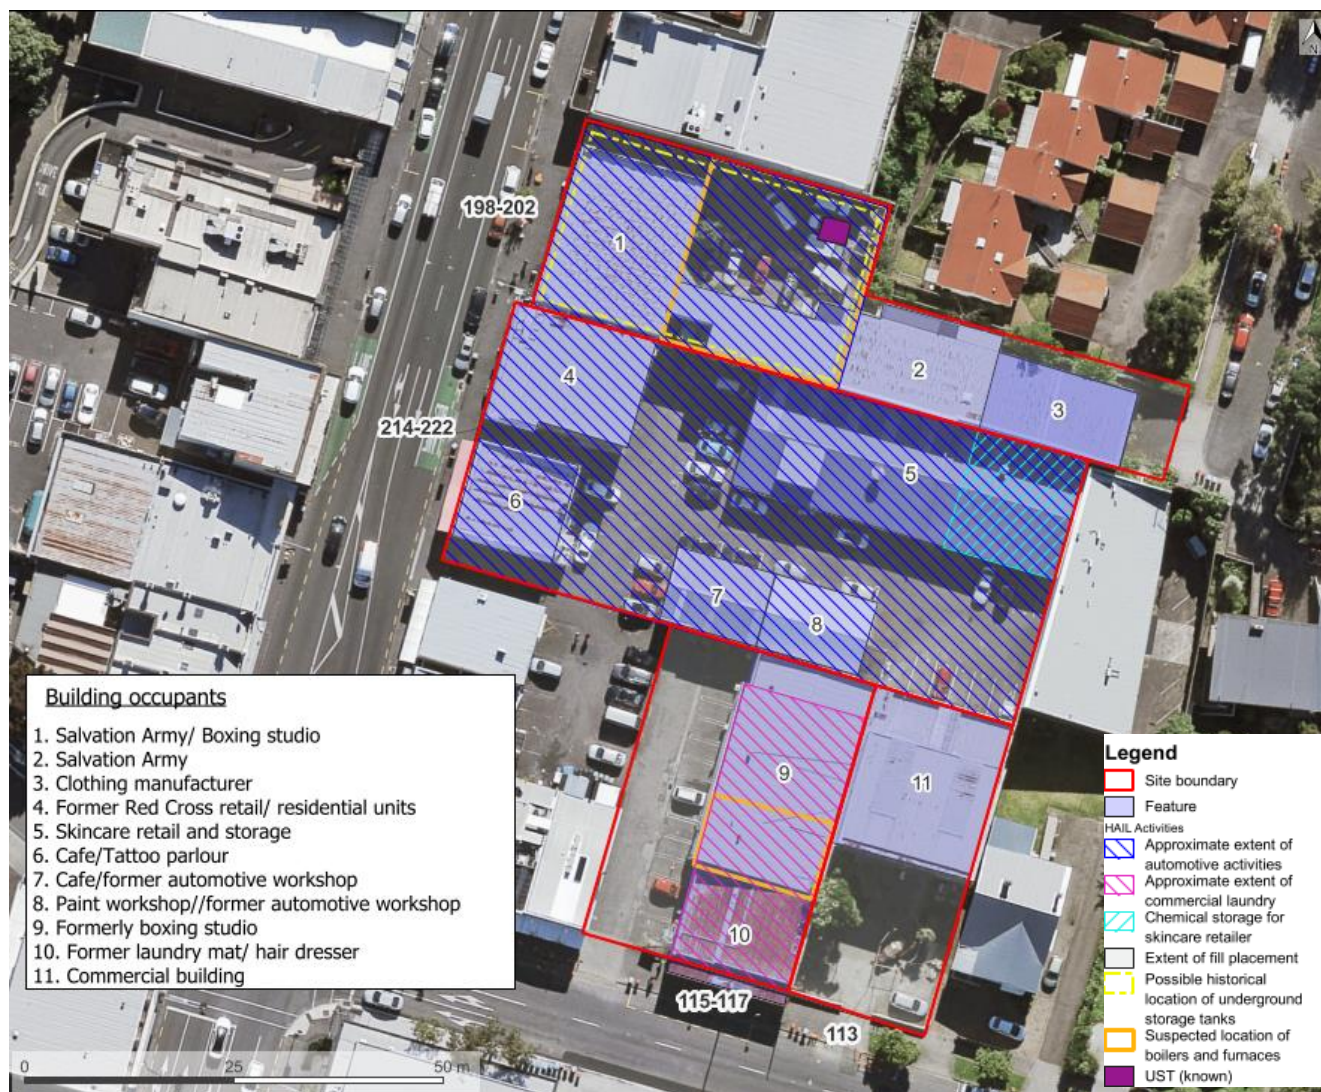
Several HAIL Activities were identified during the PSI including F4 (motor vehicle workshop), A13 (under- and aboveground fuel storage tanks (UST/AST)), E1 (degraded asbestos products) and I (accidental release of contaminants relating to filling).

Figure 2. HAIL activity areas (based on information in the PSI and WWLA contamination review letter).

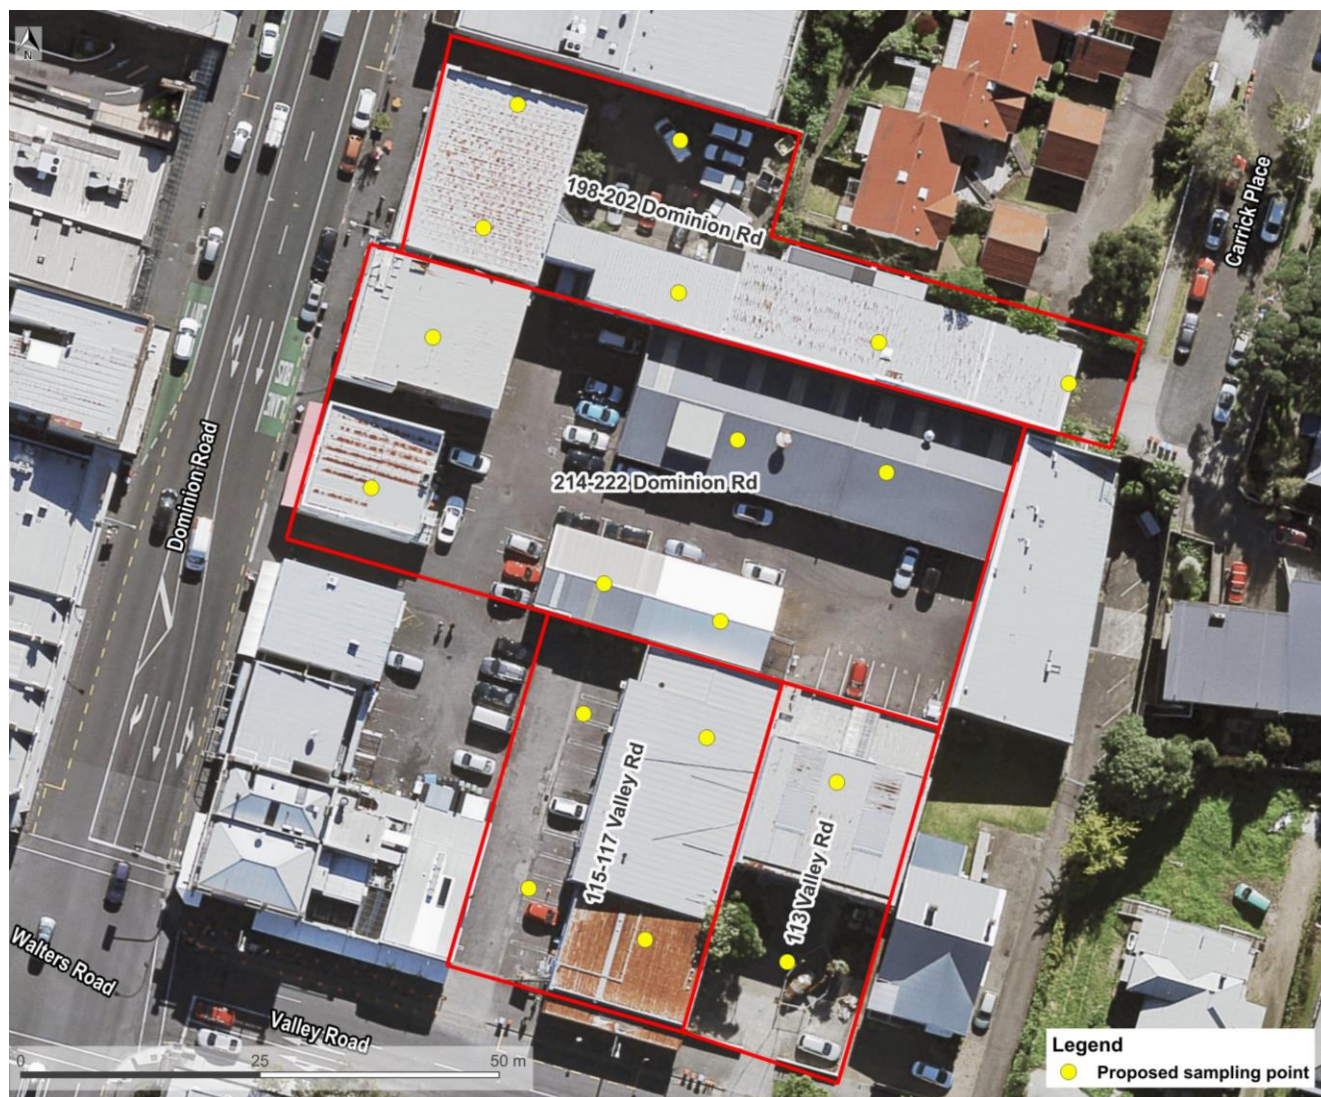
Further (post-demolition) investigation is required within current building footprint and across paved open areas of 198-202 Dominion Road and 113-117 Valley Road, to better understand soil conditions and assess any potential impacts from prior land uses including the presence of possible underground (fuel) storage tanks (UST).

Figure 3: Post-demolition sampling plan (Aerial image source: LINZ).

The outstanding investigation areas, sampling and testing plan is shown in **Figure 3** below and described in **Table 4**.

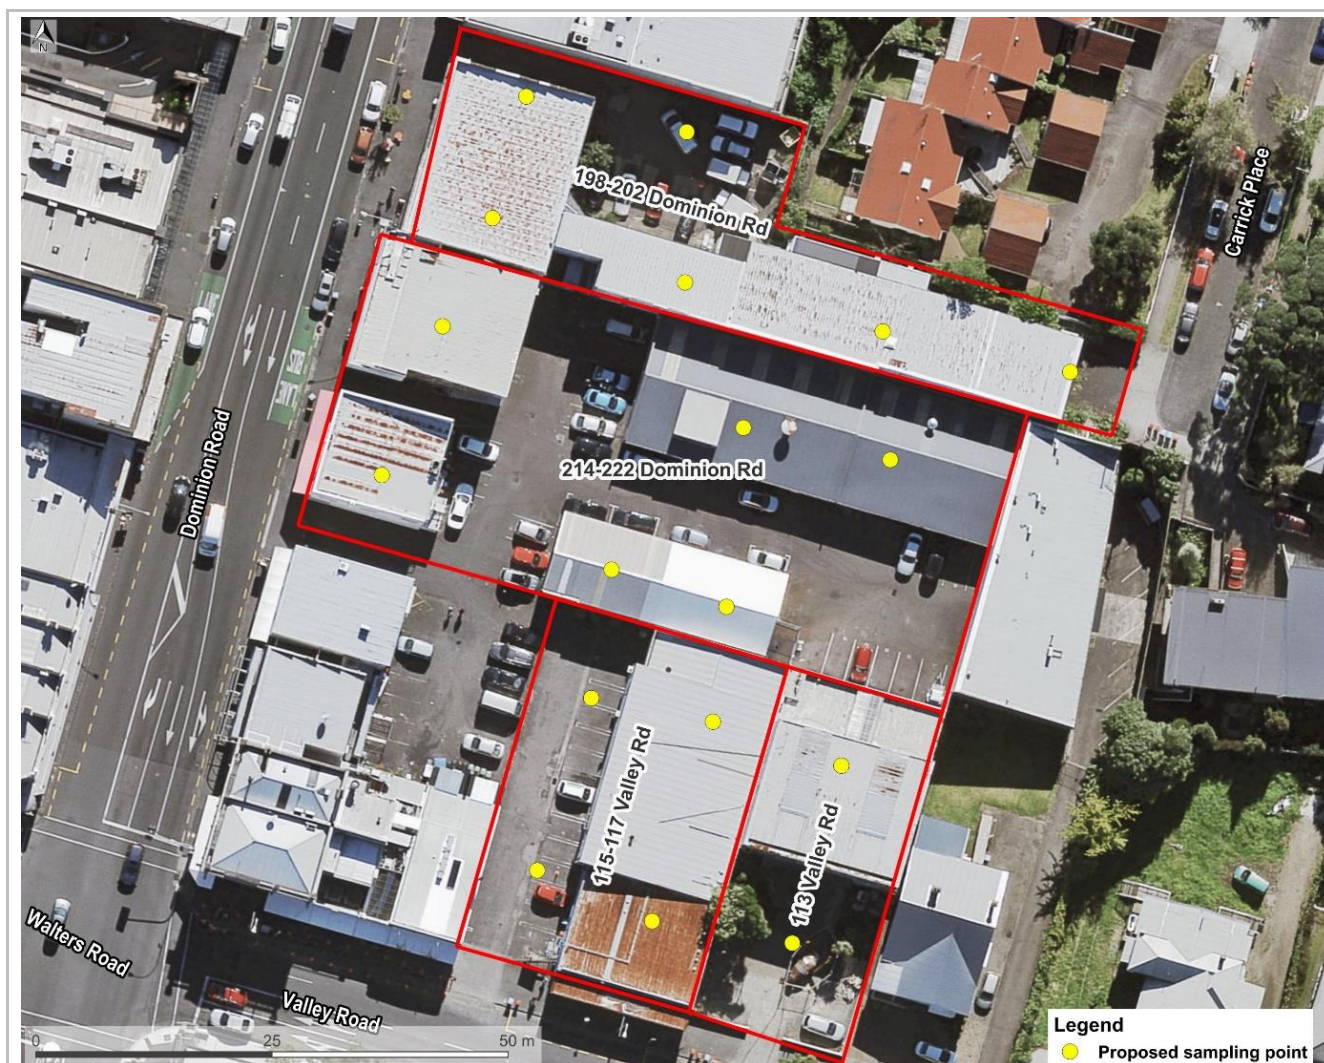
Figure A1: Post-demolition investigation plan to be **implemented by the SQEP**.

<ul style="list-style-type: none"> SQEP (i.e. WWLA) shall be notified post removal of the buildings to inspect the soil and conduct sampling as per Section 3 of the SMP. 	<input type="checkbox"/>
	<ul style="list-style-type: none"> Soils asbestos clearance, separate from the building-related clearance, shall be provided by the SQEP prior to bulk earthworks commencement. 	<input type="checkbox"/>
Post-demolition investigations	<p>SQEP (i.e. WWLA) shall investigate building footprints as per Section 3 of the SMP.</p> <p>An addendum DSI shall be provided to Auckland Council upon completion of post-demolition investigations, along with an updated SMP and or remediation action plan (RAP) if required.</p>	<input type="checkbox"/>
