# **Milldale Development Infrastructure Project 1 - Argent Lane Extension**

Geotechnical Interpretive Report

30 September 2020

**Document reference:** 402828-MMD-XX-XX-RP-GE-006

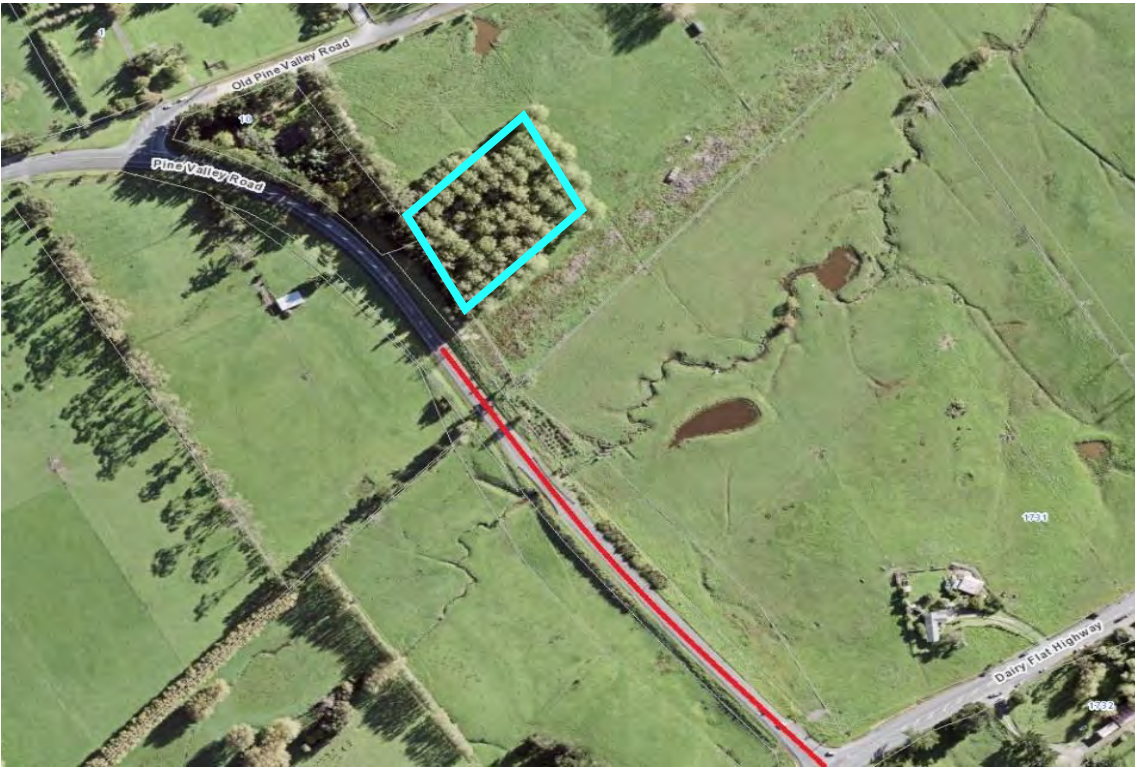
Figure 2.2: Pine Valley Road - Widening of Existing Pavement.

The approximate 400m long proposed pavement widening along Pine Valley Road (PVR) is between the tree block (indicated in cyan) and intersection with Dairy Flat Highway, see Figure 2.2. This section of Pine Valley Road dips down moderately (1V:10H) away from the intersection with Dairy Flat Highway and passes over the existing stream and then gently rises towards the intersection with Old Pine Valley Road.

The existing pavement is likely constructed over fill ground. Slopes up to 1V:2H were observed near the Dairy Flat Intersection and 1V:5H in most places along either side of the existing road pavement as shown in Table 2.2: Site Photos along either side of Pine Valley Road. Land stabilisation is likely required beyond the shoulder of the road for the widening as shown in Table 2.2. No signs of deep-seated movement were observed on the slope immediately below the Dairy Flat Highway.

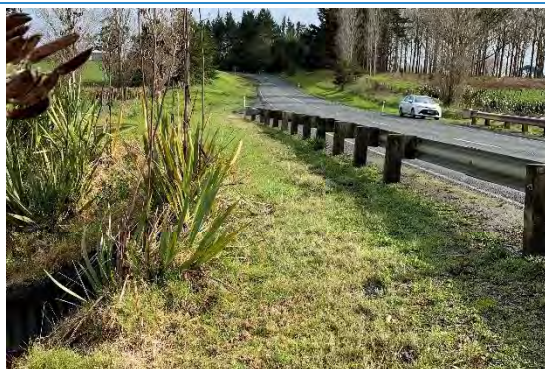
- Eastern shoulder of PVR, looking north
- Pavement constructed over fill ground

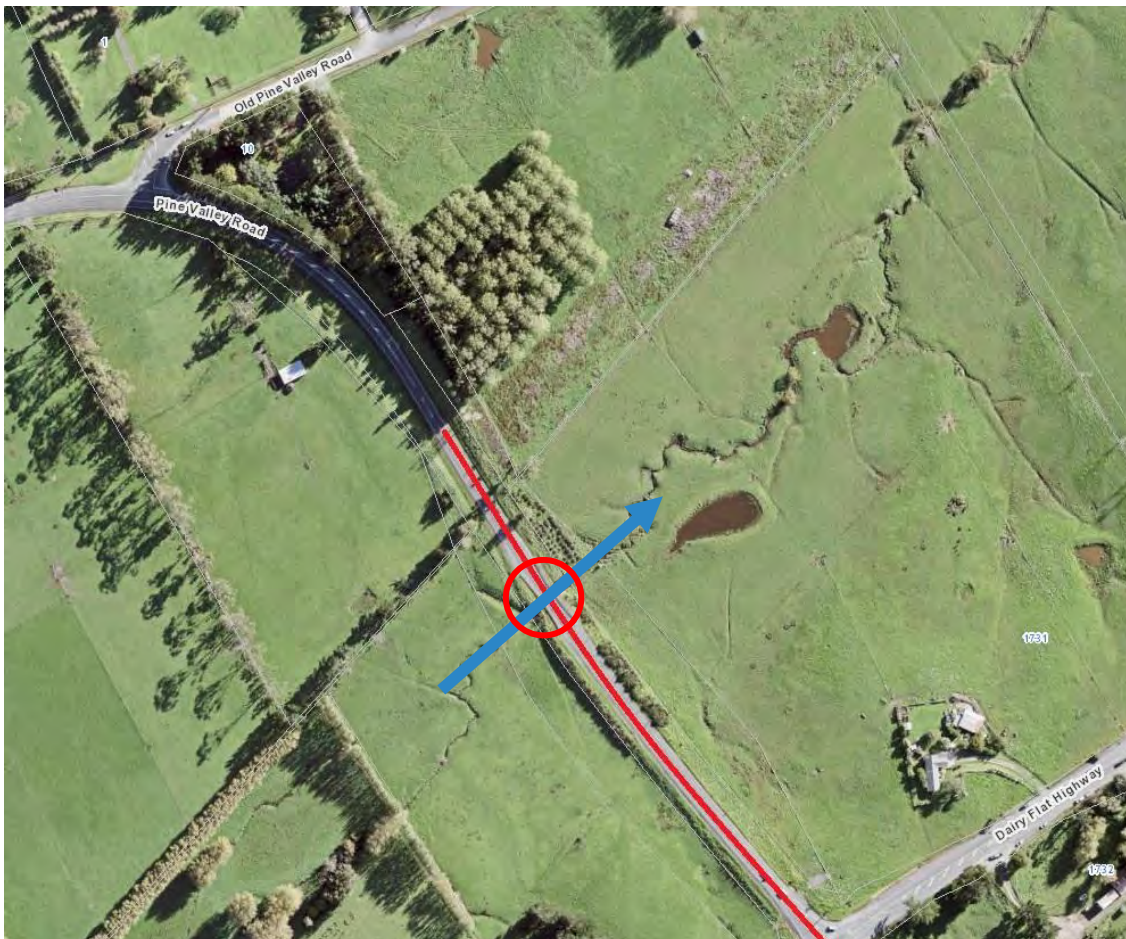
**Figure 2.3: Culvert below Pine Valley Road**

The culvert is located beneath the embankment at the lowest section along the Pine Valley Road to accommodate the stream below as shown in Figure 2.3: Culvert below Pine Valley Road. It is a bolted steel plate structure approximately 2.4m in diameter, with a 0.5m wide concrete headwall ring beam as shown in Figure 2.4.

The stream below is approximately 2.5m wide at the culvert. The direction of flow is from south-west to north-east as shown in Figure 2.3.

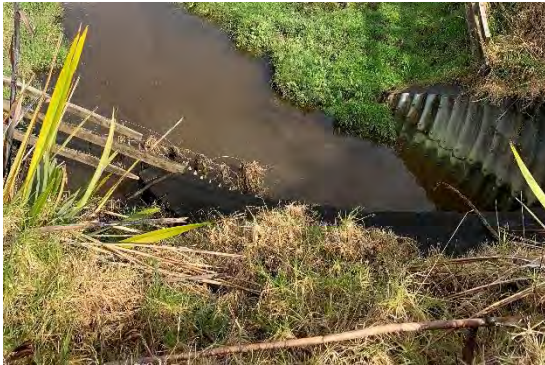
• Culvert internal

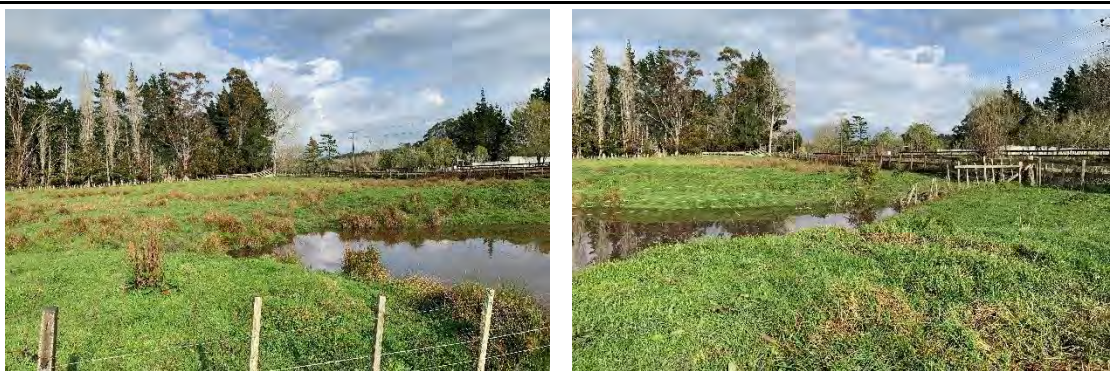
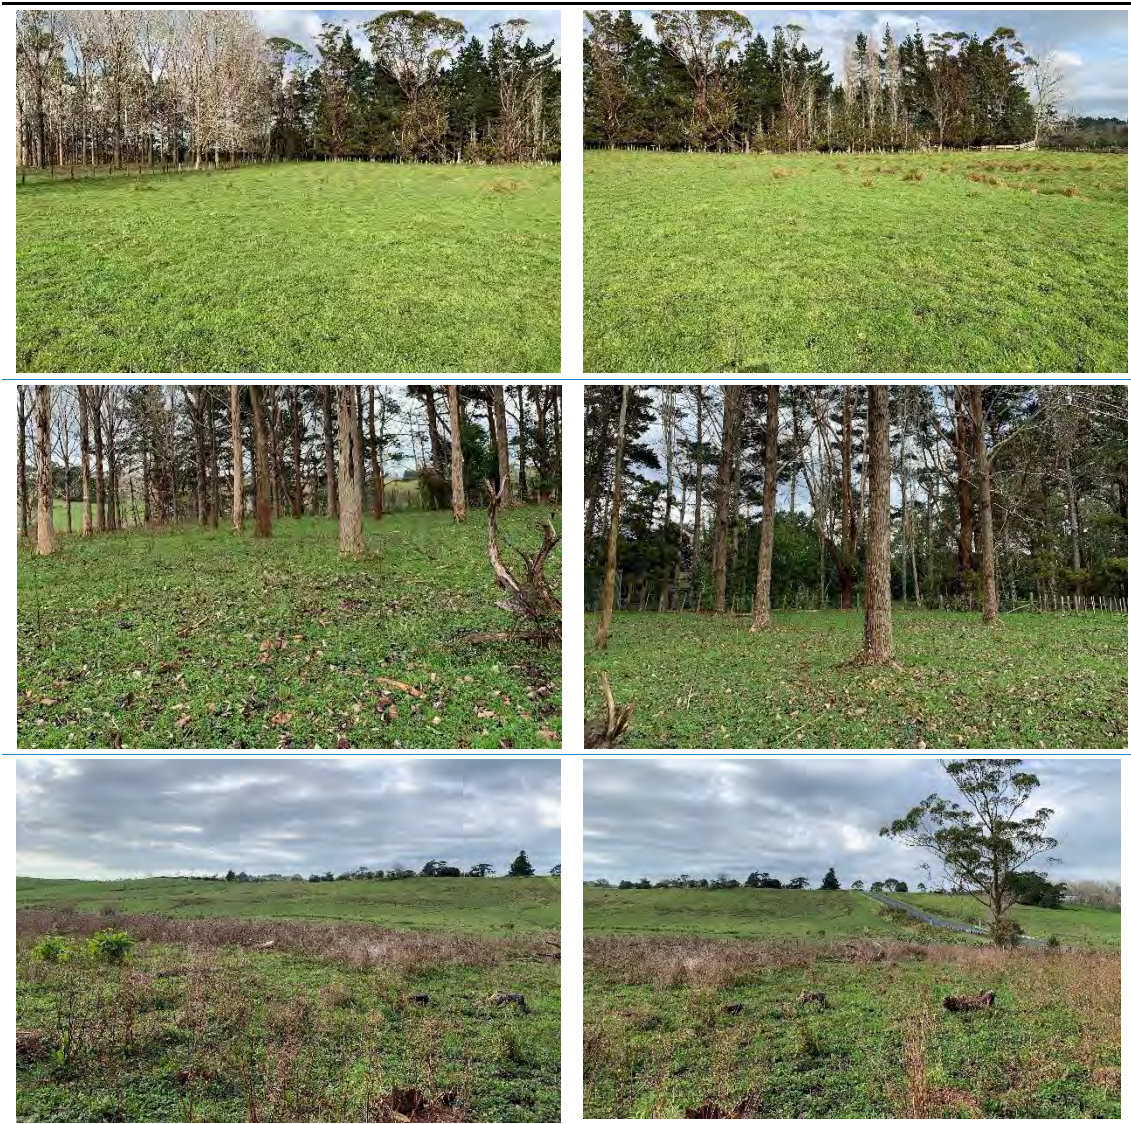
**Table 2.4: Through the green field, along the Proposed Realignment.**

Removal of some of the large poplar trees will be required to accommodate the proposed road corridor.
