To: OsborneHay**Date:** 21 January 2021**Attention:** David Hay**Ref:** 63967**Subject:** Freshwater Ecology Classifications – Warkworth Plan Change Area

Warkworth South Plan Change Area

1711 and 1723 State Highway 1
36, 40, 46 and 126 Valerie Close Road

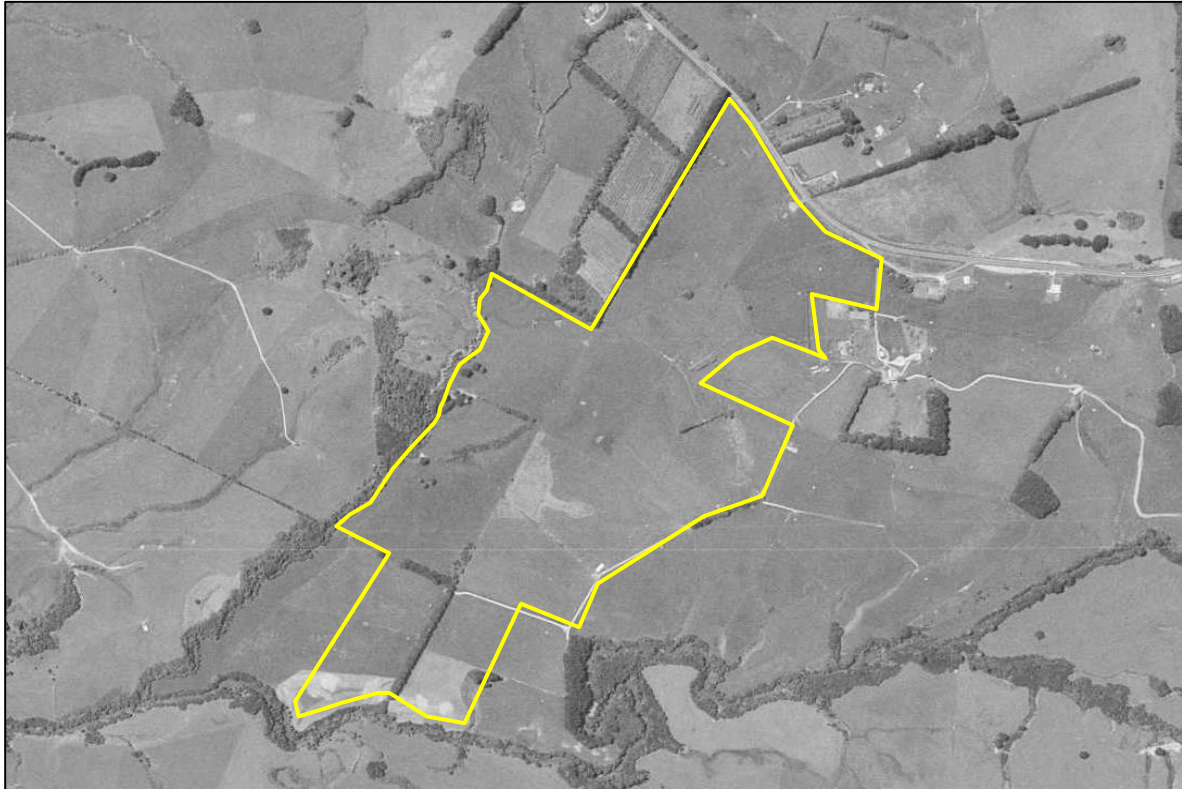
Figure 4. Historic aerial image of the site (yellow polygon) from 1966. Image from Retrolens.

Water was slow-flowing and contained predominantly in deep runs and pools, with shallow runs occasional (Photo 2). The wetted width of the upper reach was 0.5-1.5m wide and the deepest section was 0.38m. Water was present for the entire length of Watercourse 1 and, due to the consistently deep water and large catchment size (14.5ha), the watercourse was classified as a **permanent stream** (Figure 3). The stream was straight and may have been modified (through straightening and deepening) at some point in the last century, however has existed in its current state since at least 1963 (Figures 4 and 5).
