Devonport-Takapuna Local Board Workshop Programme

Attachment A – Condition Report for Claystore Heritage Building

AMIS Asset Assessor team has carried out an assessment for the general condition of **Claystore Devonport** located at 27 Lake Road in Devonport on behalf of Nicky Aziz on behalf of Kaitlyn White (Senior Renewals Coordinator).

Devonport Claystore Workshop

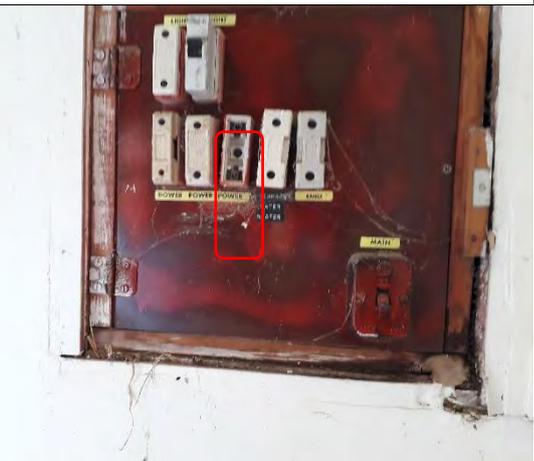
2.4	Significant Health and Safety Defects	Photos
1	Exposed conductor on the displaced MCB on the switchboard in upper floor. It is health and safety risk. Digital RFS has been raised to fix the problem

1. To rectify the exposed conductor in the switchboard on the upper floor. The missing circuit breaker should be closed or reinstalled. Separate digital RFS has been submitted by the assessor to rectify the defects.

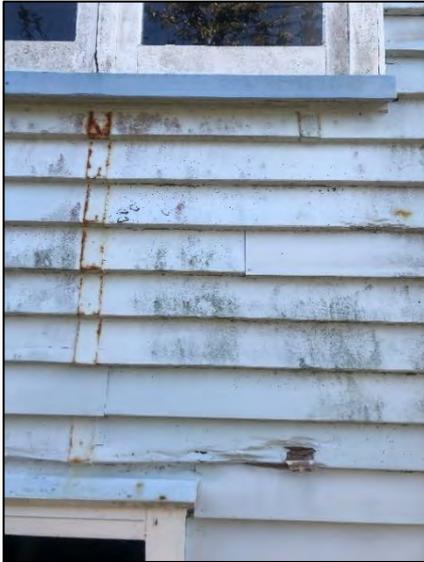
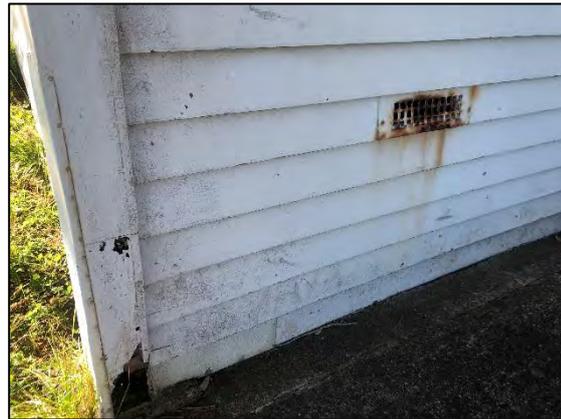
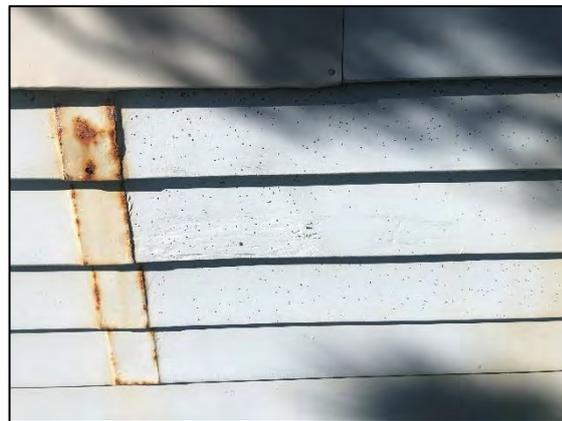
The weatherboards are in variable condition. The majority appear sound and it appears that some remedial work may have been carried out since the 2015 Conservation Plan was prepared. Nevertheless, some defects are still apparent including areas of decay and borer infestation. Some decay and evidence of water ingress which was not immediately apparent from the exterior became evident when areas of the internal linings were removed.

Decay is also evident in trim such as corner boxes and window facings. Other defects in the external cladding include rusting ventilation grilles and metal soakers over junctions between weatherboards.

Cladding defects included decayed weatherboards (left), rusting grilles and decayed corner boxes (top right) and rusting soakers (bottom right).

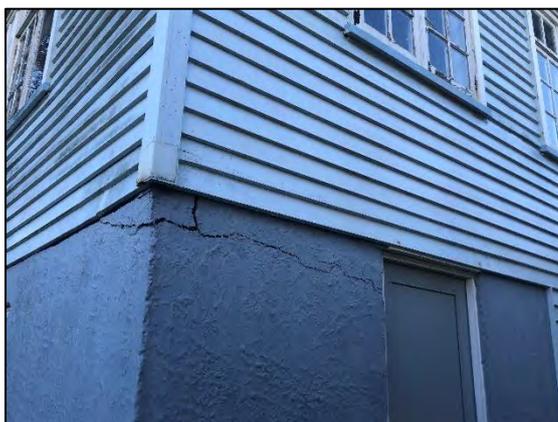
In the south corner of the building is a small basement that was constructed after the building was relocated in 1946 to provide space for a laundry. The outer wall comprises in situ concrete which has a substantial crack near the top of the wall. This could be the result of foundation settlement or rusting reinforcing within the concrete. Further movement appears to have occurred since the building was last surveyed in 2015.

Crack in foundation wall at south corner.

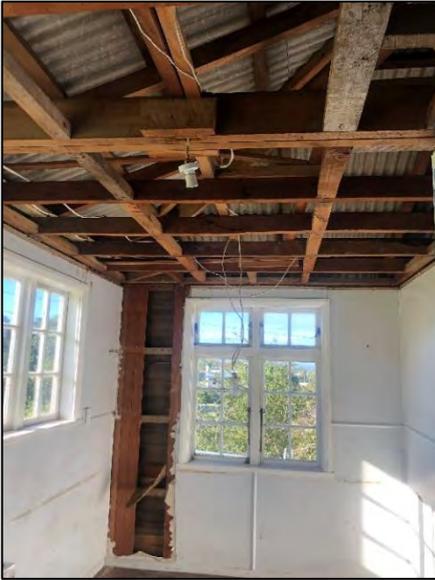
The original framing appears to have been augmented by recycled timber, essentially whatever was at hand, but possibly from some of the other buildings on the site that were demolished. Some of the additional timber is clearly *pinus radiata*. The additional framing may have been installed when the original corrugated steel roof was replaced with the current asbestos cement sheets in an effort to take the expected additional weight.

Areas of roof and ceiling framing. Note original timbers and later recycled material.

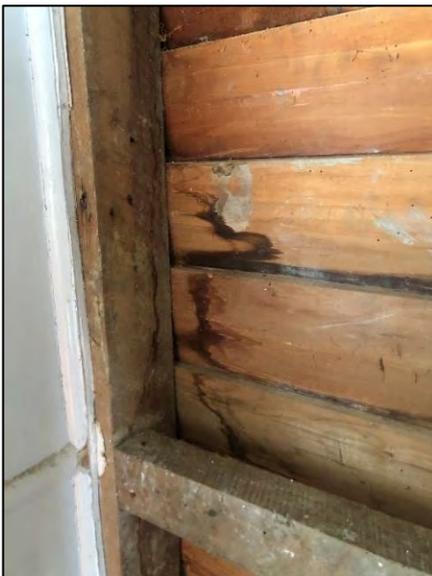
Some areas had building paper under the weatherboards, although it was missing in other areas, suggesting that the building may have been partly reclad in its life. Some additional framing had also been added.

External wall framing. Note water staining on weatherboards.

Wherever there is evidence of decayed weatherboards, the timber framing behind should be checked.

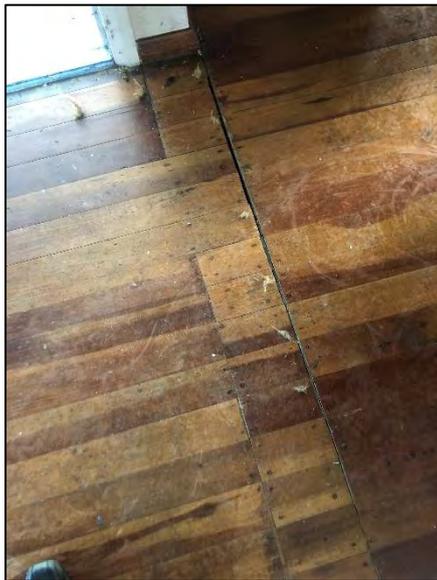
The floors comprise tongue and groove boards and generally appear to be in good condition. The timber is believed to be matai. A saw cut in the floor may have originated when the building was relocated, although the floor boards on either side of the cut do not match.

Matai tongue and groove floor boards. Note cut line.

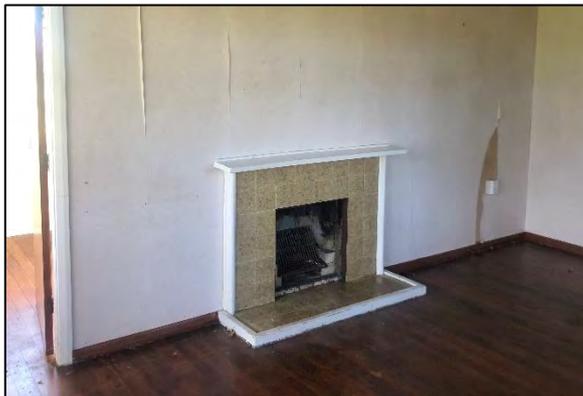
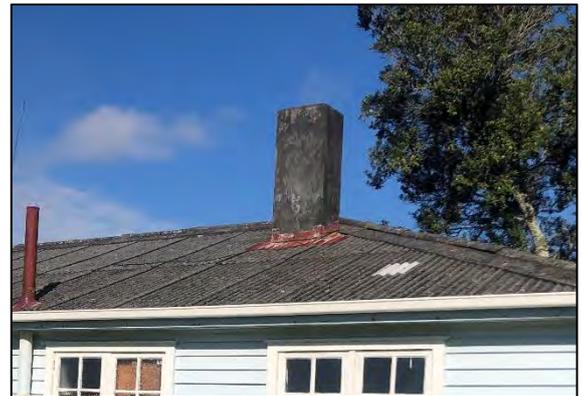
The chimney is visible in the subfloor area below the building and above the roof where it has a plaster finish. It appears to have been constructed from precast concrete sections but is probably unreinforced. The extent of the foundation below the chimney is unknown. The condition of the chimney should be checked by a structural engineer.

Fireplace (left) and chimney above the roof line.

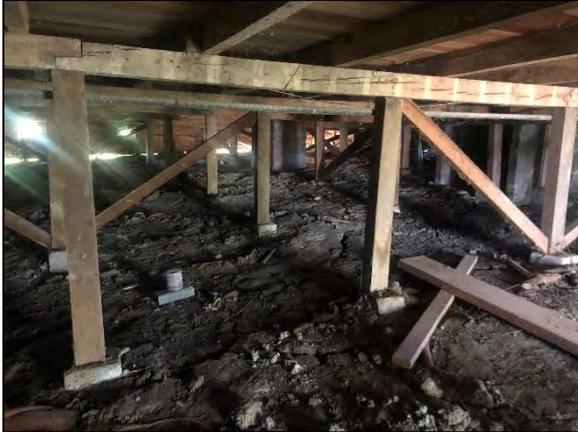
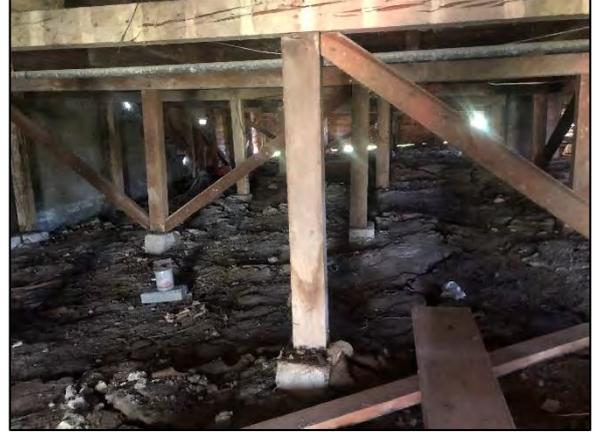
The subfloor area includes concrete piles timber jackstuds, braces, bearers and floor joists. It is likely that the subfloor framing and concrete piles were renewed when the building was relocated. Within the building, there is some unevenness in the floor, suggesting that settlement of the piles has occurred. Some piles may also have rotated due to uneven vertical loading.

The timber subfloor framing generally appears sound. In general, however, there is a lack of fixings between piles and jackstuds and jackstuds and bearers. The bracing requirements should be reviewed with additional braces provided if required.

Two views of subfloor area. Note general lack of fixings.
