Arboricultural Assessment of Effects

A concrete pathway, boardwalk and bridge construction, along with upgrading an aggregate track.

Tamaki Path, Stage 2 – Point England

Date 28 March 2024
Job ref # 2758

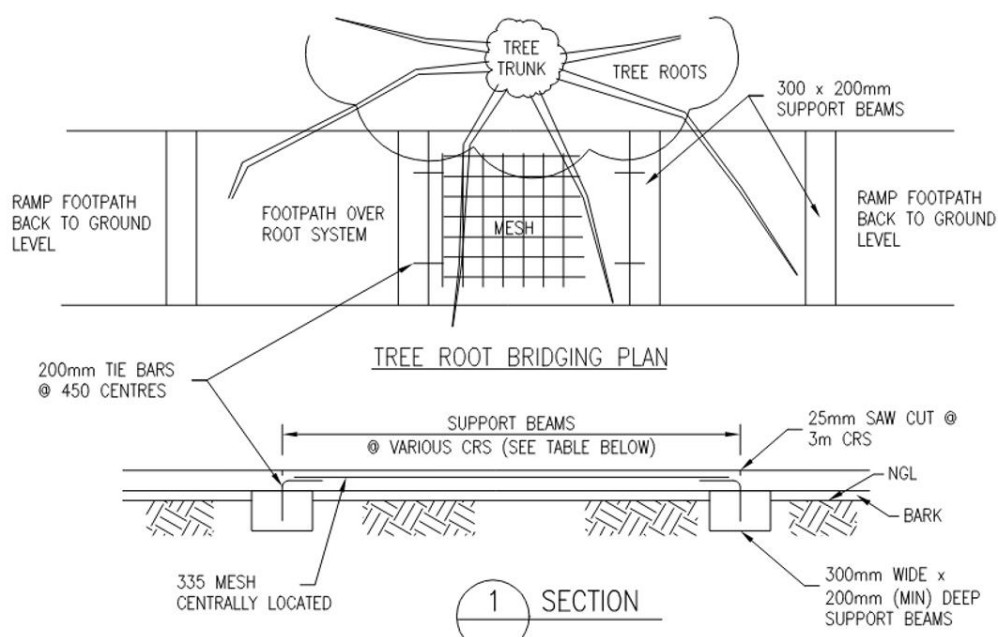
Figure 2 – Root bridging example

4.15 From the above, the concrete path heads towards a pasture area, where minimal trees are present. Before the boardwalk approach, it does encroach into the root zone of a mature gum and willow tree, both of which did not have any obvious signs of tree risk features that would warrant intervention. The canopy of the tree hangs low, and crown lifting may be required. In terms of construction methodology, should large roots be encountered, then a root-bridging footpath may need to be constructed. Figure 2 below is an example of a root-bridging detail.

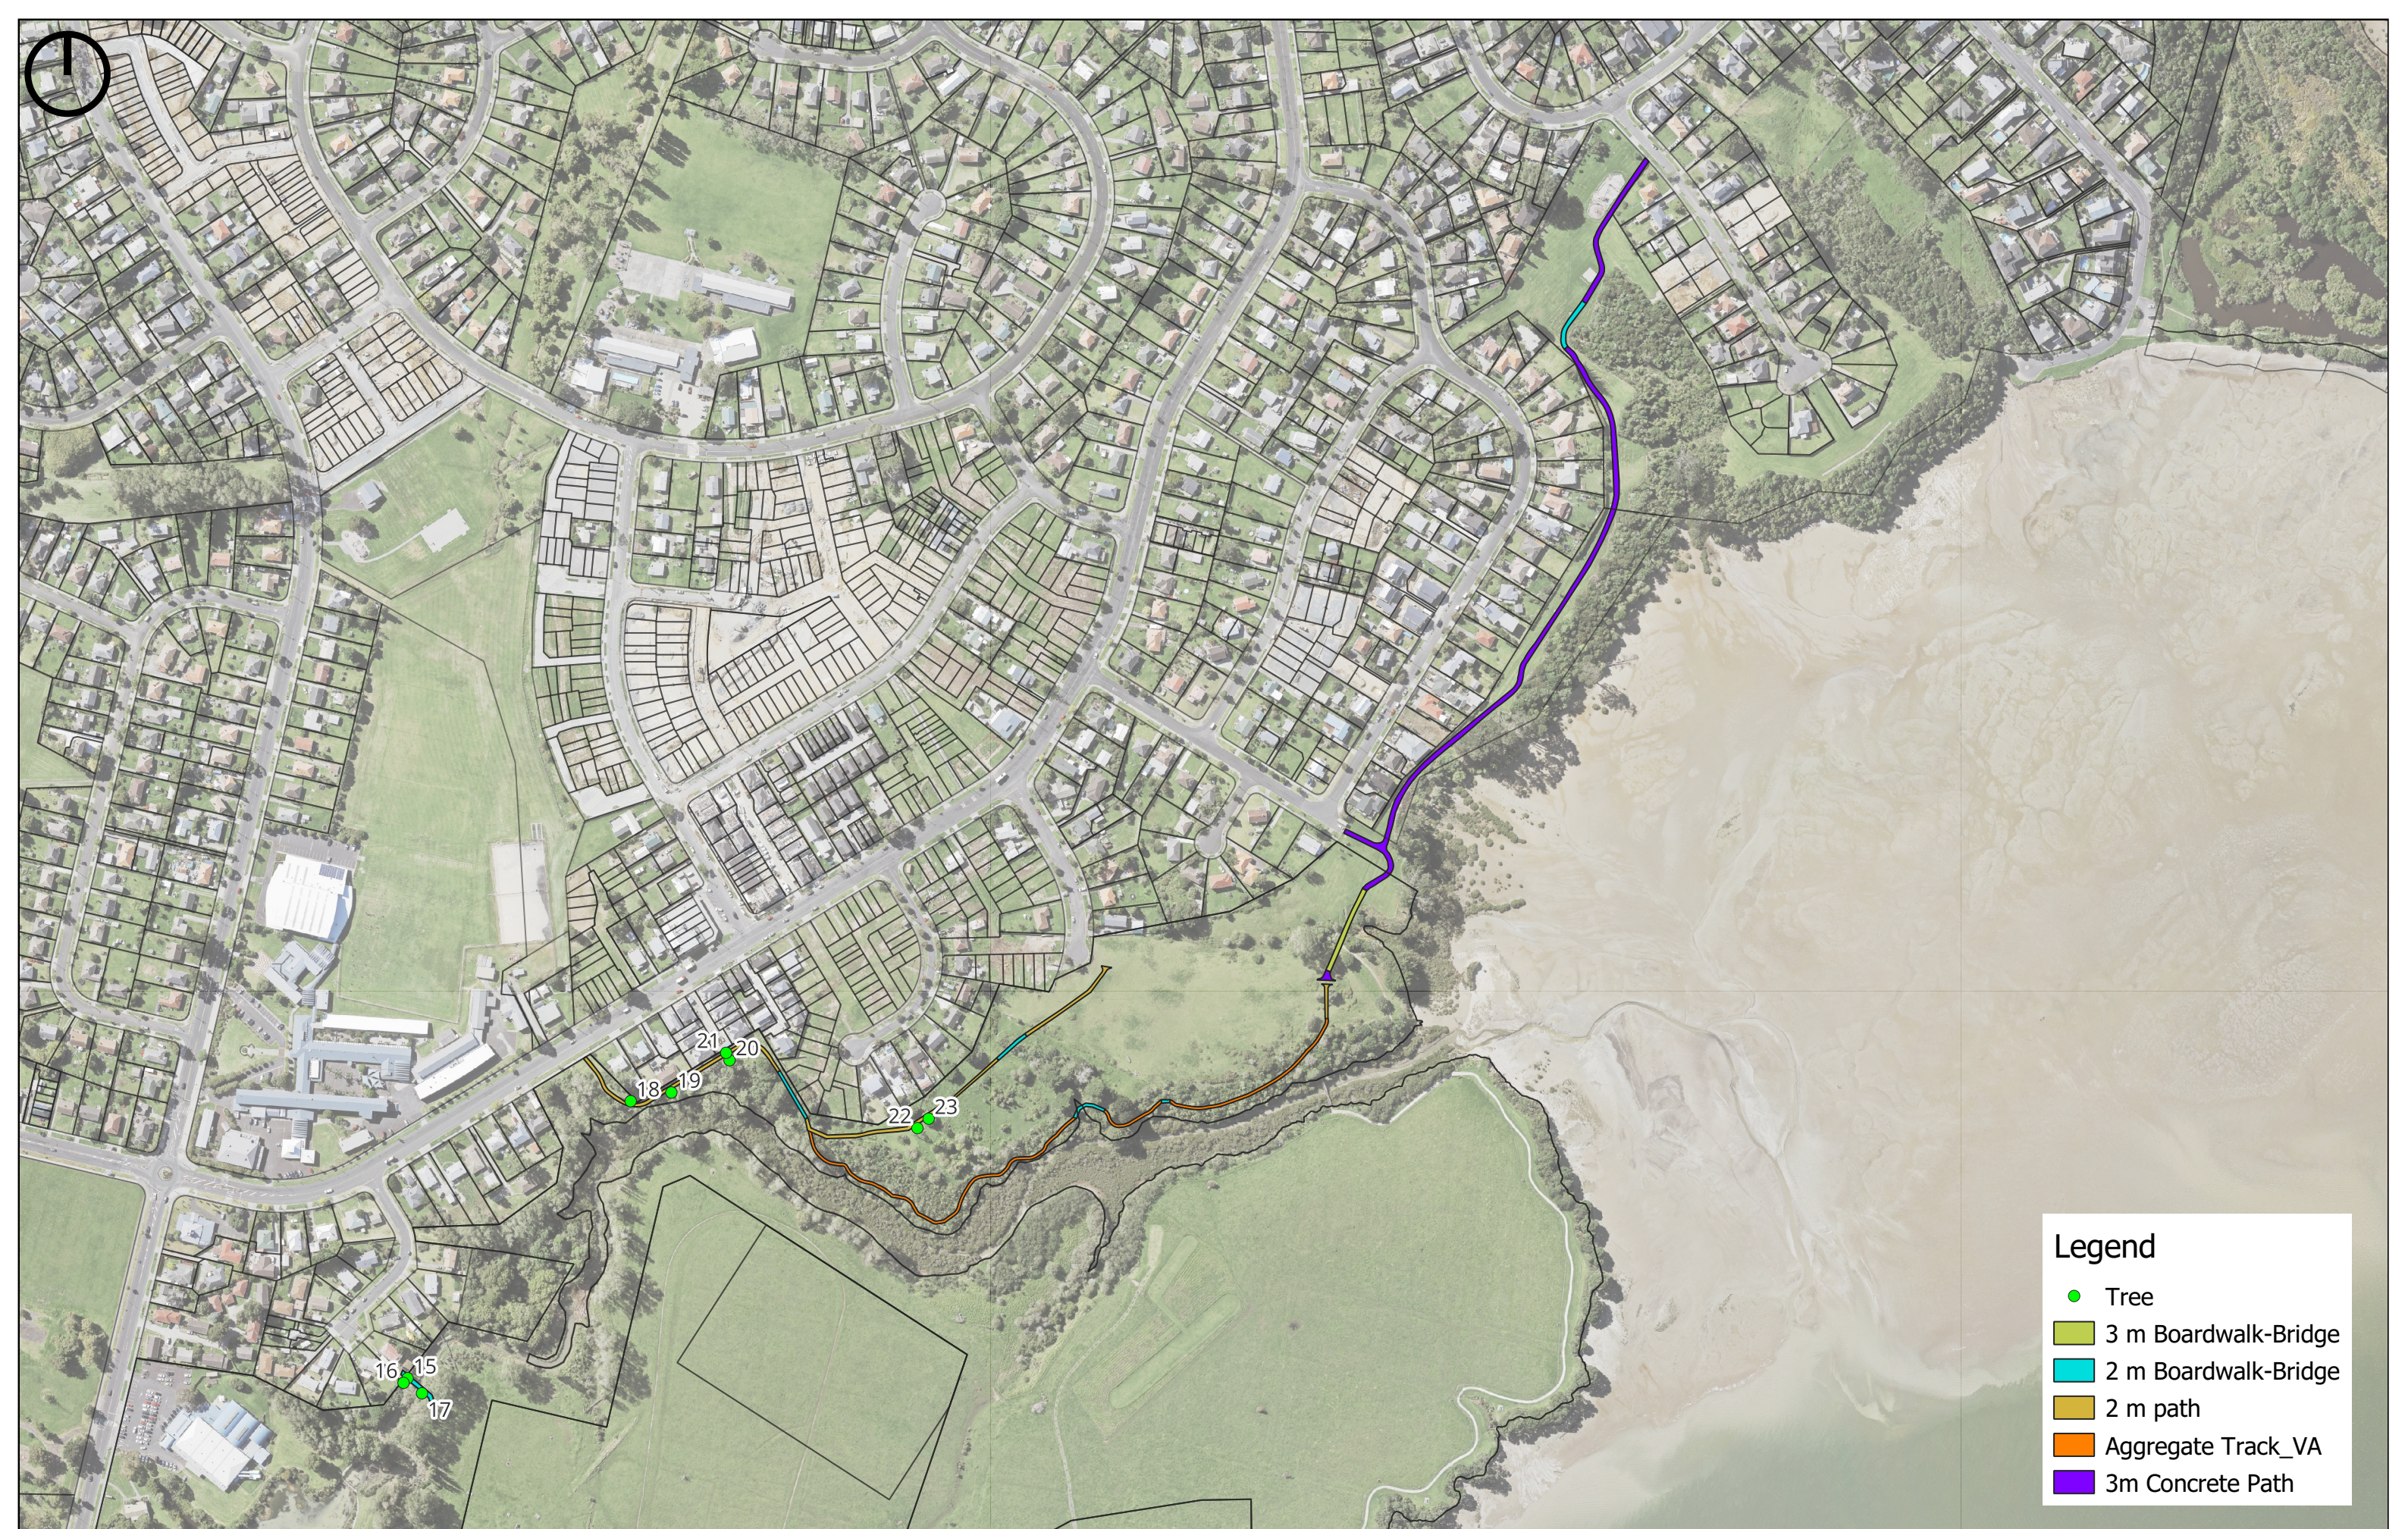
Remove puriri - poor condition

Recommended to move bridge 2-3m to SW. Final position to enable retention of T15 (pohutukawa)
