Arboricultural Assessment of Effects

A concrete pathway, boardwalk and bridge construction, along with upgrading an aggregate track.

Tamaki Path, Stage 2 – Point England

Date 28 March 2024_V2
Job ref # 2758
Reviewed by Tracey Funnell

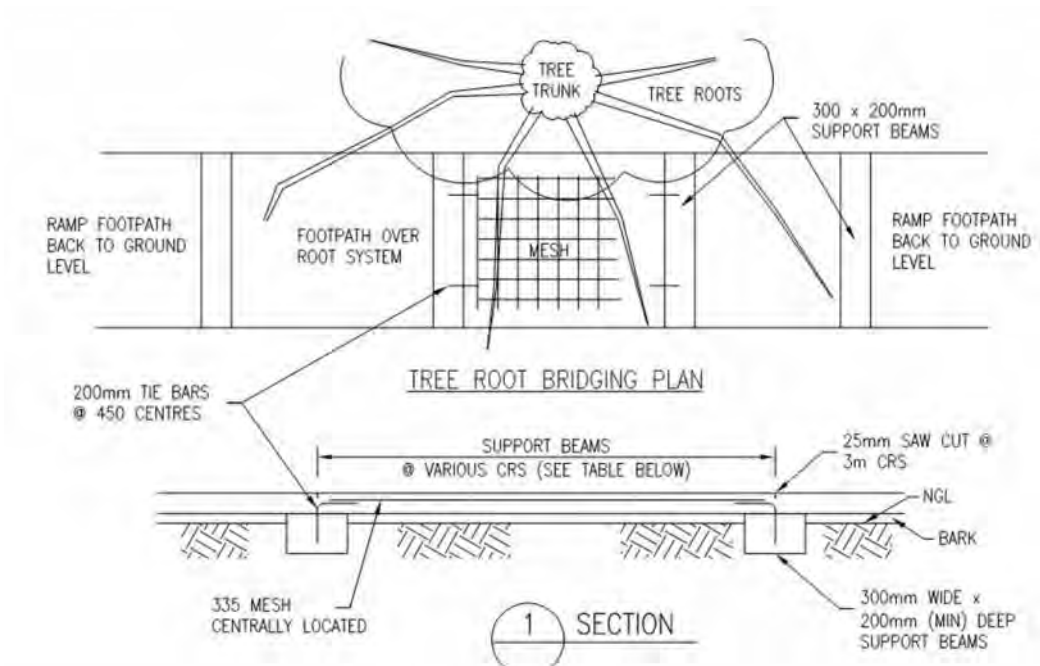
- 4.15 From the above, the concrete path heads towards a pasture area, where minimal trees are present. Before the boardwalk approach, it does encroach into the root zone of a mature gum and willow tree, both of which did not have any obvious signs of tree risk features that would warrant intervention. The canopy of the tree hangs low, and crown lifting may be required. In terms of construction methodology, should large roots be encountered, then a root-bridging footpath may need to be constructed. Figure 7 below is an example of a root-bridging detail.

Figure 7 – Root bridging example
