# Ambridge Rose Retirement Village

## COASTAL HAZARD INVESTIGATION REPORT

APRIL 2025

Bronwen Gibberd  
4D Environmental Ltd

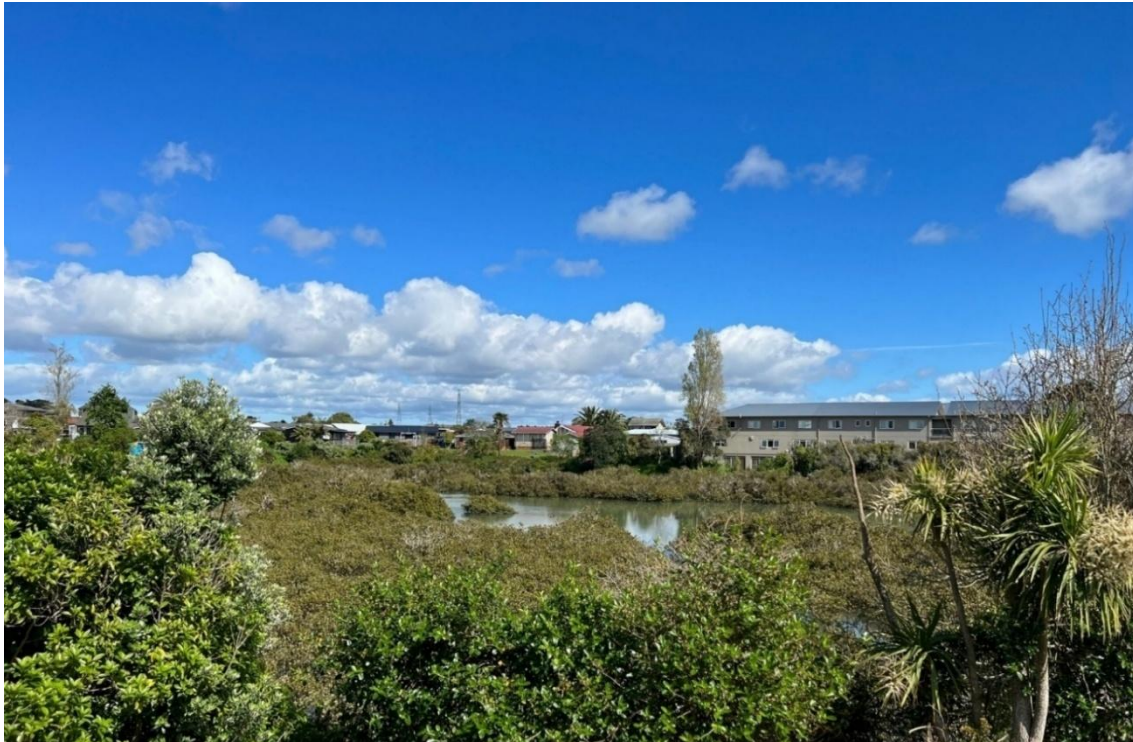
The site is adjacent to Pakuranga Creek, a tributary of the upper Tamaki River estuary. The site faces southeast and is fronted by intertidal flats and a narrow tidal channel (Figure 3). The inlet is mostly inhabited by mangroves and is approximately 100 m wide.

The coastline is characterised by a steeply sloping bank cut into Tauranga Group sediments<sup>1</sup>. The toe of the bank is at approximately 1.0 m (AVD-46) and the crest at approximately 5.0 m (AVD, 1946). Lidar and survey data indicates that the current slope of the adjacent reserve is typically 20-26 degrees.

*Figure 3: View to site of proposed Ambridge Rose Retirement Village, taken from Fremantle Place. The site of the proposed development is adjacent to the existing Ambridge Rose Manor private hospital.*
