22 April 2024

Cabra Developments Limited Unit 9B, 30 Foundry Road Silverdale Auckland 0932

Private Plan Change Geotechnical Assessment - Cabra Sites, Hobsonville, Auckland (Our Reference: 23849.000.006\_04)

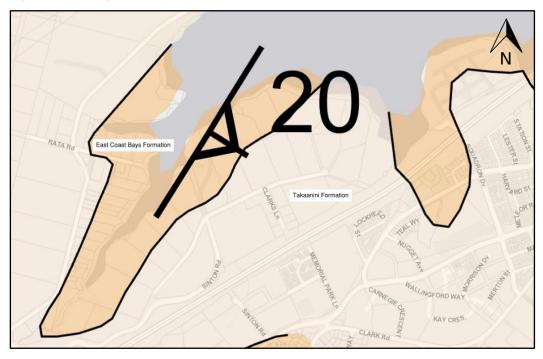
Figure 2: Geological Map

East Coast Bays Formation rock comprises alternating sandstone and mudstone with variable volcanic content and interbedded volcaniclastic grits. East Coast Bays Formation residual soils (weathered from the underlying rock) are generally described as orange and grey silts and clays with varying sand content. The geological map in Figure 2 shows a locally mapped bedding dip of 20 degrees towards the southeast, which is why East Coast Bays Formation soils and rock form the low sea cliffs across the northern side of the peninsula but are overlain by Takaanini Formation alluvium to the south.

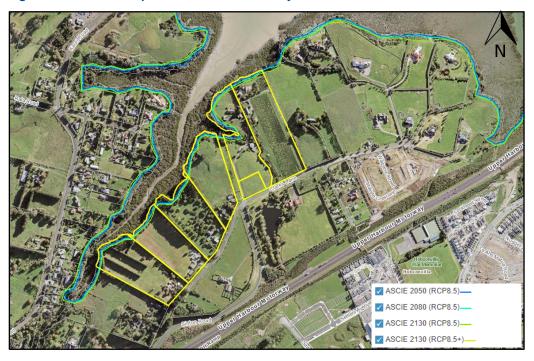
Figure 5: Areas Susceptible to Coastal Instability and Erosion

The work undertaken to develop the ASCIE layer was completed at a regional level and is intended to be used as a planning tool to indicate where a site-specific assessment will be necessary to support a change in future land use. A site-specific assessment has been completed by SLR Consulting New Zealand (ref. 850.016583.00001, dated April 2024) for the PPC area to support the plan change application.

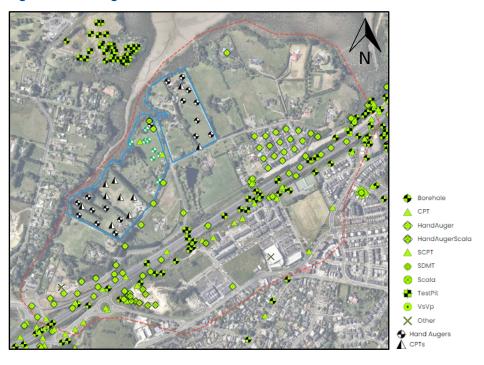
Figure 6: Investigation Data

The New Zealand Geotechnical Database has also been consulted for data over the wider peninsula area. There is a substantial data set available for the area as shown in Figure 6.

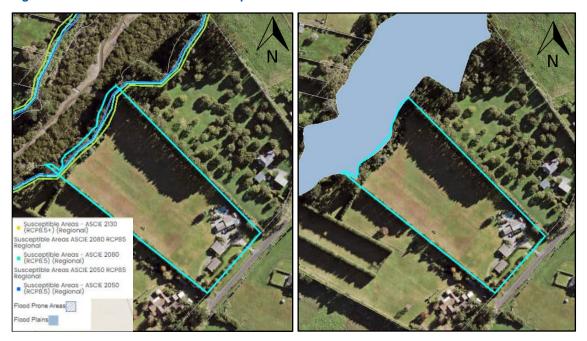
Figure 1: Auckland Council Hazard Map

The Auckland Council GeoMaps layer 'Flood Plains & Flood Prone Areas' identifies areas of land in Auckland that could be affected by flooding during and / or following periods of heavy rain. Portions of the site labelled as flood prone or flood plains are shown in Figure 1 and are limited to areas adjacent to Waiarohia Inlet.

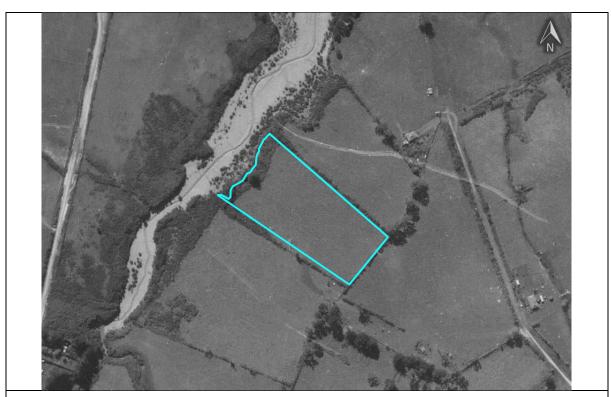
1940 (Retrolens NZ)

Date	Description
1940	The site and surrounding area comprise agricultural land; the site itself appears to be used for grazing. The northwest end of the site is vegetated and forms the edge of the Waiarohia Inlet.
1950	No significant changes to the site are noted.
1959	Some of the vegetation at the northwest end of the site has been cleared.
1963	No significant changes to the site are observed.
1968	Image quality is too poor to assess finer details; however, the west side of the site appears to have been divided into crop areas. In addition, two buildings have been constructed in the eastern portion of the site.

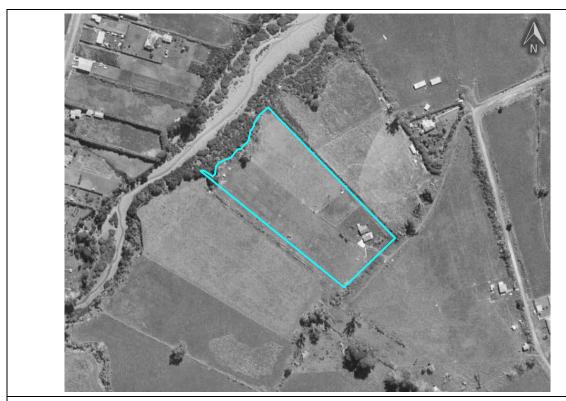
1972 (Retrolens NZ)

Date	Description		
1972	Two small sheds appear to have been constructed on-site; one in the northwest section of the site close to the inlet, and one along the northeast boundary of the site.		
1975	A rectangular shaped building has been constructed in the southern portion of the site. Two additional sheds have also been constructed towards the center of the site.		
A smaller building has been constructed to the south of the two original buildings (fir observed in the 1968 aerial photograph). Fences appear to have been erected in the quarter of site, and a small area to the northeast of the original buildings may be being as an orchard.			
1980	No significant changes to the site observed.		
1988	The site has been divided into four sections. The northern, southern and western sections appear to be used for horticultural activity.		
1996	Image quality is too poor to assess finer details; however, a swimming pool appears to have been constructed north of the original two buildings. In addition, three brown circular features can be seen in the northern section of the site that may represent stockpiled material.

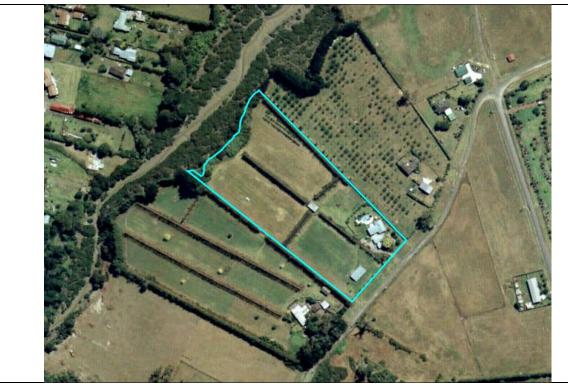
2000 (Auckland Council GeoMaps)

2000	The circular features are no longer observed. The three sections previously used for horticultural uses appear to have been cleared.		
2006	No significant change to the site observed.		
2008	The shelterbelts dividing the site into sections appear to have been removed. Another light circular feature that seems to represent a stockpile has appeared on the north side of the site. An additional structure has been constructed to the north of the southern rectangular building. The structure at the center of the site appears to have been removed.		
2010 / 2011	The previously observed stockpile appears to have been removed.		
2012	No significant changes to the site are observed.		
2017	No significant changes to the site are observed.		
2018	No significant changes to the site are observed.		
2019	A small building appears to have been constructed in the south side of the site.		
2020	The previously mentioned building appears to have been removed.
