Map3 - Bank and Channel Modification Type & Extent

Client **AUCKLAND COUNCIL**
Project **NGAKAROA WAR**

Project no. **P01644**
Date **16 Jun 2018**

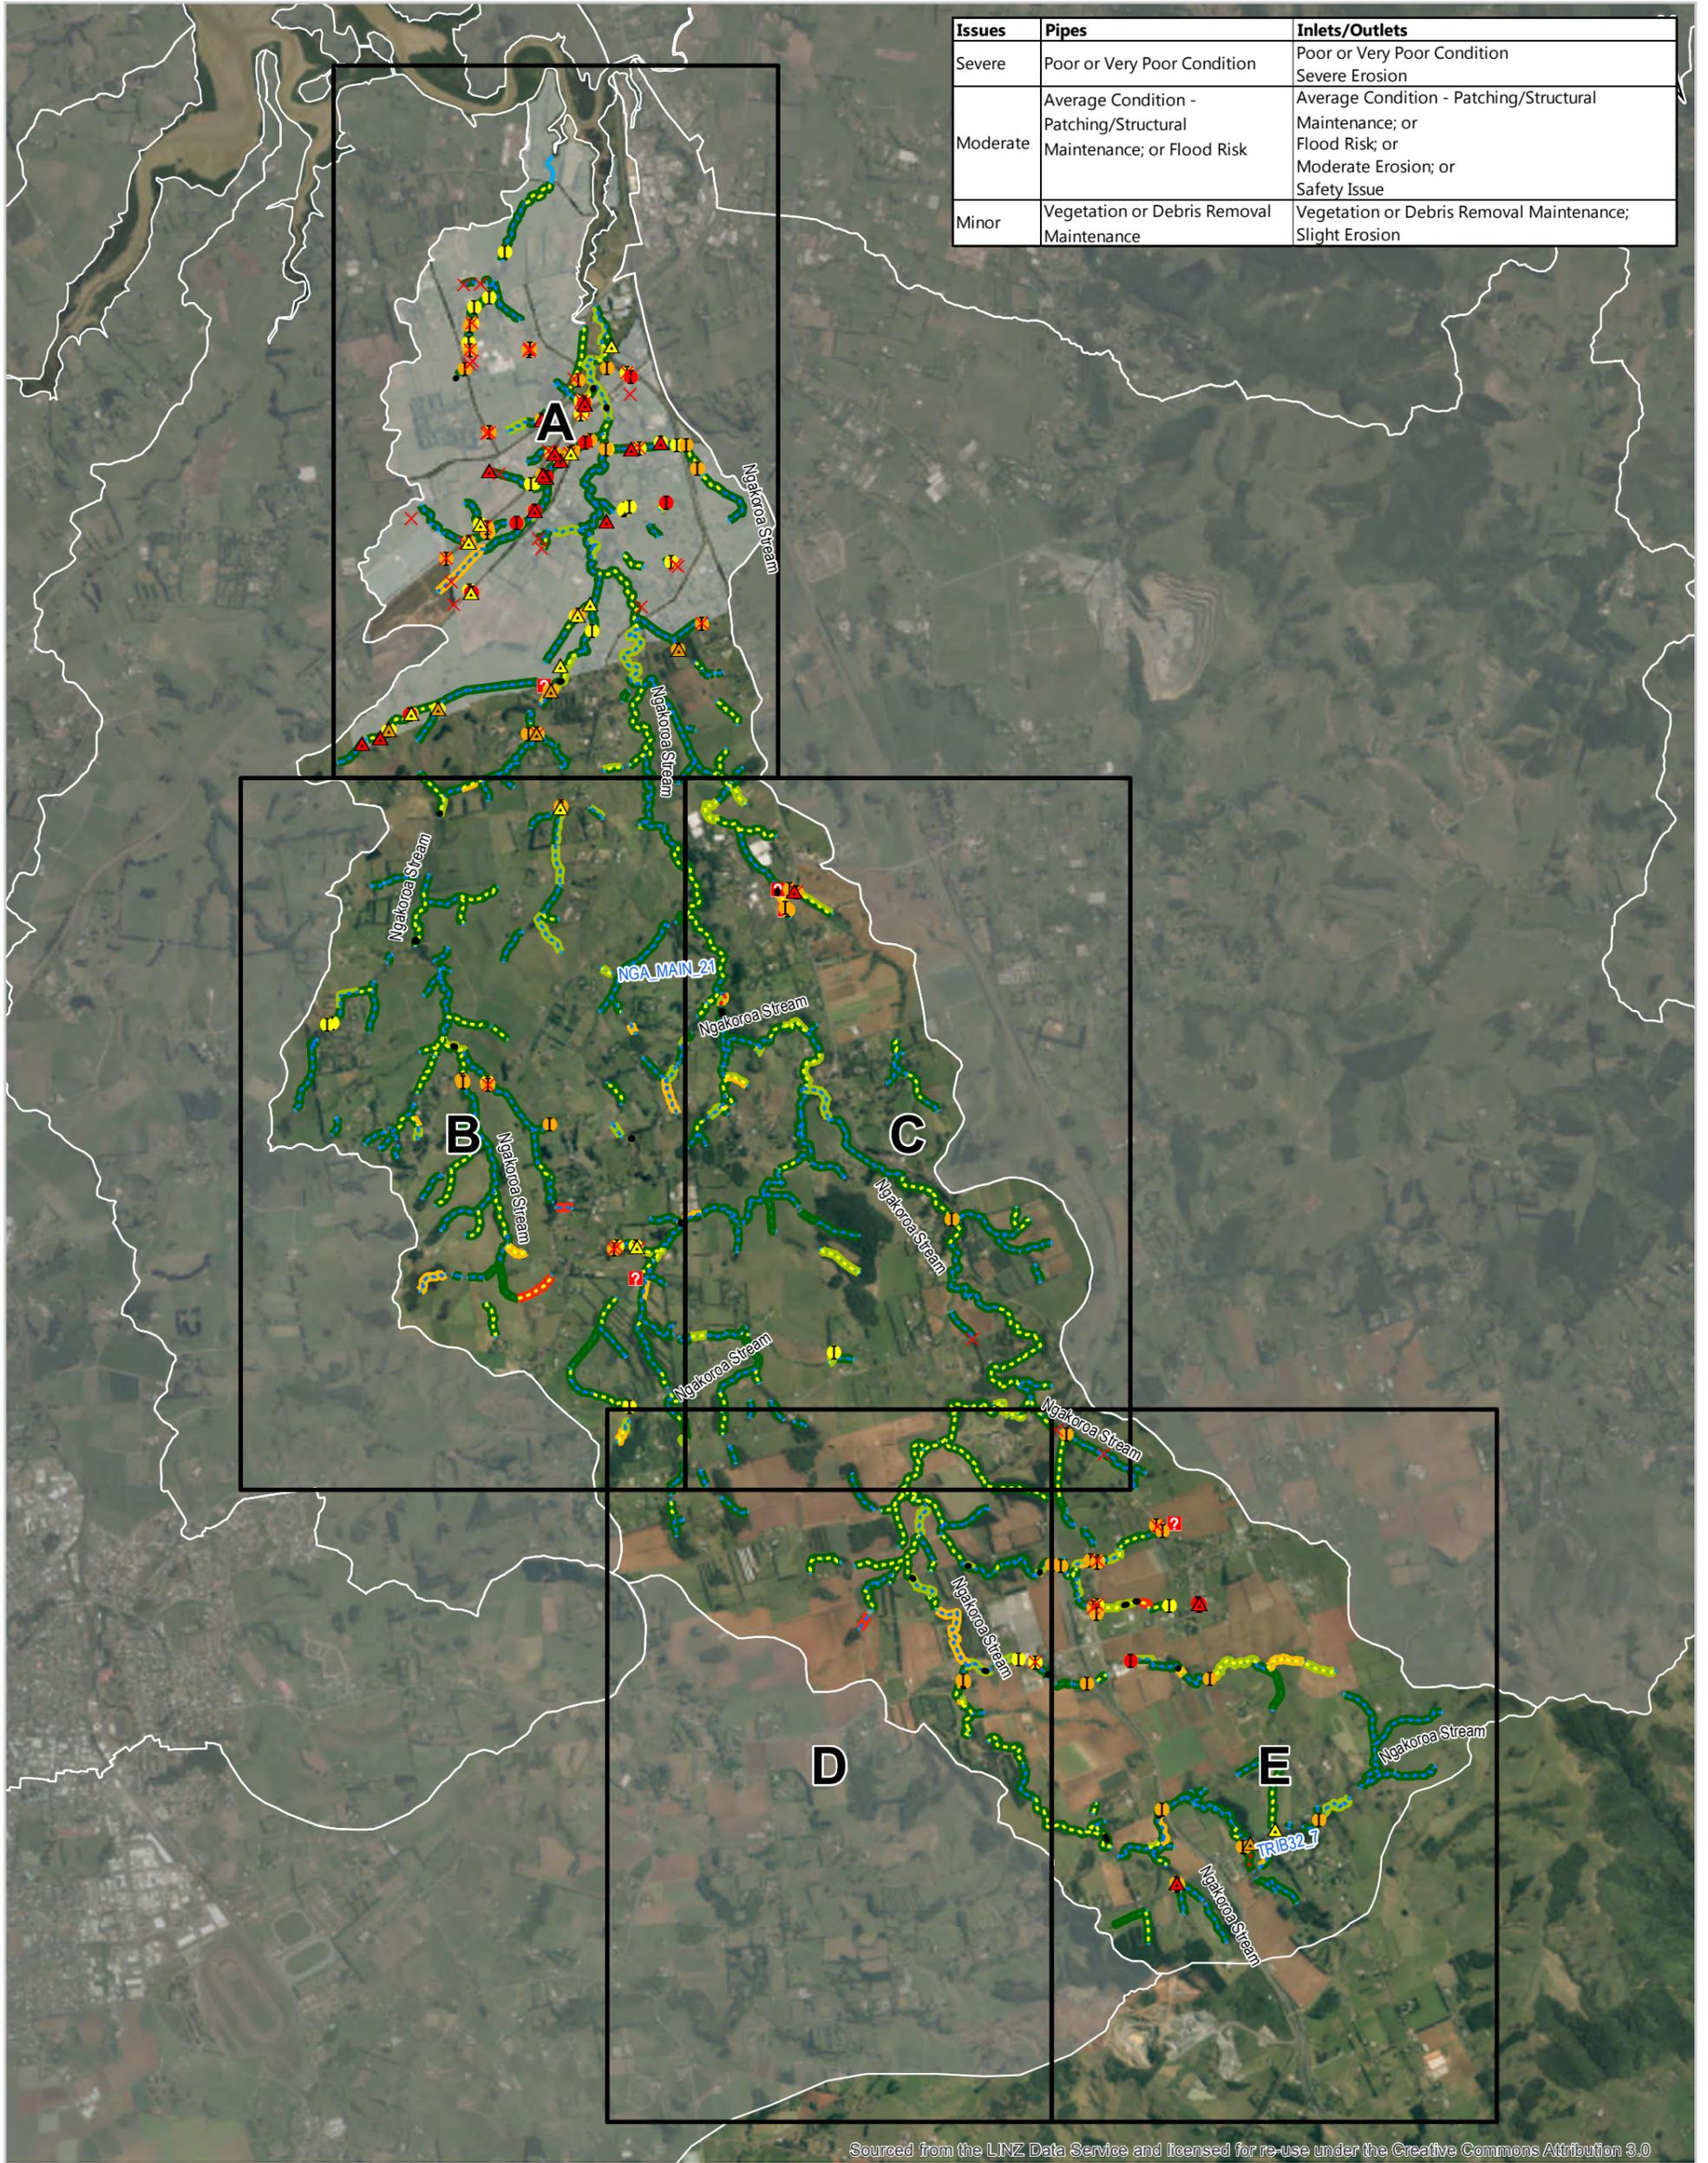
Issues	Pipes	Inlets/Outlets
Severe	Poor or Very Poor Condition	Poor or Very Poor Condition Severe Erosion
Moderate	Average Condition - Patching/Structural Maintenance; or Flood Risk	Average Condition - Patching/Structural Maintenance; or Flood Risk; or Moderate Erosion; or Safety Issue
Minor	Vegetation or Debris Removal Maintenance	Vegetation or Debris Removal Maintenance; Slight Erosion
