Oira Catchment Watercourse Assessment Report (Draft)

June 2017

Oira Catchment

Watercourse Assessment Report

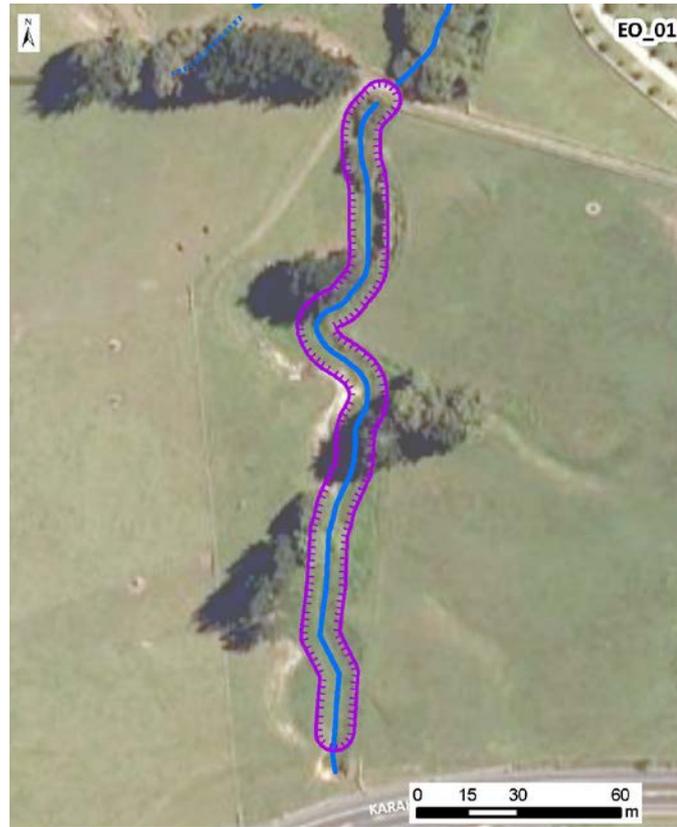
Plan

| Notes | <p>In its present state, the stream running through this enhancement opportunity is unfenced, unplanted and has been impacted by stock damage. Erosion issues are also present at the culverts leading into and out of the area.</p> <p>The land owner expressed an interest in fencing and replanting the area and as this site has good public visibility from State Highway 22, an excellent opportunity exists to involve the community in any enhancement project, thus improving the amenity value of the site. This could be achieved by involving school children from the nearby Karaka School in replanting the stream margins with native vegetation.</p> | | | | | | | |

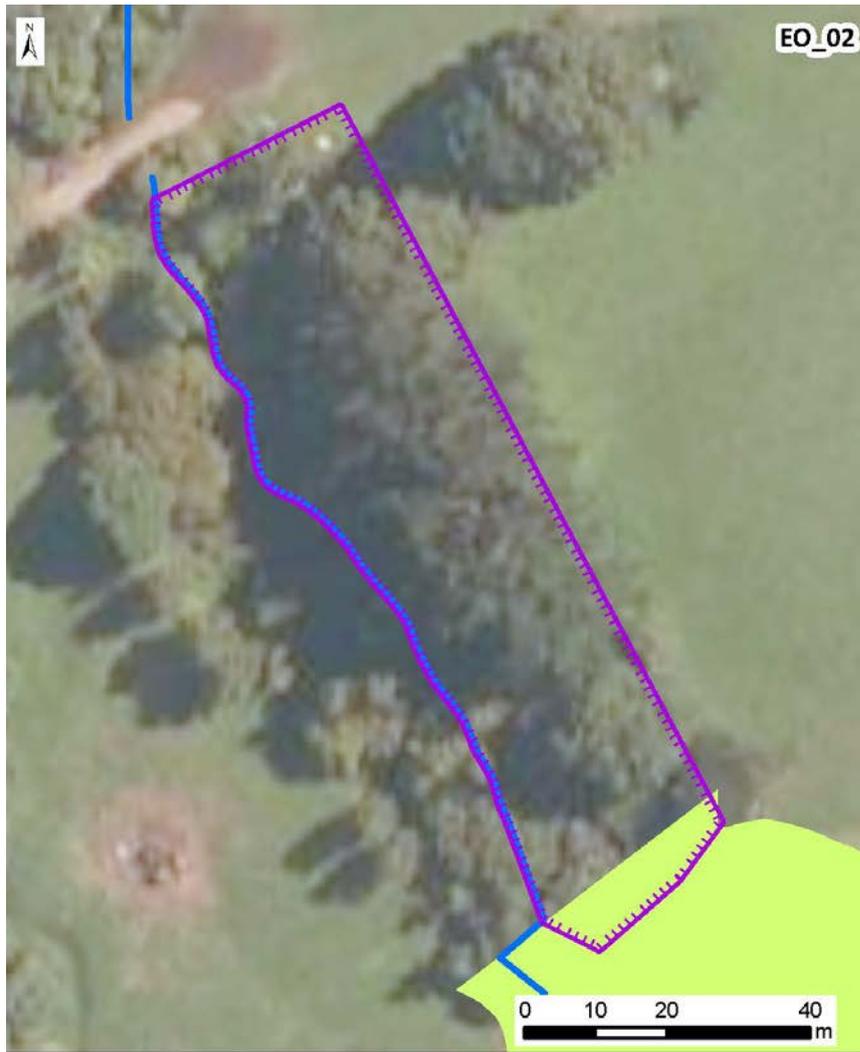
Plan

| Notes | <p>A wide, low gradient flood plain exists around a poorly channelised stream. The flood plain is currently dominated by weed species and is littered with debris and rubbish. The stream has the potential to offer good bankside spawning habitat but needs to be replanted with native species. The habitat could be further enhanced by removing the debris and rubbish, which may also present a future conveyance issue if left.</p> <p>At the upstream end of the site, improvements could be made to the artificial online pond. Some erosion issues, where trees have been felled are present, while the culvert that was in place appears to no longer function. The overflow channel may also be impacting fish passage upstream.</p> | | | | | | | |

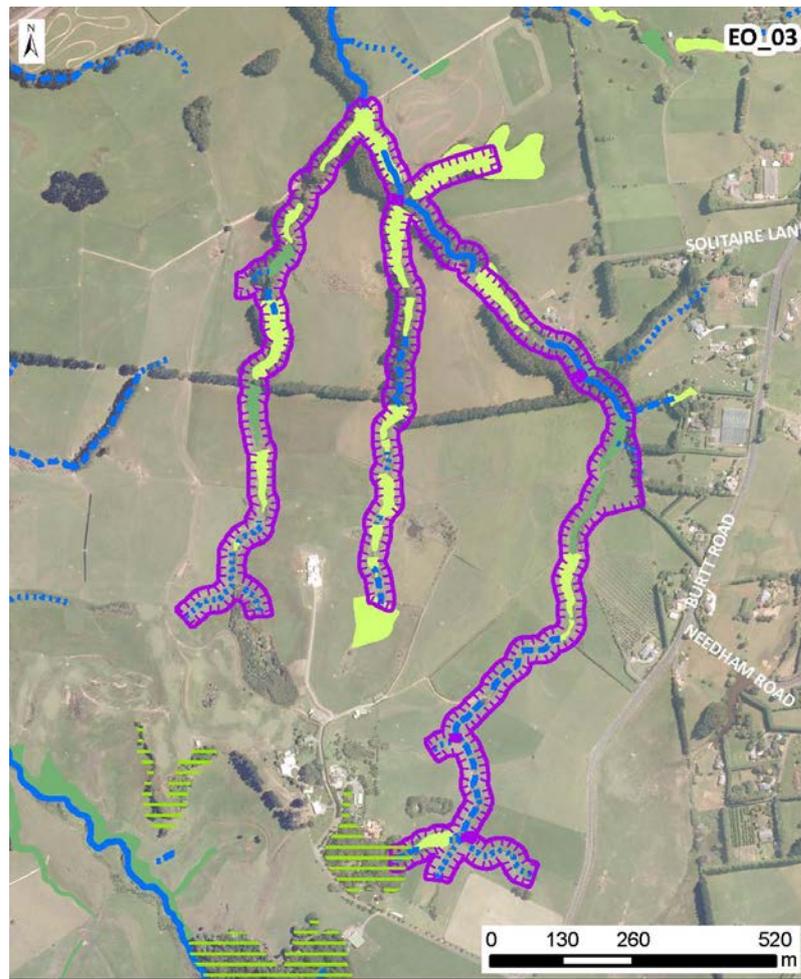
Plan

Perched culverts were present on many of these artificial wetlands. This potentially causes significant fish passage issues throughout the catchment as well as creating general stream conveyance problems. An area of concern is Enhancement Opportunity 3 (EO3) where culvert damming, because of a series of farm ponds and perched culverts, has led to a widespread *Glyceria* infestation. This has resulted in the conversion of multiple stream reaches into a *Glyceria* dominated wetland (See section 5.2.3 for more details).

| Notes | <p>A series of farm ponds and perched culverts have likely created significant ecological and conveyance issues throughout this area. Poor drainage has resulted in a serious build-up of the noxious weed <i>Glyceria</i>. This ecologically damaging species, reduces the conveyance capacity of streams and rivers and poses a health risk to livestock (see section 3.1.3 for more details).</p> <p>While removing <i>Glyceria</i> from all three stream channels would require extensive weed control, large-scale clearances are economically cheaper than small scale clearances, in terms of a reduction of infested area per unit invested (Loo et al. 2009). In the upper catchment (eastern fork) there are currently landowners who are controlling <i>Glyceria</i> via spraying, therefore it is likely that approaching landowners to help combat the problem would be positively received. Improving the riparian margins within the reaches would also help to reduce the risk of infestations returning.</p> <p>Reconnecting the stream network through replacement of culverts that are perched above the water table would also provide benefits to the watercourse. A more consistent flow may help prevent <i>Glyceria</i> establishing across the channel, while the removal of significant fish barriers would improve the accessibility of upstream areas to native fish species.</p> | | | | | | | |

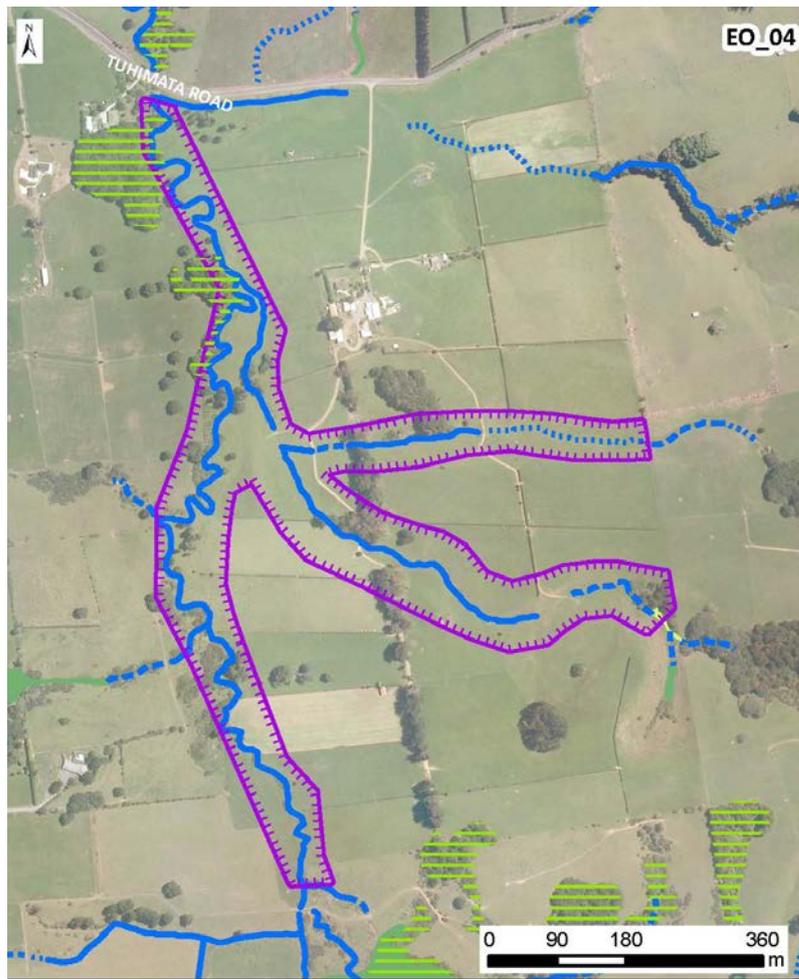
Plan

| Notes | <p>The streams running through this section of the catchment were observed to be the most degraded during the watercourse survey. A lack of fencing, combined with severe stock damage has resulted in significant erosion issues throughout the area, with multiple erosion hot spots identified.</p> <p>There is an overall absence of riparian vegetation and sections of the stream have been piped to increase the amount of space available for livestock grazing. Multiple perched culverts existed creating erosion issues and fish barriers are present. The incidence of mosquito fish presents further challenges to native fish.</p> <p>This area needs significant attention and the watercourse would benefit immensely from fencing and stock exclusion. Naturalising, including riparian vegetation planting and the daylighting of piped sections of stream would improve the stream function and increase habitat for native fish, while erosion protection and the incorporation of fish passage devices into many of the culverts would help to alleviate fish passage issues and culvert erosion.</p> <p>The proximity between this EO and EO_07 presents an opportunity to link the two areas forming a more continuous corridor of native riparian vegetation. A scenic reserve (SEA_T_5351) also exists directly downstream from this EO, providing further potential for ecological linkages.</p> | | | | | | | |

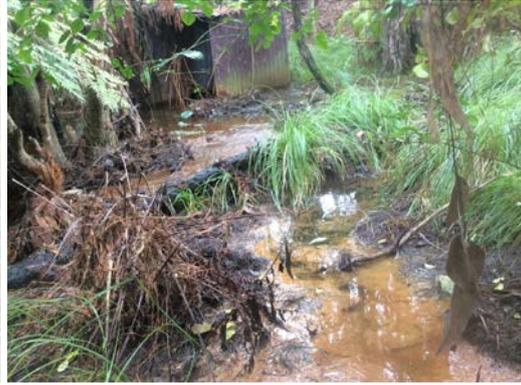
Two of the sites (ecolines 1_020_A and 2_005_A) had potential for enhancement. This is in large part due to the disconnect between the spawning habitats and upstream reaches caused by perched culverts. Remediation/removal of these culverts along with additional planting along the banks and the removal of debris creating natural stream impediments would be beneficial to these areas. More details on these sites as enhancement opportunities can be found in Section 5.2.5 and 5.2.6 of this report.

Perched culvert

Downstream inanga spawning habitat
