## The Tree Consultancy Company

**To:** Maureen Glassey – Principal Advisor, Auckland Council  
**From:** Andrew Benson – Urban tree ecophysiologicalist, The Tree Consultancy Company  
**cc:**  
**Date:** 13<sup>th</sup> October 2020  
**Re:** PRELIMINARY summary of findings – Western Springs Pines

The following information pertains to assessments of 198 standing pine trees (*Pinus radiata*) in Western Springs, Auckland, carried out between 21<sup>st</sup> September and 9<sup>th</sup> October 2020. It is a concise summary of our methods and findings and is provided as **PRELIMINARY** only. We expressly indicate at this stage that the data have not been fully checked and it may be that some of the numbers presented will change by the end of the week pending full data analysis and review.

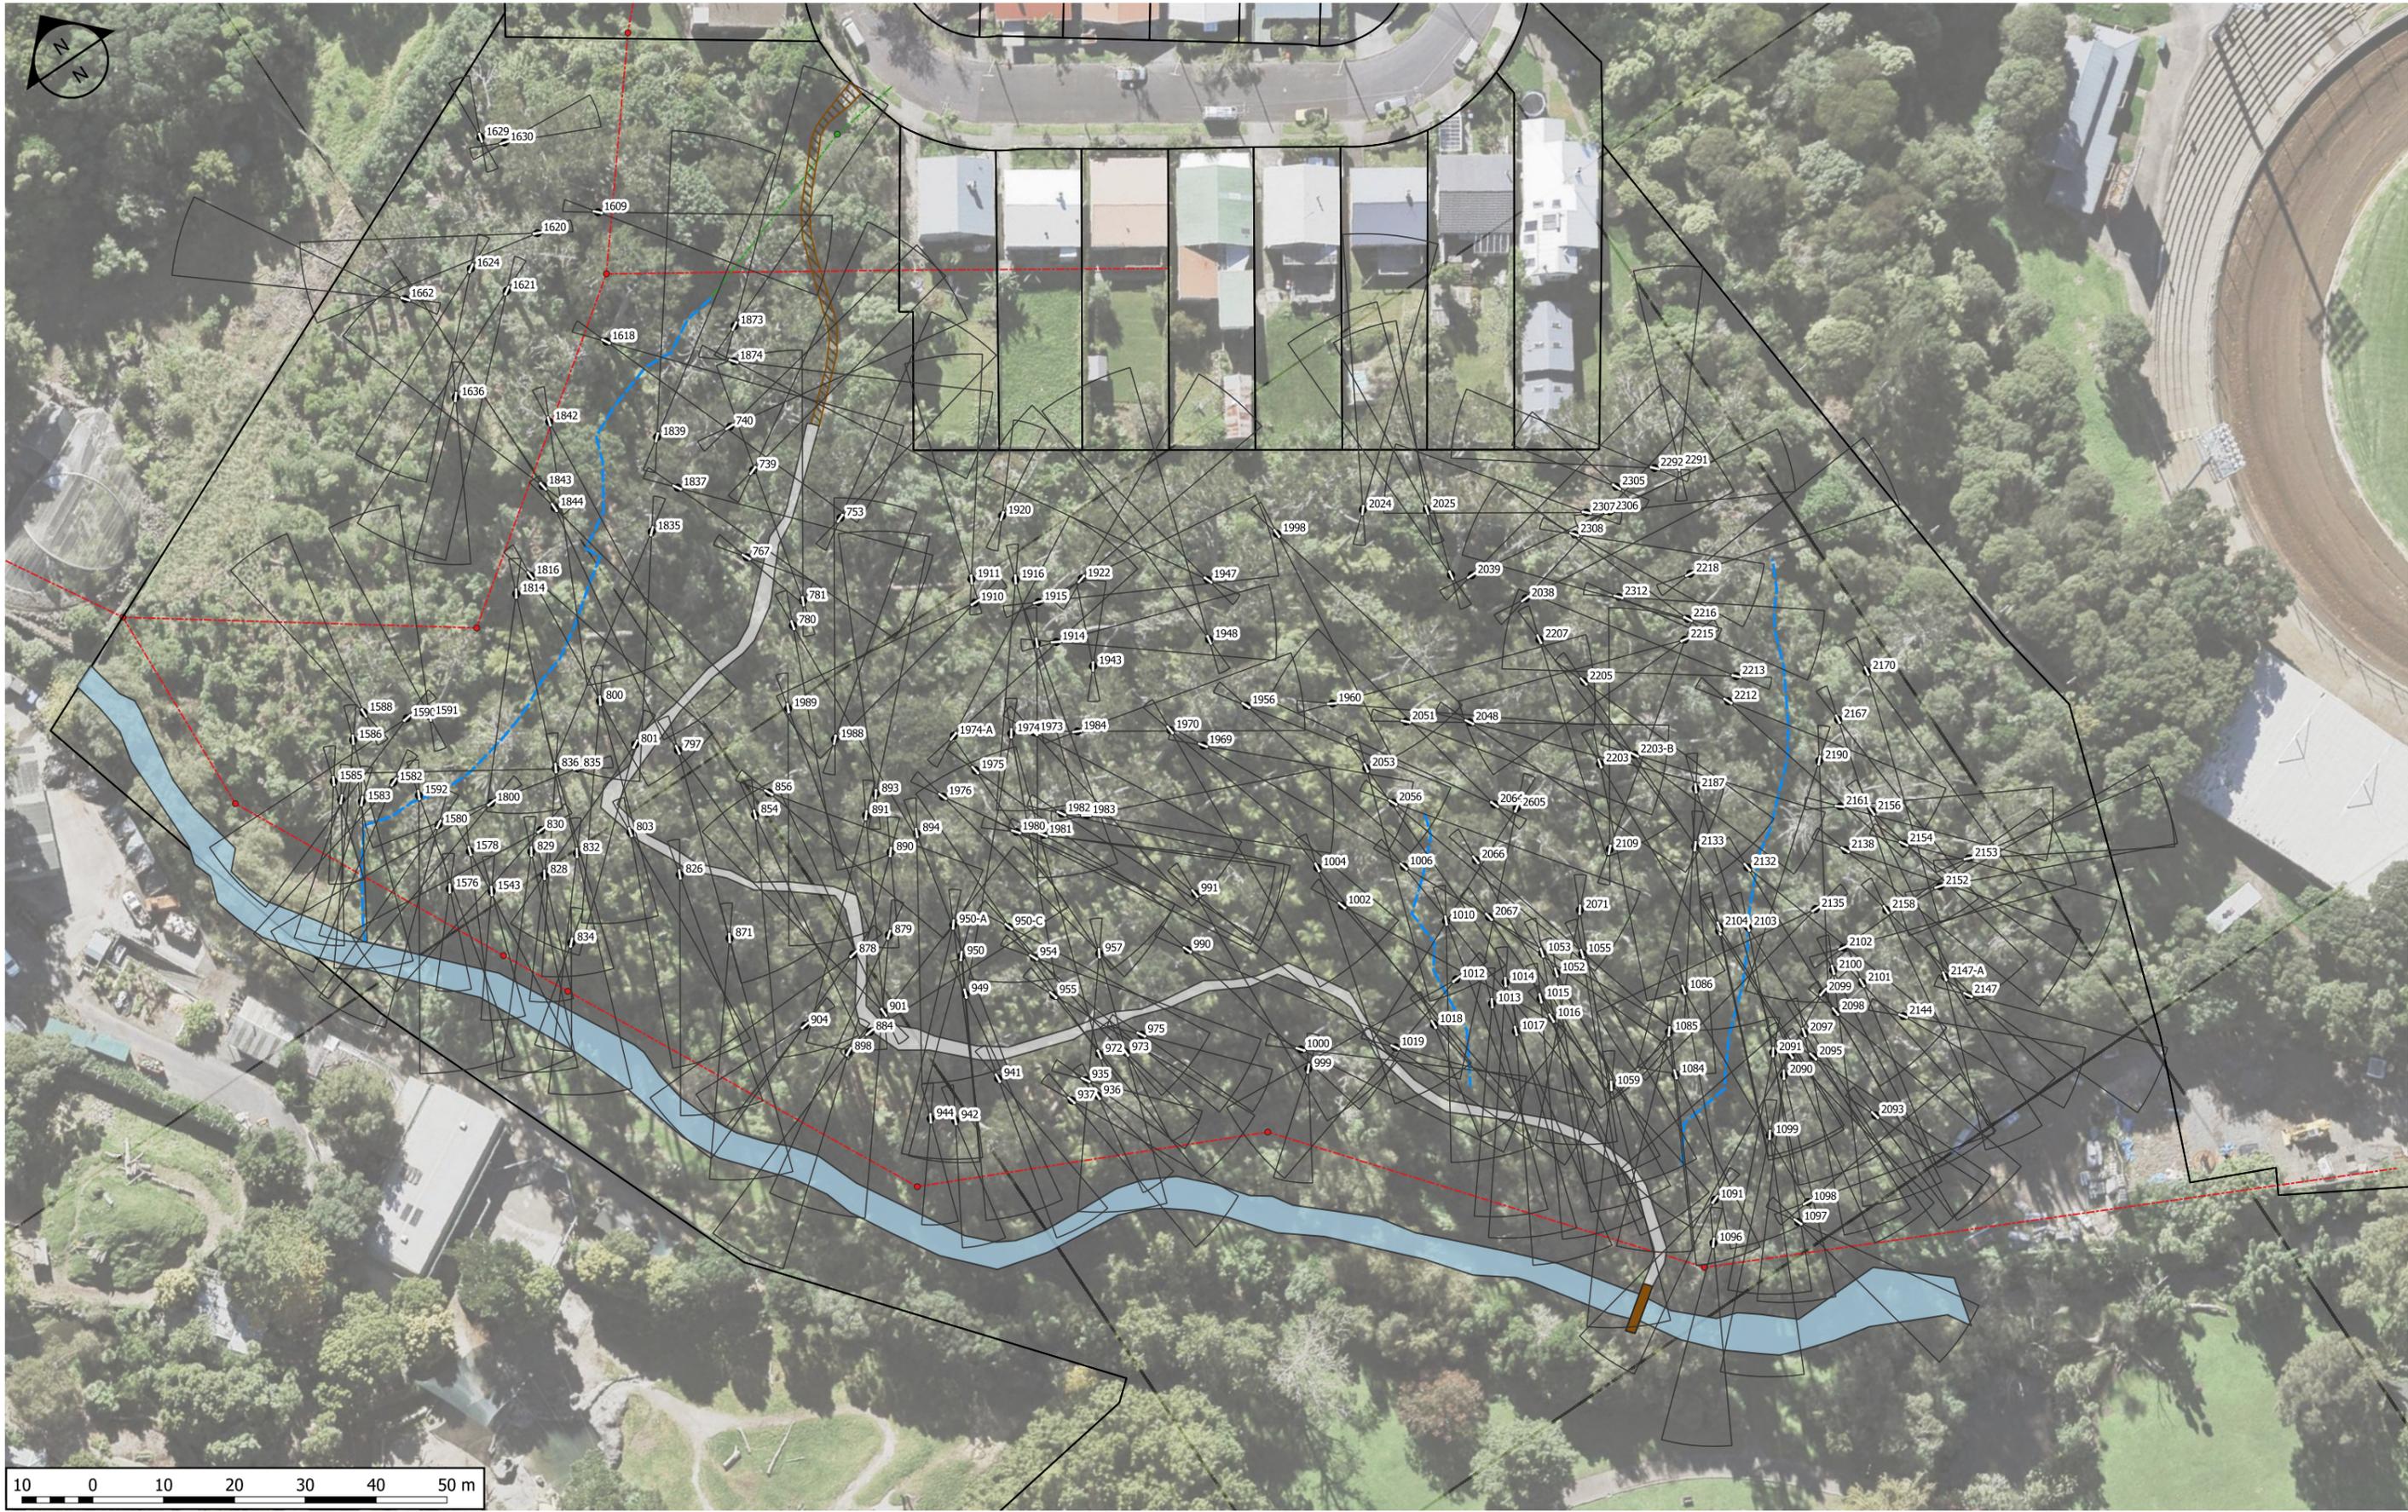
Western Springs Pine Forest  
Tree condition plan  
PRELIMINARY

- Based on the most likely mode of tree failure (stem breakage) and the recorded trunk azimuths, there are:
  - 139 'Acceptable' risks (70%)
  - 7 'Tolerable' risks (4%)
  - 50 'Not tolerable' risks (25%)
  - 2 'Not acceptable' risks (1%)
- The overall risk to pedestrians using the path during normal operation is 'Unacceptable'.
