Jubilee Bridge Structural Condition Assessment Report (Post Auckland Extreme Weather Events)

Panmure Basin, Lagoon Drive,
Panmure

Job No. 21785

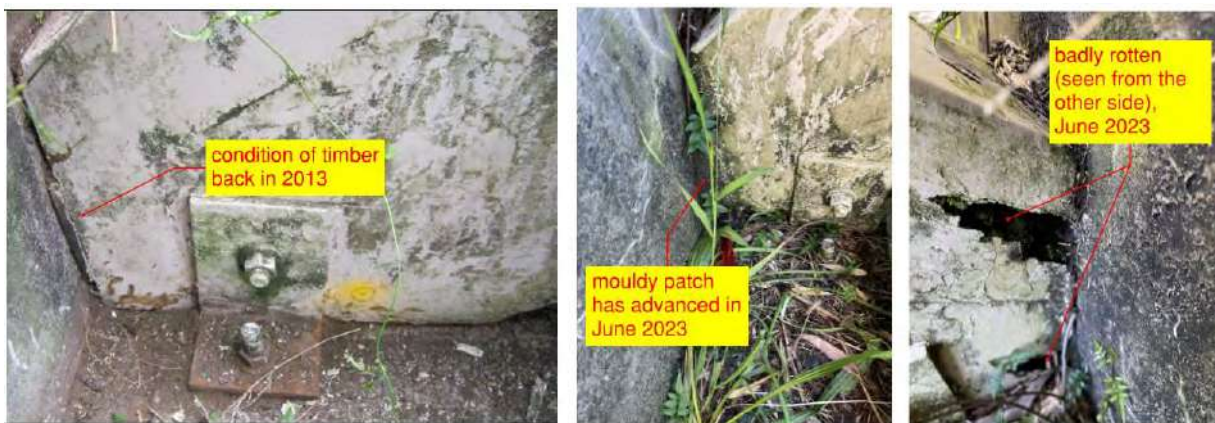
Figure 15: Side-by-side comparison of the base of the main timber arches on the Watene Rd side – Northern arches.

Comparing the conditions of the base of the main timber arches that were observed during the recent site investigation and the previous site investigation back in 2013, it's apparent that the bottom of the main arches has deteriorated further, and decay is noticeably in a more advanced stage (see the comparisons in Figures 14-

15). We also observed that the timber piers supporting the main horizontal beams were at an advanced deterioration at the ends (refer to Figure 16).

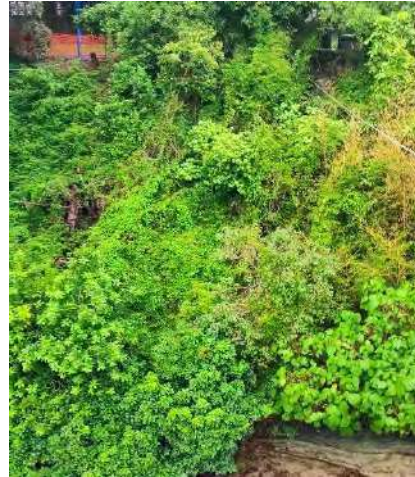
2. Steel cable obstructed by vegetation

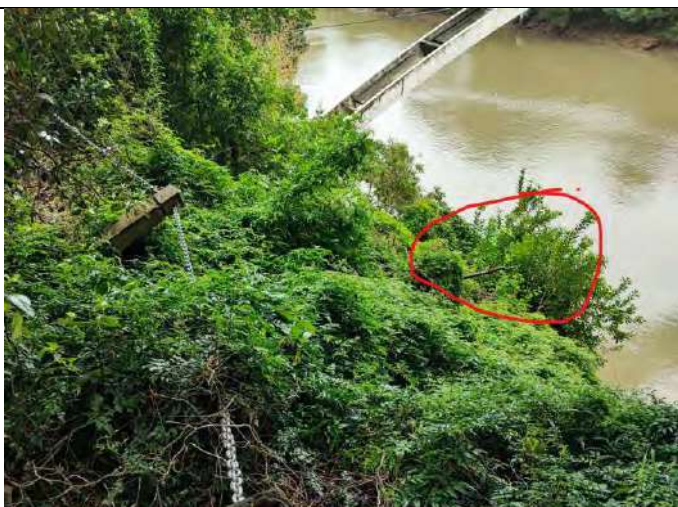
5. New slips beside the bridge on the west end

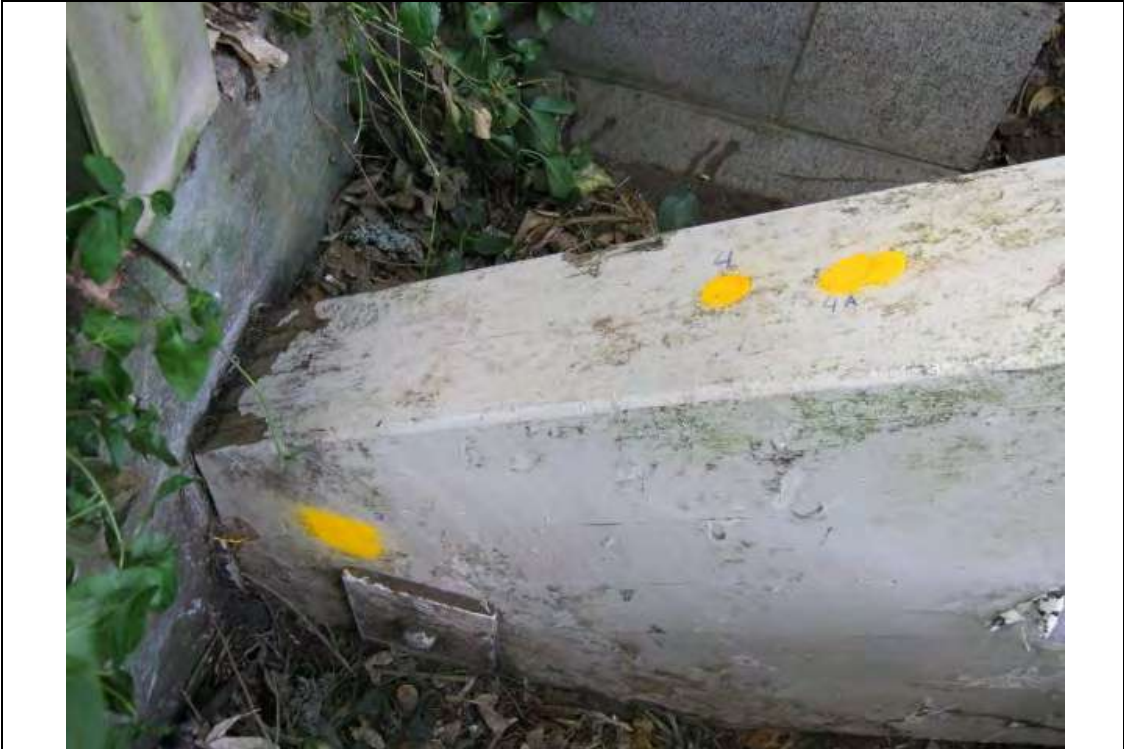
Probe #3 & #4 (#4A is the location of the "failed" probe) (Beam "B")

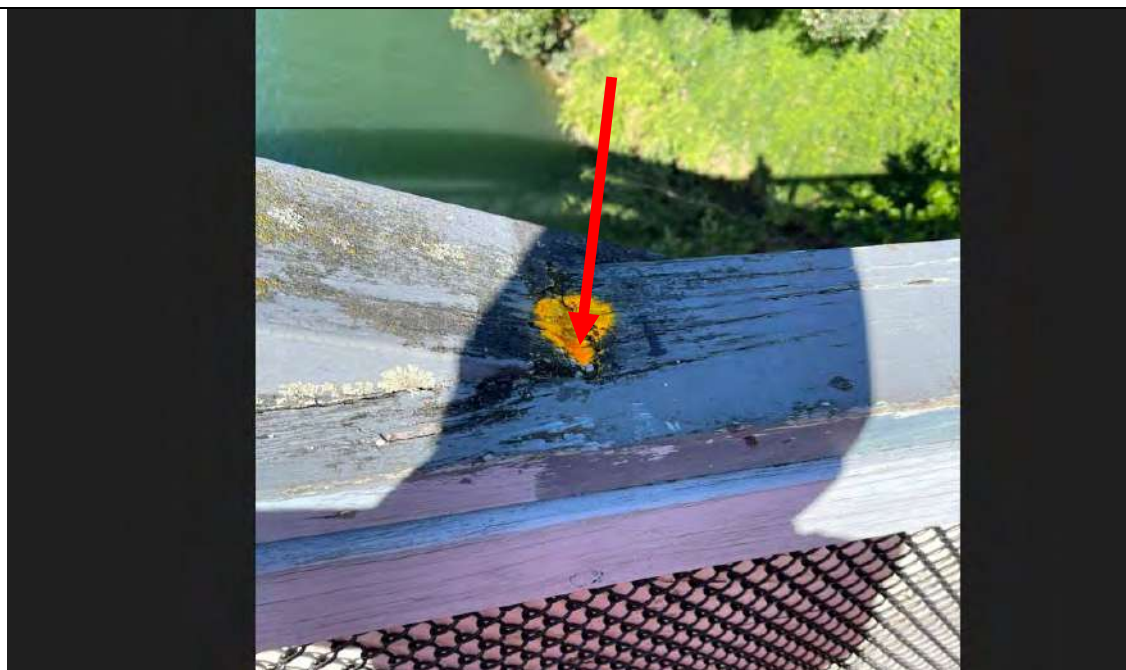
Photo showing the location of test drilling #1 The red arrow(s) depict the approximate drilling angle(s)

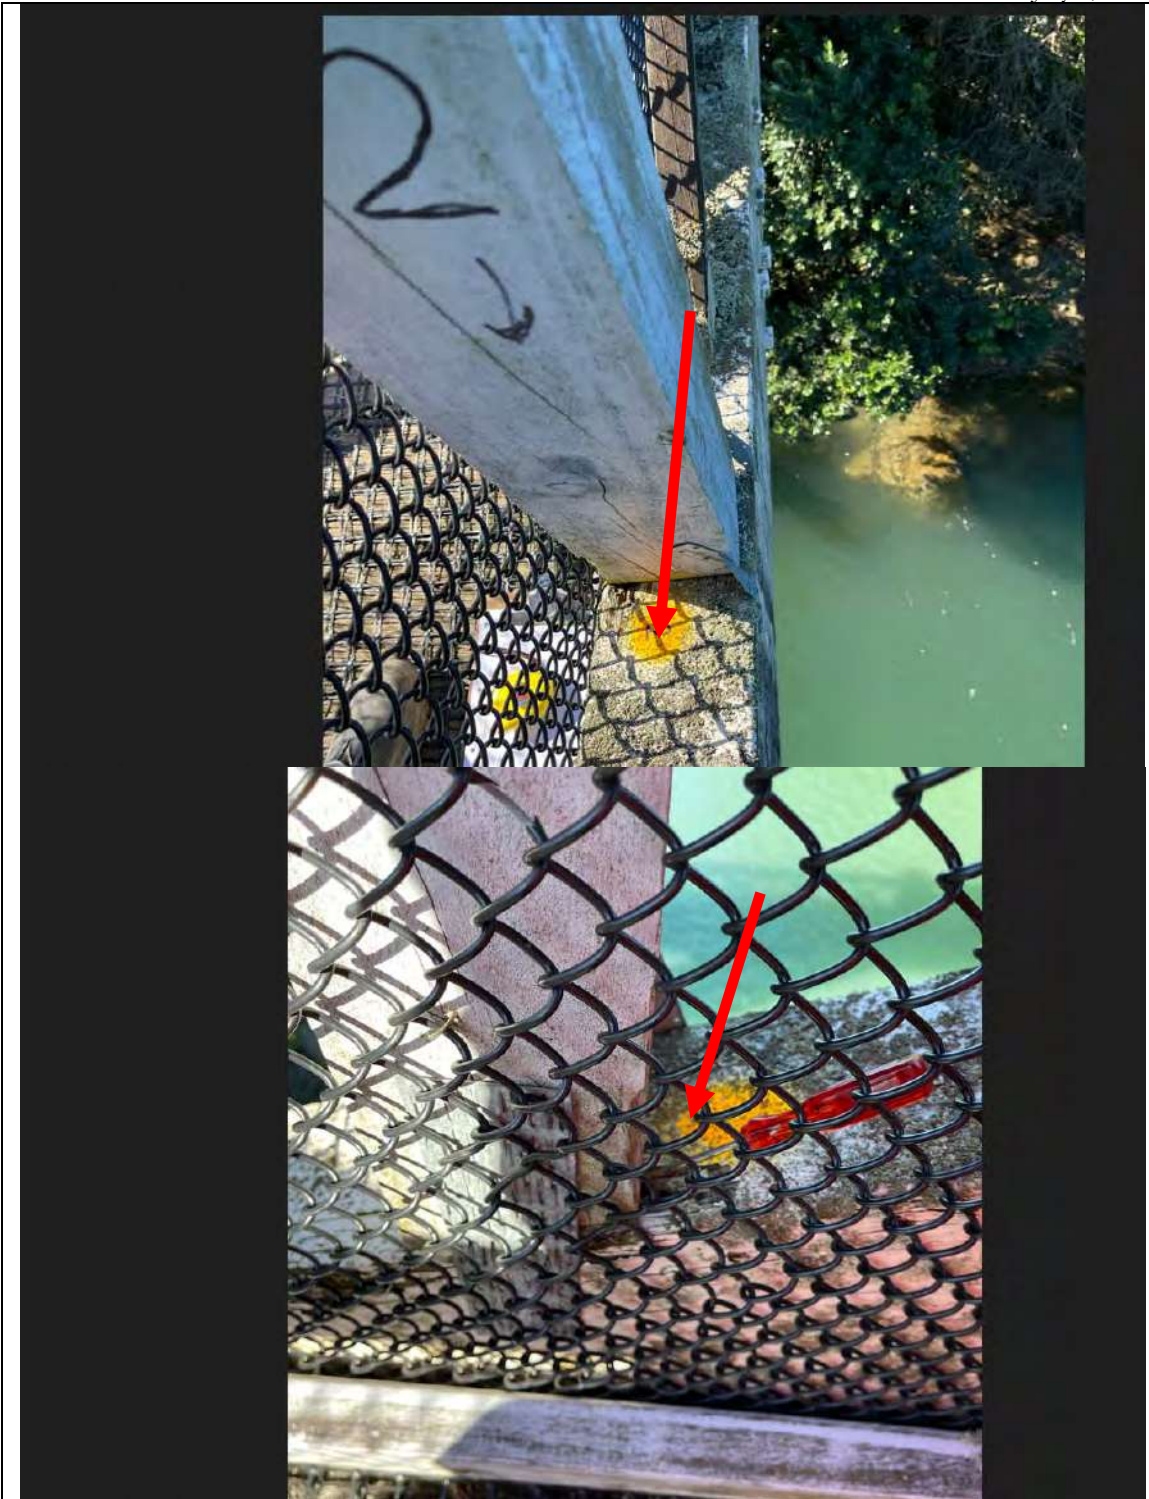
Photo showing the location of test drilling #2. The red arrow(s) depict the approximate drilling angle(s)

#2 severe decay detected under handrail post

It is recommended that additional investigations are undertaken including the disassembly of critical parts for closer inspection and assessment by suitably qualified and experienced personnel and possible (laboratory) testing to determine the structural strength of any

componentry, severity of decay and identification of the any fungal species that may be active and could affect the structural integrity of any of the componentry.

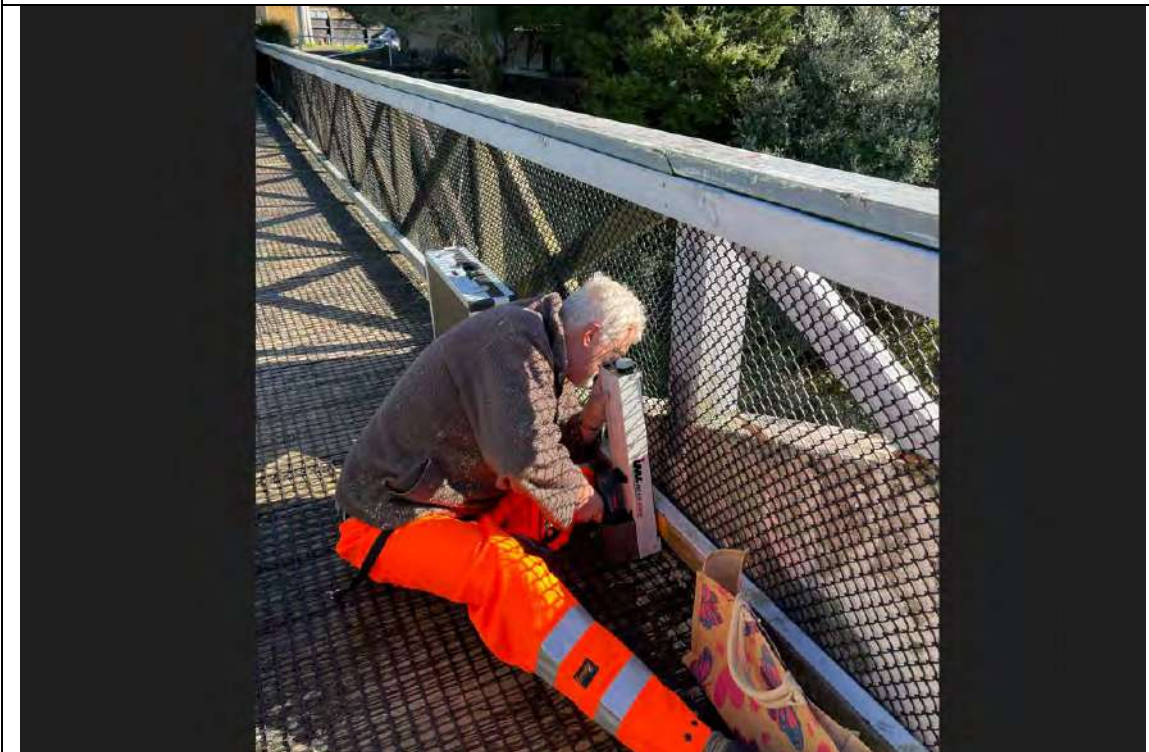
Photo showing the location of test drilling #3 The red arrow(s) depict the approximate drilling angle(s) Drilling was undertaken near vertical through the deck into horizontal beam

As per above
