Waitakere Coastal Communities Landslide Risk Assessment

**Appendix B – Muriwai Engineering
Geological Report**

Auckland Council

15 May 2024

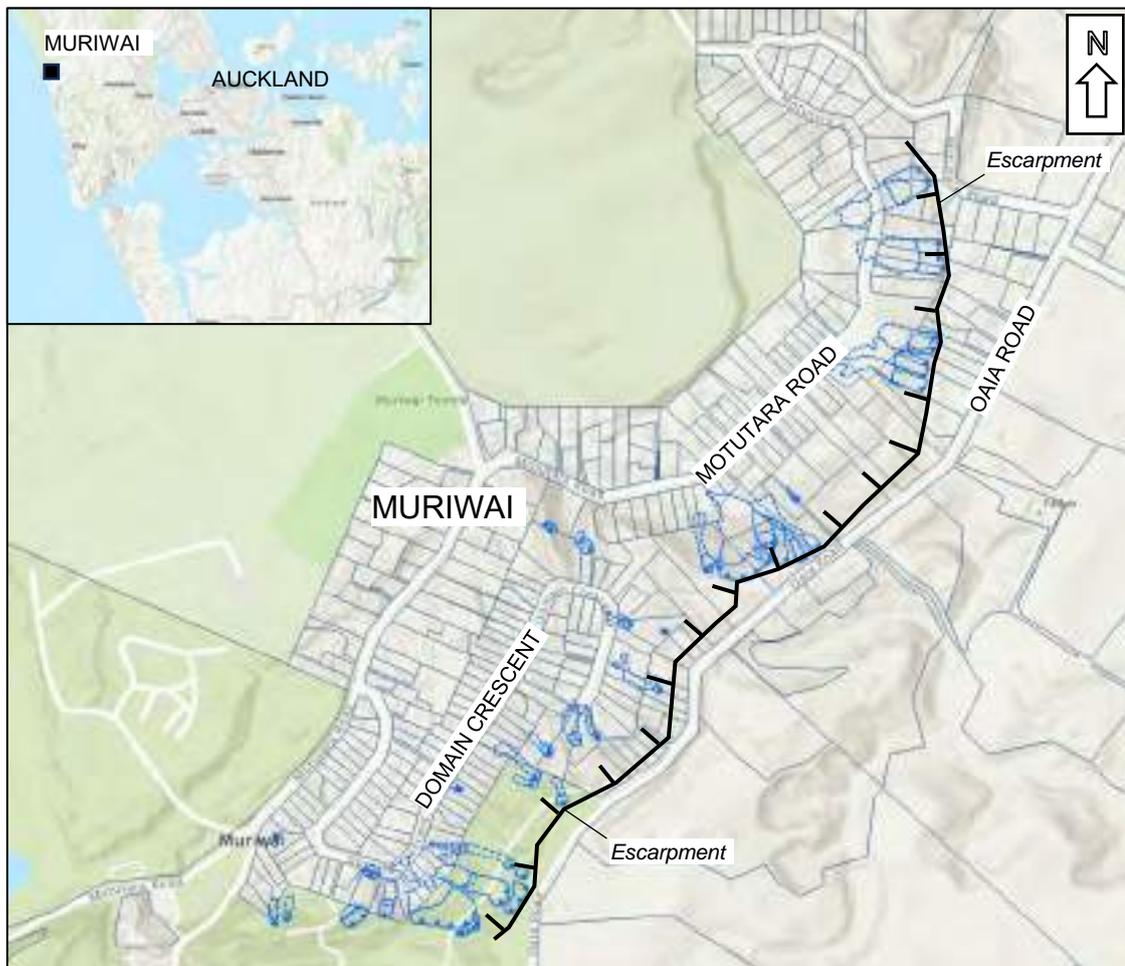
Figure B1 Muriwai location showing the February 2023 landslides mapped by GHD (blue lines)

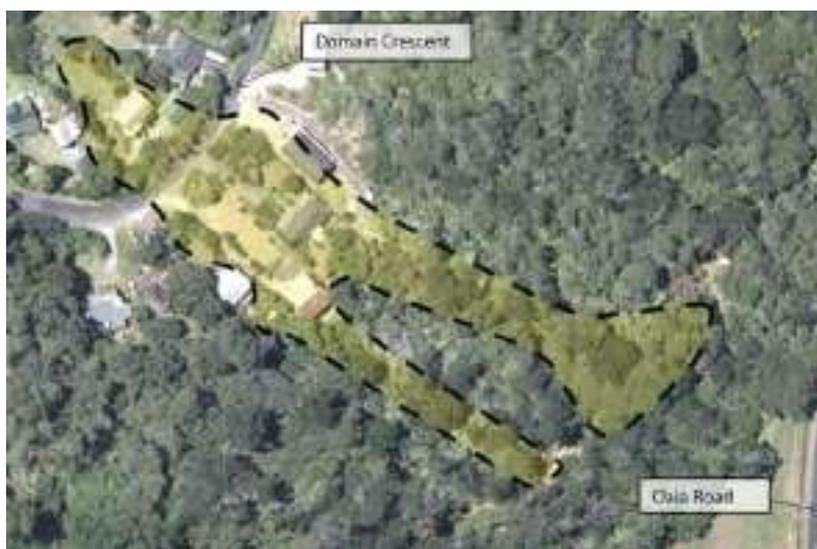
Figure B5 Mapped extent of 1965 Landslides (after Wright 1966)

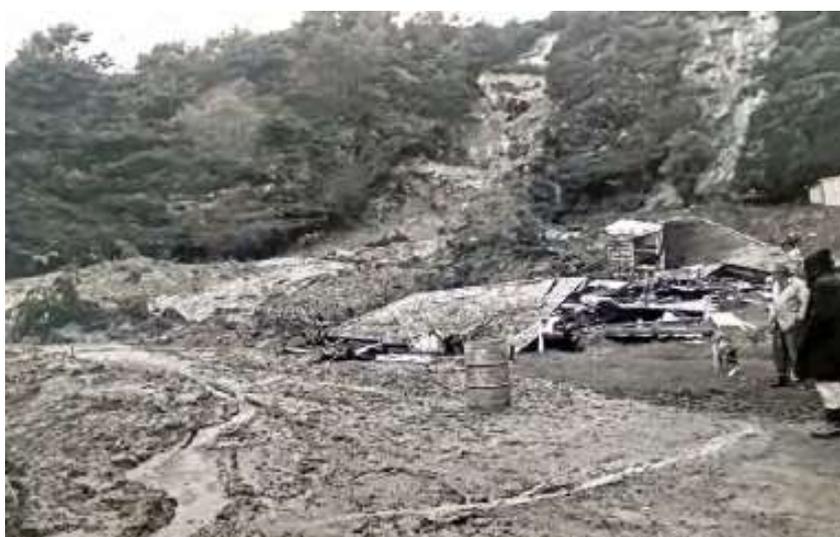
The two separate debris paths coalesced near the bottom of the escarpment and flowed across Domain Crescent (Figure B5 and Figure B6). Both the destroyed dwellings were located on the uphill side of the road and were translated with the debris flow.

Figure B6 View from Domain Crescent of 1965 landslides and destroyed dwellings (after Wright 1966)

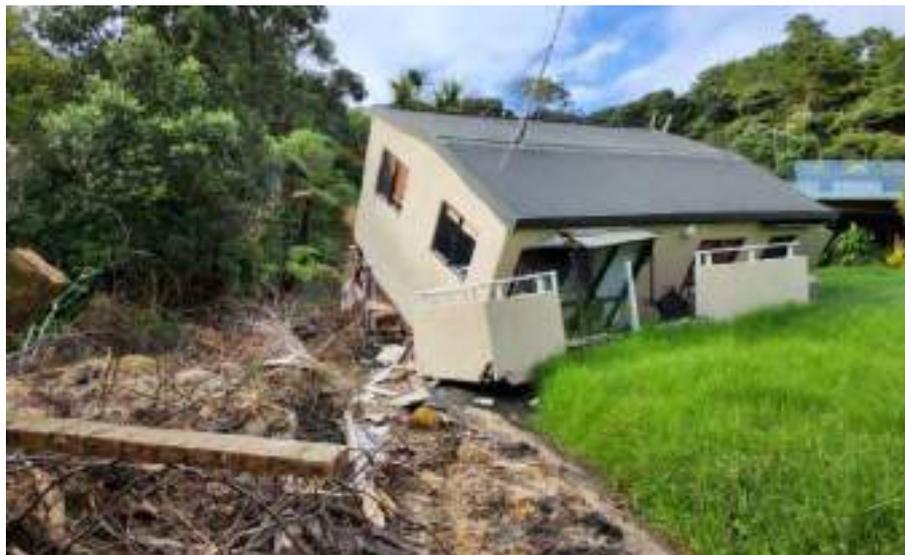
Figure B8 *Example of significant destruction of dwelling, associated with landslide debris runout, GHD 2023. Debris resulting from Landslides M-LS12.*

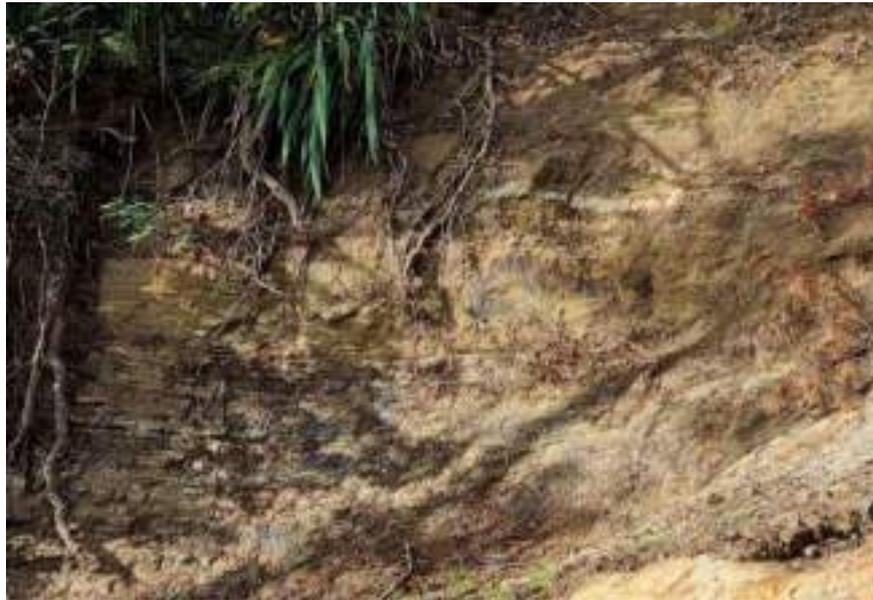
Figure B13 Outcrop of Awhitu Sand Formation - Less Cemented Sands, cross bedding evident (left). Exposed within 2023 landslide, Domain Crescent.

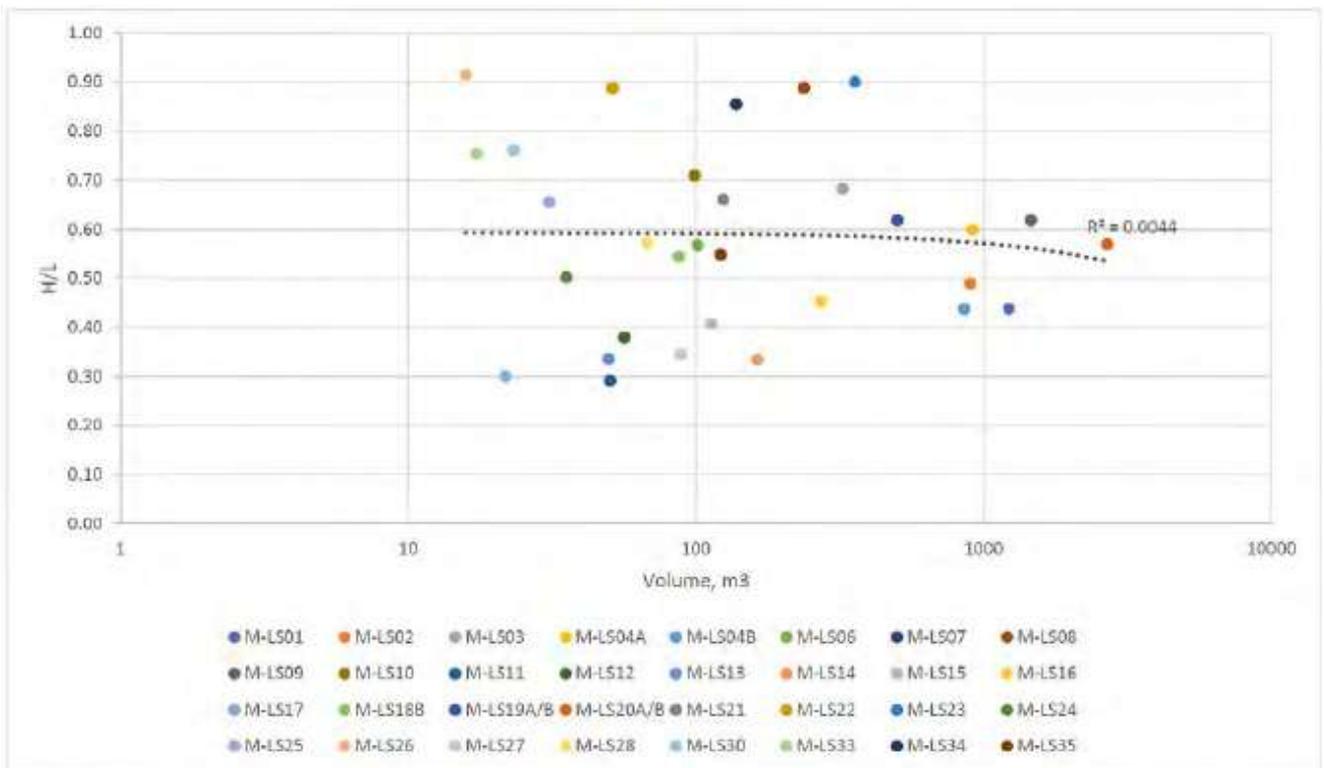
We have also compared the relationship between landslide volume and runout distance by presenting the data on a H / L vs volume plot (Figure B28). As is apparent from the plot, there is a broad scatter of data with a poor correlation between the H / L ratio and landslide volume. Runout estimation methods based on a volume relationship such as Finlay et al (1999) therefore do not appear to be useful in the case of Muriwai. This is consistent with commentary in the literature by Hungry et al. (2005).

Figure B28 Height / Length ratio vs volume plot for all Muriwai landslides on the main escarpment

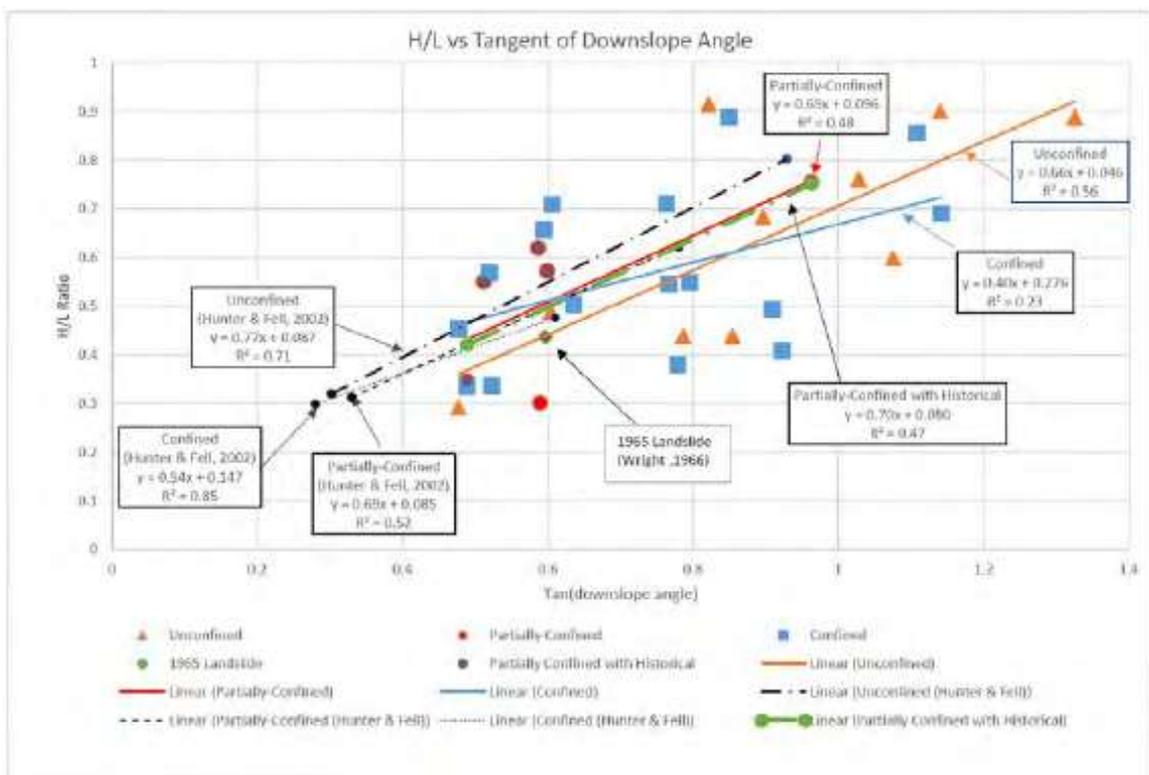
The predicted travel distances using the Muriwai relationship are very similar to the Hunter & Fell (2002) method, albeit usually at the higher end of the travel distance angle range. Based on the results of this exercise there is a good correlation between landslide runout and the downslope angle for the landsliding at Muriwai, meaning that landslide runout will vary across the escarpment depending on the local geomorphology. The close similarity between the Hunter & Fell (2002) predictive method and the Muriwai relationship probably suggests that while some variability is to be expected, future landslides are unlikely to travel appreciably further than the observed February 2023 runout distances.

Figure B29 H/L versus tangent of the downslope angle α_2 plot for Muriwai data together with Hunter & Fell (2002) relationships for rapid slides on steep natural slopes in dilative soils.

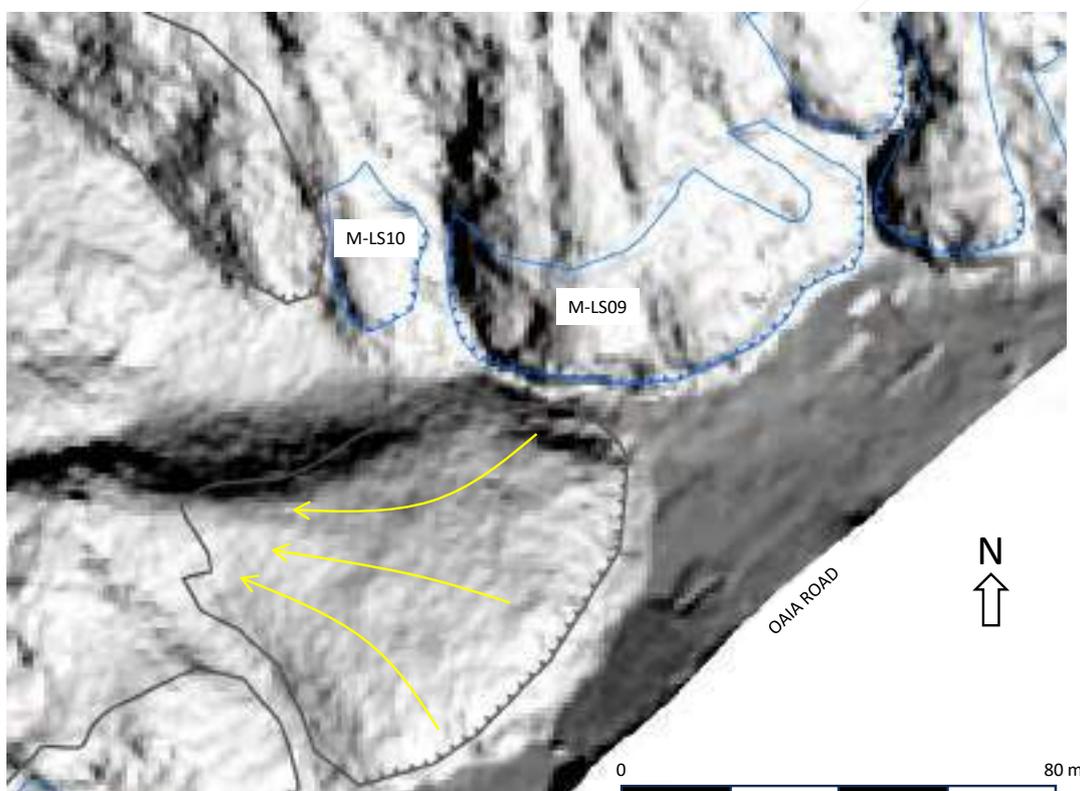
Figure B30 Potential landslide failure zones have been identified by GHD based on having similar geomorphology (ground shape) and geology to February 2023 landslide source areas. The above example shows a potential landslide source zone (grey outline) that has similar bowl-shaped characteristics to recently failed blue areas. Yellow lines indicate expected debris flow path. Background surface model has a 'hill shade' applied to highlight the geomorphology. Location is below the escarpment and west of Oaia Road.

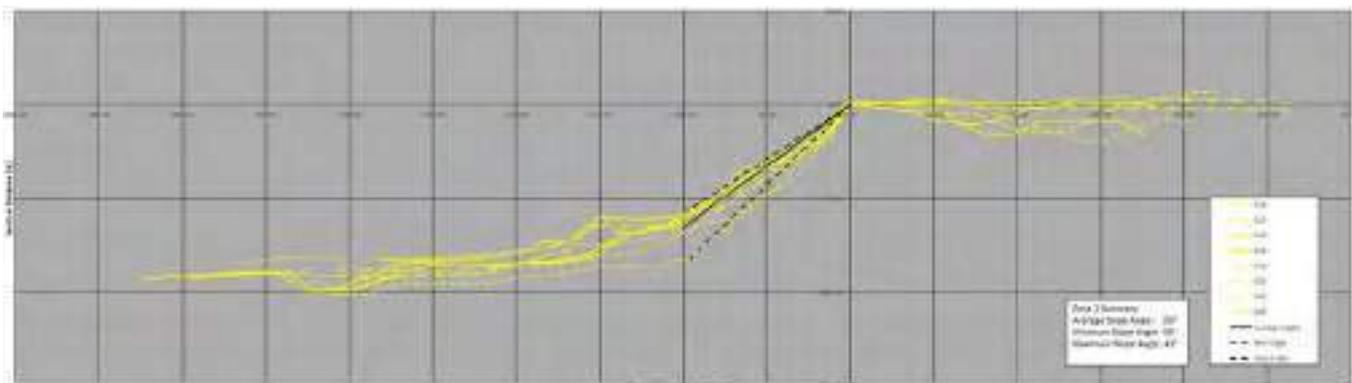
Figure B37 Slope profile comparison of Zone 2 surface cross sections (see Figure A137 for location of sections)

- The average slope angle is 33° but is locally much steeper (see Figure B37).
- The vertical height of the slope is greater than 70 m on average, which is the highest of all zones.
- Thirteen large landslides occurred in Zone 2 in the February 2023 storm, with two having a volume greater than 500 m³. The landslides are commonly broader relative to other zones (e.g. Zone 3).
- The general slope-facing direction is to the west, which is expected to be towards future sub-tropical cyclone storm events.
- The shape of the escarpment tends to be mostly gently and continuously curving. Elsewhere on the escarpment, for example in Zone 3, there are many distinctive, tightly curved headscarp features.

The above observations align well with this area having the potential for multiple, highly damaging landslides, as was the case in the February 2023 event.

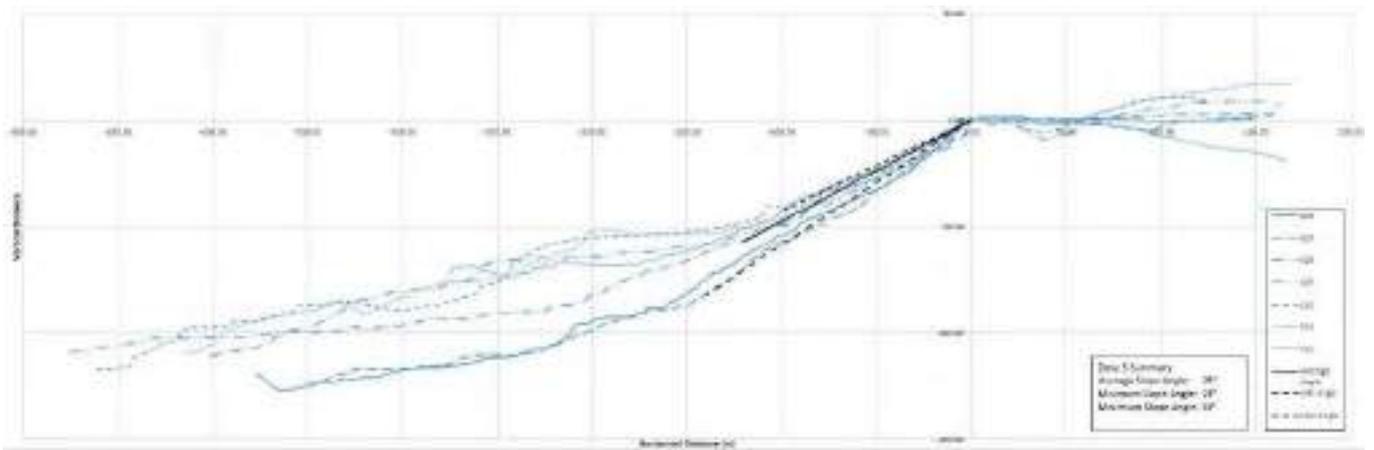
Figure B39 Slope profile comparison of Zone 3 surface cross sections (see Figure A137 for location of sections)

- The slope is approximately 25° on average, which is relatively flat (see Figure B39).
- The vertical height of the slope at this steepness is approximately 60 m, which is relatively high.
- Eight large landslides occurred in February 2023, all with a volume of less than 600 m³.
- The general slope-facing direction is to the west, which is potentially towards future sub-tropical cyclone storm events.
- The escarpment has many distinctive, tightly curved headscarps in marked contrast with Zone 2. Debris flows are typically more channelised in this zone.

The observations above indicate a regime with potential for large, destructive landslides.

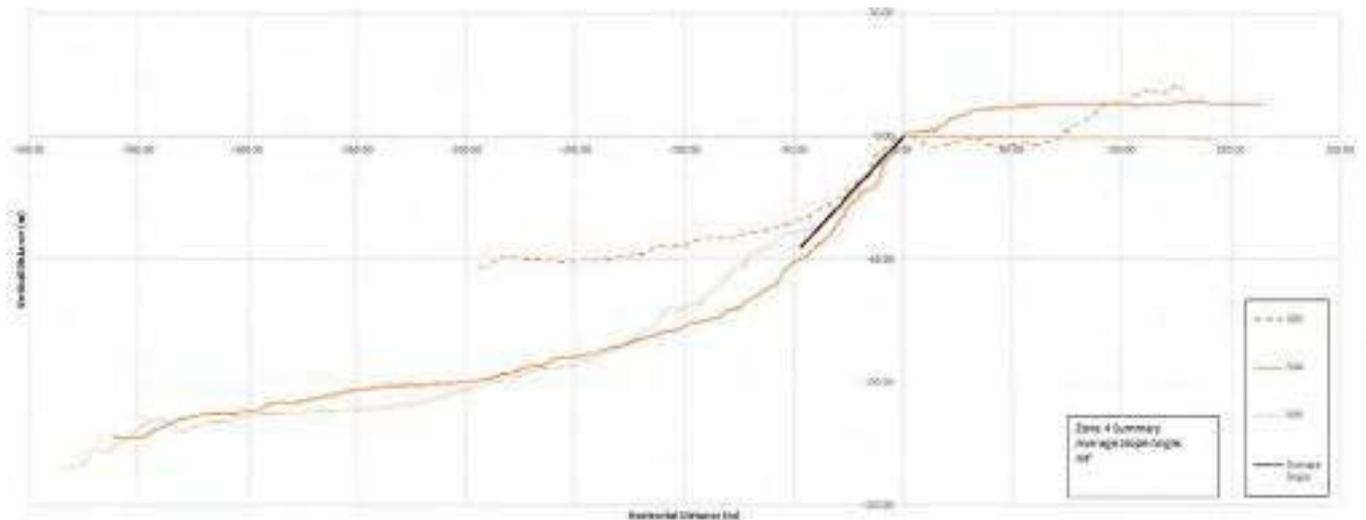
Figure B41 Slope profile comparison of Zone 4 surface cross sections (see Figure A137 for location of sections)

- The average slope angle is 44°, which is relatively steep (see Figure B41).
- The vertical height of the slope at this steepness is approximately 50 m, which is less than in Zones 2 and 3.
- Five large landslides occurred in February 2023, with one over 1000 m³ in volume. Note that Zone 4 is smaller than other, similar zones and so the number of landslides may give a false impression of the exposure of dwellings at the slope base.
- This is the location of the large 1965 landslide (see Section B3.3.2).
- The general slope-facing direction is to the west, which is expected to be towards future sub-tropical cyclone storm events.
- The escarpment has many distinctive, tightly curved headscarps.

The observations above indicate a regime with a demonstrated potential for large, destructive landslides on a similar scale to Zone 2.

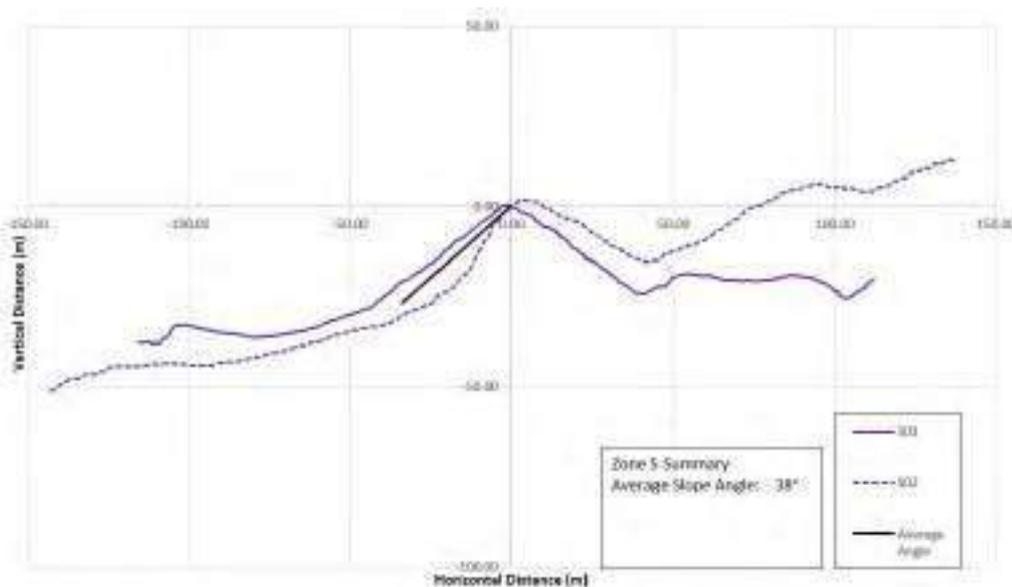
Figure B42 Slope profile comparison of Zone 5 surface cross sections (see Figure A137 for location of sections)

- The slope is approximately 38° , which is derived from only two cross sections (see Figure B42).
- The slope facing Domain Crescent is one side of a ridge, meaning that the catchment for surface water or groundwater recharge is limited compared with escarpment zones. This may mean that Zone 5 is less susceptible to landslides.
- Four landslides occurred in the February 2023 storm, most of which were less than 50 m^3 ; none impacted dwellings.
- The general slope-facing direction is towards the northwest, which may be the direction of origin for future sub-tropical cyclone storm events.

When considering the potential for future landslides, we suggest that Zone 5 may have favourable conditions due to the topography, which does not encourage storage of groundwater behind the slope, and the limited potential for surface runoff to saturate the slope.

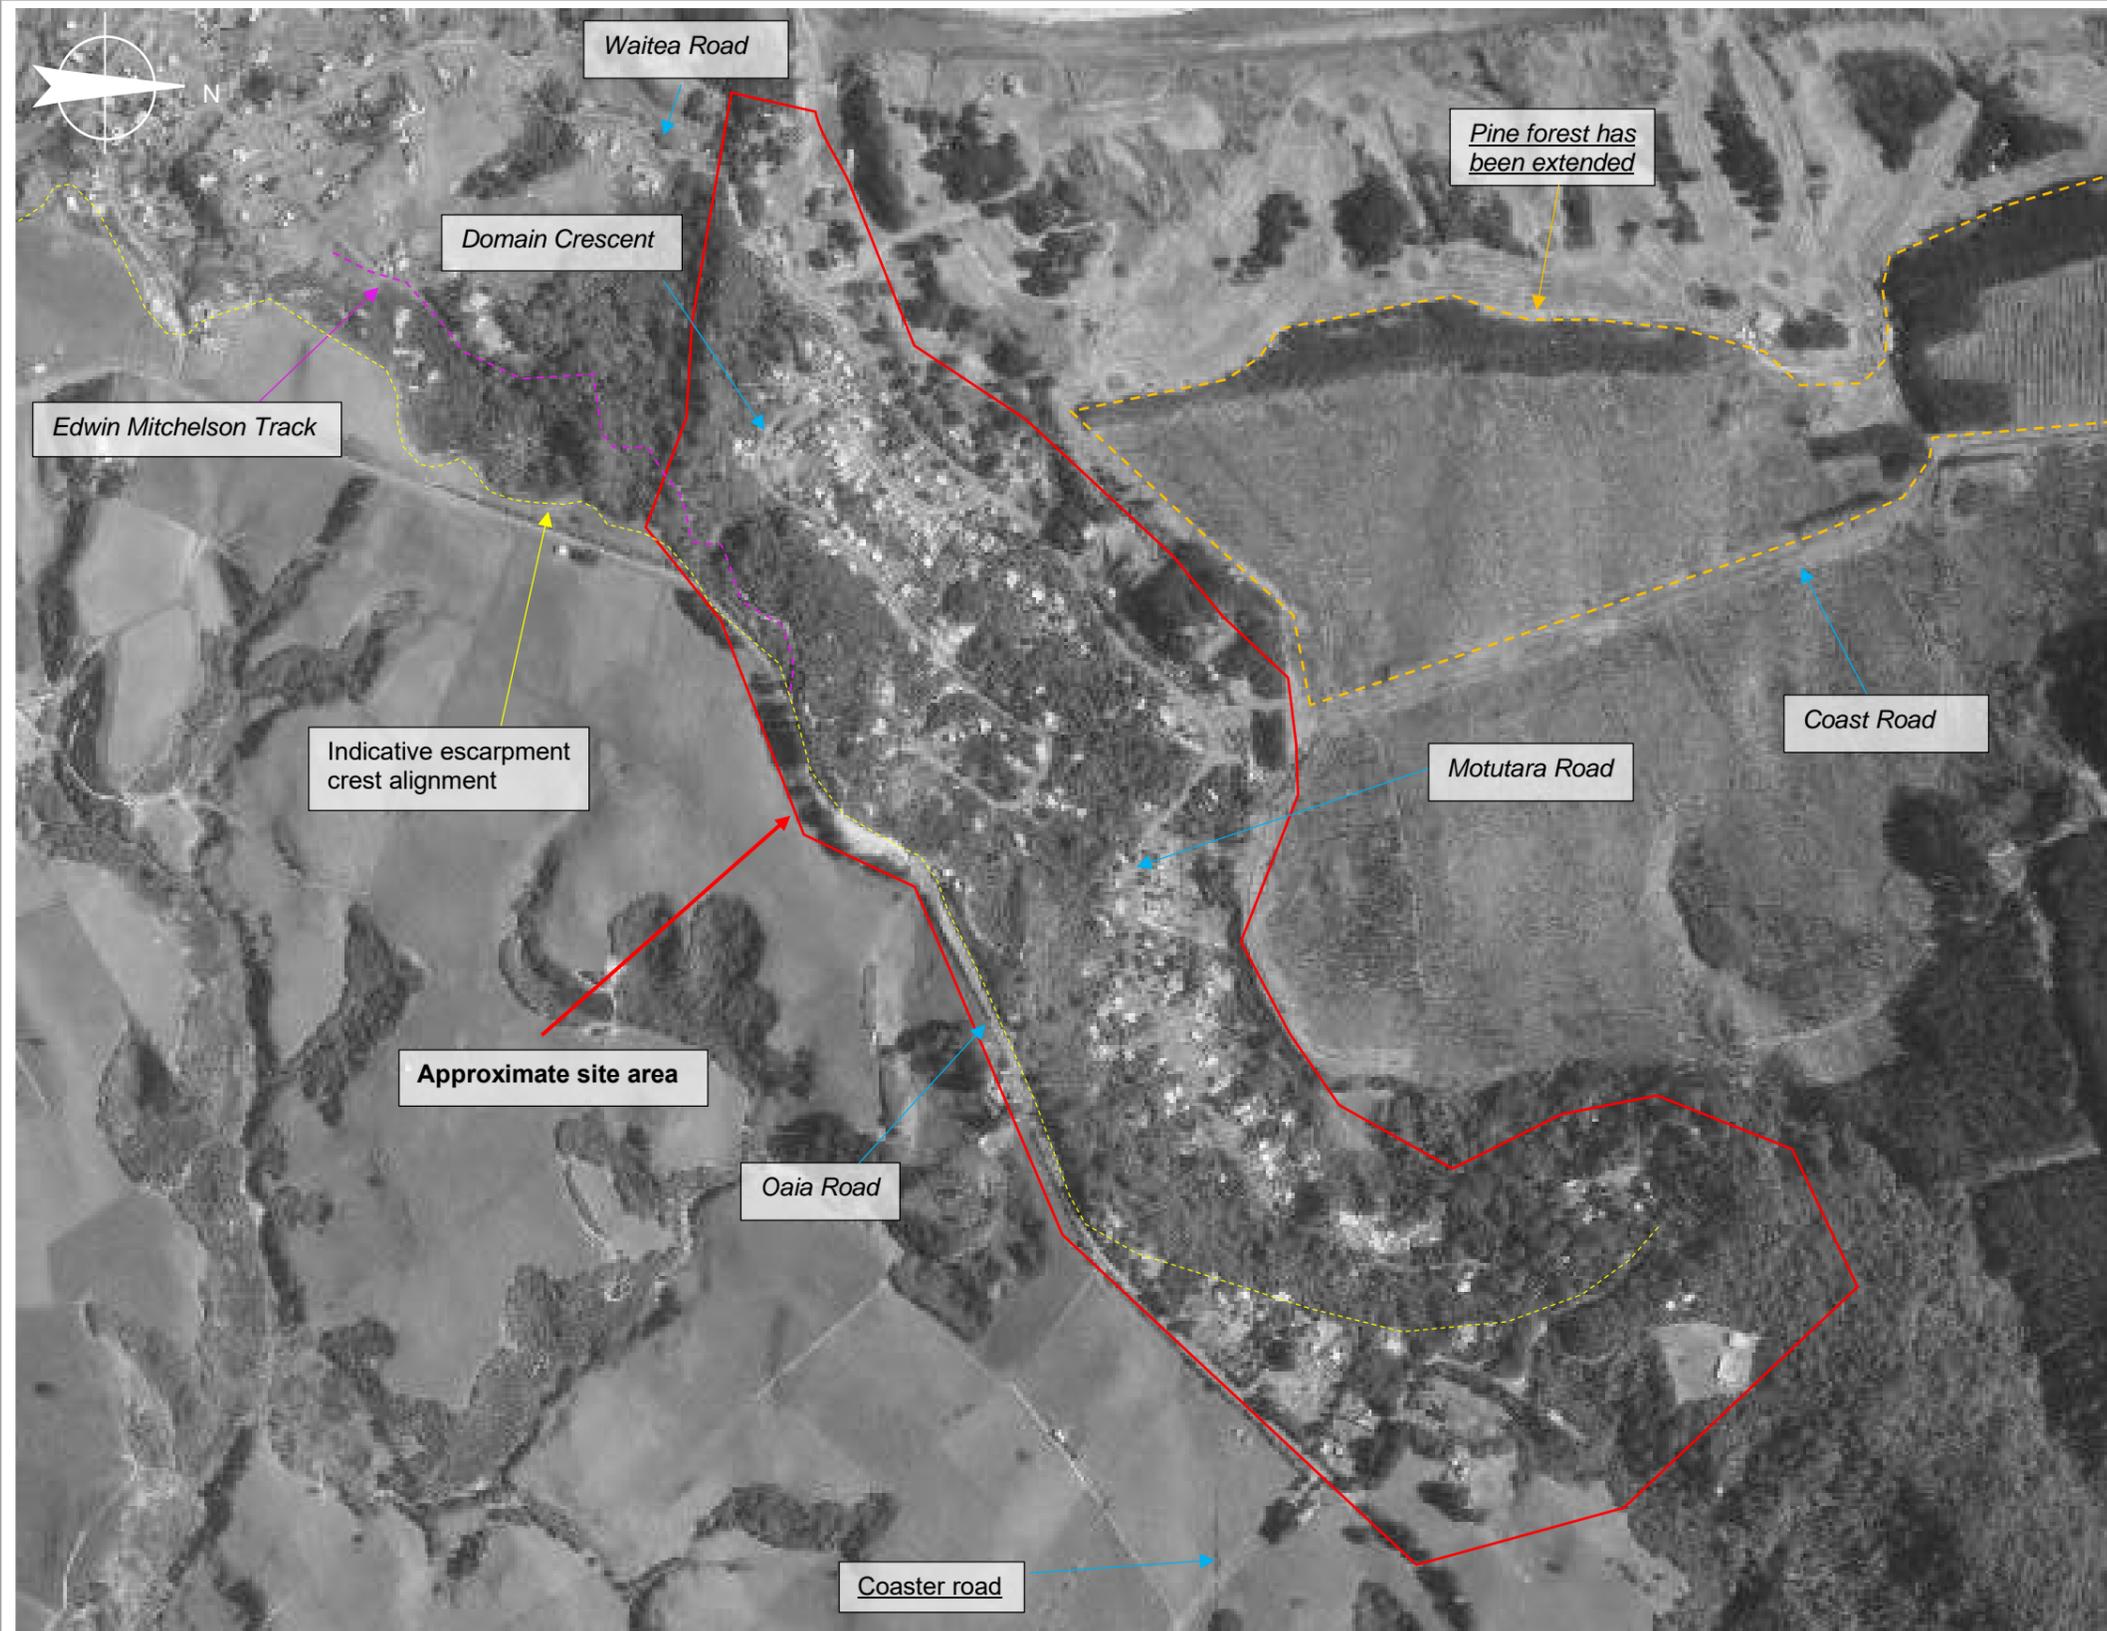
- Two landslides occurred in 1965 between the Edwin Mitchelson track (which is located along the escarpment) and Domain crescent due to blocked water table.
- Further property development within the site. Most prominently along Motutara Road.
- The current Muriwai Fire Station facility has been established as of 1965.
- Waitea Road has been extended and now intersects Motutara Road.
- Pine forest has been extended to the west of Coast Road.

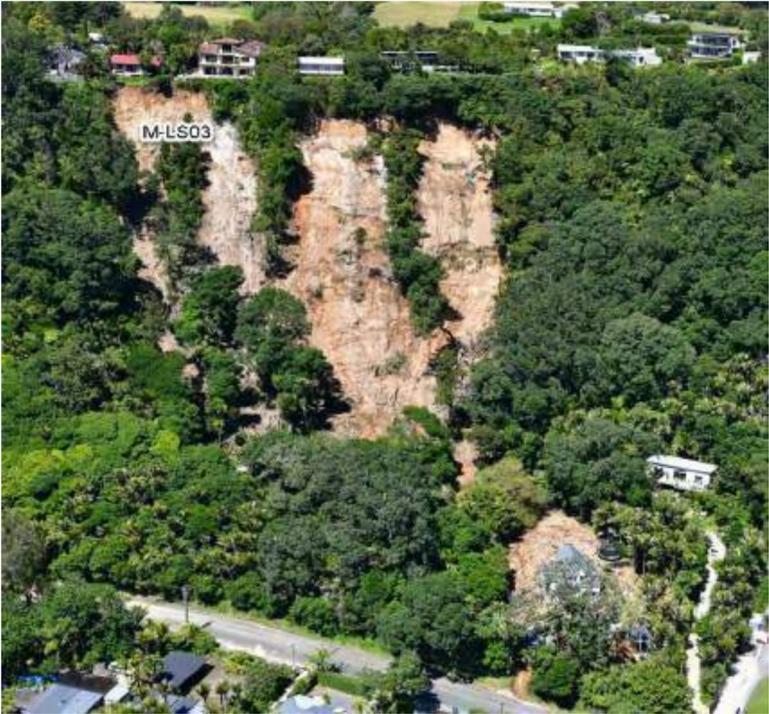
Geomorphology Zone	Landslide ID	Landslide Mechanism, Type	Coordinates (NZTM)		Landslide Dimensional Data				General Landslide Information	Photographs
			Easting (m)	Northing (m)	Approx. Main Scarp Width (m)	Approx. Average Depletion Zone Depth (m)	Approx. Debris Runnout Length (m)	Approx. Local Slope Angle (Degrees)		
Zone 2	M-LS03	Translational, Debris flow	1728528.85	5923806.37	33	0.25	91	42	Large landslide above Watercare's water treatment plant on Motutara Road

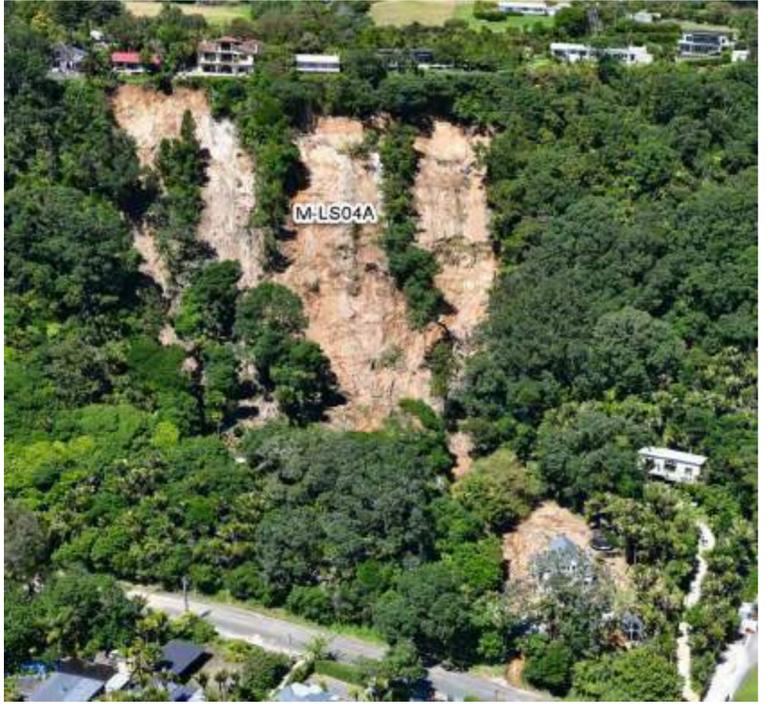
M-LS04A	Translational, Debris flow	1728515.77	5923775.84	26	0.75	116	47	Large landslide with strip of intact trees down the middle. Spring daylighting near the base of escarpment

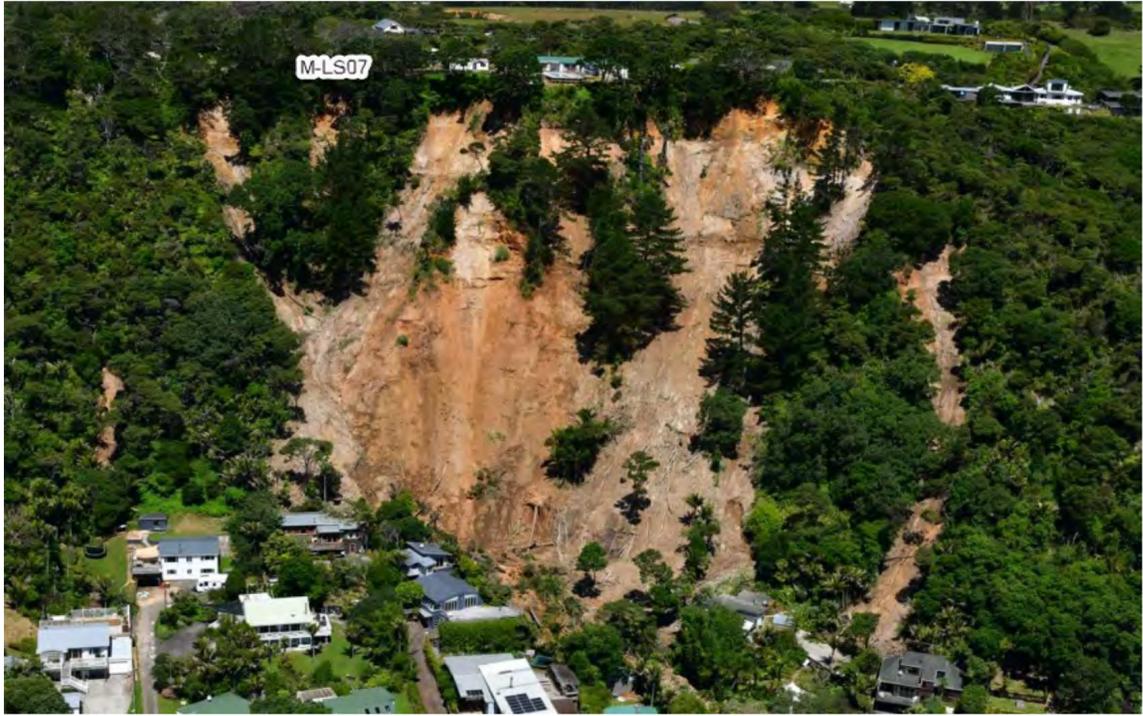
Geomorphology Zone	Landslide ID	Landslide Mechanism, Type	Coordinates (NZTM)		Landslide Dimensional Data				General Landslide Information	Photographs
			Easting (m)	Northing (m)	Approx. Main Scarp Width (m)	Approx. Average Depletion Zone Depth (m)	Approx. Debris Runnout Length (m)	Approx. Local Slope Angle (Degrees)		
Zone 2	M-LS07	Translational, Debris flow	1728341	5923497.96	16	0.25	10	31	Three distinct landslides. Spring located towards the base of the slope. A darker confining layer is present below the spring.

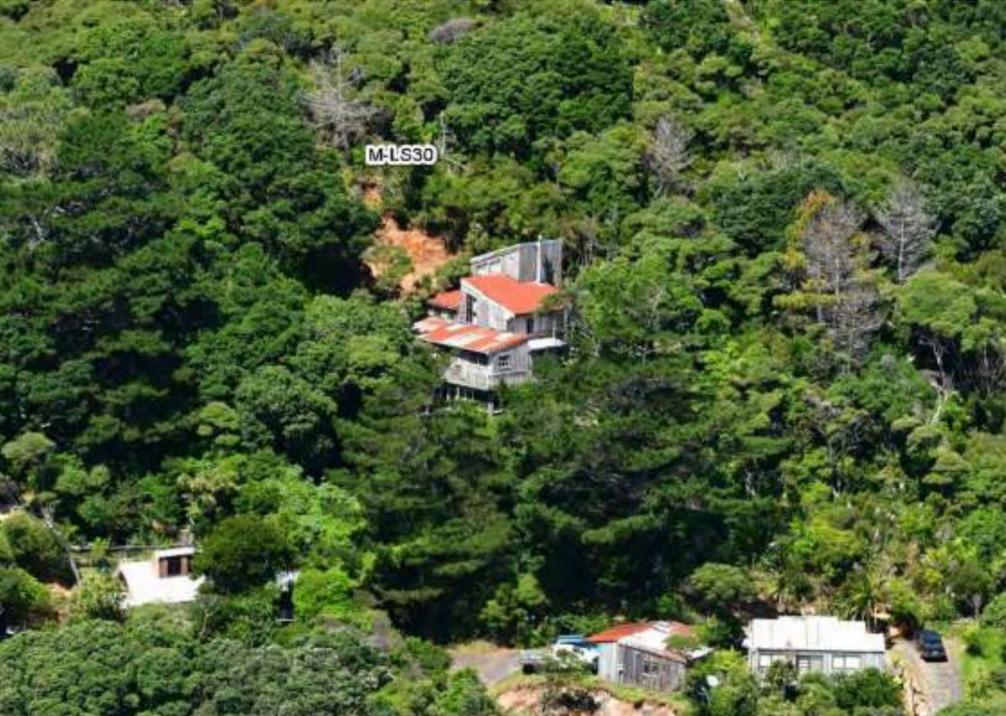
M-LS30	Translational, Debris flow	1728143.531	5923377.985	7	0.5	14	46	Small headscarp located behind dwelling at 114 Domain Crescent. Debris locally arrested by house.

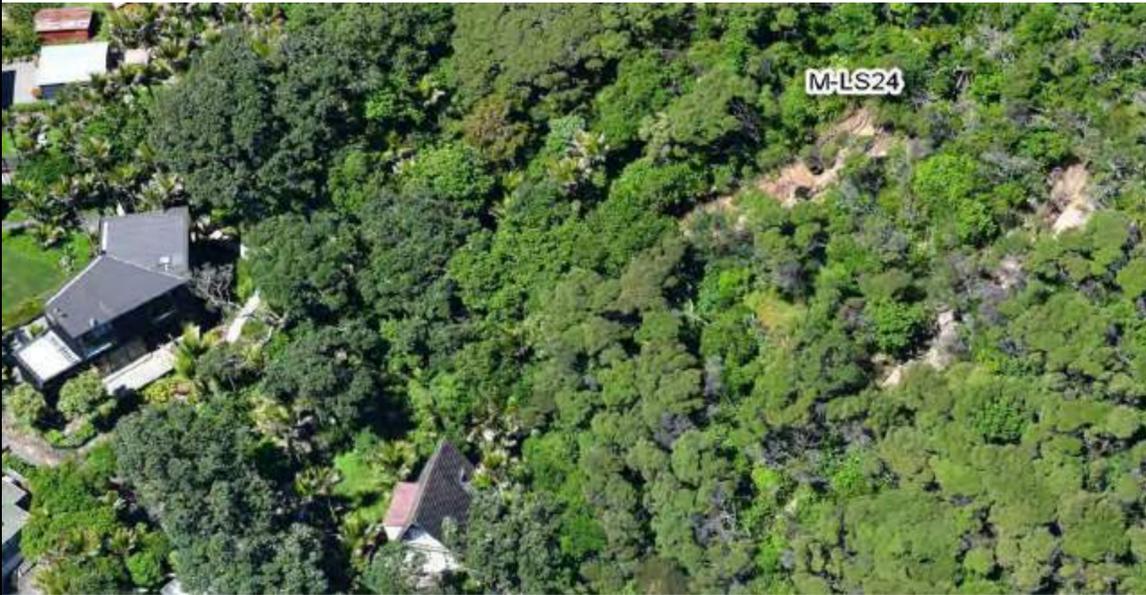
Geomorphology Zone	Landslide ID	Landslide Mechanism, Type	Coordinates (NZTM)		Landslide Dimensional Data				General Landslide Information	Photographs
			Easting (m)	Northing (m)	Approx. Main Scarp Width (m)	Approx. Average Depletion Zone Depth (m)	Approx. Debris Runnout Length (m)	Approx. Local Slope Angle (Degrees)		
Zone 5	M-LS24	Translational, Debris flow	1727573.789	5922959.879	12	0.25	39	32	Landslide within Awhitu Sand has displaced minimal soil and mostly comprises vegetation. Significant scour observed within the escarpment.

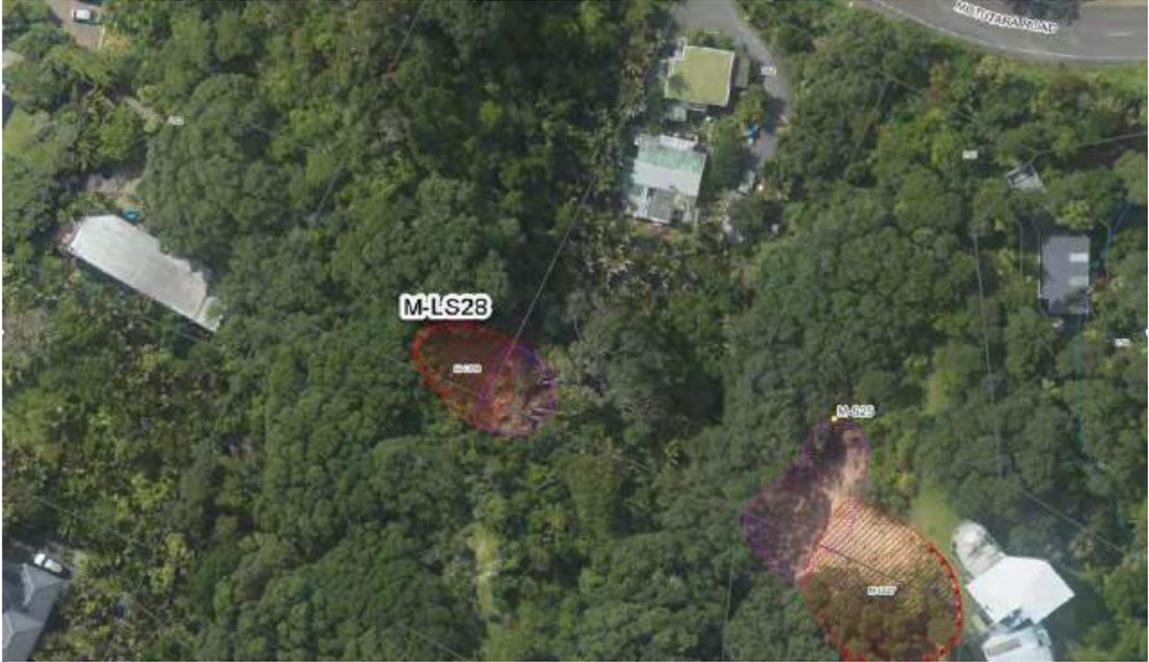
M-LS28	Translational, Debris flow	1727970.984	5923538.966	11	0.5	20	31	Landslide has occurred off a spur off the main escarpment
