12 October 2021

David Moore  
Director  
Golf Strategy Group Ltd  
60 Clearwater Avenue  
**CHRISTCHURCH 8051**

## **MURIWAI DOWNS GOLF PROJECT: UPDATED PRELIMINARY SITE INVESTIGATION**

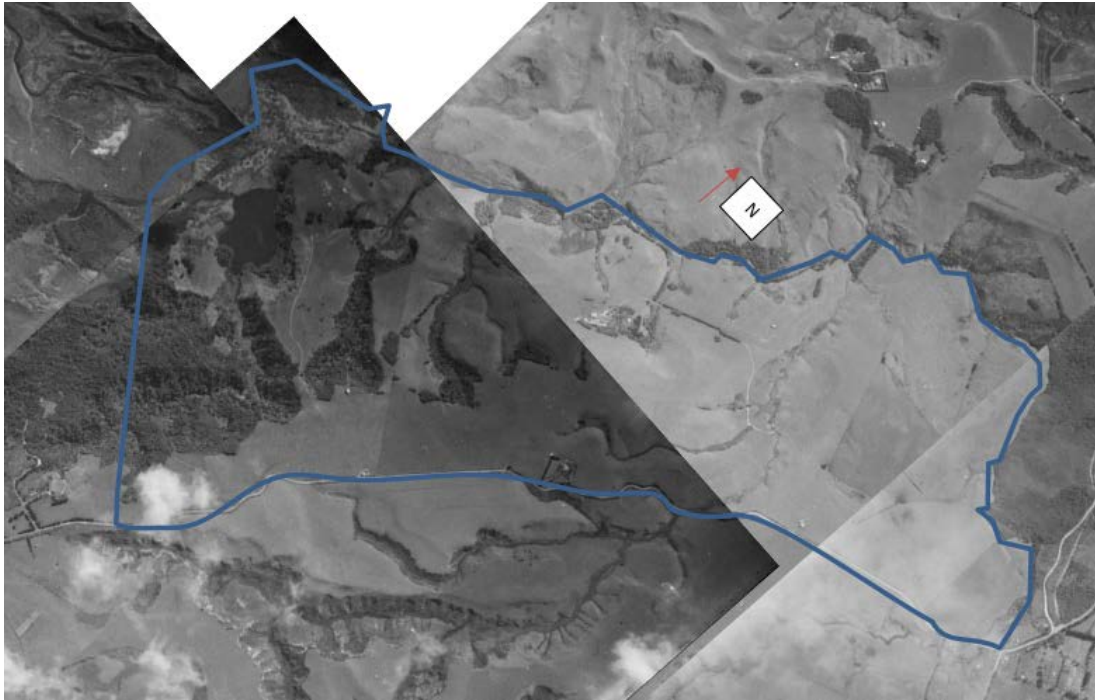
**1940 Aerial**

The 1940 aerial is the oldest photograph obtained for the site. The site appears to be largely pastoral with bush present in many gullies and large areas in the western section of the site. Multiple structures/dwellings are visible onsite (two structures in the southwest, one dwelling and ancillary structures in the central south of the site along Muriwai Road, one structure further northeast along Muriwai Road and one structure in the far eastern corner of the site).

A few buildings/structures (one of which could be the former boarding house noted in the Request for Proposal [RfP] [Mitchell Daysh, 2020]) are located near Lake Okaihau in the western section of the site. Some unidentifiable items are also visible adjacent to one of the structures.

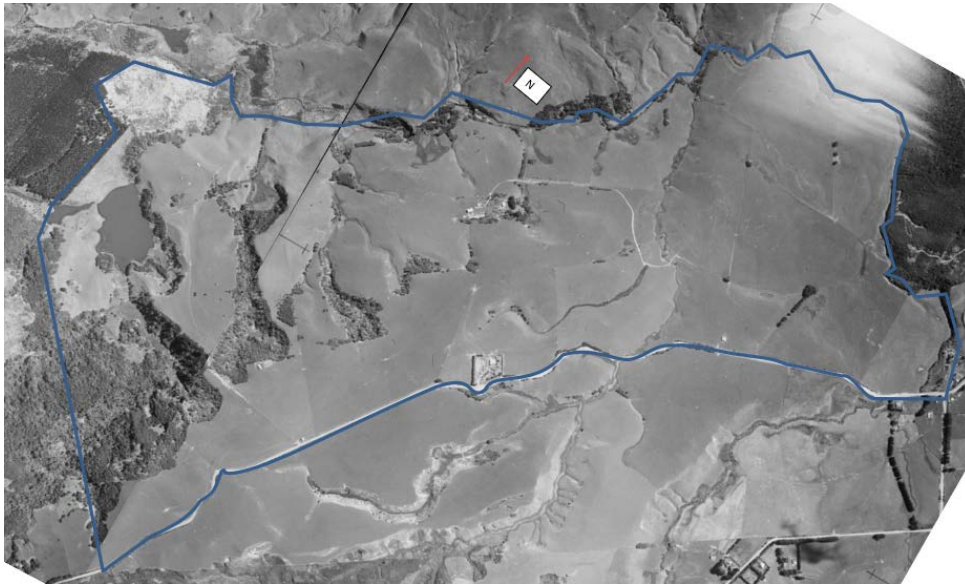
**1950 Aerial**

The site is largely as described in 1940; however, the structure formerly located further to the northeast of the woolshed and the unidentifiable items formerly located adjacent to a structure near Lake Okaihau are no longer visible.

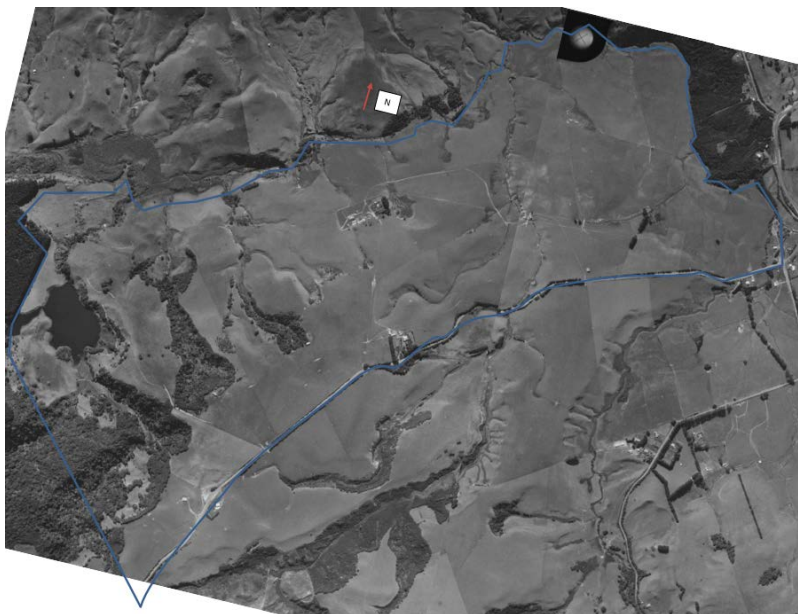
**1963 Aerial**

The site is largely as described in 1950; however, all buildings/structures formerly located near Lake Okaihau are no longer visible, and there is one new dwelling in the southwestern corner of the site, one additional structure in the central western and central eastern parts of the site and two new structures in the eastern section of the site and additional ancillary structures (in the known workshop area) associated with the dwelling in the central south of the site (described in the 1940 aerial).

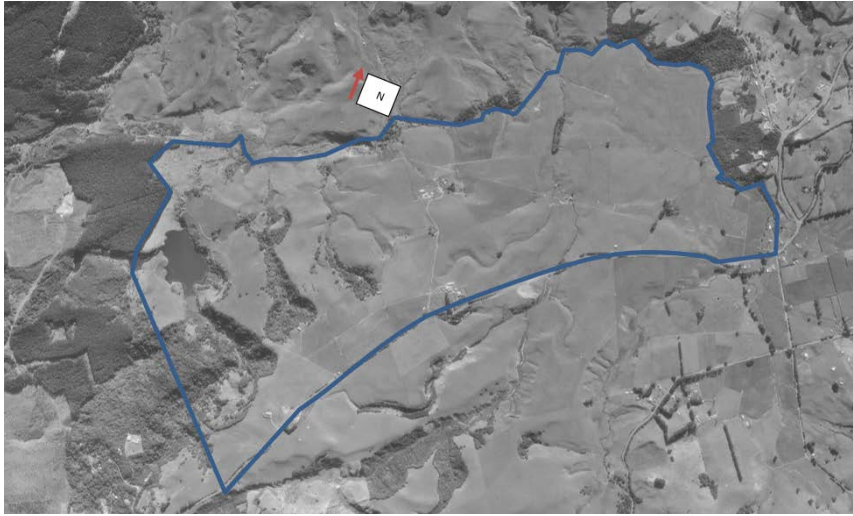
**1975 Aerial**

The site is largely as described for 1963, but there is an additional ancillary structure associated with the dwelling in the central south of the site (described in the 1940 aerial), one additional structure immediately to the southwest of the same dwelling and one additional structure in the northwestern section of the site. The land to the west and southwest of the workshop area (adjacent on both sides of Muriwai Road) appear to be possibly used for horticulture. Additionally, a small area of land to the east of the workshop area (adjacent to the south of Muriwai Road) appears to be disturbed (likely to be the start of the small quarry operations on the 697 Muriwai Road property).

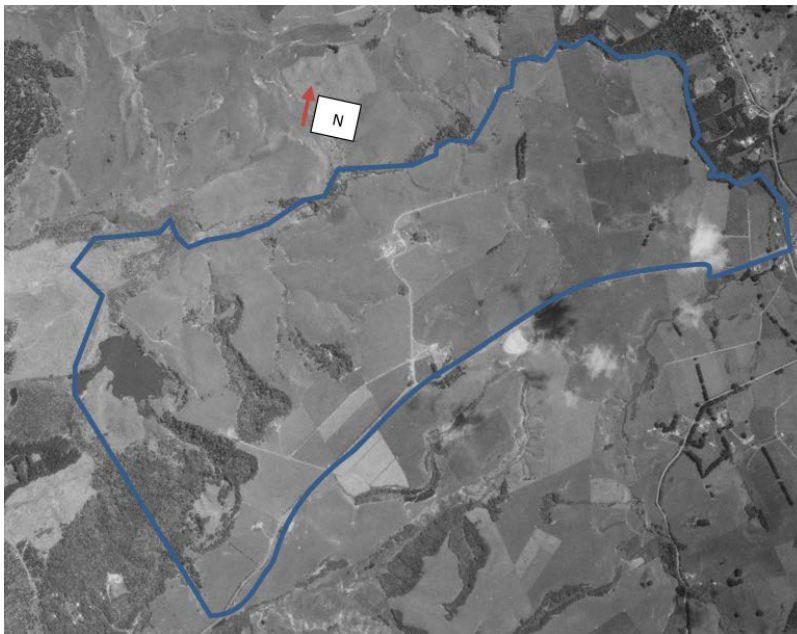
**1980 Aerial**

The site remains largely as described for 1975; however, the structure next to Muriwai Road in the east of the site and the structure in the central eastern part of the site are no longer visible. Unknown items are present immediately to the west of the workshop area. Additional areas of pastures within the 697 Muriwai Road property appear to be possibly used for horticulture.

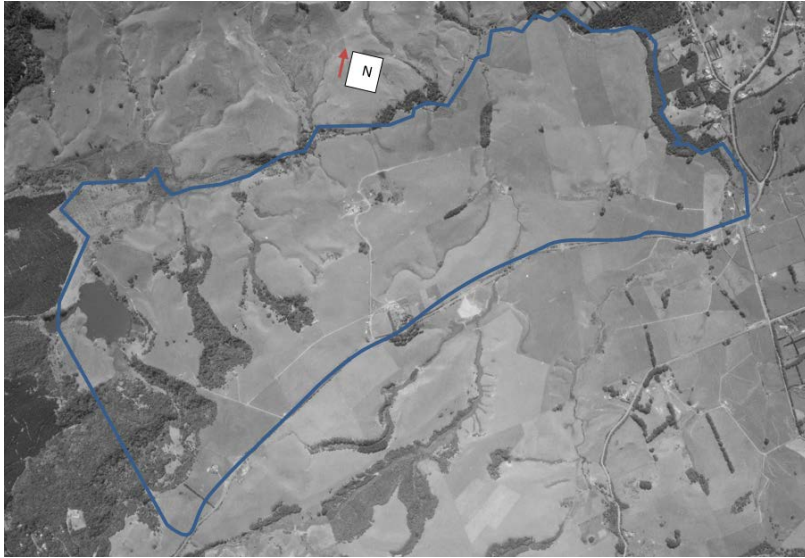
**1988 Aerial**

The site and surrounding land remain largely as described for 1980. However, the land to the southwest of the workshop area no longer appears to be utilised for horticultural use.

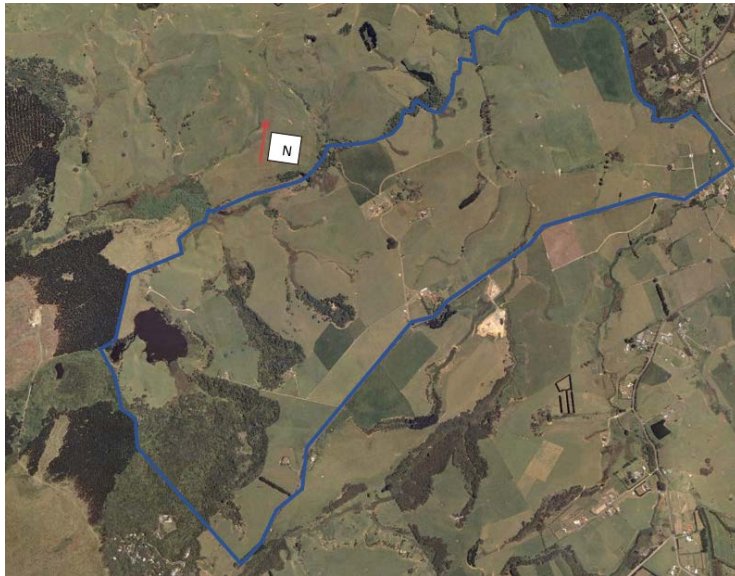
**2003/2004 Aerial**

The site remains largely as described for 1988; however, there are two new dwellings with ancillary structures – one in the southwestern section of the site (680 Muriwai Road) and one to the east of the woolshed (614 Muriwai Road). One of the structures to the west of the workshop area is no longer visible. There are also two new structures present in the eastern section of the site. Some paddocks in the central and eastern sections of the site appear as if they could be used for horticulture. The small quarry within 697 Muriwai Road has extended to the south.

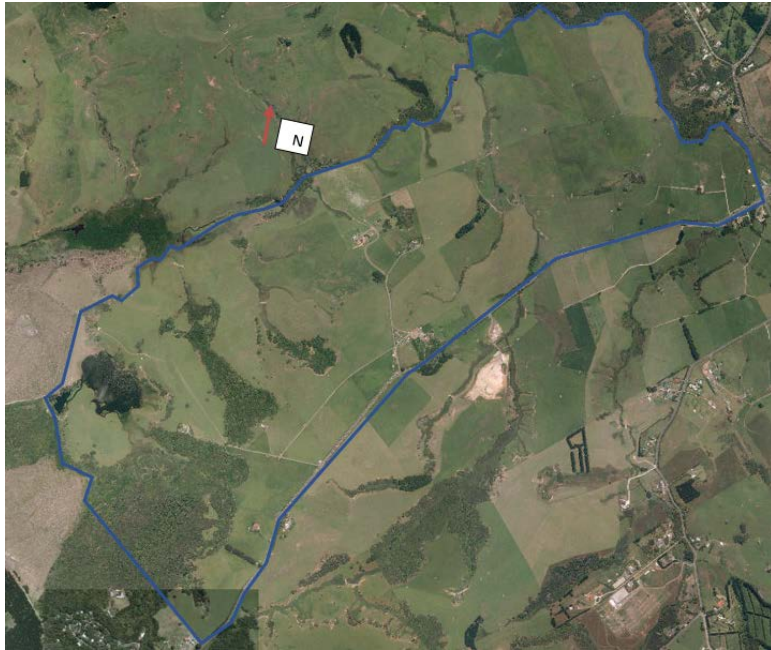
**2010/2011 Aerial**

The site remains largely as described for 2004; however, the small quarry within 697 Muriwai Road has extended further to the south.

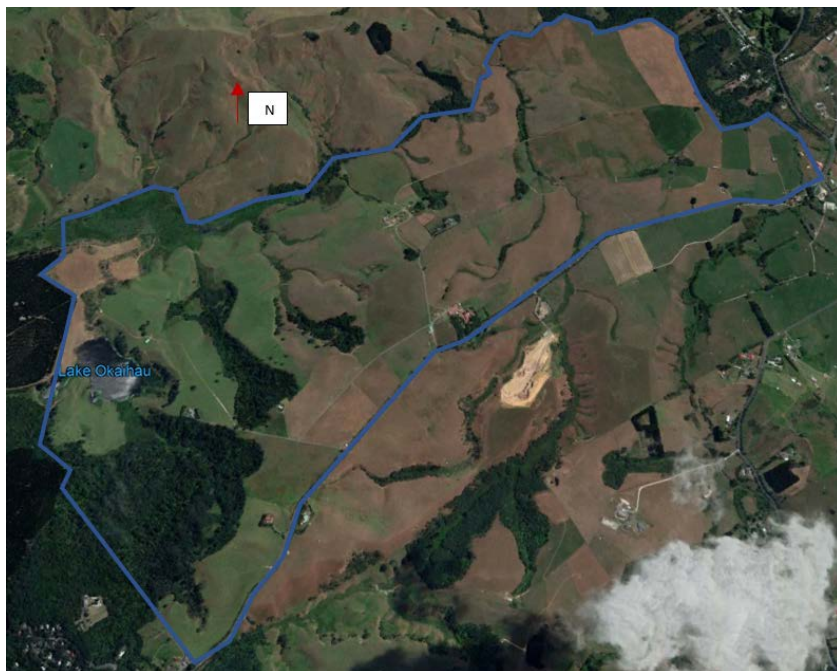
**2019 Aerial**

The site and surrounding land use remains largely as described for 2010/2011; however, some cropping is evident adjacent to the south of Muriwai Road straddling (the northeastern corner of) 697 and (the southern section of) 451 Muriwai Road. The small quarry operations on 697 Muriwai Road has again extended to the southwest.

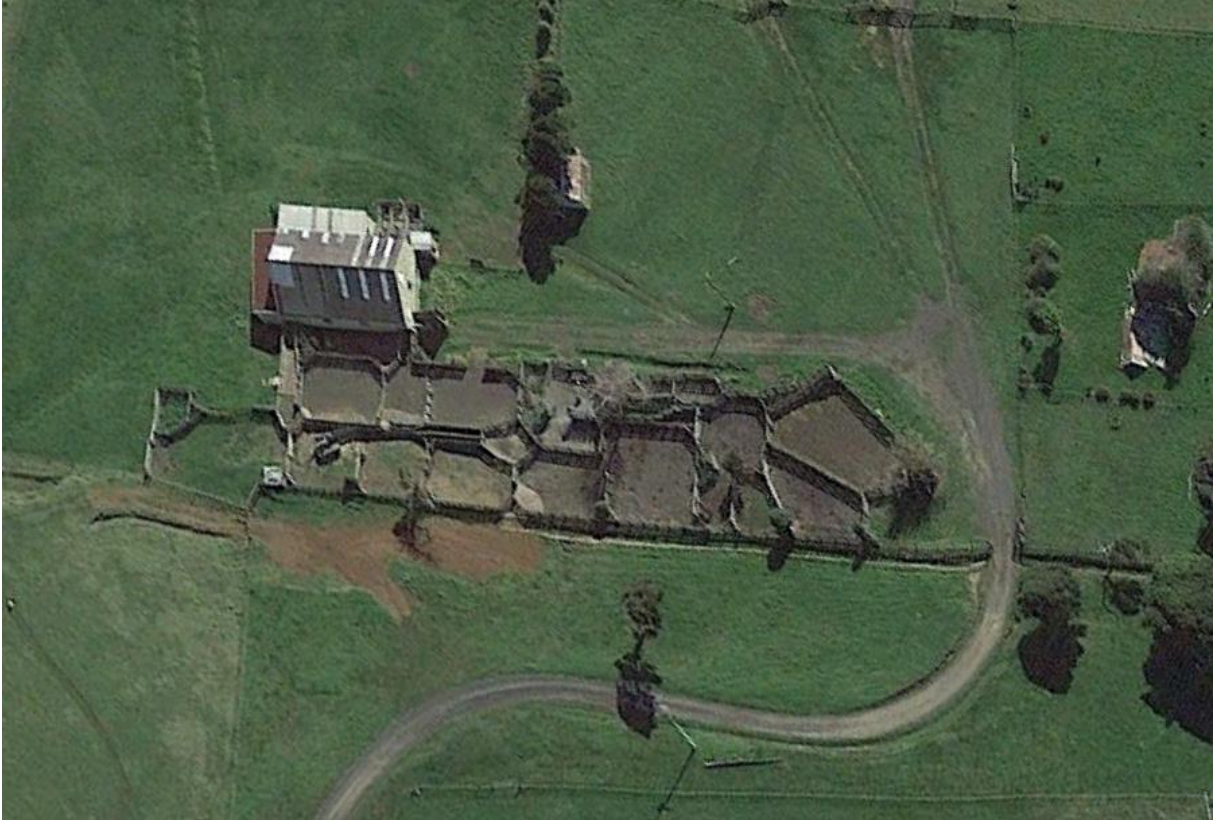
There is no contamination information held within Council's records for the site 610 Muriwai Road, Muriwai Valley. However, aerial records indicate sheep farming activities occurring on site and a potential spray race operation as seen in the below aerial. Additionally, a number of unknown materials appear to be stored outside to the east of the buildings in the southern portion of the site. Furthermore, consent records indicate the northern building of these structures is utilised as a workshop.
