PRELIMINARY SITE INVESTIGATION (PSI)

301 BUCKLAND ROAD, PUKEKOHE

Reference Number: REP-1258/PSI/NOV18

16 NOVEMBER 2018

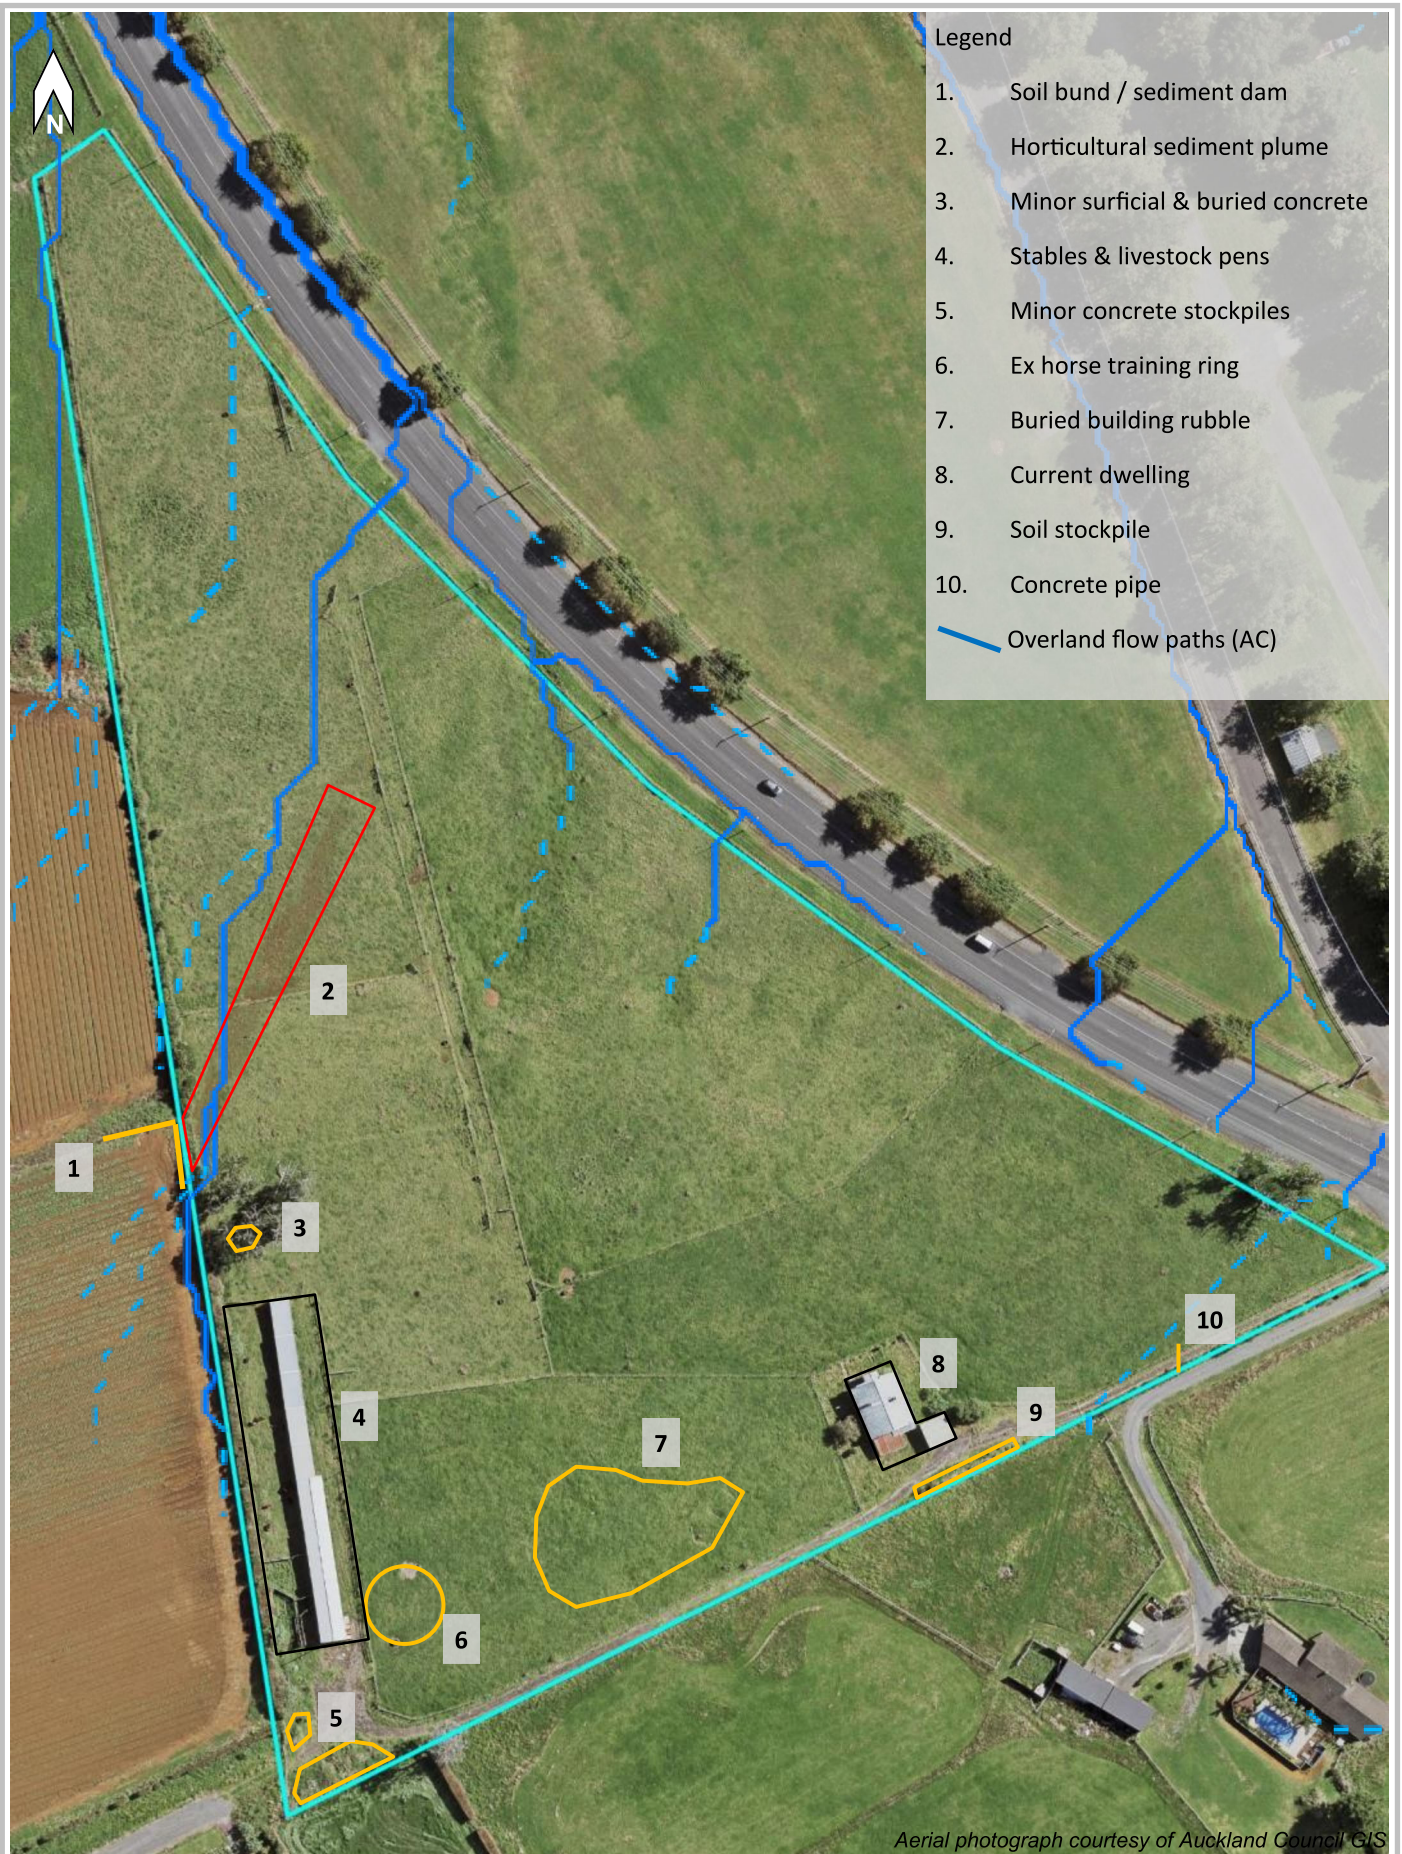
Title:	Figure 2 - Identified Features	Reference: J1258
Project name:	301 Buckland Road, Buckland	Date: 15-11-2018
geosciences <small>ltd</small> <small>ENVIRONMENTAL</small>	Level 1, 47 Clyde Road, Browns Bay, 0630, Tel: (09) 475 0222	Drawn: CD
		Approved: COB

The single residential dwelling on the southern boundary of the site appeared in relatively good condition, with no noticeable damage to the exterior of the building. A gravel driveway in a state of disrepair extends along the southern boundary of the property, from Buckland Road to Webb Street. Minor surficial rubbish around the house was noted, but no signs of significant dumping or buried rubbish were identified. A small grassed stockpile of soil lies along the southern boundary opposite the timber-frame car port, and is most likely locally derived material stockpiled during the construction of the house. The remnants of a horse training circle is located in front of the stables, with shallow coarse sand overlying geotextile material present beneath the current layer of grass.

There are currently no visible signs on site of horticulture having occurred. However, it was noted that material from the neighbouring horticultural farm to the west of the site has migrated across the site along an overland flow path during heavy rain events. The horticultural field to the west is slightly elevated above the level of the site, with an earth berm running from north to south along the boundary line. It appears that this bund, and the boundary between the north and south horticultural fields forms a ‘dam’ where sediment accumulates during rainfall. The earth berm on the boundary does not appear to be structurally reinforced, so it is considered that periods of prolonged or heavy rain result in material migrating along the overland flow path as water moves from the horticultural field down gradient onto the site. This migration is visible in the 2017 aerial photograph.

Identified features appear on Figure 2, and site photographs are attached in Appendix G.

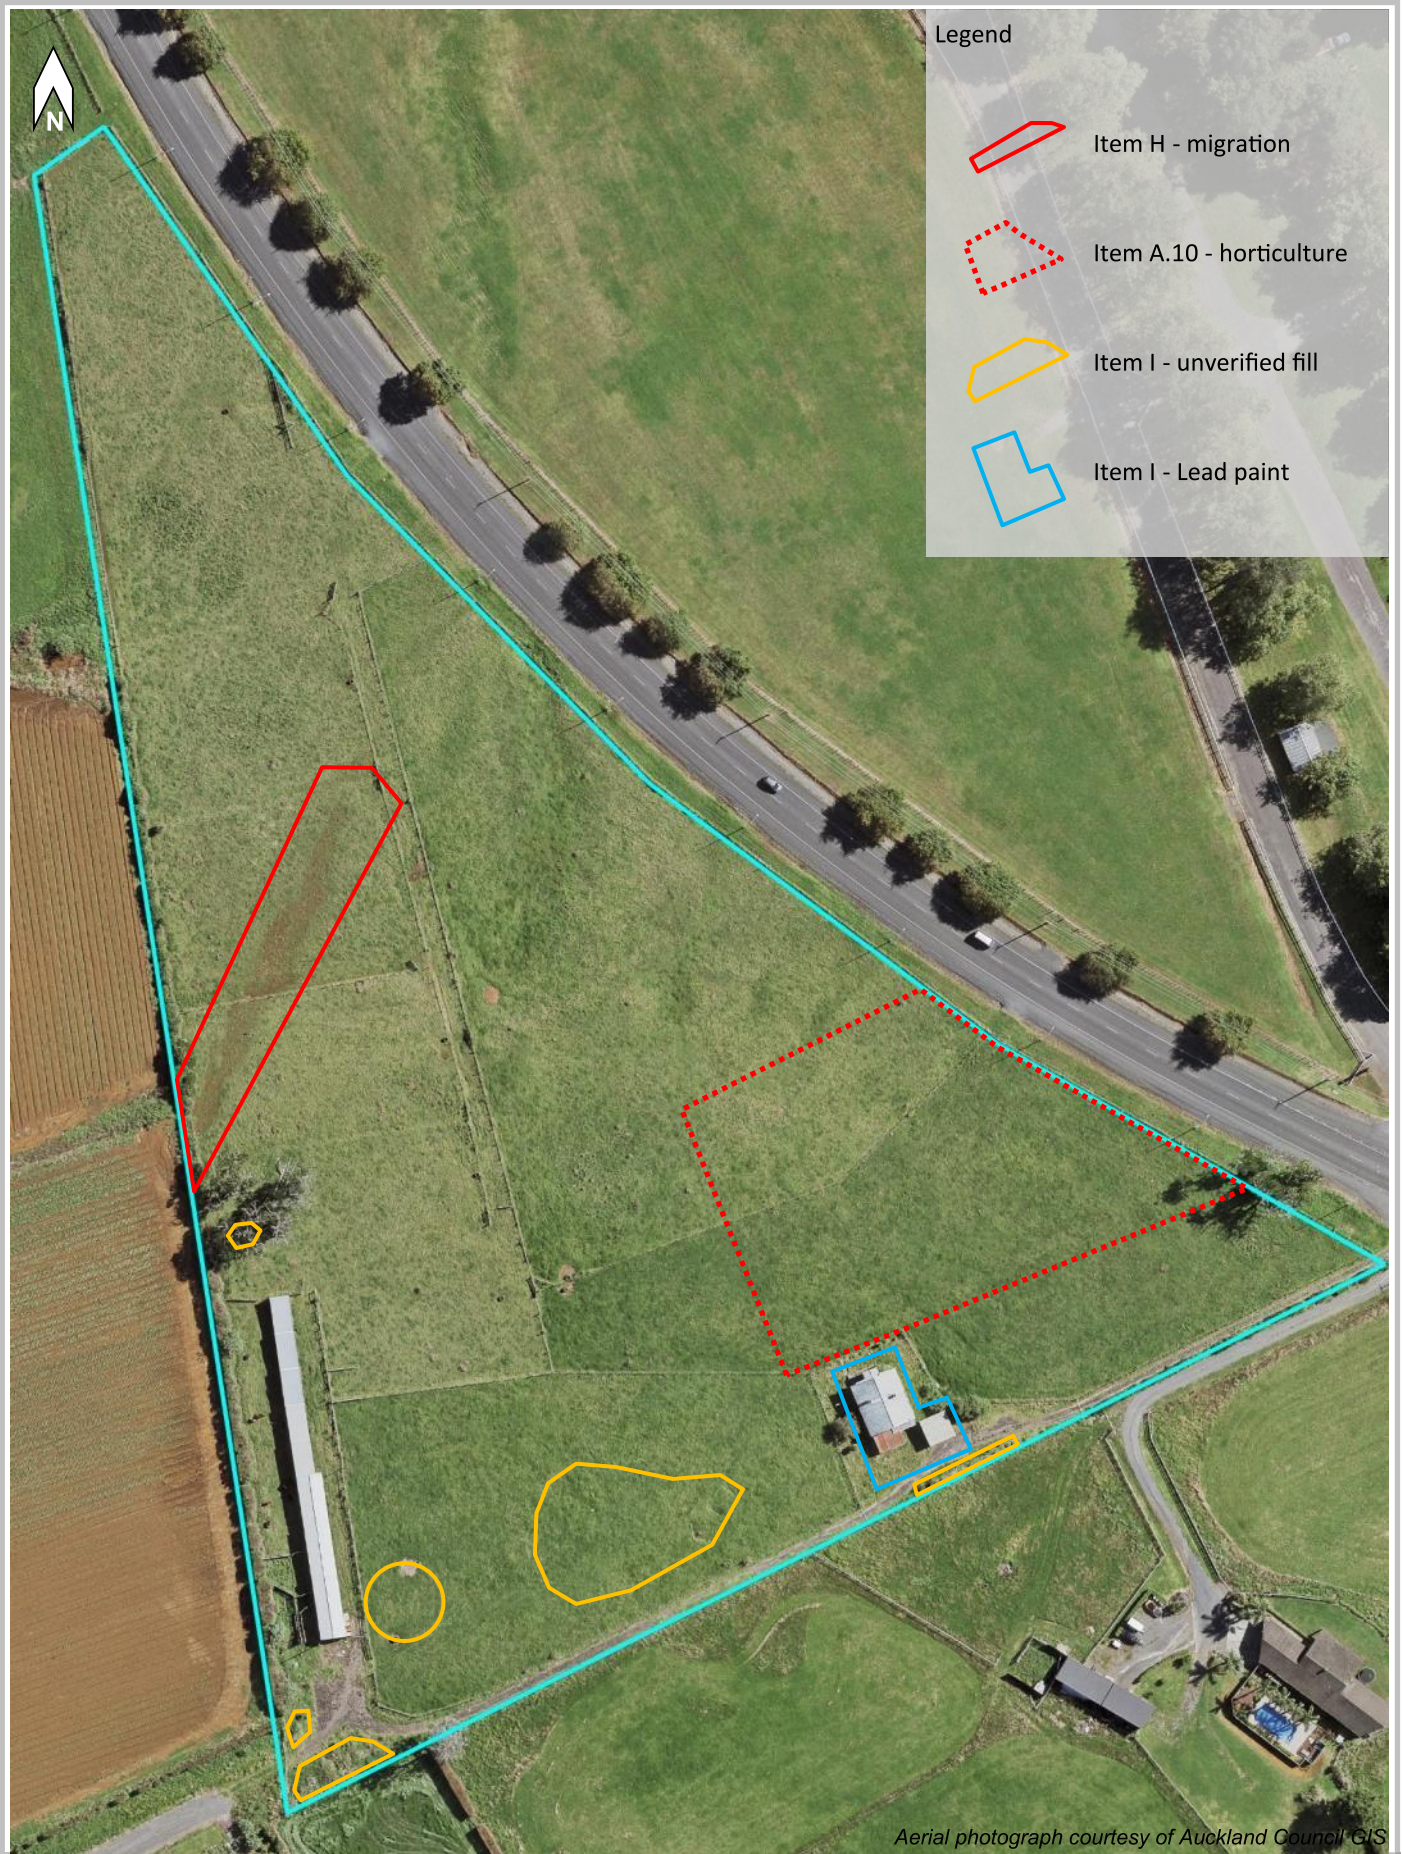
Title:	Figure 3 - Potential HAIL	Reference: J1258
Project name:	301 Buckland Road, Buckland	Date: 15-11-2018
geosciences ltd ENVIRONMENTAL	Level 1, 47 Clyde Road, Browns Bay, 0630, Tel: (09) 475 0222	Drawn: CD
		Approved: COB

The results of the investigation have indicated that the following potential sources of soil contamination exist on site (Figure 3):

ACTIVITY	POTENTIAL HAZARDOUS SUBSTANCES
Migration of soil from neighbouring horticultural fields (Item H)	Persistent pesticides, including arsenic, copper, lead, and organochlorine pesticides (OCPs)

Portions of the land under redevelopment meets the definitions of HAIL land and will therefore require a detailed site investigation including soil sampling and analysis prior to the development being approved. The specific areas of the site that have been identified as being the location of HAIL landuses have been indicated in Figure 3. The NES regulations apply only to these pieces of land.

As a result of the findings of this report as outlined above, any subdivision, change in landuse, soil disturbance, or development projects conducted on the areas of the property where historic HAIL activities have been identified (refer Figure 3), are required to address the requirements of the NES, and the AUP(OP), and a suitable detailed site investigation, which includes the analysis of representative soil samples for the presence of potential contaminants of concern, will be required.
