Hingaia Stream Catchment Watercourse Assessment Report Draft

[July 2018]

Hingaia Stream Catchment Watercourse Assessment Report

4Sight Consulting¹

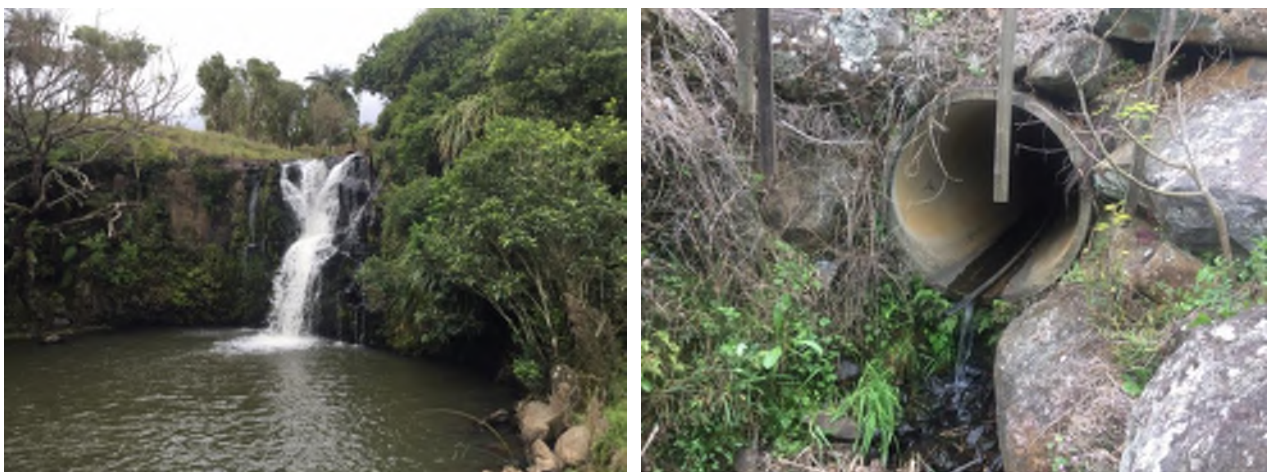
Fish barriers associated with culverts that were perched above the watercourse and/or experienced low flow impedances not characteristic of the surrounding reaches were present on 39% (358 of 918) of all culverts surveyed. The majority of these issues were associated with perched culverts where erosion at the outfall has resulted in a vertical drop from the culvert to the downstream channel. In many cases the culvert is also overhanging, making entrance impossible for fish. Culvert related fish passage issues were much more of an issue through the rural areas of the catchment, where privately installed culverts and pipes were often undersized or poorly placed. There were 326 fish passage issues recorded on rural, private assets, representing 91% of the total number of assets assessed as having some form of fish passages issues.

Figure 6: Representative photos of fish passage issues. A) a natural barrier to fish passage (large waterfall) and B) artificial barrier to fish passage (perched culvert).

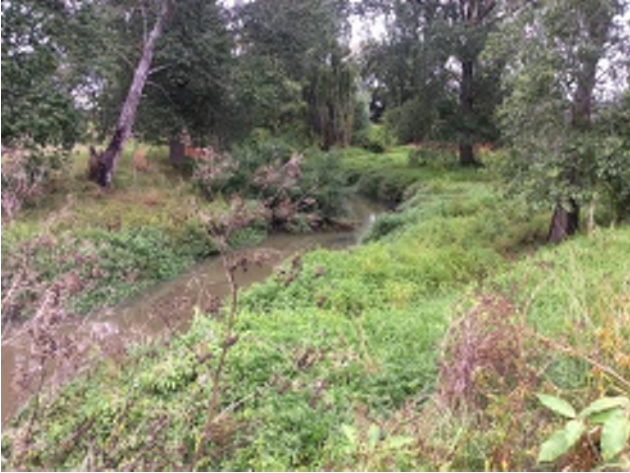
<p data-bbox="233 801 772 837">Poorly vegetated esplanade reserves.</p>

While riparian planting is likely to improve ecological and conveyance values the addition of a walkway would provide significant amenity enhancements to these esplanade reserves. In many areas the esplanade reserve is wide enough to support a walkway/cycleway. This would improve public access to the area and provide better linkages between people and the natural environment. The provisions of a walkway/cycleway would also contribute to Auckland's Greenways networks, including the Papakura Greenways Plan

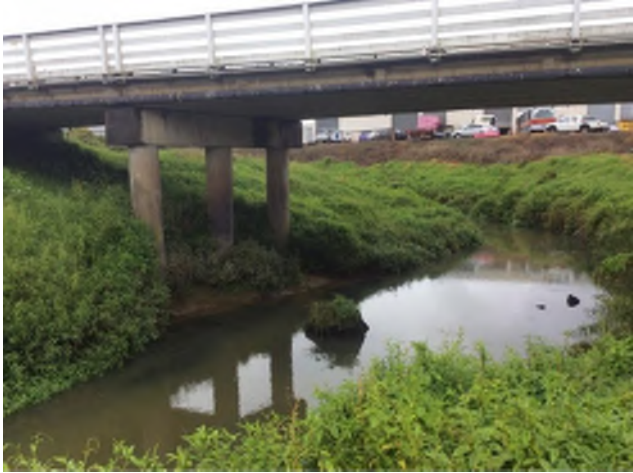
<p data-bbox="887 801 1522 887">Lack of riparian vegetation around Norrie Rd bridge.</p>	<p data-bbox="456 913 549 949">Notes</p>	<p data-bbox="1059 913 1353 949">Benefits to Council</p>
<ul data-bbox="201 981 852 1693" style="list-style-type: none"> • Existing esplanade reserves through Drury township are poorly vegetated and have limited public access. • Flooding is a major issue through the township. • Improving riparian planting offers an opportunity to improve amenity, ecological and conveyance values of the lower Hingaia Stream. • Walkway/cycleway could be incorporated into any plans for enhancement, in line with the Local Board plans. • Ecological and amenity linkages with other enhancement opportunities and development areas (Drury South). 	<ul data-bbox="919 981 1522 1402" style="list-style-type: none"> • Land immediately available (existing esplanade reserves). • Contributes to erosion protection, flood filtration measures within Drury township. • Good opportunity for school, Iwi and community involvement. • Contributes to Local Board Greenways Plan.

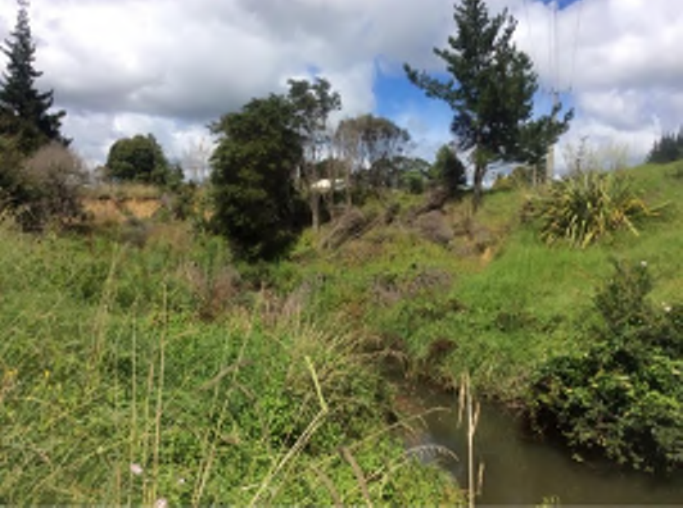
<p data-bbox="169 842 839 931">Poorly vegetated riparian margins, with erosion evident in the background.</p>

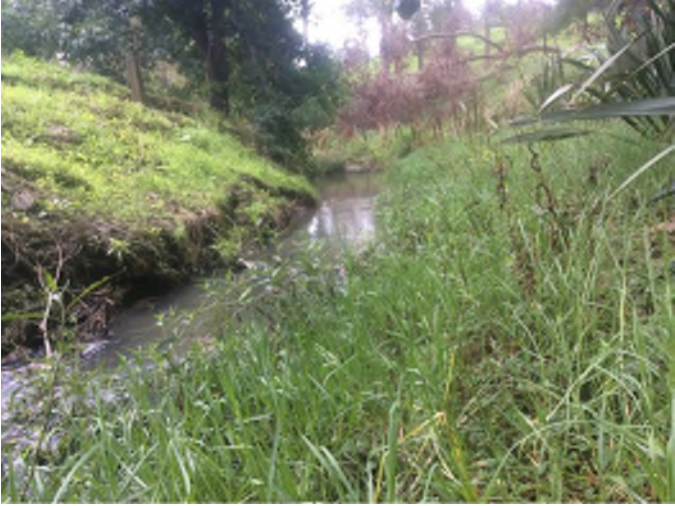
<p data-bbox="177 835 829 925">Limited riparian vegetation, low TLB providing some potential fish spawning habitat</p>

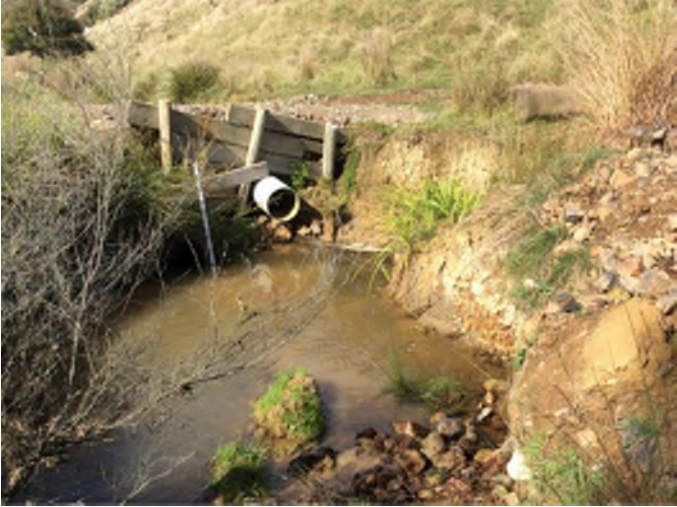
<p data-bbox="151 837 807 920">Poorly placed and possibly undersized culvert with significant erosion issues.</p>

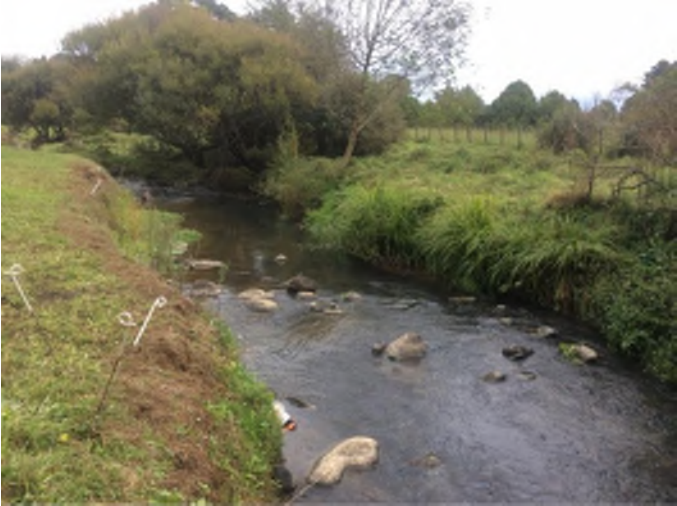
<p data-bbox="151 837 730 920">Hard-bottomed stream with poor riparian vegetation cover and stock access.</p>

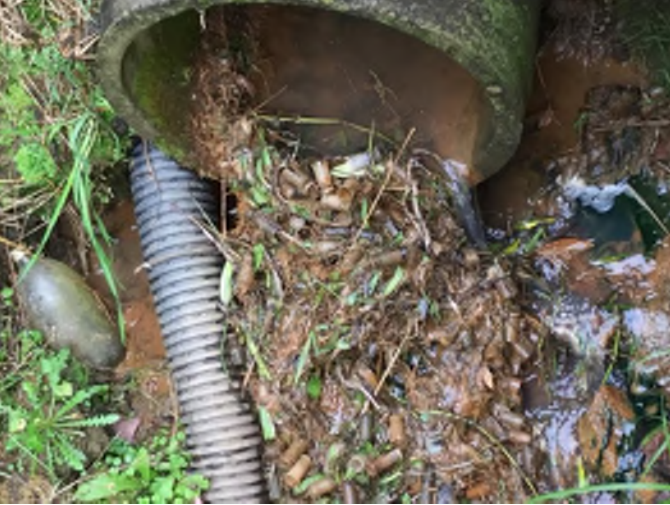
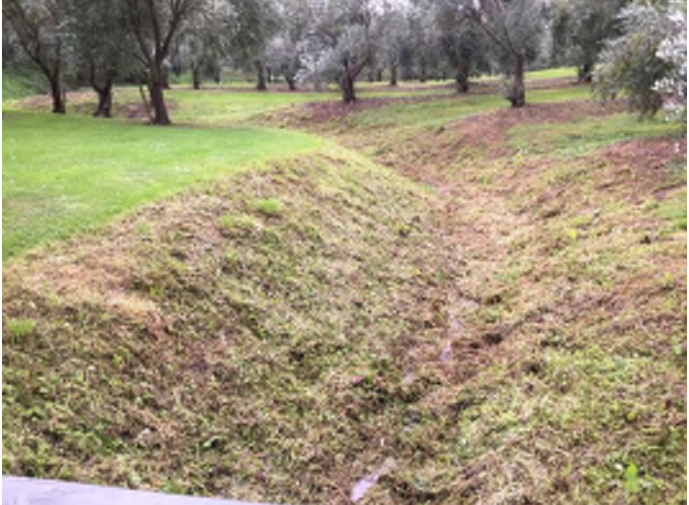
<p>Used shotgun cartridges accumulating downstream of duck shooting pond.</p>	<p>Modified intermittent stream channel through olive estate.</p>
<p>Notes</p>	<p>Benefits to Council</p>	<ul style="list-style-type: none"> • Head water streams through olive estate. • Limited riparian vegetation. • Litter issues associated with shotgun cartridges associated with clay bird and duck shooting. • Erosion issues around unplanted ponds. • Few artificial downstream fish barriers so fixing fish barrier issues within this area would open upper catchment to climbers and anguilliforms 	<ul style="list-style-type: none"> • Good opportunity to work with commercial landowner to meet their corporate social responsibilities. • Riparian enhance would protect stream/pond banks from erosion. • Riparian enhance would limit potential agrichemical runoff.
