**K200265-2**

**18 February 2021**

**GEOTECHNICAL INVESTIGATION REPORT  
BAYSWATER MARITIME PRECINCT  
21 SIR PETER BLAKE PARADE  
BAYSWATER**

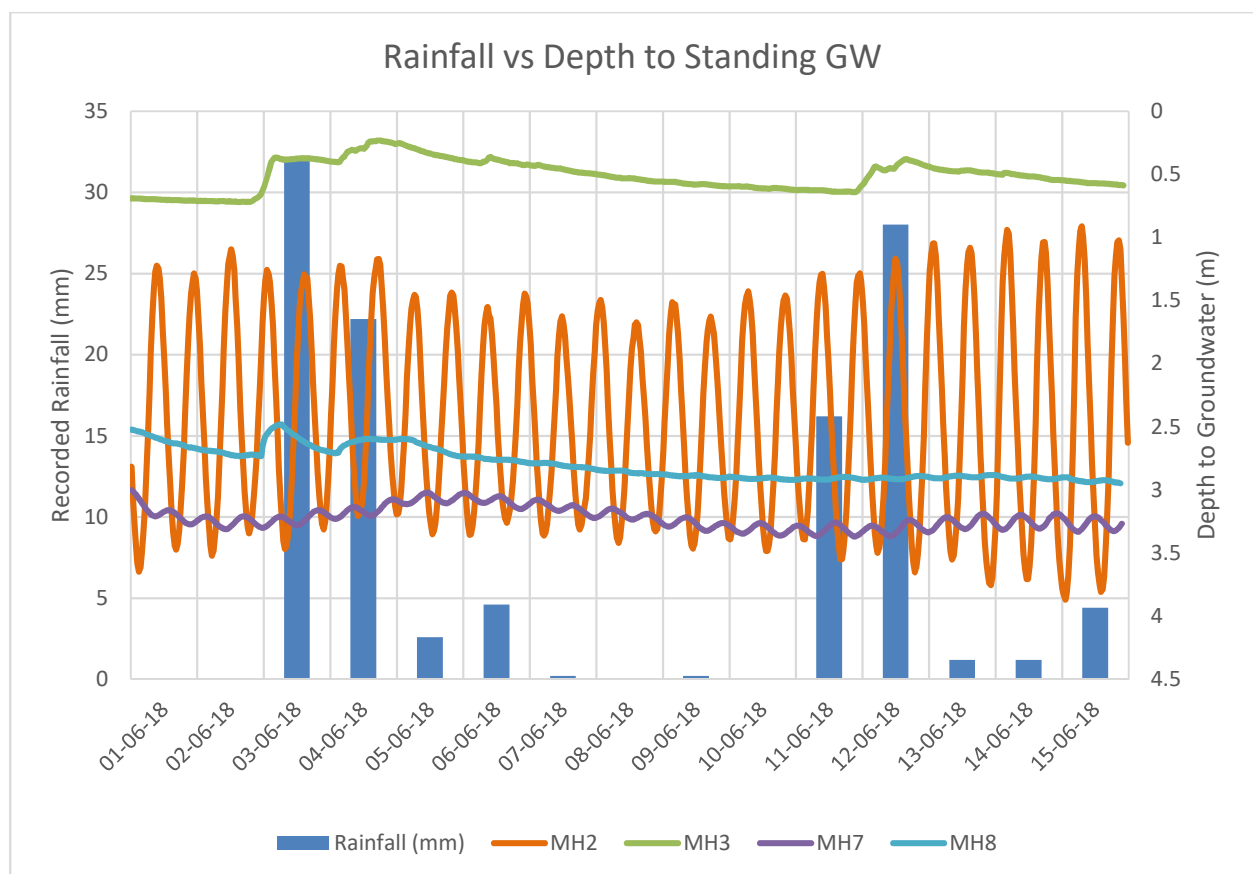
**Figure 2 - Groundwater Monitoring Results vs Recorded Rainfall**

- MH2 showed a notable response to tidal fluctuations.
- MH3 showed a response to rainfall, but not to tidal fluctuations.
- MH8 showed a response to the rainfall events around 3-6 June 2018, but not to the rainfall around 11-15 June 2018. After the effects of the 3-6 June 2018 rainfall had dissipated, MH8 showed only a very minor response to tidal fluctuations.

An indicative historic daily rainfall record for the general area of the site was taken from the Meteorological Service of New Zealand Limited (Metservice) Auckland Airport weather station. An indicative daily tide record was taken from the Land Information New Zealand (LINZ) Auckland tidal gauge. The daily rainfall records, together with the recorded groundwater levels in each borehole are shown in Figure 2 below. The tide records together with the groundwater levels in each borehole are shown in Figure 3 below.

As indicated in Table 3, and in Figure 2, high tide RL is above the maximum water level in boreholes MH7 and MH8, however the average tide level is lower than the average water in both MH7 and MH8.

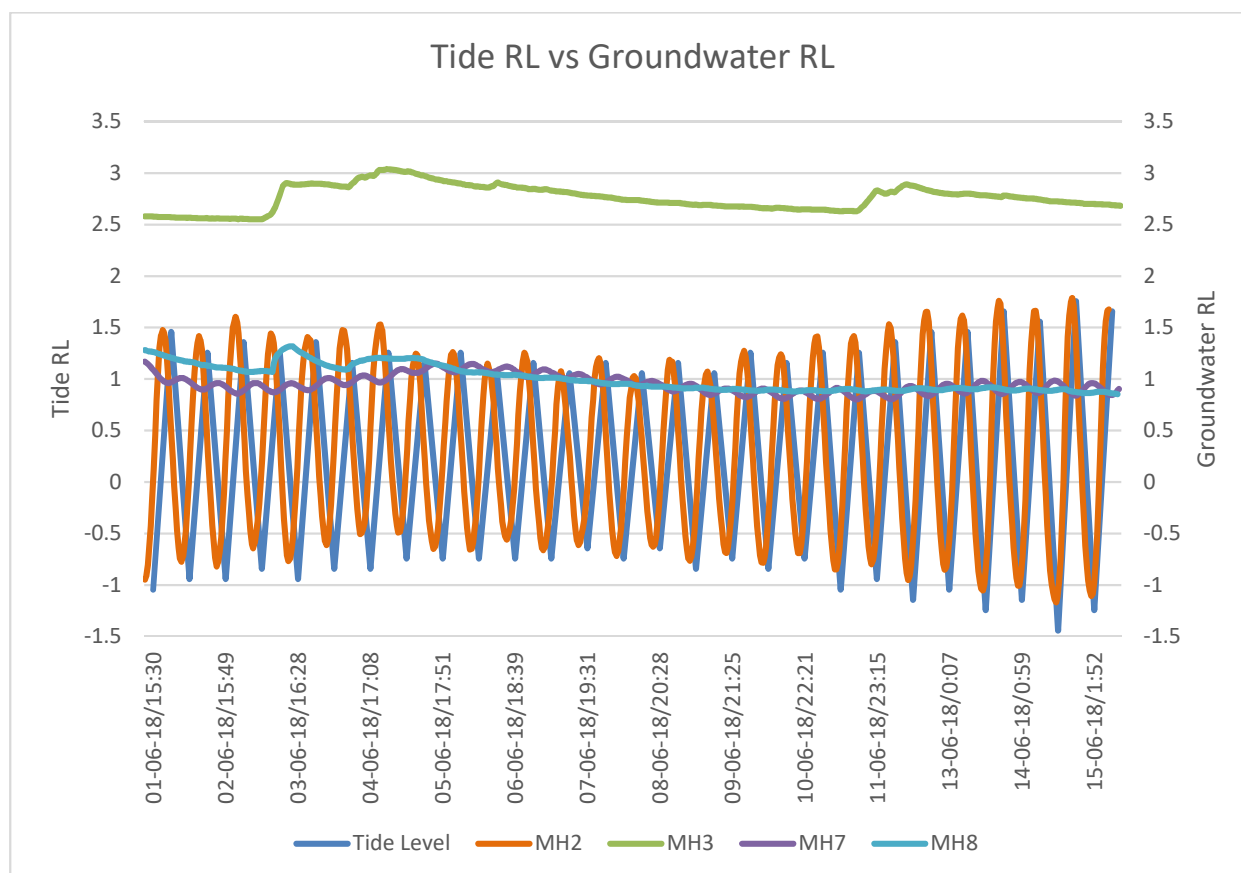
**Figure 3 – Groundwater Monitoring Results vs Recorded Tide Levels**
