**K200265-2**

**GEOTECHNICAL INVESTIGATION REPORT  
BAYSWATER MARITIME PRECINCT  
21 SIR PETER BLAKE PARADE  
BAYSWATER**

**Geotechnical Investigation Report**  
**Bayswater Maritime Precinct**  
**21 Sir Peter Blake Parade**  
**Bayswater**

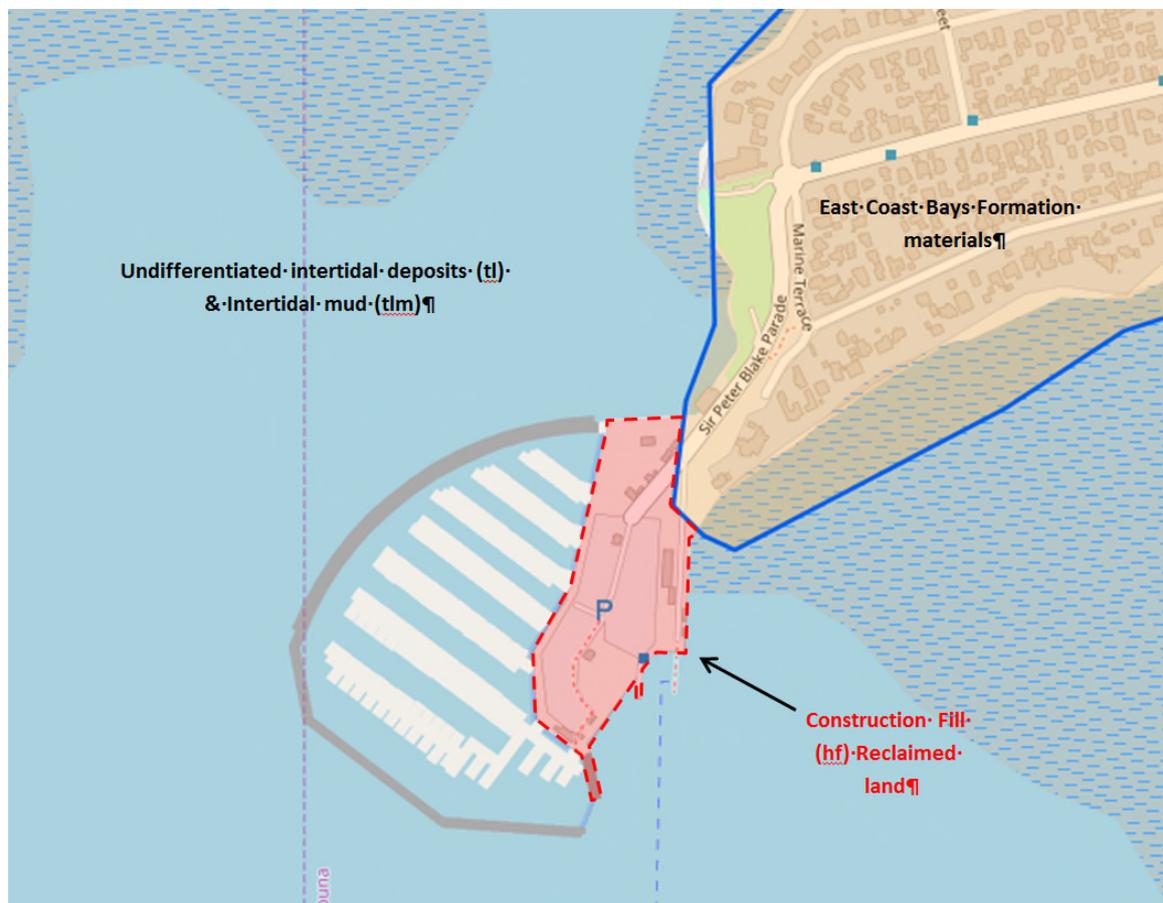
**Figure 1. Regional geology map extract from GNS Geology Web Map**

The geology of the site and surrounding area is detailed on the geologic map entitled “Geology of the Auckland Area”, Institute of Geological & Nuclear Science, scale 1:250 000, geological map 3. This shows that the geology beneath the site and nearby properties comprises of Holocene aged, human-made deposits (reclaimed land) overlying an eroded platform of East Coast Bays Formation materials of the Warkworth Subgroup, part of the Waitemata Group materials of Miocene age. The surrounding harbour consists of undifferentiated intertidal deposits & intertidal.

The text associated with the geologic map describes the Holocene human-made deposits as re-compacted clay to gravel sized materials; which may include demolition debris.

The East Coast Bays Formation materials were originally deposited as submarine landslide, or turbidity current deposits, that have since lithified into alternating layers of siltstone and sandstone, which have subsequently been uplifted to be exposed above sea level today. Since being exposed above sea level, the materials have weathered in situ to form a mantle of residual soil over the rock and depth. Weathering in these materials is often gradational, with no distinct soil/rock boundary present.

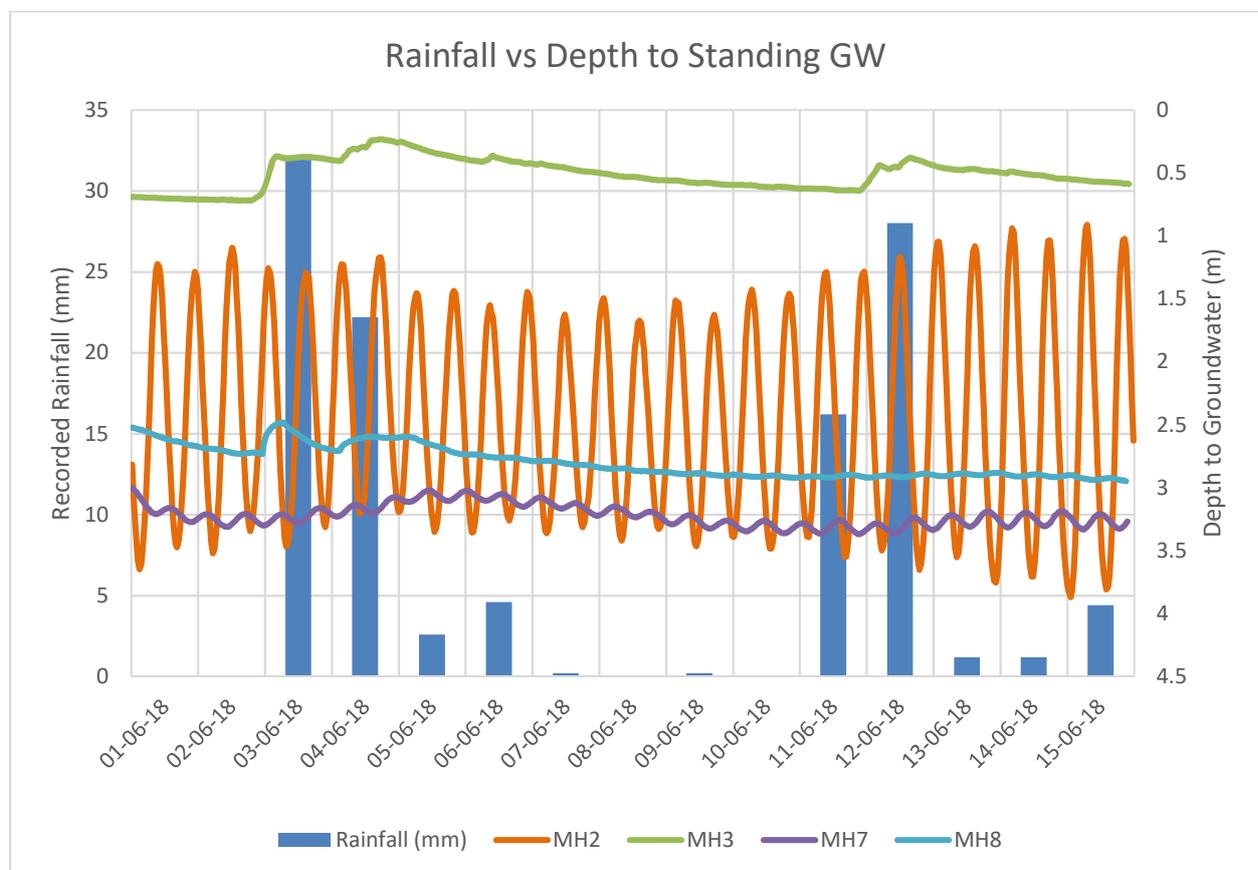
**Figure 2 - Groundwater Monitoring Results vs Recorded Rainfall**

An indicative historic daily rainfall record for the general area of the site was taken from the Meteorological Service of New Zealand Limited (Metservice) Auckland Airport weather station. An indicative daily tide record was taken from the Land Information New Zealand (LINZ) Auckland tidal gauge. The daily rainfall records, together with the recorded groundwater levels in each borehole are shown in Figure 2 below. The tide records together with the groundwater levels in each borehole are shown in Figure 3 below.

- MH2 showed a notable response to tidal fluctuations.
- MH3 showed a response to rainfall, but not to tidal fluctuations.
- MH8 showed a response to the rainfall events around 3-6 June 2018, but not to the rainfall around 11-15 June 2018. After the effects of the 3-6 June 2018 rainfall had dissipated, MH8 showed only a very minor response to tidal fluctuations.

- MH3 was anomalous in that groundwater was recorded at much shallower depths than in any other borehole. Attempts to purge this Piezometer were fruitless, as groundwater was found to recharge the piezometer just as fast as it could be purged. In this instance we consider that, as the borehole was drilled within the carpark, it is possible that the pavement basecourse material is saturated, and that water was able to enter the Piezometer and recharge it up to the level we measured.

- It is possible that the seal around the top of MH8 had not properly formed prior to the rainfall events of 3-6 June, but that it had effectively sealed following that event, which is why no further response to rainfall was noted in borehole MH8.
- Whilst MH7 is one of the boreholes located farthest from the sea, the tidal response shown in this piezometer is likely due to seawater tracking through the intermediary, high permeability bund, and also along the interface between the historic reclamation revetment to the east and the subject site.
- The tidal response shown later in the monitoring period in MH8 is considered likely to be influenced similar to MH7.

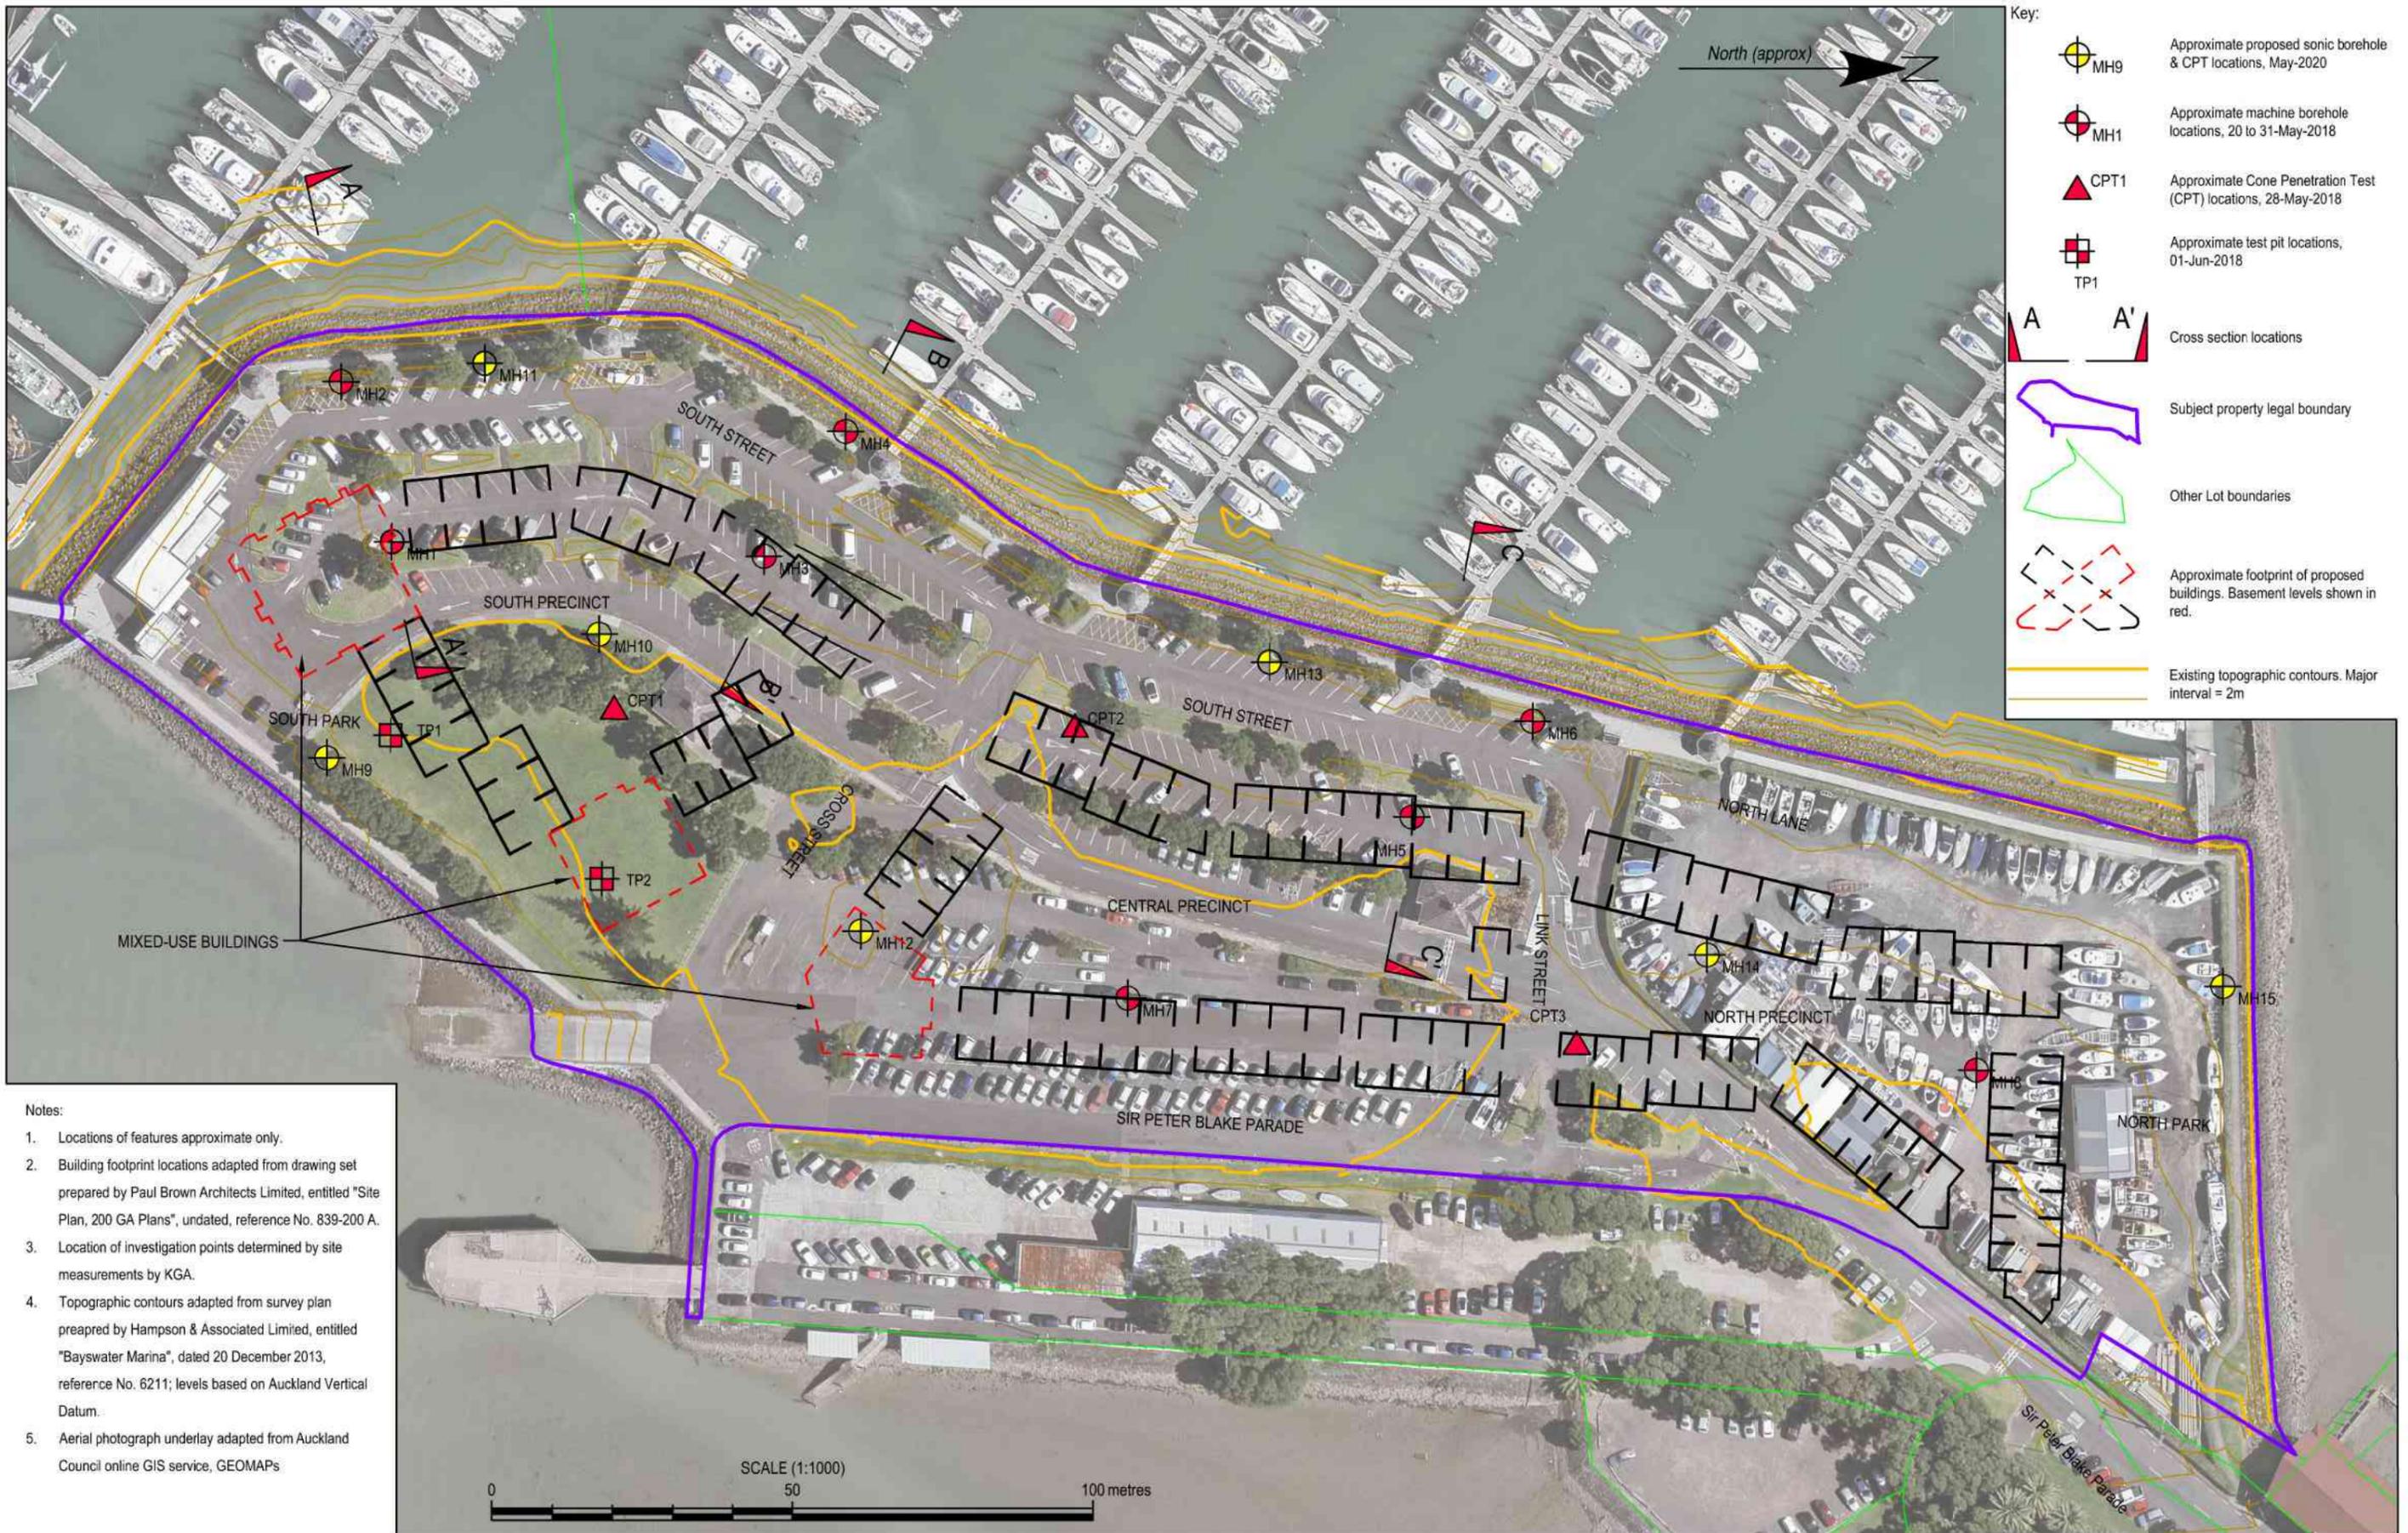
- MH9 Approximate proposed sonic borehole & CPT locations, May-2020
- MH1 Approximate machine borehole locations, 20 to 31-May-2018
- CPT1 Approximate Cone Penetration Test (CPT) locations, 28-May-2018
- TP1 Approximate test pit locations, 01-Jun-2018
- A A' Cross section locations
- Subject property legal boundary
- Other Lot boundaries
- Approximate footprint of proposed buildings. Basement levels shown in red.
- Existing topographic contours. Major interval = 2m

REVISION NO: A		DATE: SEPT-20	CLIENT: BAYSWATER MARINA HOLDINGS LIMITED	PROJECT: BAYSWATER MARITIME VILLAGE 21 SIR PETER BLAKE PARADE BAYSWATER	TITLE: SITE PLAN AERIAL IMAGE UNDERLAY	Auckland   Christchurch 09 478 6655   03 343 5302 www.kga.co.nz		JOB NO: K200265
DRAWN BY: PH		CHECKED BY: RH						SHEET NO: KGA 1
SEPT-2020	A	REPORT ISSUE	SCALE (A3 ORIGINAL): 1:1000	CAD REF: K180425_Dwgs.dwg				
DATE	REVISION	DESCRIPTION						
AMENDMENTS

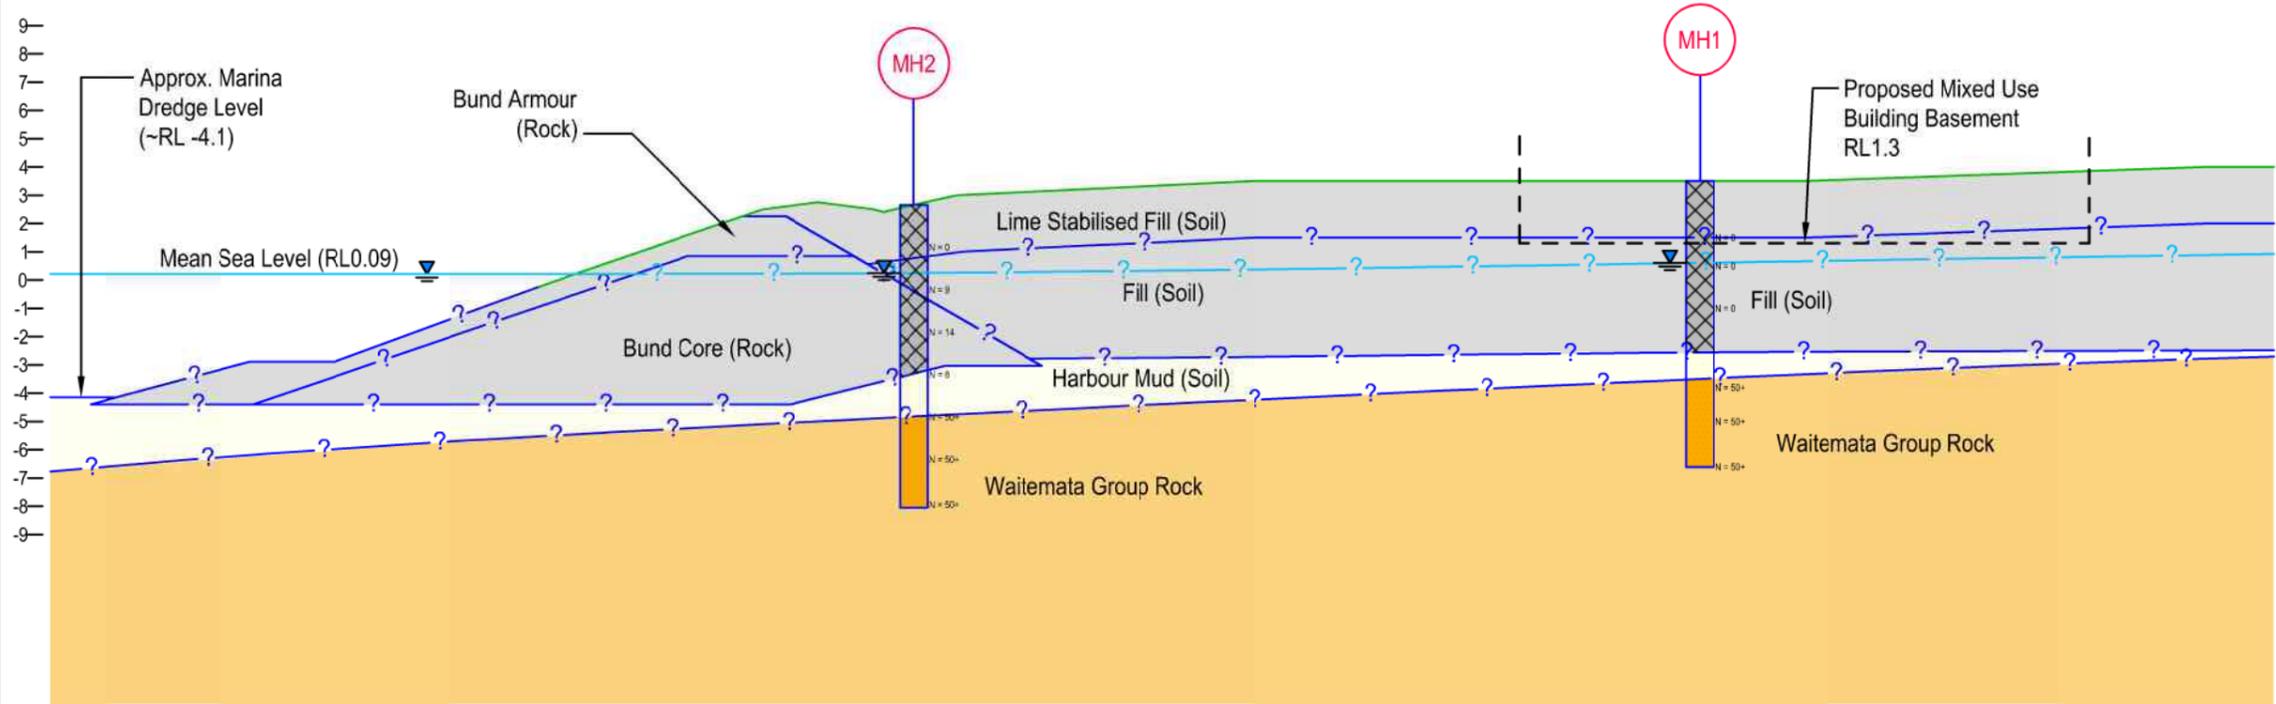
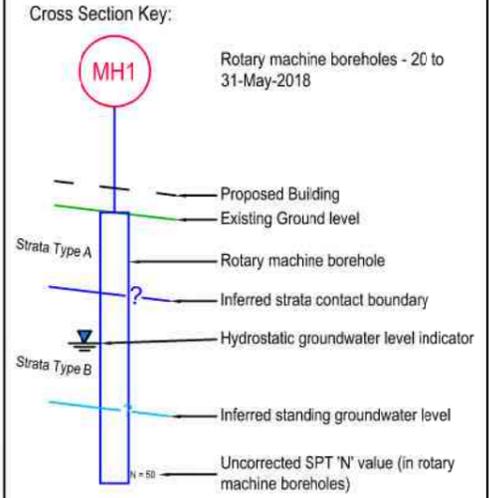
A

A'

Using the topographic survey information provided, the results of our desk study and our subsurface investigation, we have generated three cross sections through the location of the bund in selected locations around the site (A – A', B – B' & C – C') in order to graphically represent our objective interpretation of the subsurface conditions in these parts of the site. The locations of our cross sections are shown on our drawing entitled "Site Plan, Aerial Image Underlay", Sheet KGA 1, with each cross section shown on our drawings entitled "Cross Section A - A'", "Cross Section B - B'" and "Cross Section C - C'", Sheet KGA 3, 4 and 5 respectively, presented within Appendix 1.

We point out that in preparing our objective subsurface models, the ground conditions have been inferred between and away from our investigation points. It must be accepted, however, that, the conditions may vary between each investigation point from what has been inferred on our models.

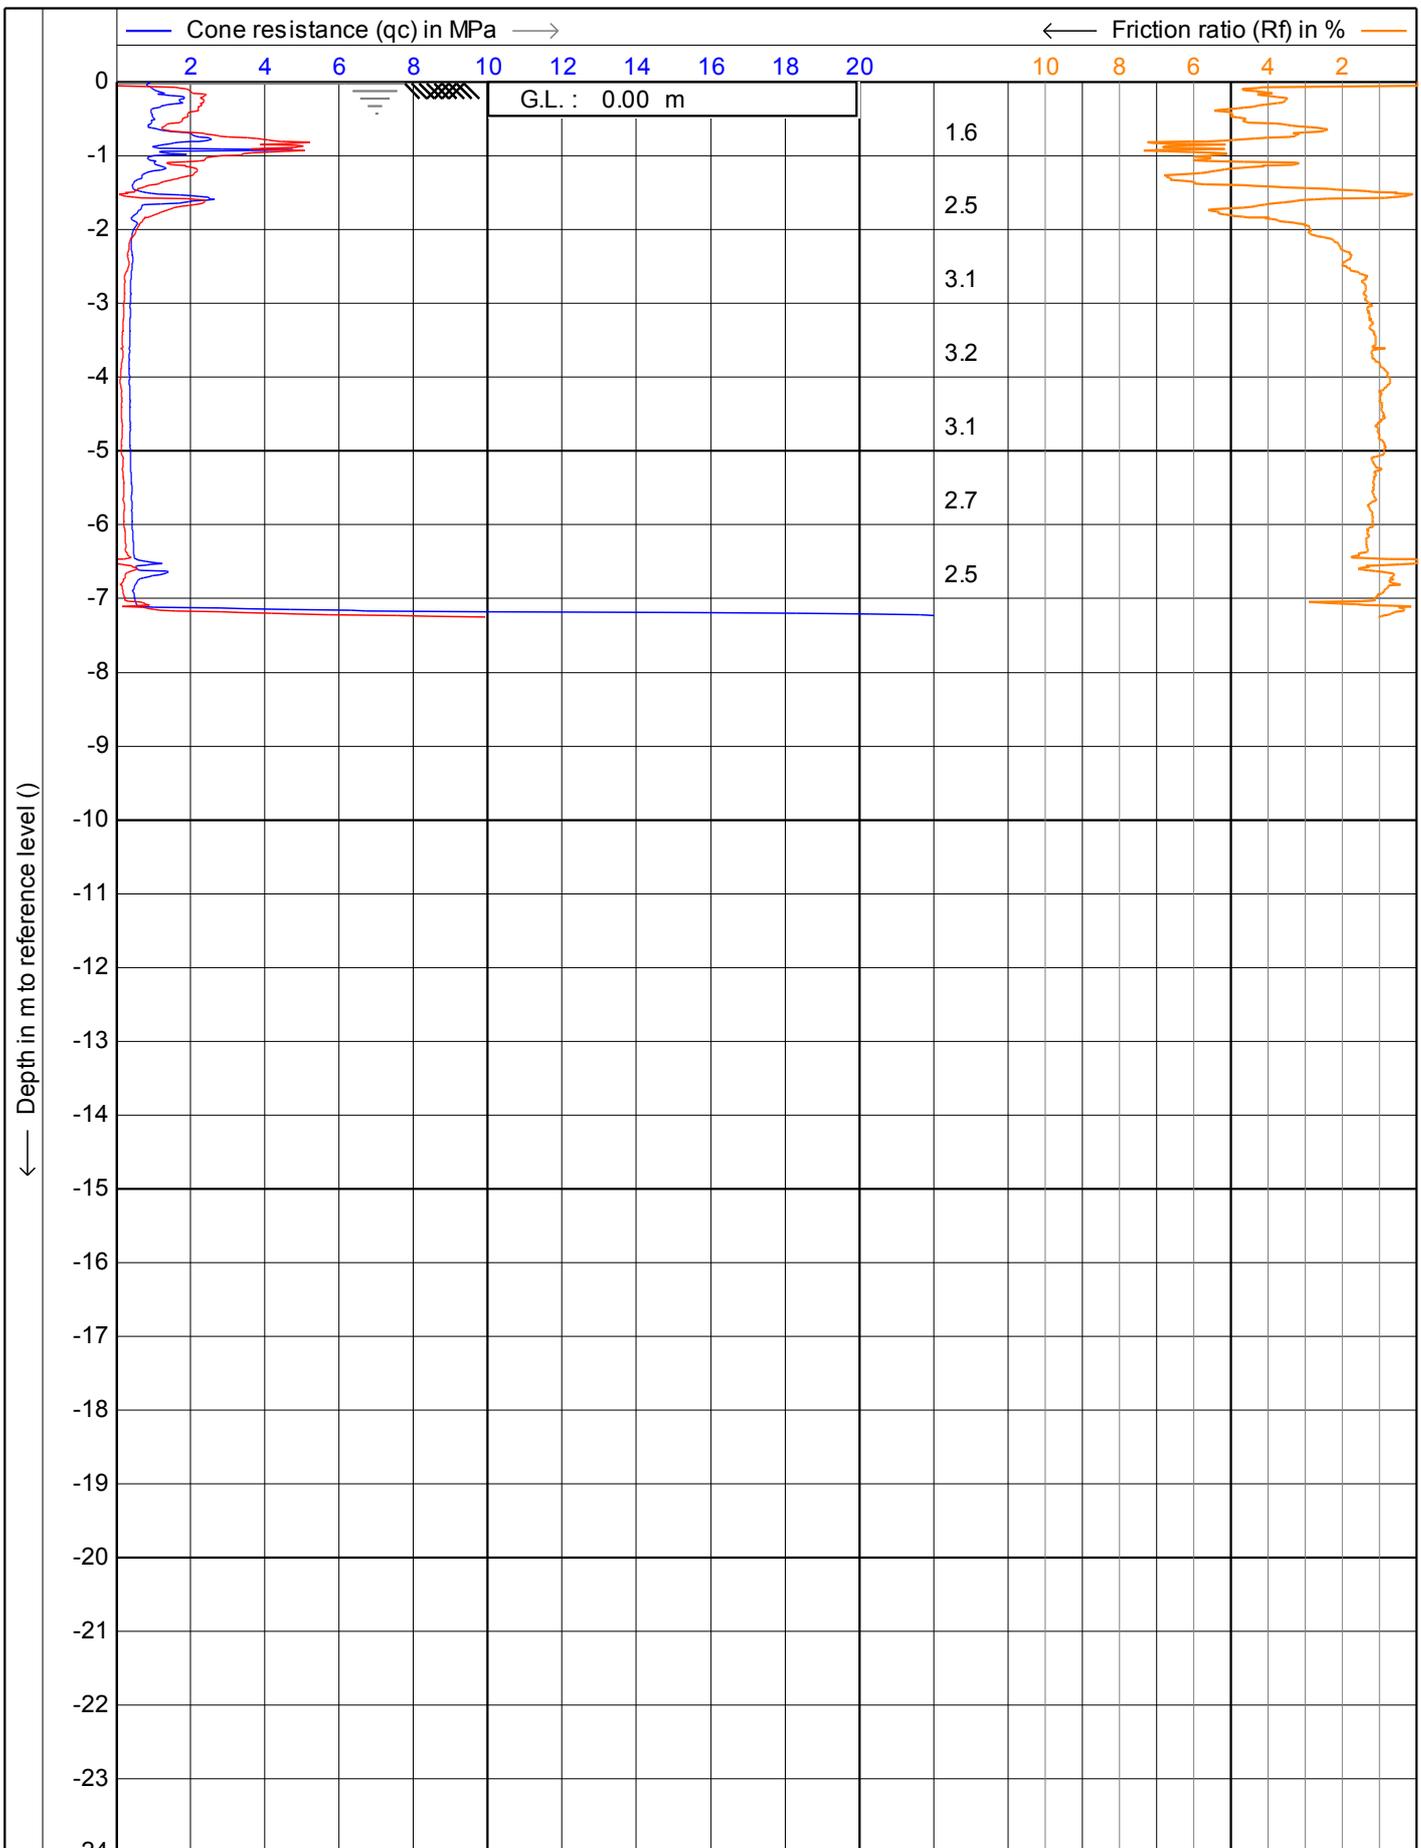
Project : <b>Bayswater Marina</b> Location: <b>Bayswater Marina</b> Position: <b>0, 0</b>	Test according NEN 5140 class 1		Date : <b>28/05/2018</b>	
			Cone no. : <b>S15CFIIP.S16243</b>	
			Project no. : <b>Bayswater Marina</b>	
			CPT no. : <b>CPT1</b>	<b>1/15</b>

**Fill (Reclaimed Land):** Fill is inferred to be present from ground surface in CPT01, CPT02 and CPT03. The CPT probe soil behaviour type classification output generally inferred similar material types to what was found within the nearby investigation points, namely clay silt and silty clay type materials, with only minor horizons of sand identified towards the base of each probe.

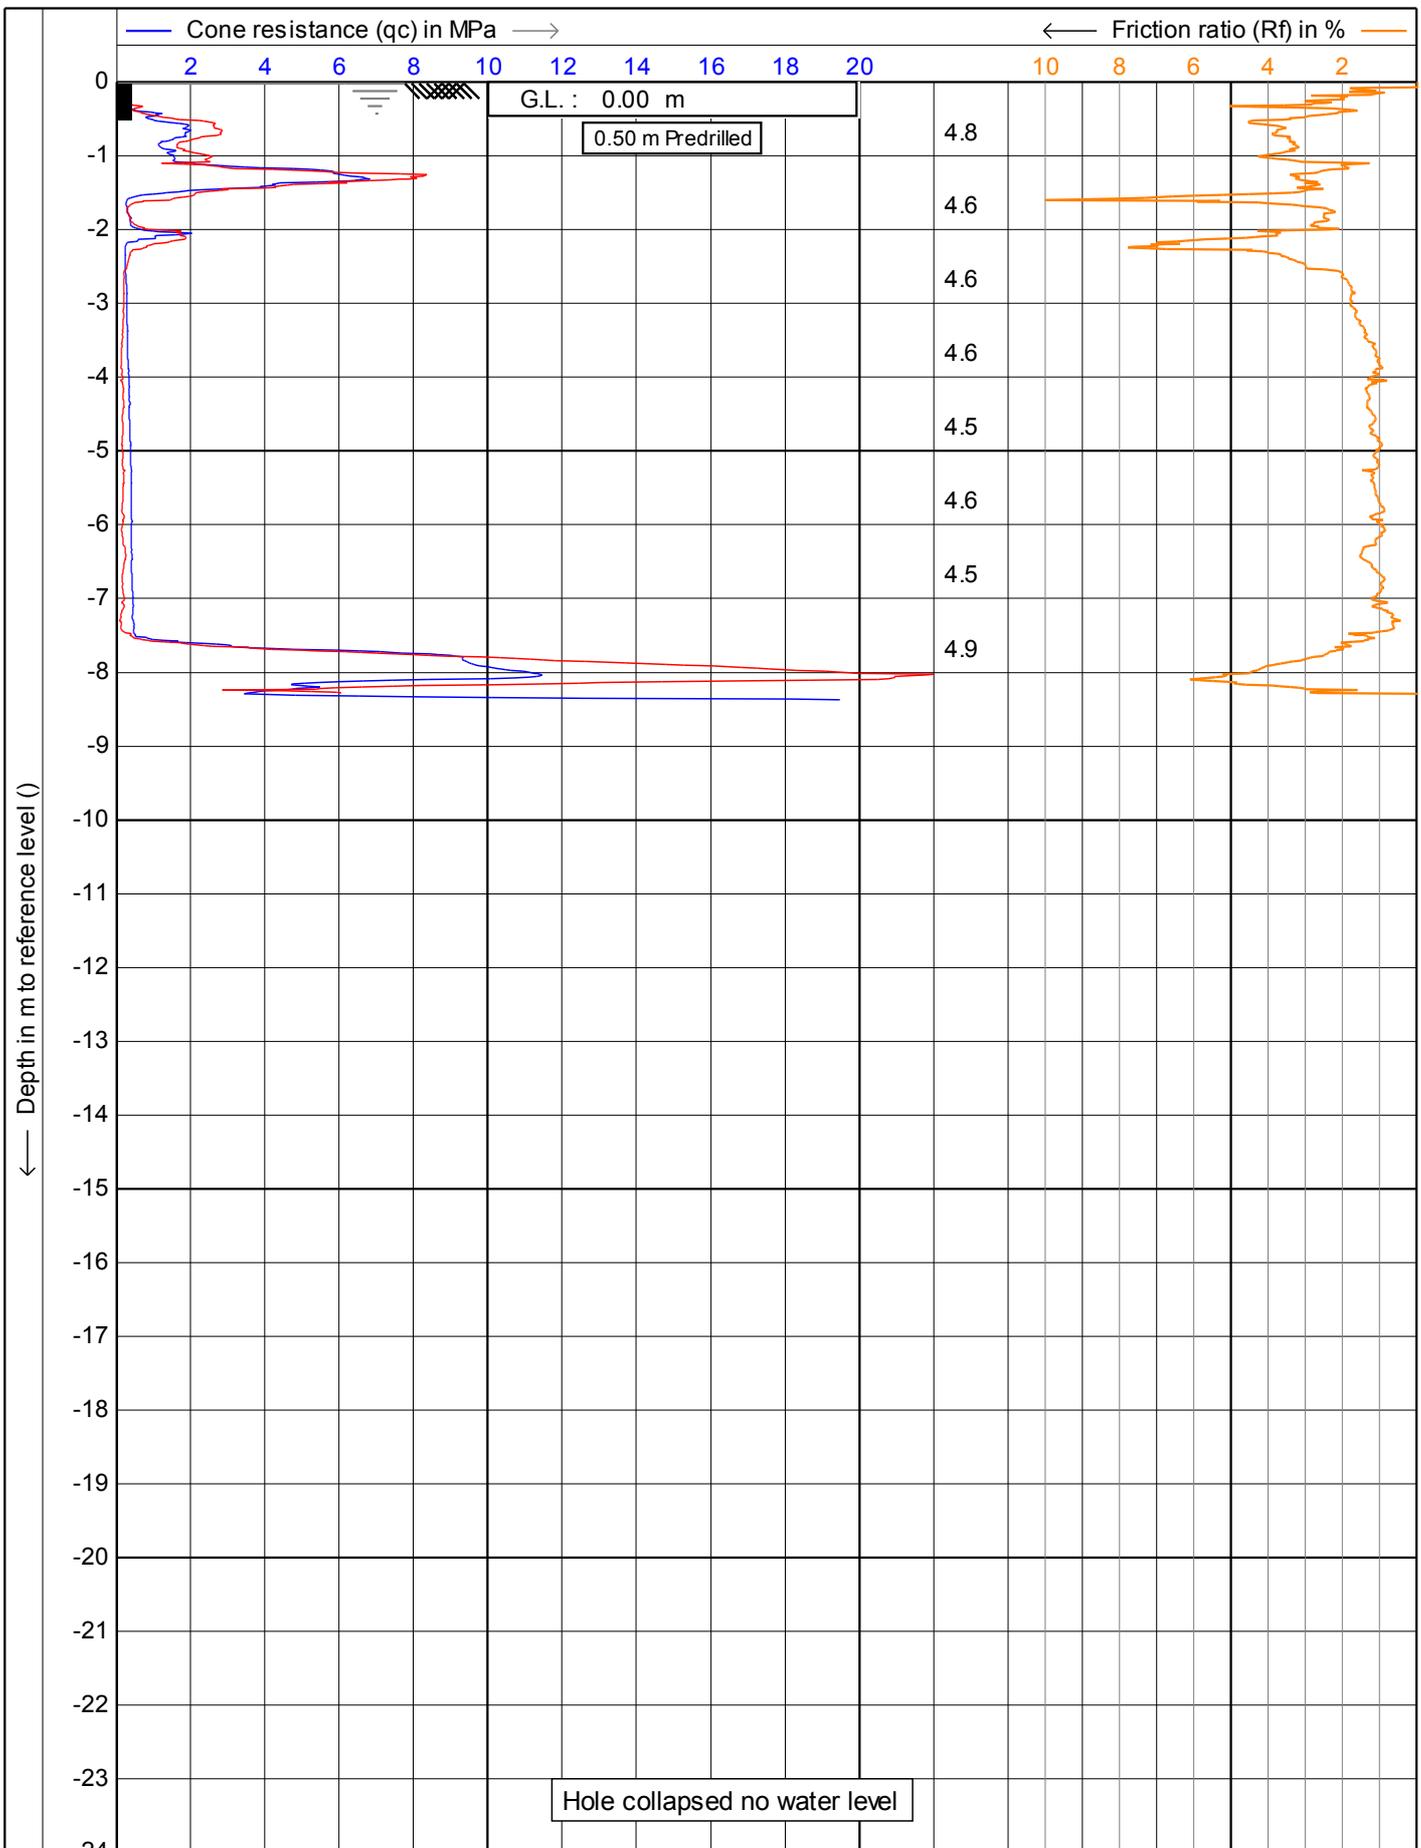
Test according NEN 5140 class 1		Date : 28/05/2018	
Project : <b>Bayswater Marina</b>		Cone no. : <b>S15CFIP.S16243</b>	
Location: <b>Bayswater Marina</b>		Project no. : <b>Bayswater Marina</b>	
Position: <b>0, 0</b>		CPT no. : <b>CPT2</b>	1/15

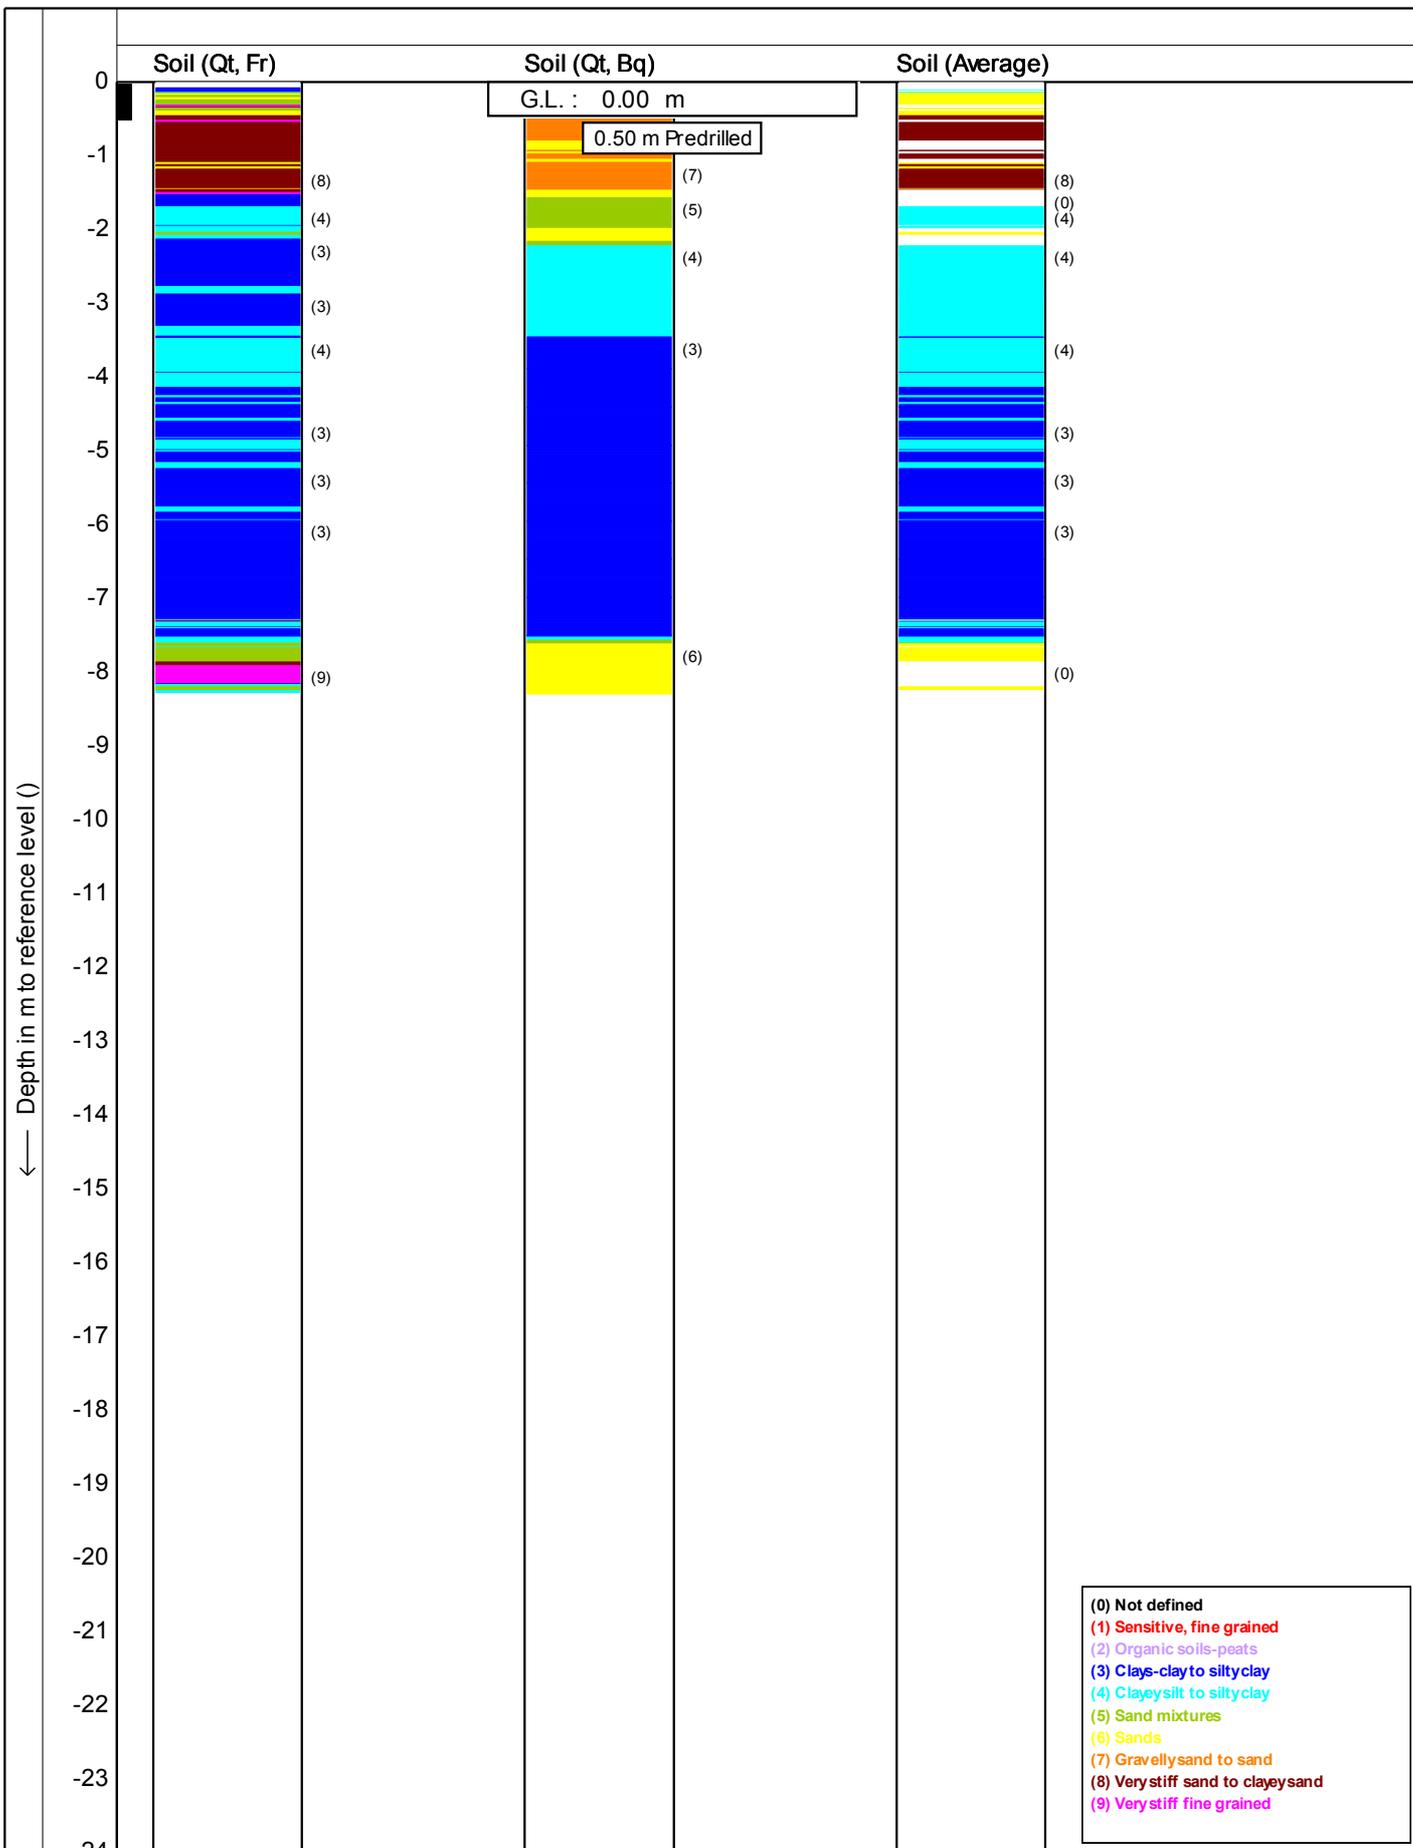
Soil behaviour type classification after Robertson 1990

Project : <b>Bayswater Marina</b> Location: <b>Bayswater Marina</b> Position: <b>0, 0</b>	Test according NEN 5140 class 1	Date : <b>28/05/2018</b>
		Cone no. : <b>S15CFIIP.S16243</b>
		Project no. : <b>Bayswater Marina</b>
		CPT no. : <b>CPT2</b> 14/15

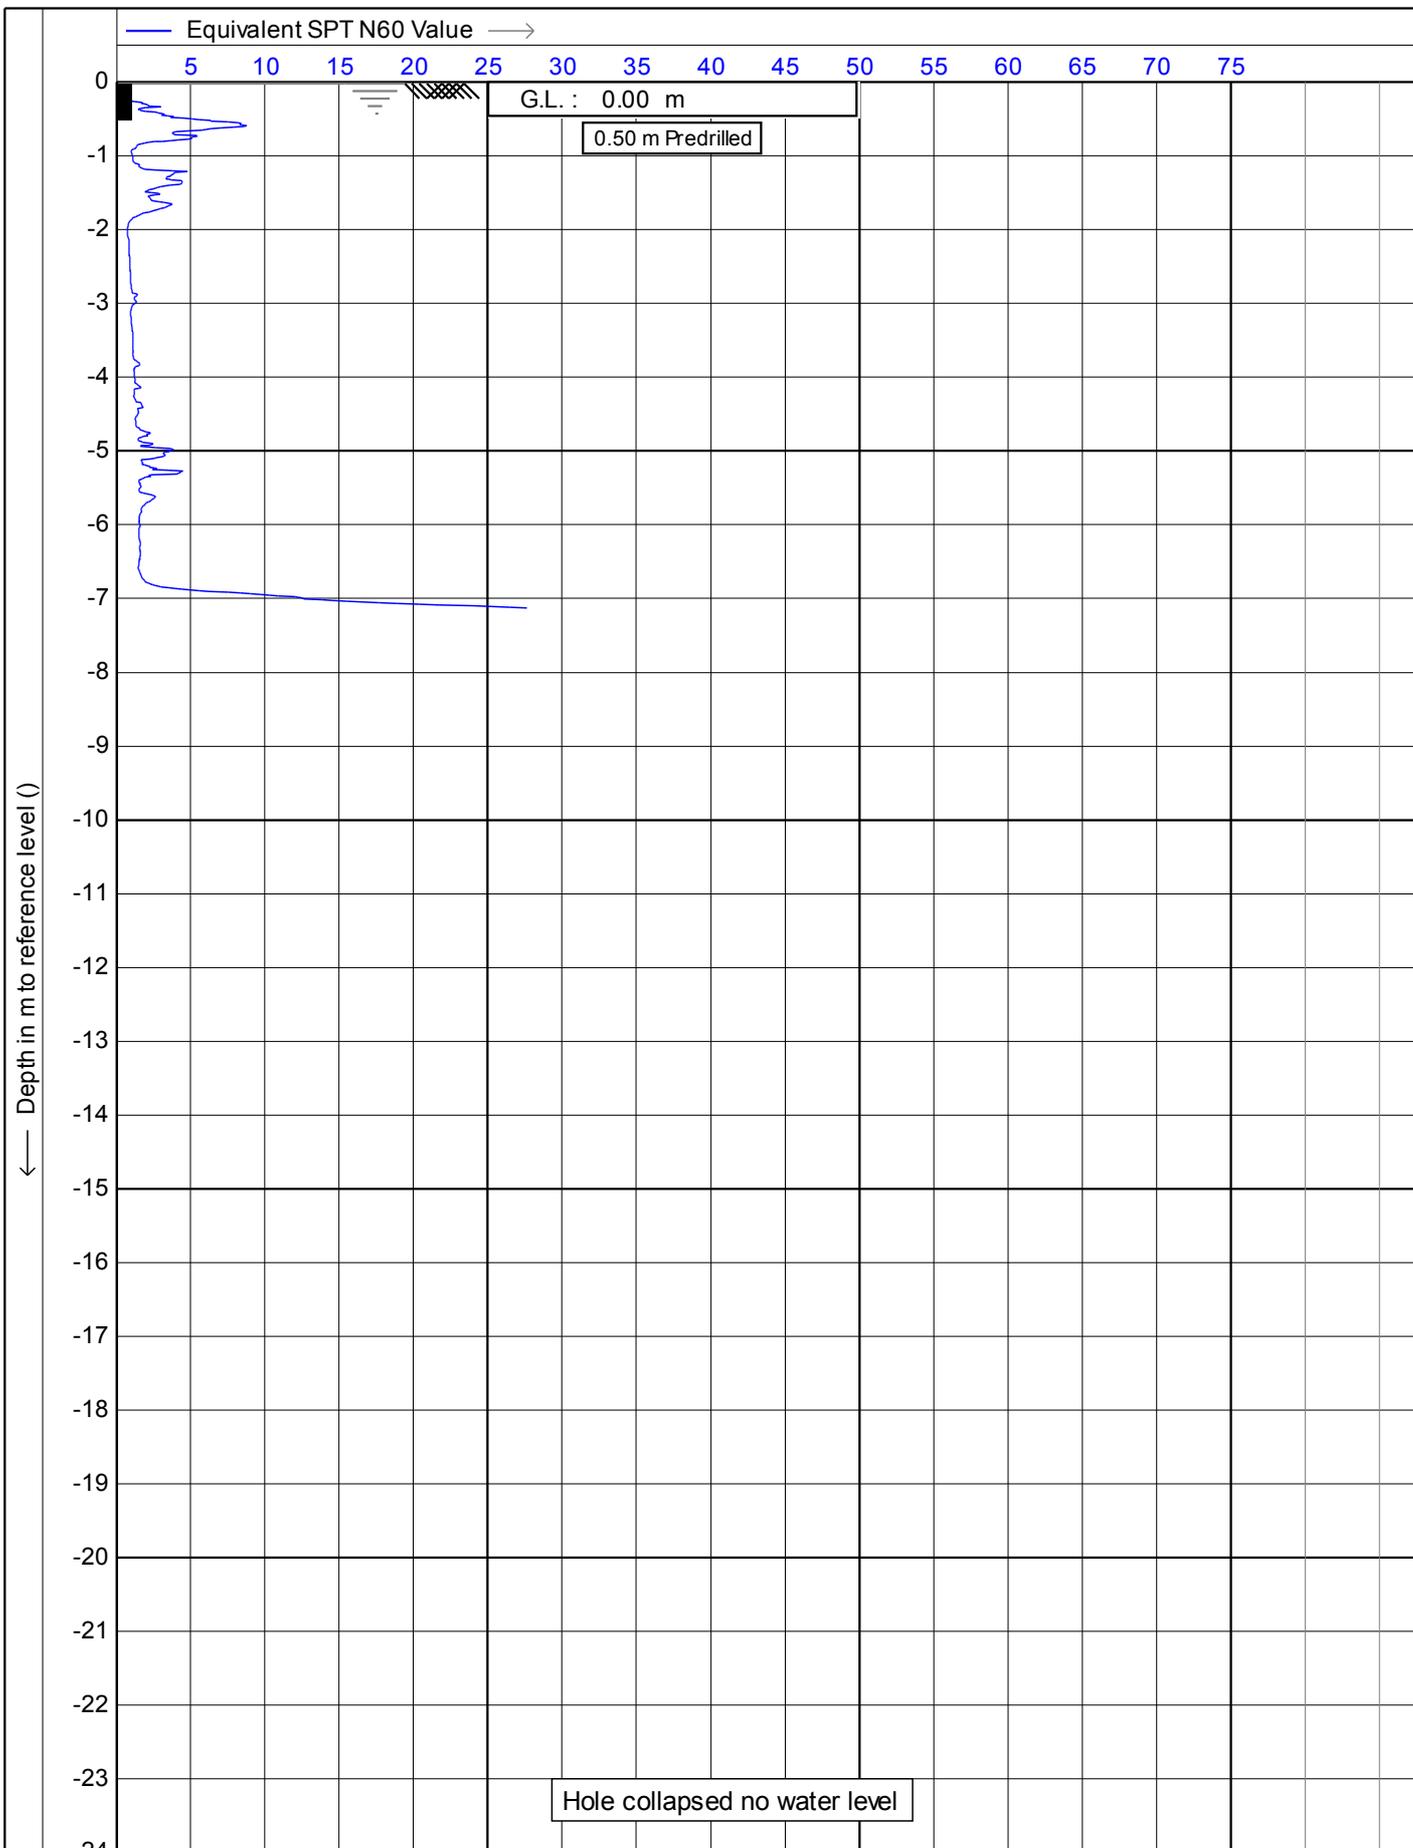
Test according NEN 5140 class 1 Project : <b>Bayswater Marina</b> Location: <b>Bayswater Marina</b> Position: <b>0, 0</b>	Date : <b>28/05/2018</b>	
	Cone no. : <b>S15CFIIP.S16243</b>	
	Project no. : <b>Bayswater Marina</b>	
	CPT no. : <b>CPT3</b>	<b>11/15</b>

Relative density (over-consolidated) in % →

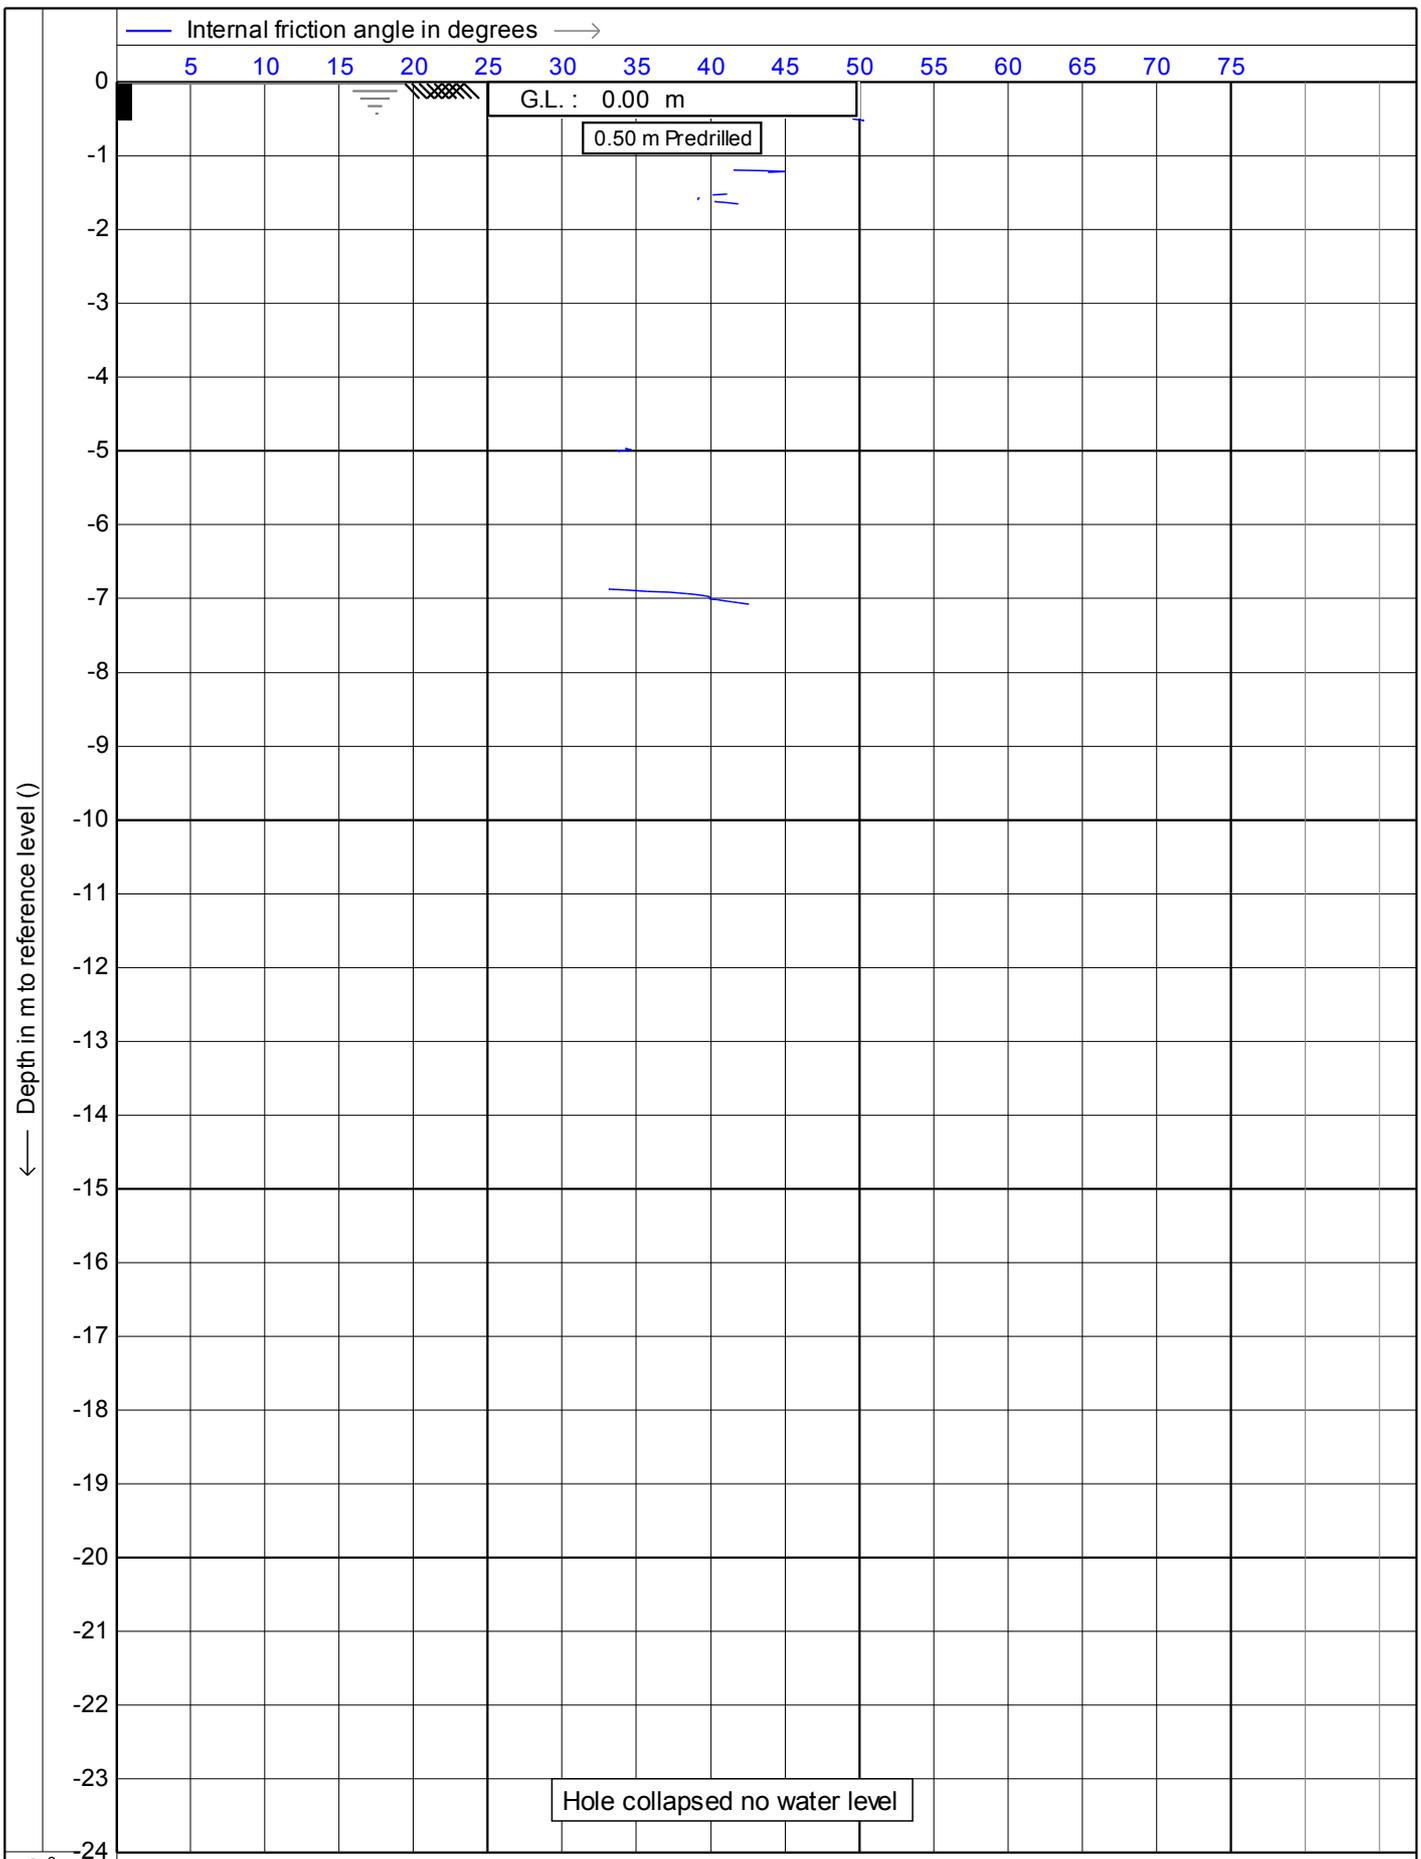
Project : <b>Bayswater Marina</b> Location: <b>Bayswater Marina</b> Position: <b>0, 0</b>	Test according NEN 5140 class 1	Date : <b>28/05/2018</b>
		Cone no. : <b>S15CFIIP.S16243</b>
		Project no. : <b>Bayswater Marina</b>
	CPT no. : <b>CPT3</b>	<b>14/15</b>

Soil behaviour type classification after Robertson 1990
