**K200265-2**

**GEOTECHNICAL INVESTIGATION REPORT  
BAYSWATER MARITIME PRECINCT  
21 SIR PETER BLAKE PARADE  
BAYSWATER**

**Geotechnical Investigation Report**  
**Bayswater Maritime Precinct**  
**21 Sir Peter Blake Parade**  
**Bayswater**

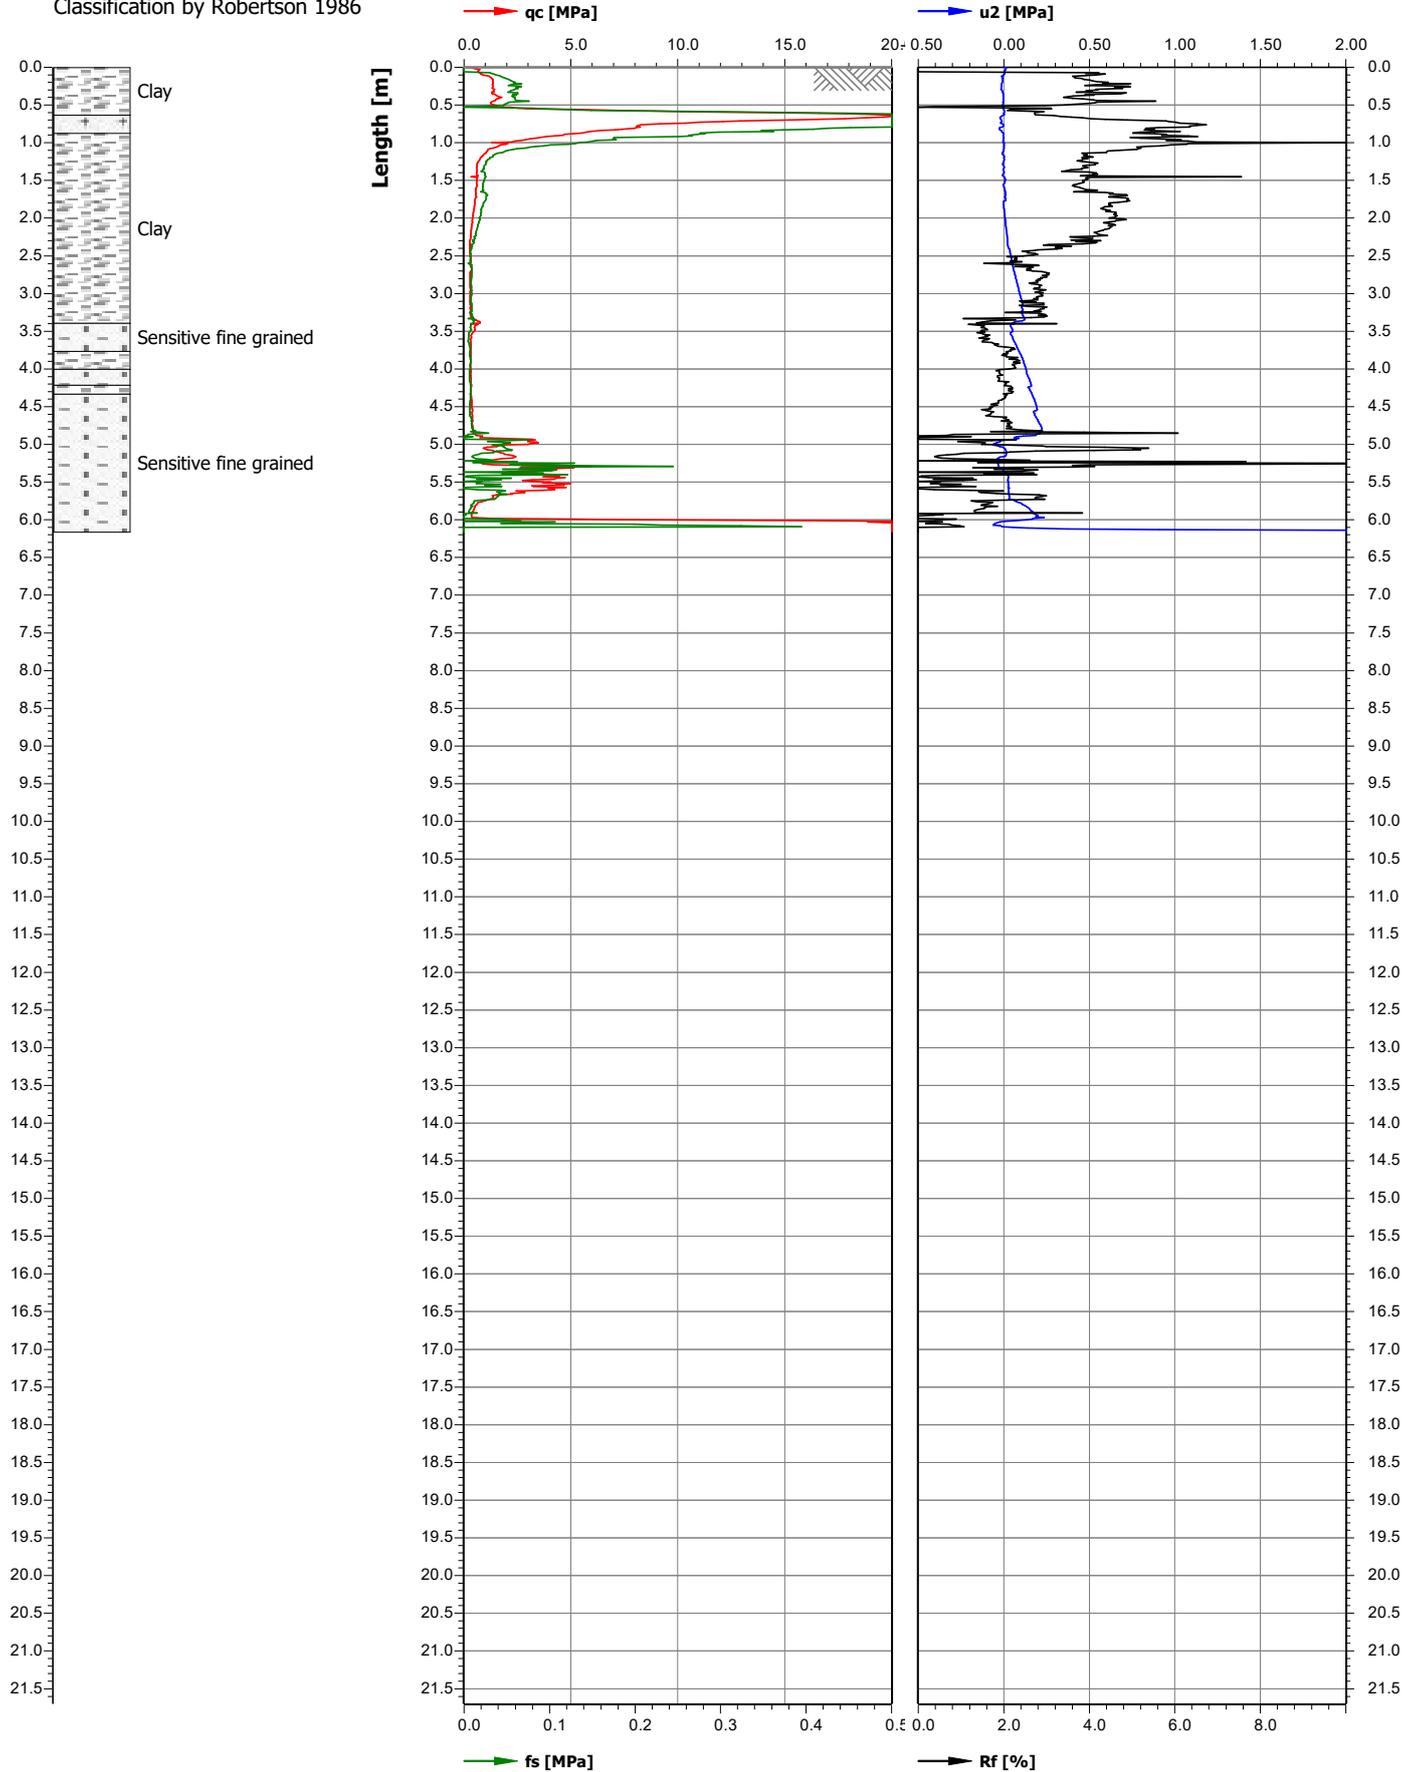
Classification by Robertson 1986

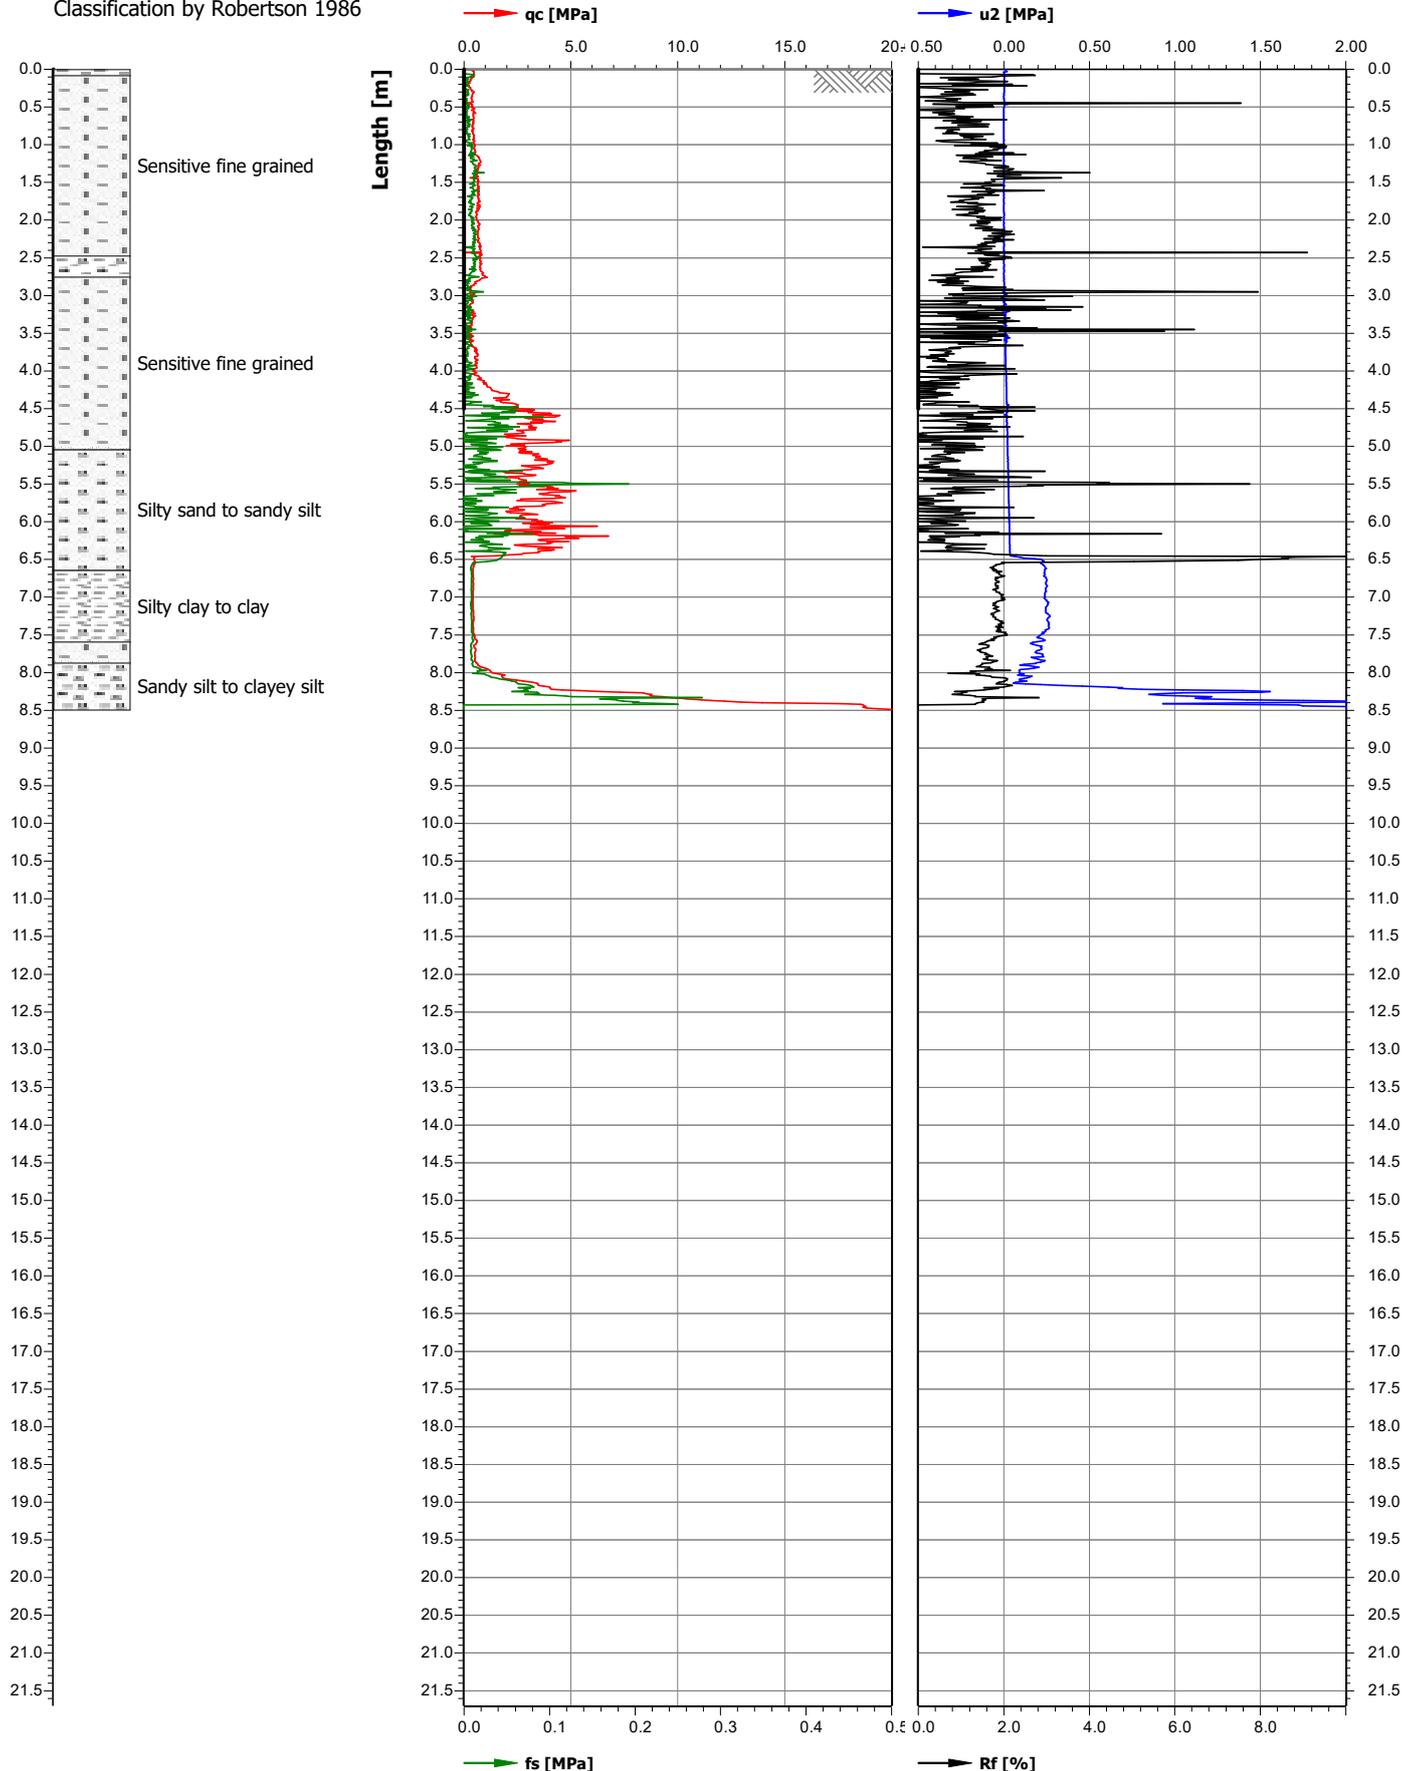
Classification by Robertson 1986

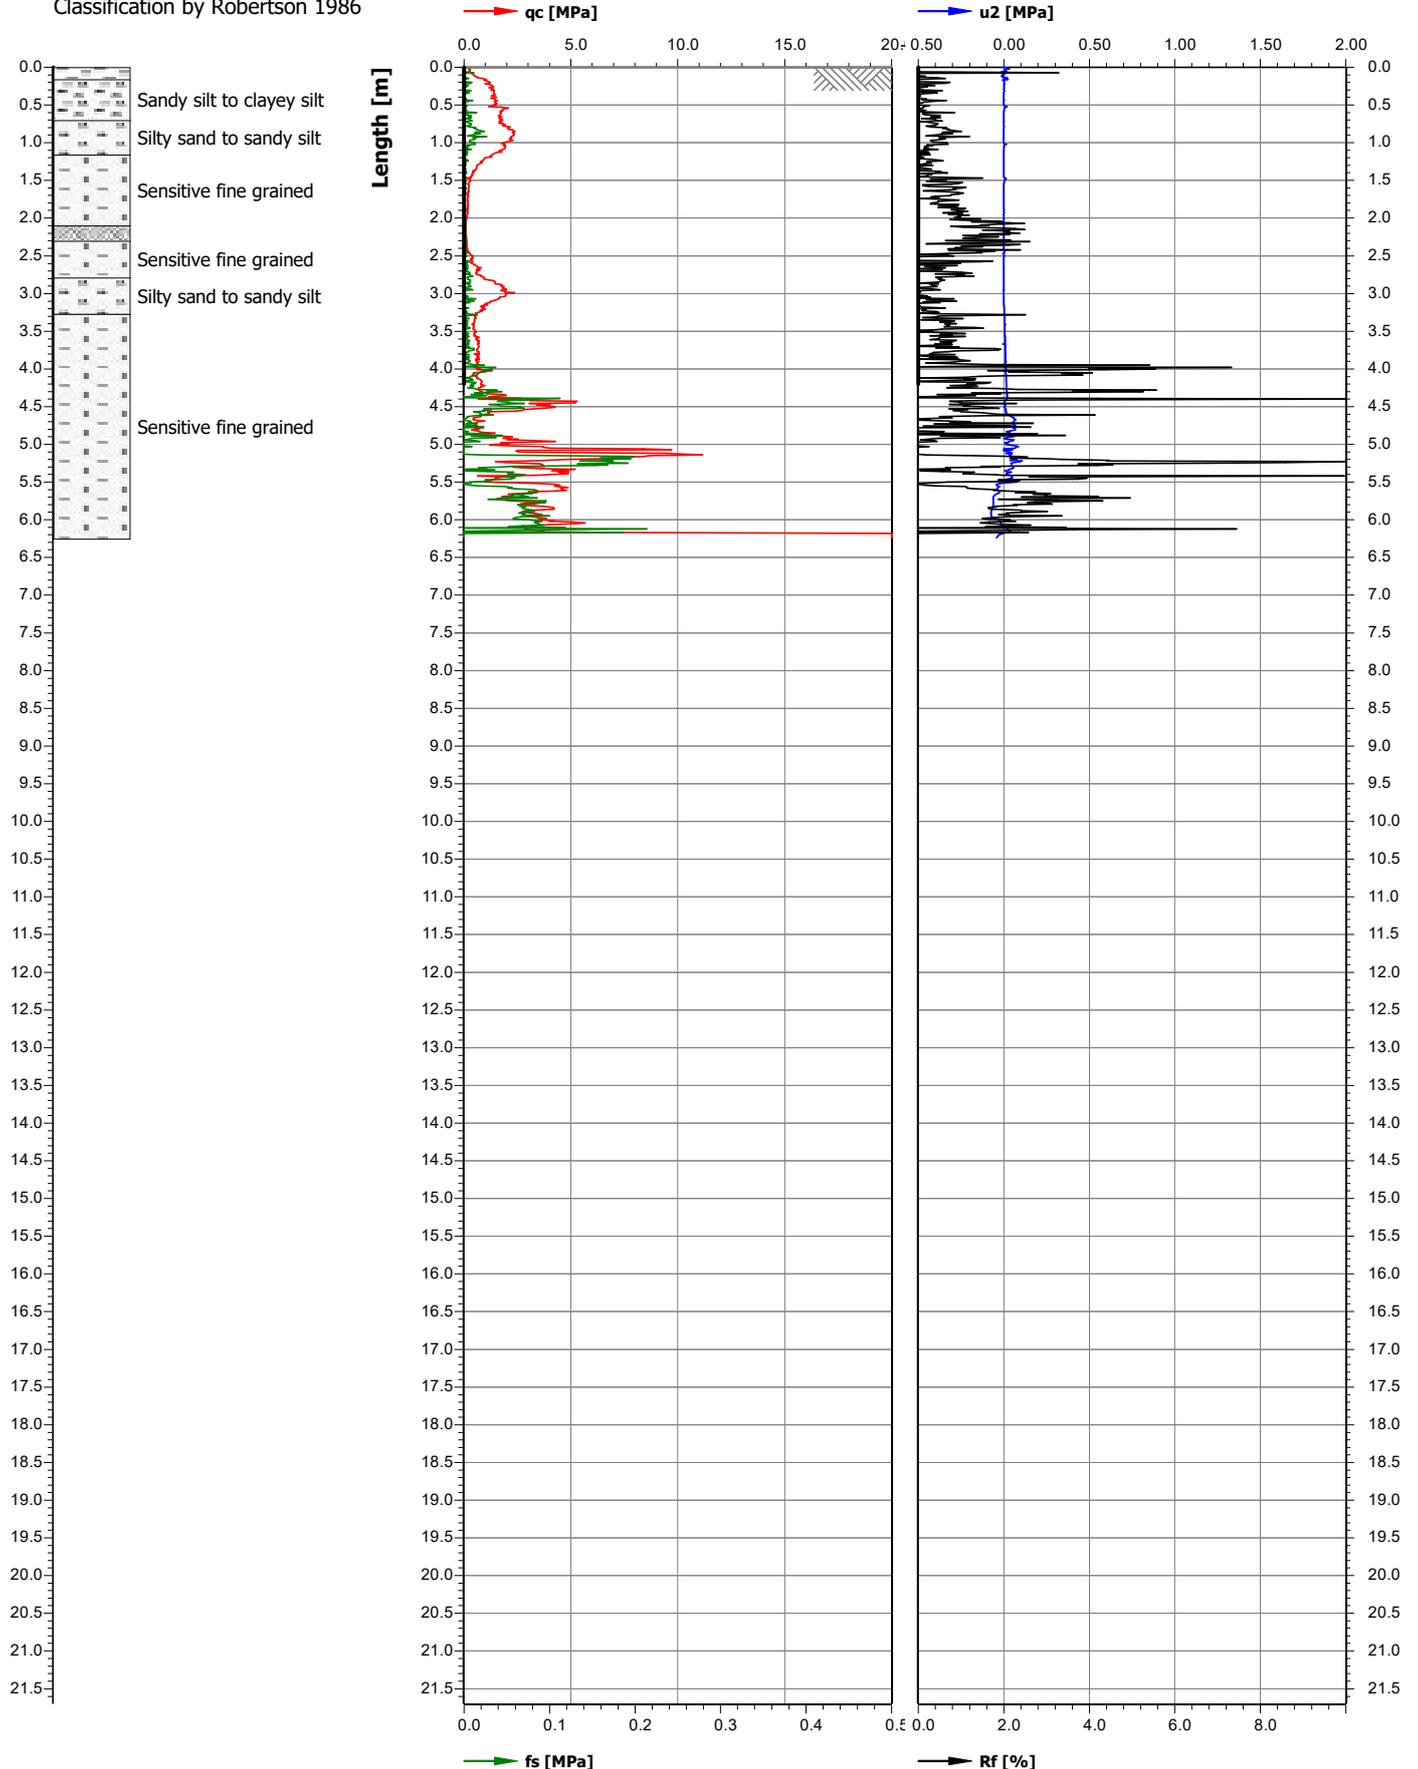
Classification by Robertson 1986

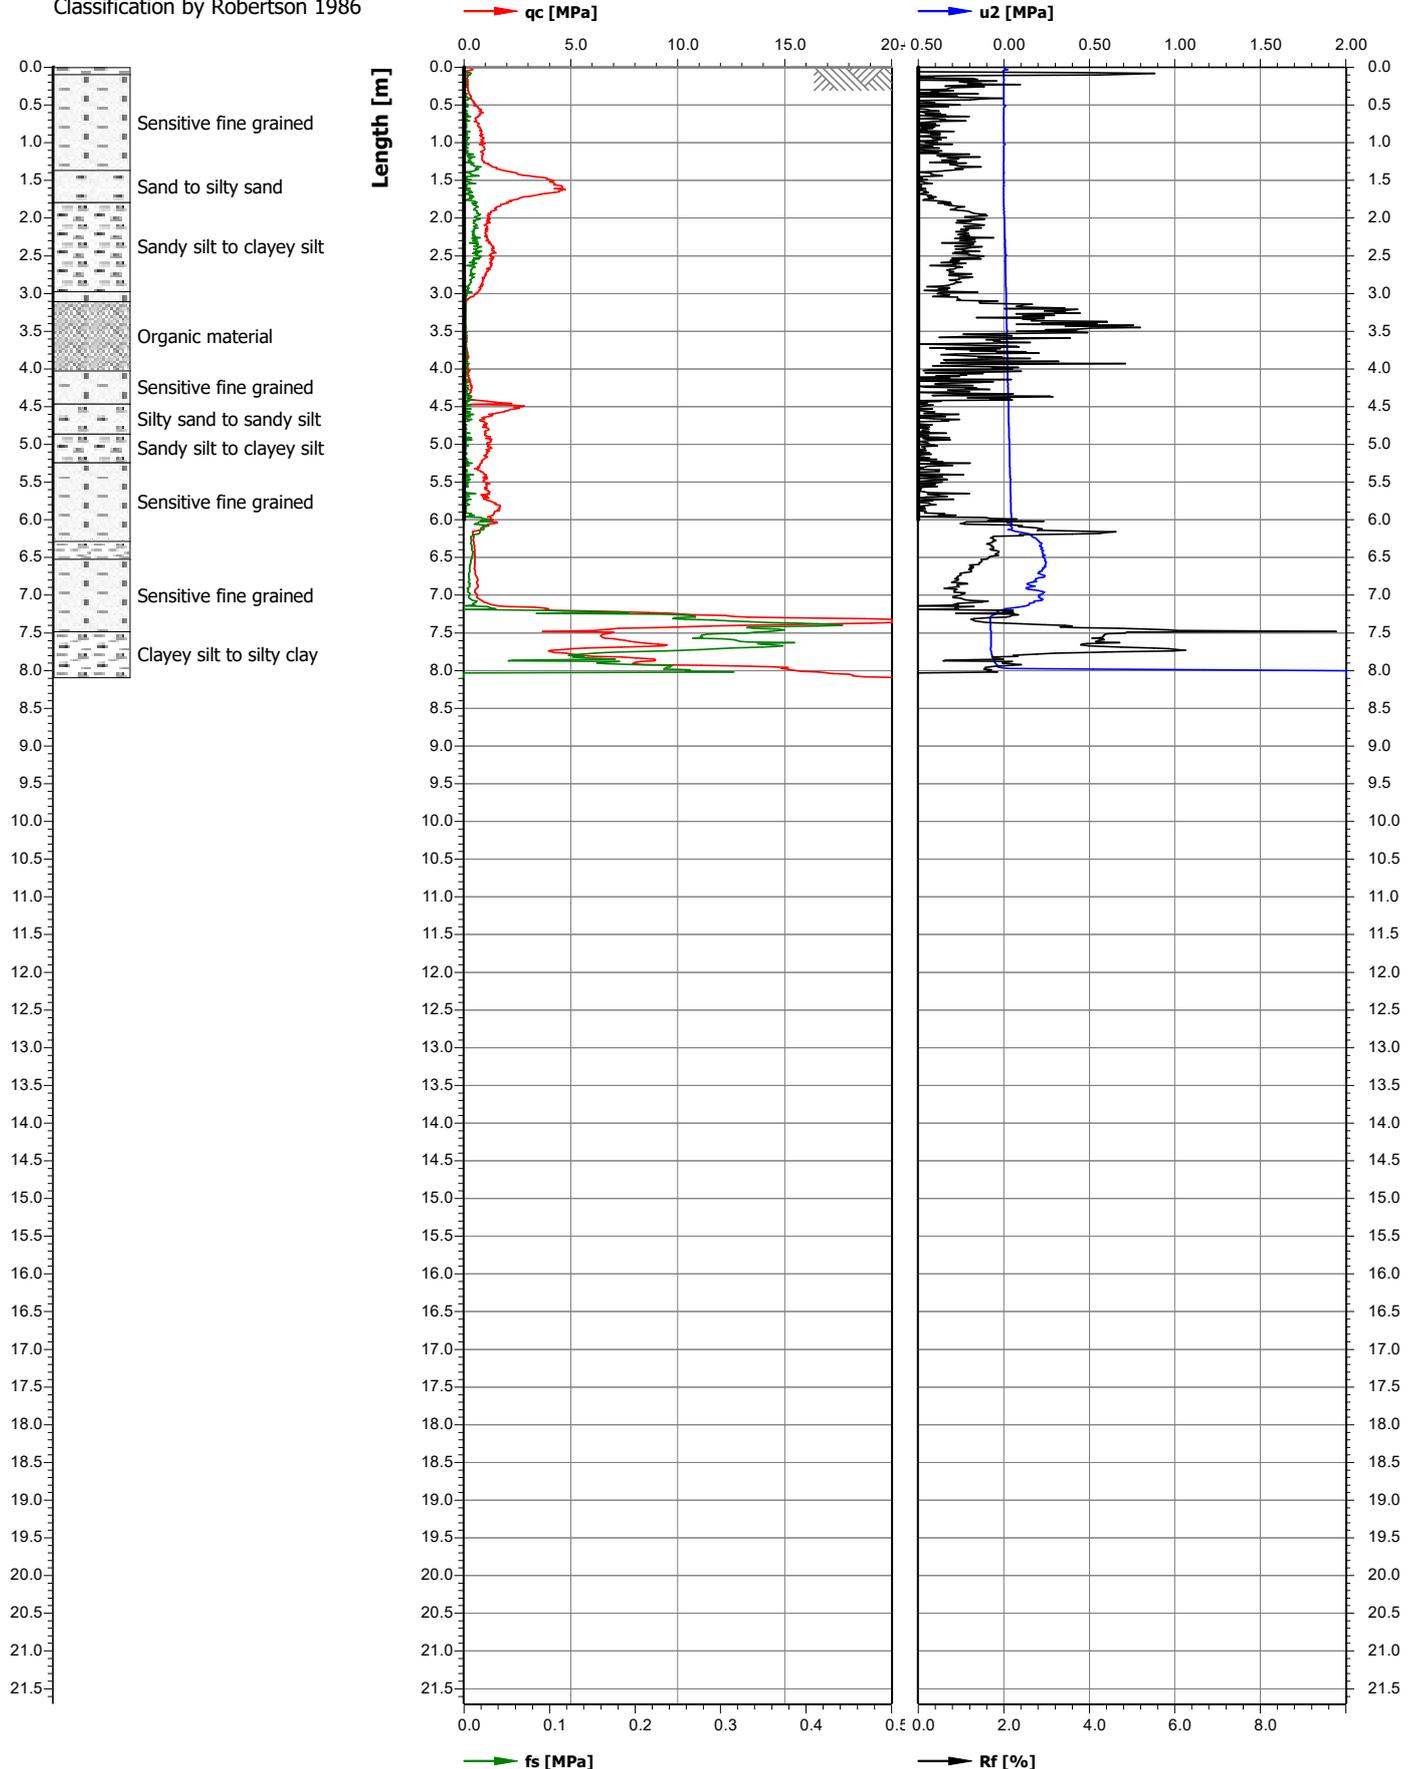
Classification by Robertson 1986
