## Auckland Regional Landfill

**Stormwater pond damming: s92 response**

Tonkin & Taylor Ltd

December 2019

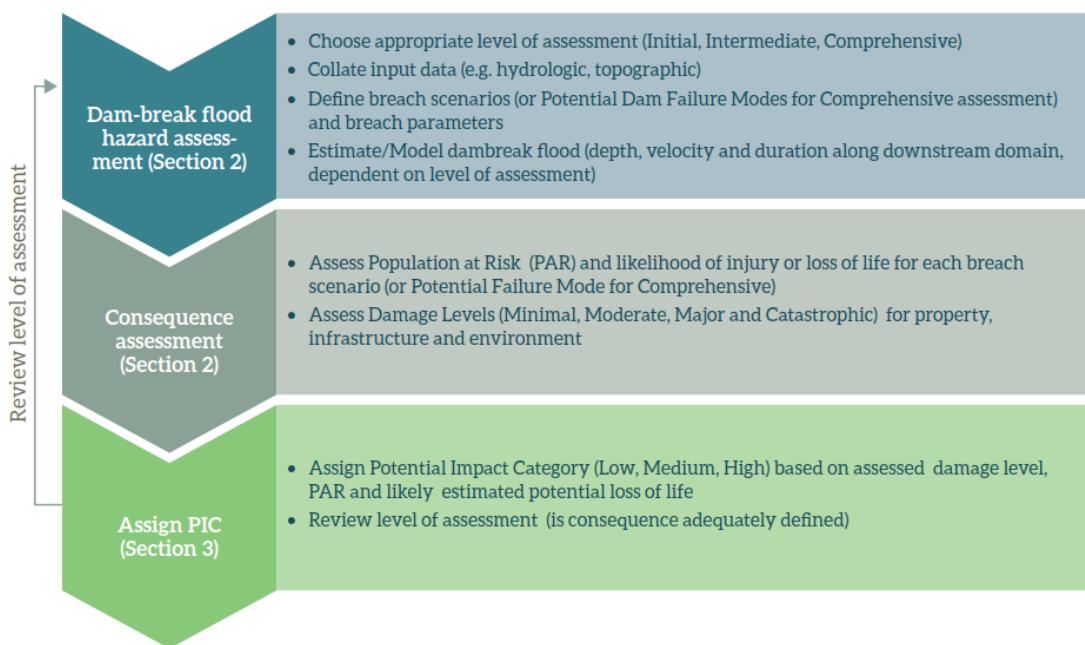
Figure 8.1: Overview of the dam classification process (extracted from NZSOLD's DSG 2015)

- The first step involves a dam-break flood hazard assessment. There are three levels of dam-break assessment that could be undertaken: initial, intermediate and comprehensive. Therefore, a decision must be made at the outset as to what level of assessment will be adopted. This decision is dependent on the amount of data available and the overall objective of the assessment. The process requires that the decision regarding the level of assessment be reviewed once the PIC has been determined. For this study we have completed an intermediate assessment.

- The second step involves the determination of a damage level that a dam failure event is expected to cause to private properties, critical or major infrastructure, or the natural environment as well as taking into account the anticipated recovery time following the failure incident. This second step also assesses the population at risk (PAR) that will likely be exposed to the flooding caused by a hypothetical dam failure incident.

- In the third and final step, the PIC of the dam is assigned based on the assessed damage level and the PAR in step 2.

The overall process is summarised in **Figure 8.1**. Each step is outlined in more detail in the following sections.

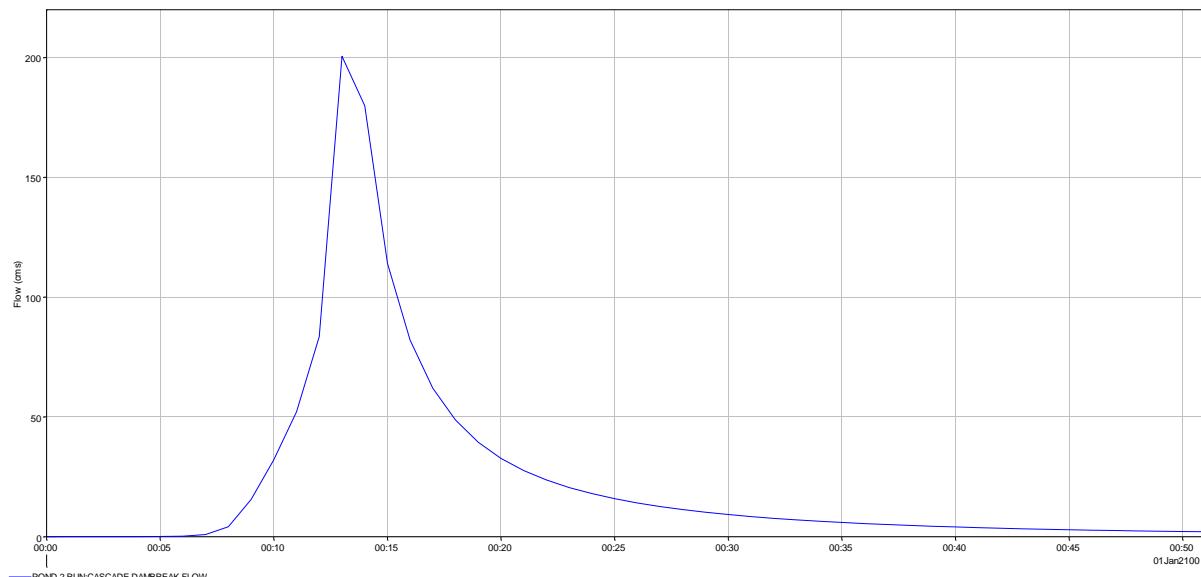
Figure 8.2: Combined dam-break flood hydrograph coming out of Pond 2 (horizontal axis showing time in minutes)

HEC-HMS version 4.3 was used to simulate a cascade dam failure scenario, i.e. the ‘domino’ effect of the failure of an upstream dam causing consequential failure of downstream dams. Breach parameters used in the model for each dam were estimated using Froehlich (2008) method. Breach parameters are used in the model to simulate the failure process associated with the dam. Breach parameters include factors such as the final breach shape and the time it takes to reach the final breach shape. Froehlich (2008) method, like many other methods, uses empirical formula developed from historical dam failure cases.

- Pond 4 dam, the most upstream, will fail when pond water level is at primary spillway level of 85.2 mRL. Dam-break outflow from Pond 4 will then discharge into Pond 3 raising Pond 3 water level.
- Pond 3 dam will fail when water level reaches its auxiliary spillway level of 84.7 mRL. Dam-break outflow from Pond 3 will then discharge into Pond 2, the most downstream, raising Pond 2 water level.
- Pond 2 dam will fail when water level reaches its auxiliary spillway level of 78.5 mRL. Combined dam-break outflow from Pond 2 will then discharge into the downstream environment.

The combined dam-break hydrograph out of Pond 2, obtained from the HEC-HMS model was then routed through a 2 dimensional (2D) flood model to estimate the downstream dam-break flood impact. Maximum combined dam-break discharge coming out of Pond 2 was estimated at approximately 200 m<sup>3</sup>/s. The dam-break hydrograph coming out of Pond 2 is shown in Figure 8.2 below.

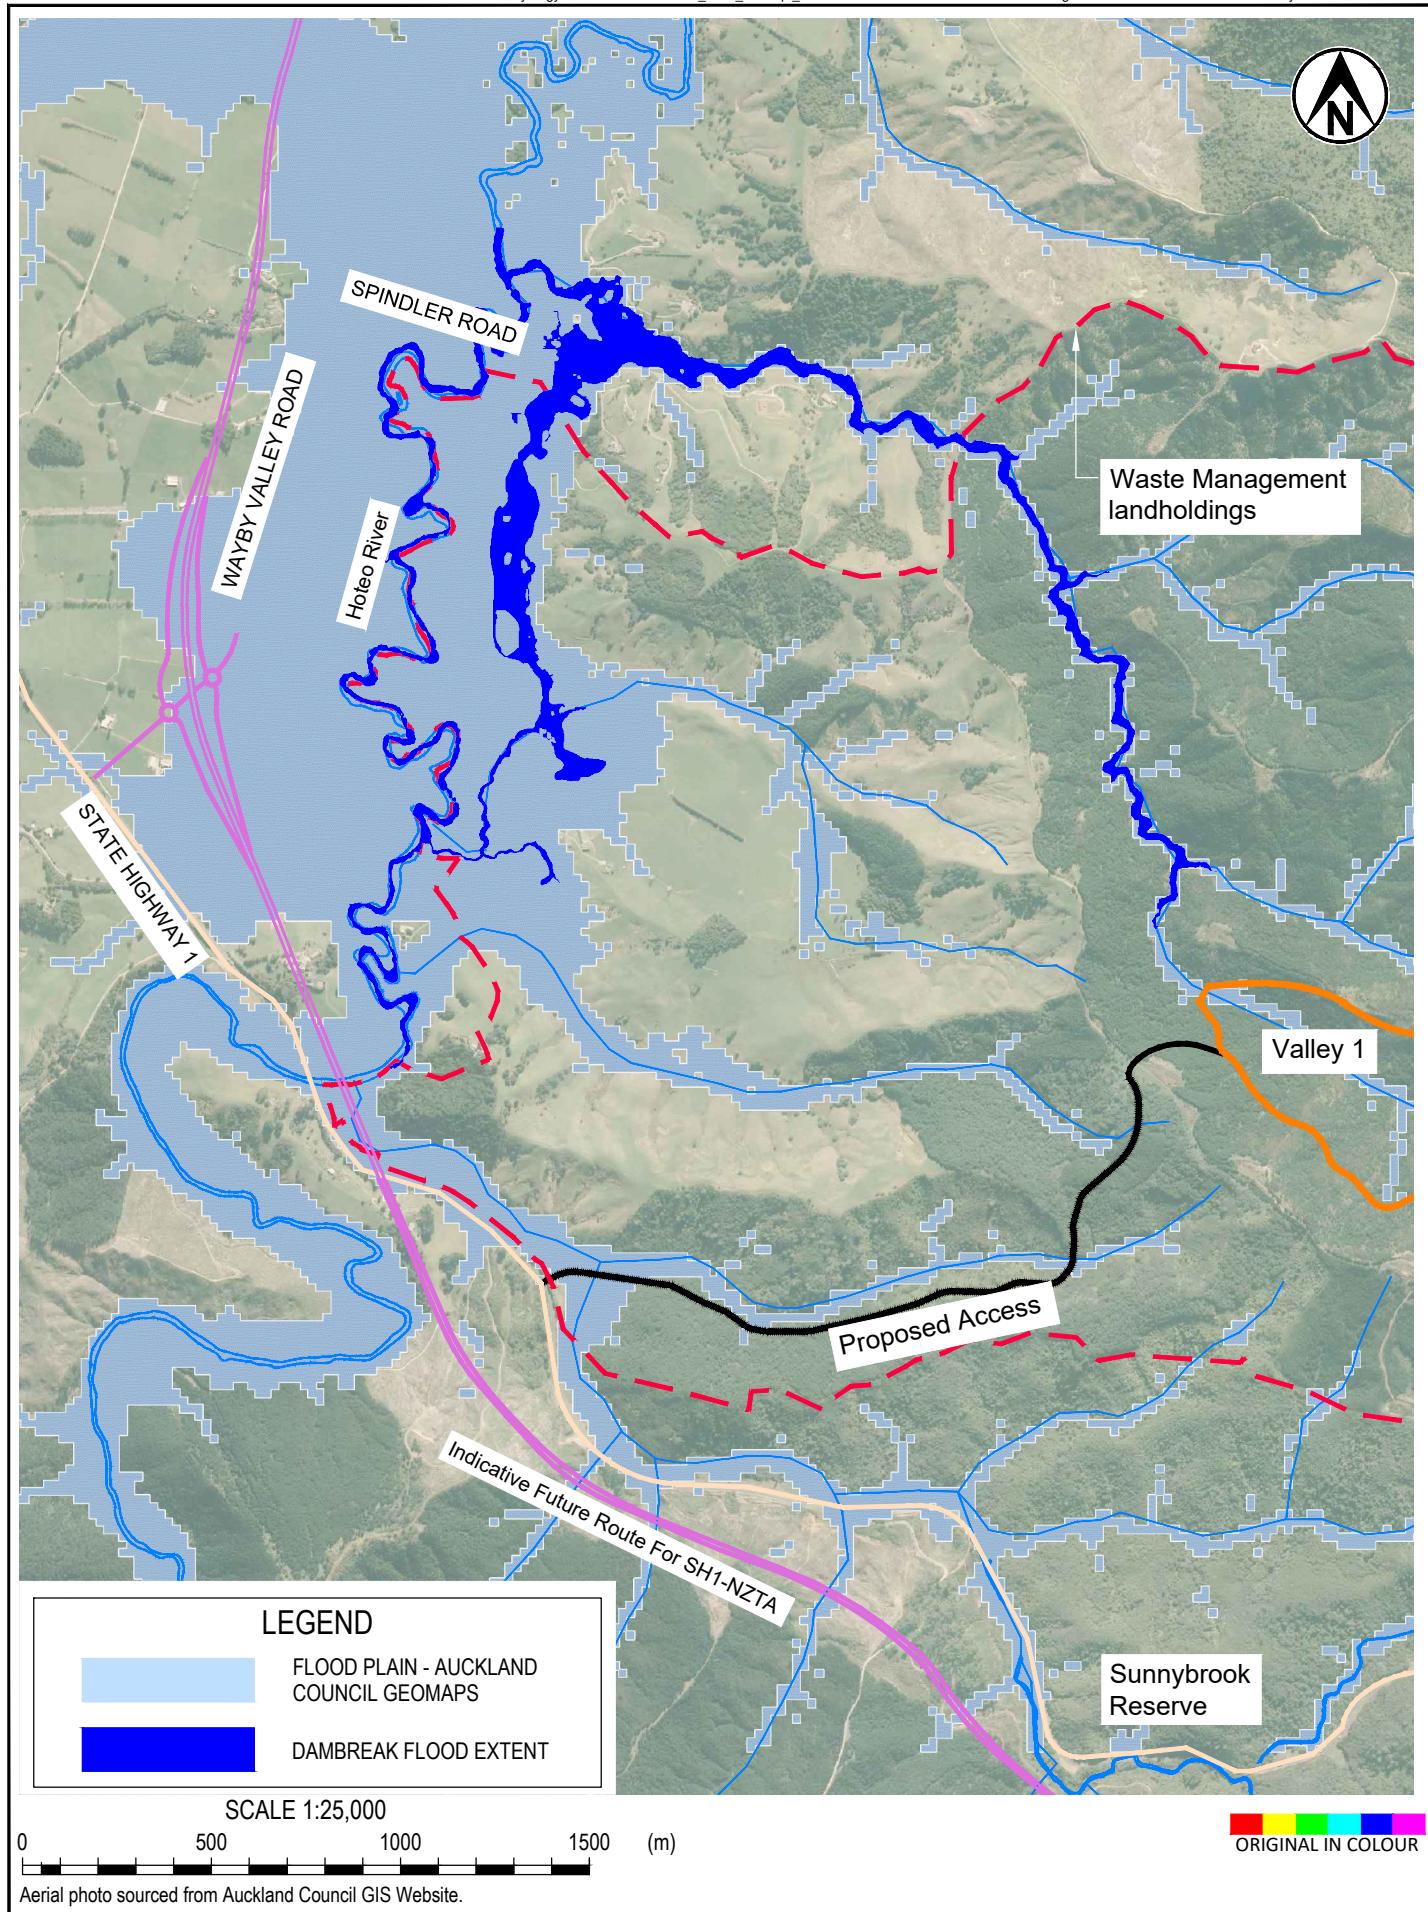
## **Appendix B: Figure from dam-break assessment**

Based on the findings of the dam-break assessment, the damage level under a cascade failure scenario of Ponds 2, 3 and 4 is considered minimal.

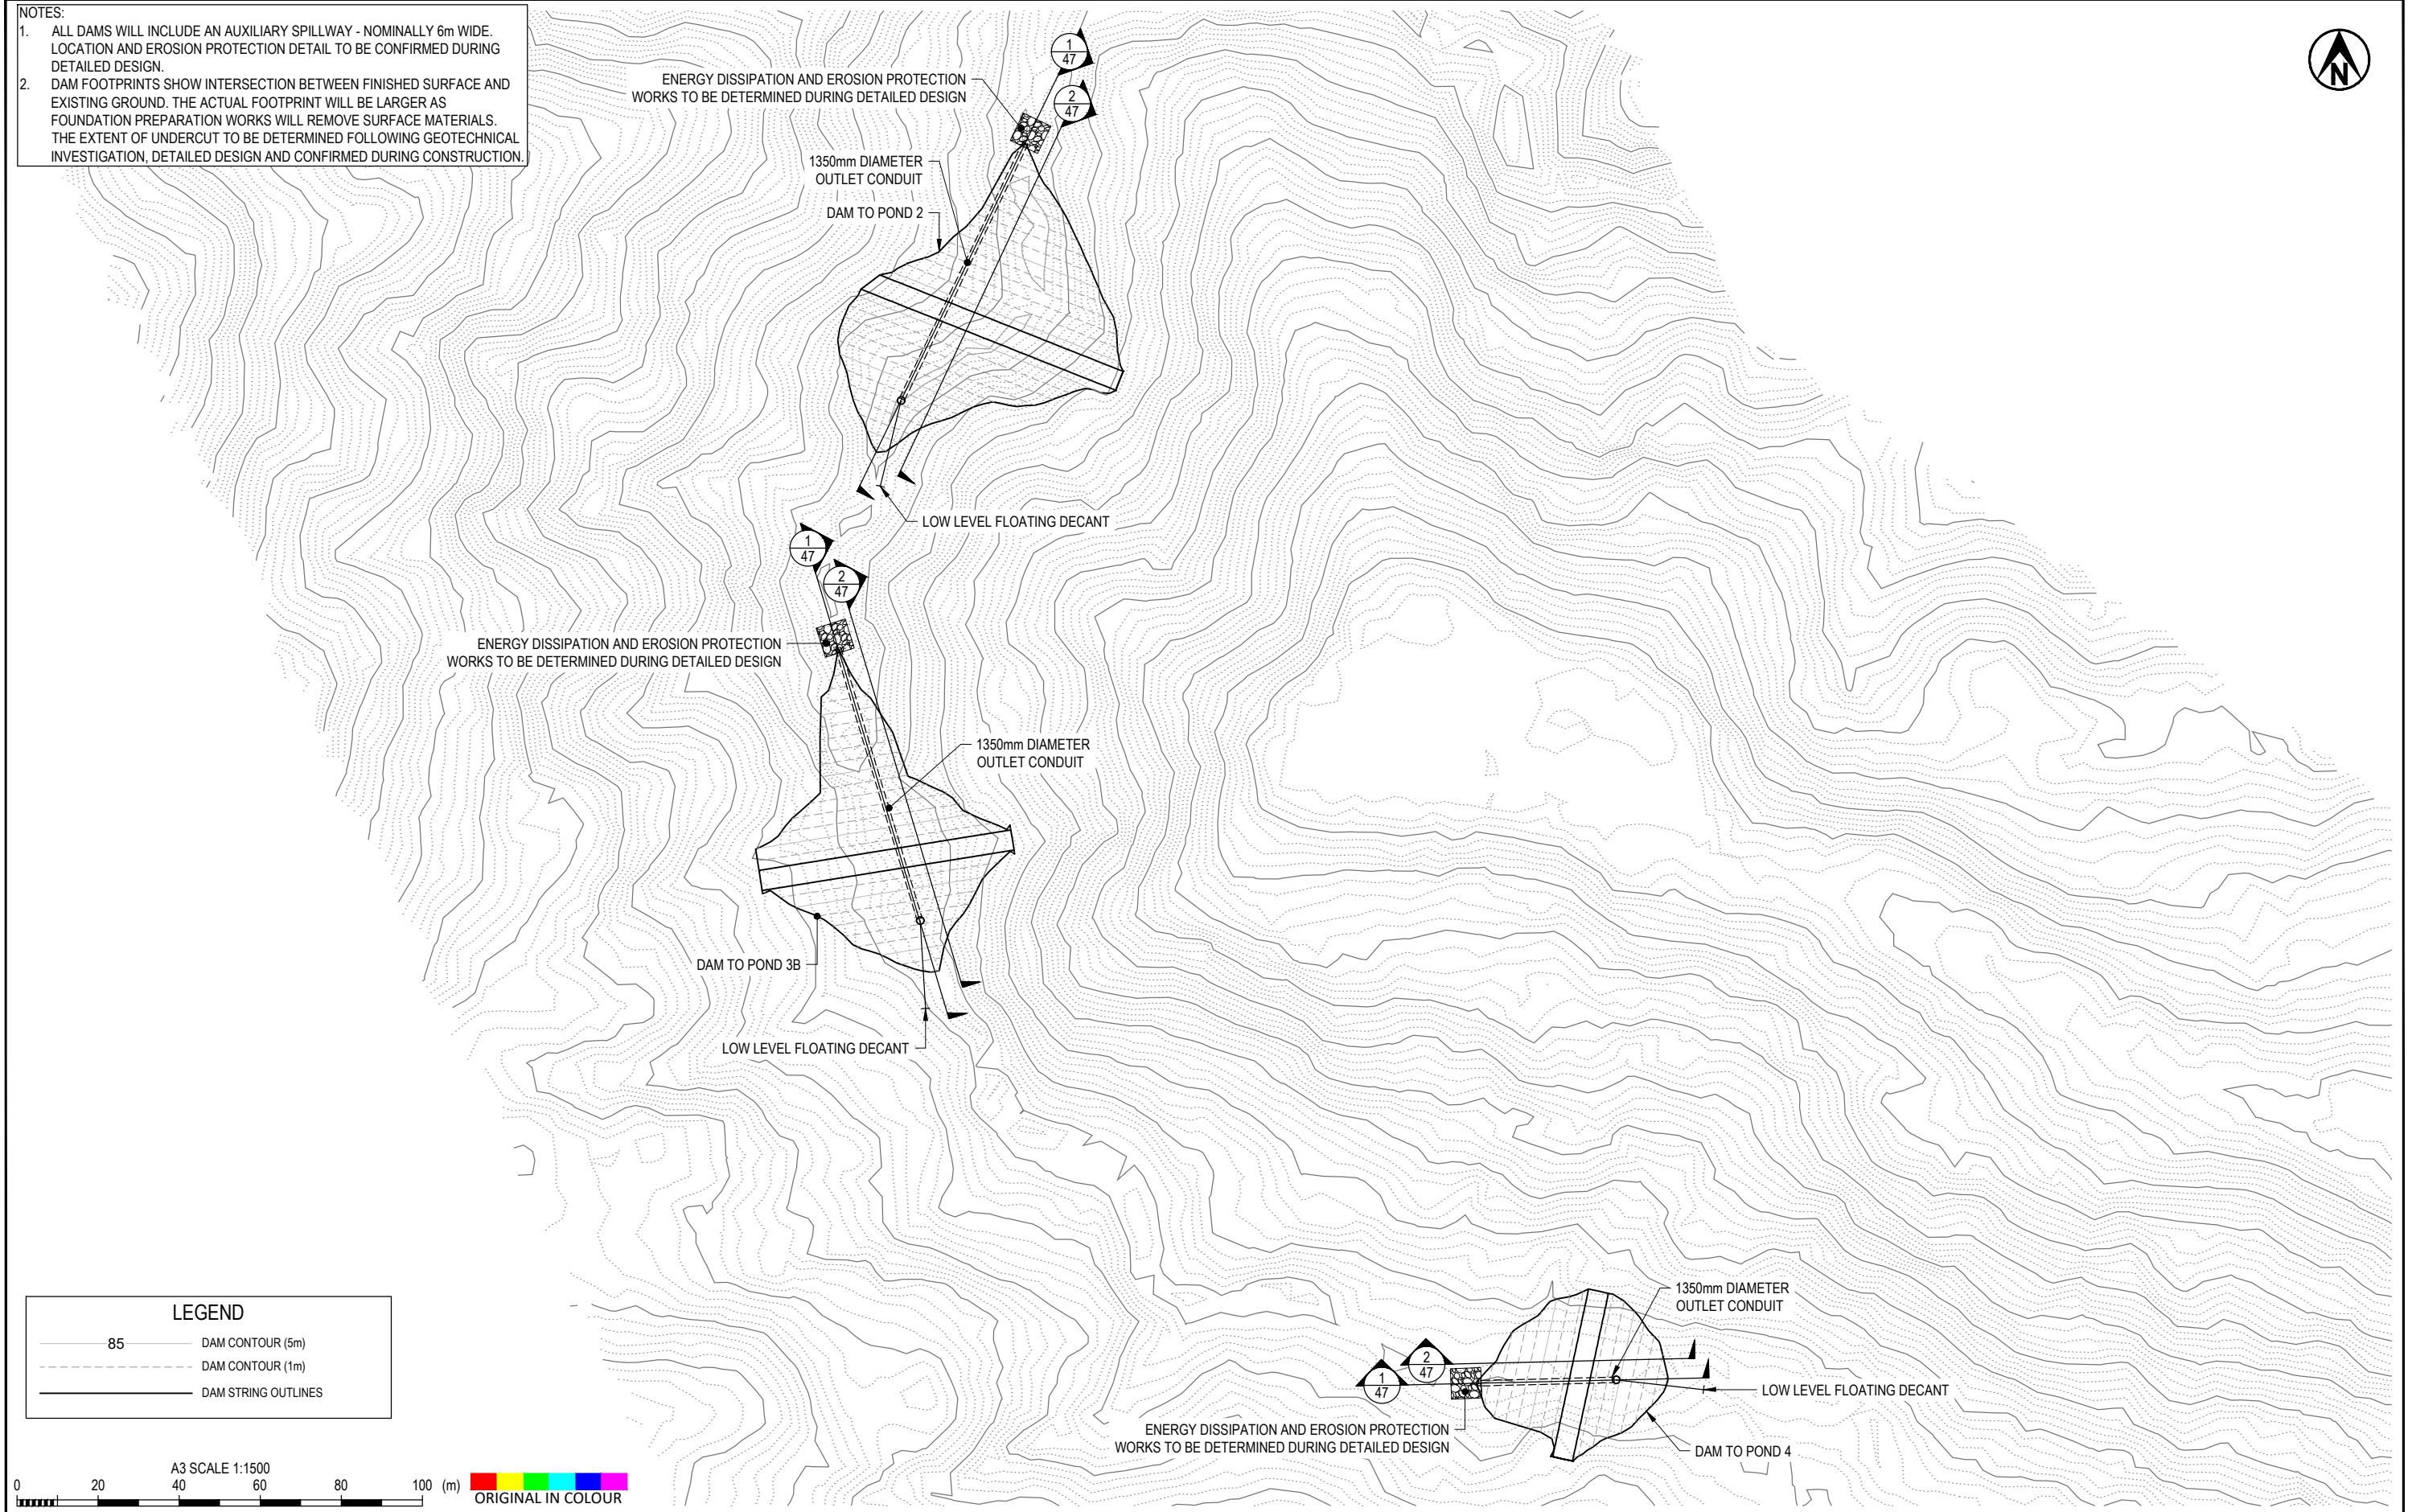
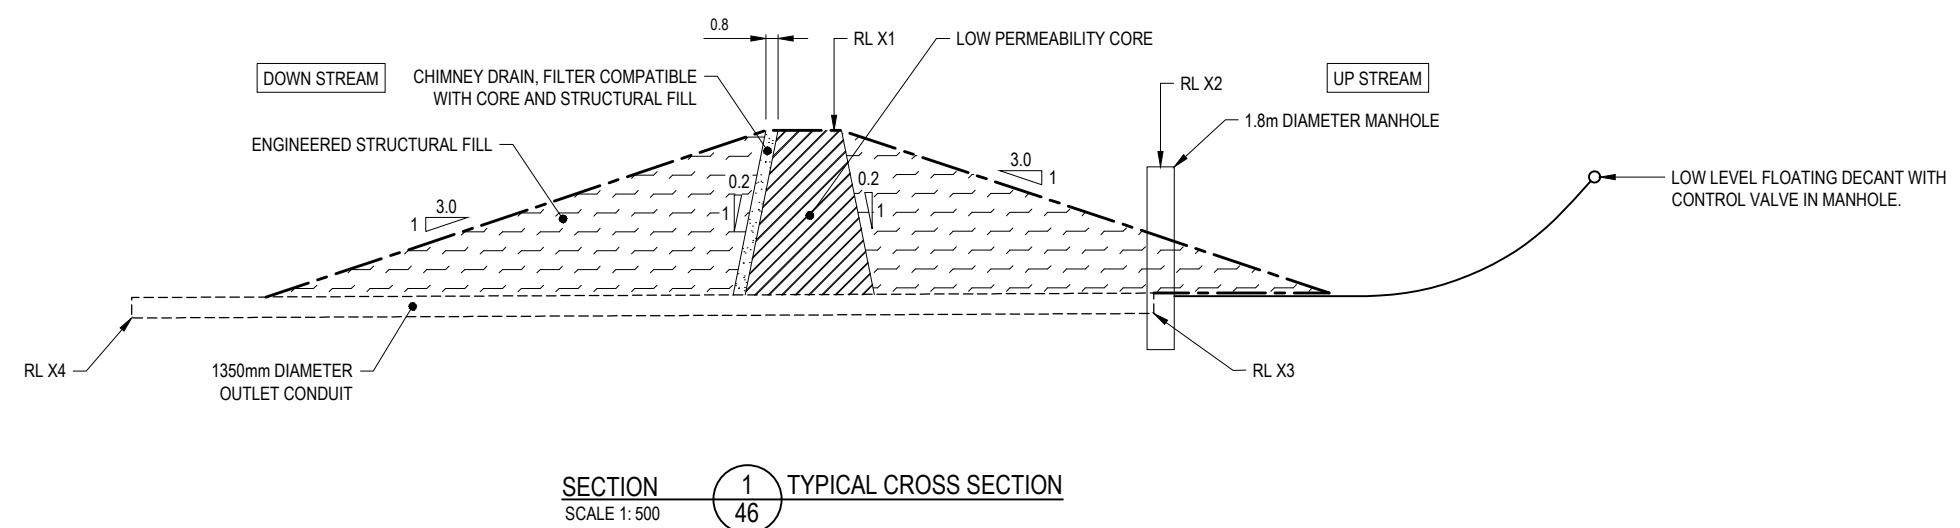
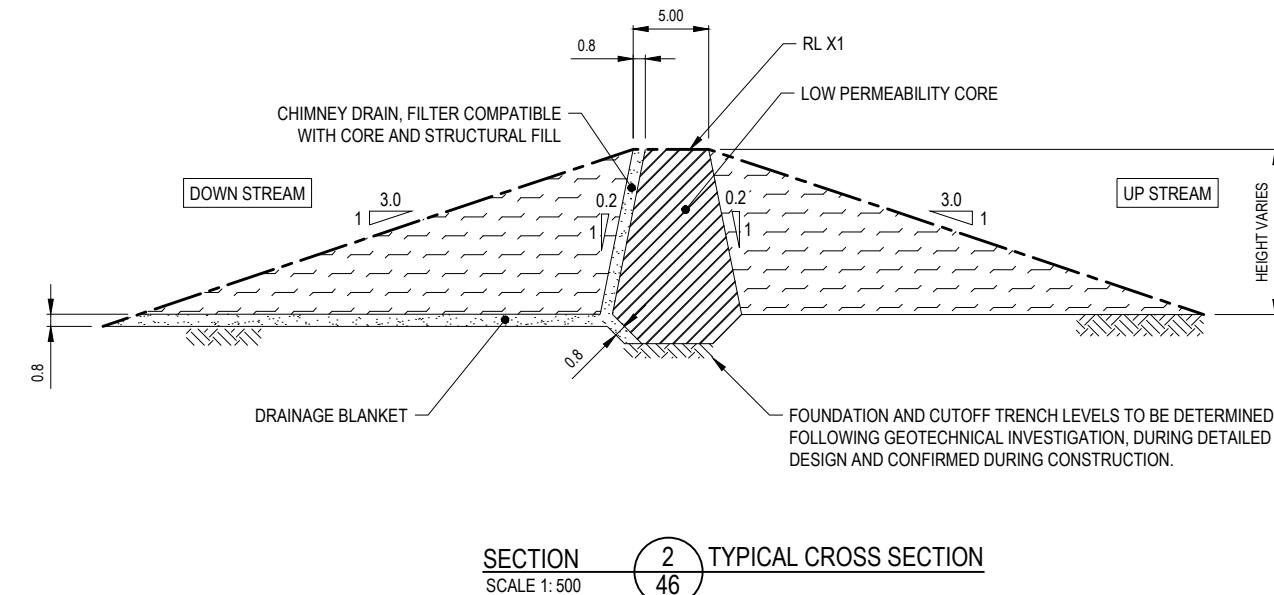
## **Appendix C: Drawing**

- ALL DAMS WILL INCLUDE AN AUXILIARY SPILLWAY - NOMINALLY 6m WIDE. LOCATION AND EROSION PROTECTION DETAIL TO BE CONFIRMED DURING DETAILED DESIGN.
- DAM FOOTPRINTS SHOW INTERSECTION BETWEEN FINISHED SURFACE AND EXISTING GROUND. THE ACTUAL FOOTPRINT WILL BE LARGER AS FOUNDATION PREPARATION WORKS WILL REMOVE SURFACE MATERIALS. THE EXTENT OF UNDERCUT TO BE DETERMINED FOLLOWING GEOTECHNICAL INVESTIGATION, DETAILED DESIGN AND CONFIRMED DURING CONSTRUCTION.

POND 2	POND 3B	POND 4
RL X1	80.6m	86.8m	87.4m
RL X2	78.2m	84.4m	85.2m
RL X3	68.5m	78.5m	81.5m
RL X4	68.2m	78.2m	81.2m
