### NZ Steel - Glenbrook Steel Mill Structural Inspection of Southside and Northside Outfalls

### 1 Introduction

This report summarises the findings of our structural inspection, and includes commentary on the expected structural integrity of the outfalls over the term of the consent (up to 35 years), including the effects of predicted sea level rise.

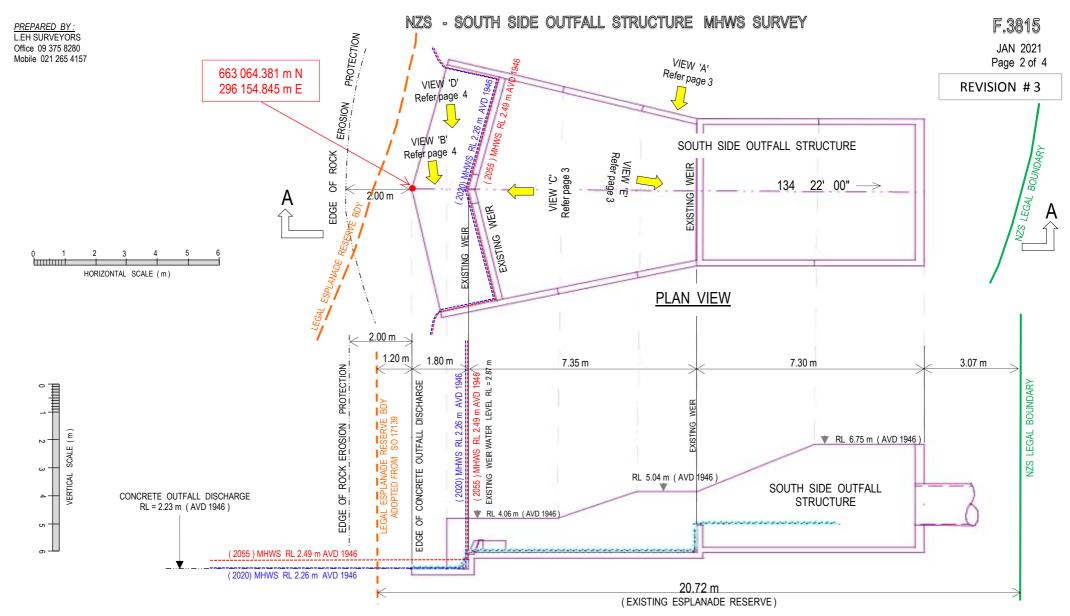
## LONGITUDINAL SECTION THROUGH SOUTH SIDE OUTFALL STRUCTURE <u>ELEVATION 'A - A'</u>

#### Future projected MHWS levels ( supplied by Tonkin & Taylor ) MHWS ( m AVD - 46 ) **PERIOD** Year Present 2020 2.26 m 2045 2.41 m 25 Years 2055 35 Years 2.49 m 100 Years 2120 3.23 m

To confirm the extent that the outfalls will be within the Coastal Marine Area (CMA) over the 35 year term of the consent, a level survey was undertaken by LEH Surveyors in January 2021. Survey results are included in Appendix A, together with current and predicted future Mean High Water Springs (MHWS) levels provided by T+T.

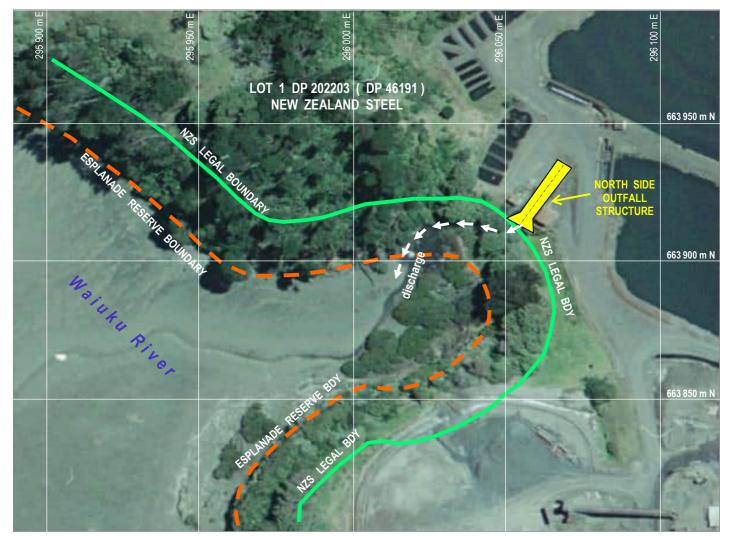
AERIAL PHOTO - PLAN VIEW

## NZS - NORTH SIDE OUTFALL STRUCTURE MHWS SURVEY SITE LOCALITY PLAN

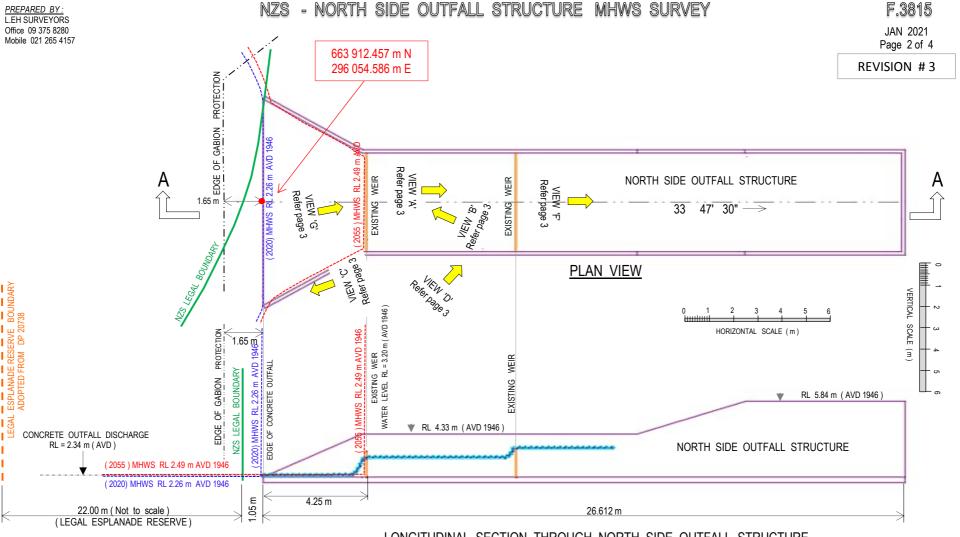
## LONGITUDINAL SECTION THROUGH NORTH SIDE OUTFALL STRUCTURE <u>ELEVATION 'A - A'</u>

Future projected MHWS levels ( supplied by Tonkin & Taylor )			
	<u>PERIOD</u>	<u>Year</u>	MHWS ( m AVD - 46 )
	Present	2020	2.26 m
	25 Years	2045	2.41 m
	35 Years	2055	2.49 m
	100 Years	2120	3.23 m
