Document Ref: AKL2021-0235AC Rev 2

Maven Associates Limited

RE: GEOTECHNICAL APPRAISAL REPORT 1738 STATE HIGHWAY 1, WARKWORTH

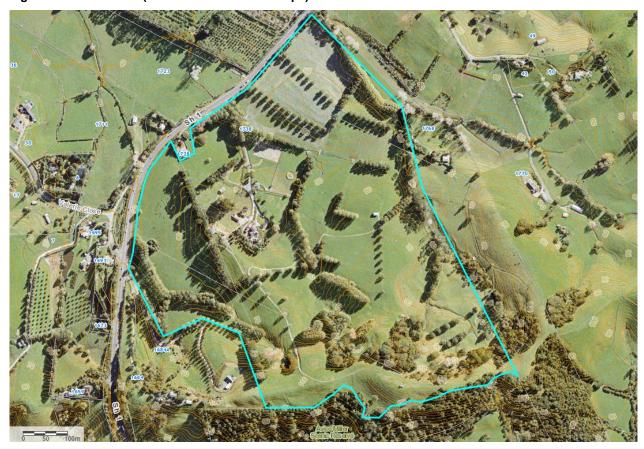
Figure 2: Site Location and Landform (Auckland Council GeoMaps)

The site location and current general landform, together with associated features located within and adjacent to the site is presented on Figures 1 and 2 below.

Topography of the site is dominated by a relatively steep, prominent ridgeline along the southern boundary with a maximum elevation of approximately RL 129m. Two smaller ridgelines spur off this prominent ridge, grading steeply to moderately to the north of the site. Maximum elevations along these spur ridges range between RL 50m and RL 100m. Topography in the northern portion of the site is generally characterised by gentler, rolling hills. Multiple head scarps are visible across the site, mainly along the heads and flanks of gullies, with a large instability feature present toward the southeast corner of the site extending outside of the site boundary.

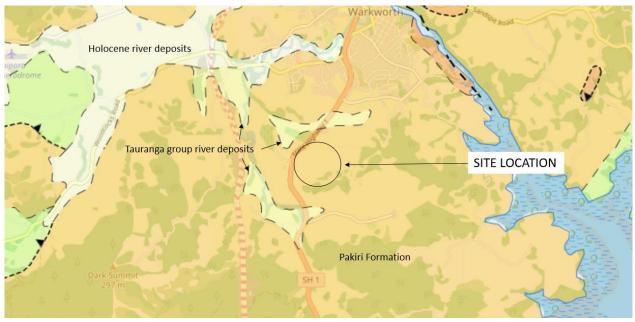
Figure 3: Regional Geology (GNS Science Web Geology Map)

Published geological maps¹ depict the area as comprising Pakiri Formation of the Waitemata Group, described as alternating thick-bedded, volcanic rich, graded sandstone and siltstone with volcanic grit beds which age back to the Neogene. North of the site the Pakiri Formation is overlain with middle to late Pleistocene river and hillslope deposits from the Tauranga Group. Surrounding geologies also include Holocene river deposits and Mahurangi Limestone of the Northland Allochthon, as illustrated in Figure 3 below.

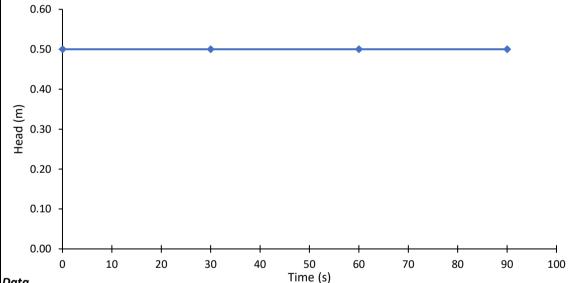
Hvorslev (1951) Time Lag and Soil Permeability in Ground-Water Observations , Fig 18, p49

0.00E+00 ms⁻¹

0.00 m/day

CLIENT:	Maven Associates Ltd	DESIGNER:	TE
PROJECT:	TECT: 1738 State Highway 1, Warkworth CHECKED: RK REVISION: 4		
	Warkworth	REVISION:	4
TITLE:	Folling Hood Permophility Toot	DATE:	5/08/2022
	railing nead Permeability Test	PROJECT:	AKL2021-0235

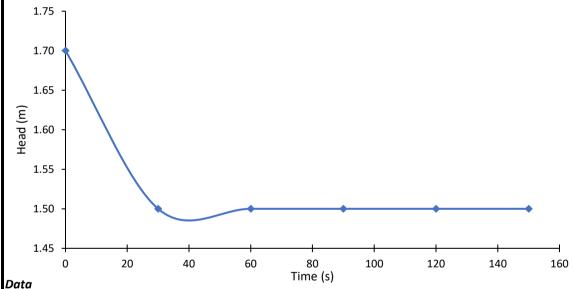
0.14 m/day

Time (s)	Tape Avg (m)	Head (m)	Perm. Length		Hvorslev 'k'	CIRIA 113 'k'
0 0.000		1.700	(m)		Case G (ms ⁻¹)	(ms ⁻¹)
30	0.200	1.500	1.900		8.32E-06	7.95E-05
60	0.200	1.500	1.800		0.00E+00	0.00E+00
90	0.200	1.500	1.800		0.00E+00	0.00E+00
120	0.200	1.500	1.800		0.00E+00	0.00E+00
150 0.200		1.500	1.500 1.800		0.00E+00	0.00E+00

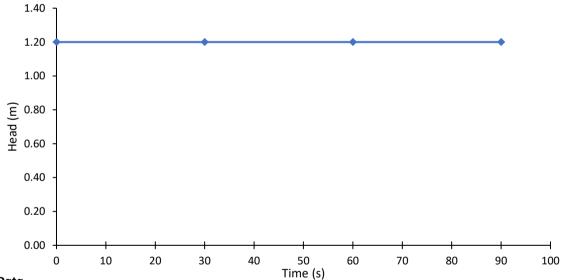
$$k = \frac{d^2 \ln\left(\frac{mL}{d} + \sqrt{\left(\frac{mL}{d}\right)^2 + 1}\right)}{8L(t_2 - t_1)} \ln\frac{H_1}{H_2} = 0.00E + 00 \text{ ms}^{-1} = 0.00 \text{ m/ds}$$

STRATIGRAPHIC LOG						
	Topsoil					
	Clayey Silt					
EOH @	D 2m					
	<i></i>
