Soil&Rock Consultants

Our Ref. 16425

12 August 2016

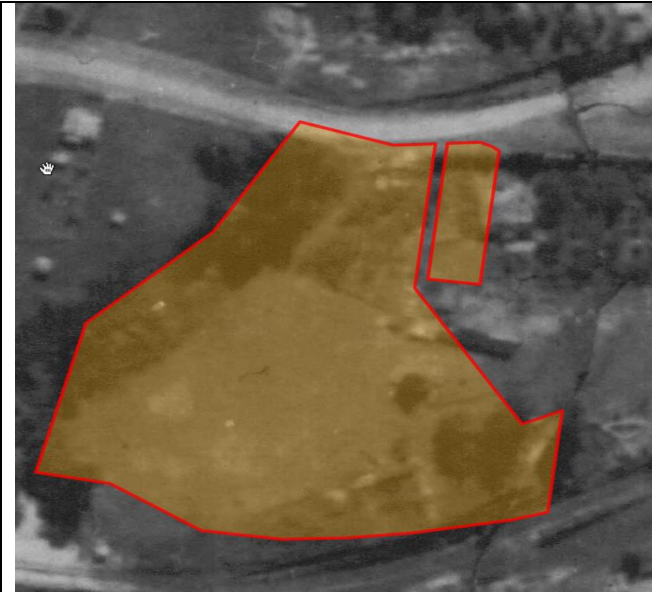
Photograph 1: Aerial photo taken in 1940 indicating no major development and the subject site being used as rural land.

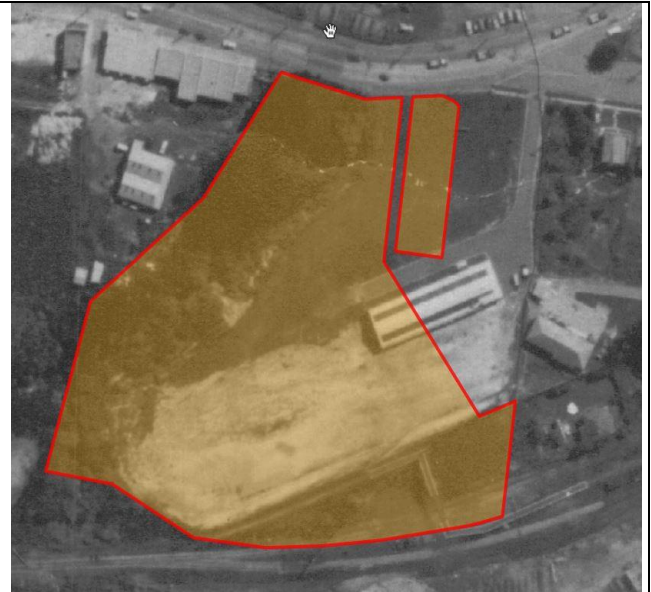
Photograph 2: Aerial photo taken in 1959 indicating the first building erected on the subject site and earthworks possibly in progress for further building platforms. Surrounding developments are also in progress.

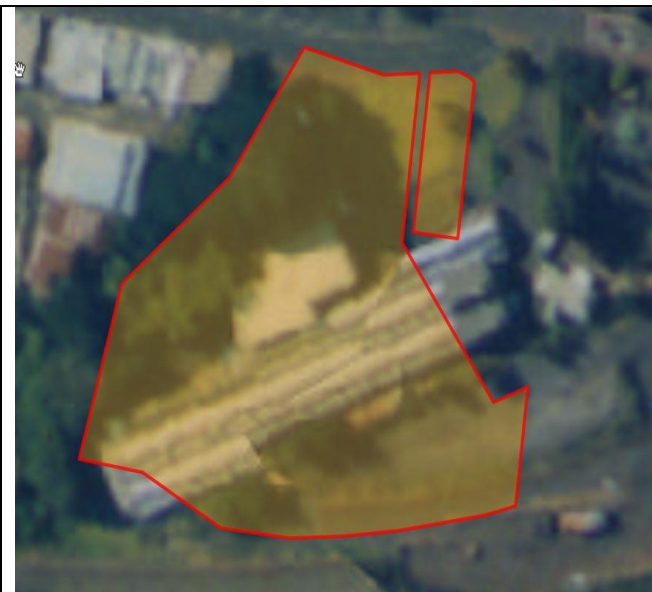
Photograph 3: Aerial photo taken in 1996 indicating the main commercial building that still occupies the site today has been fully erected.

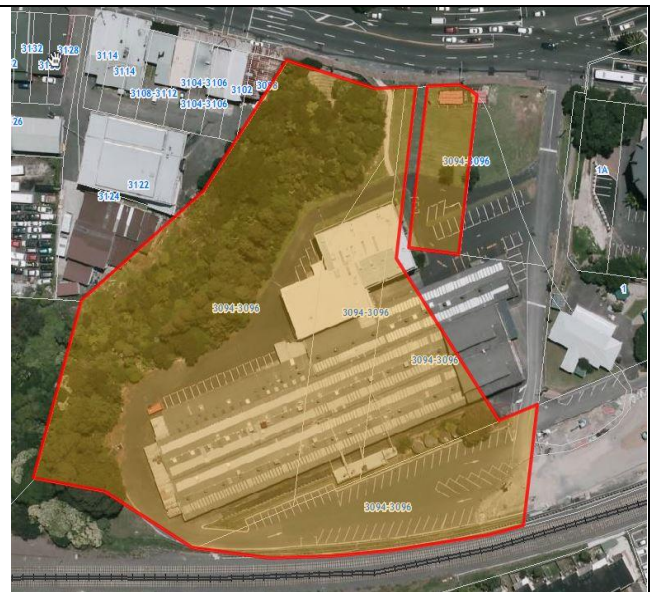
Photograph 4: Aerial photo taken in 2010 indicating the site has been fully developed to include extensive pavement areas for car parking and access and access.

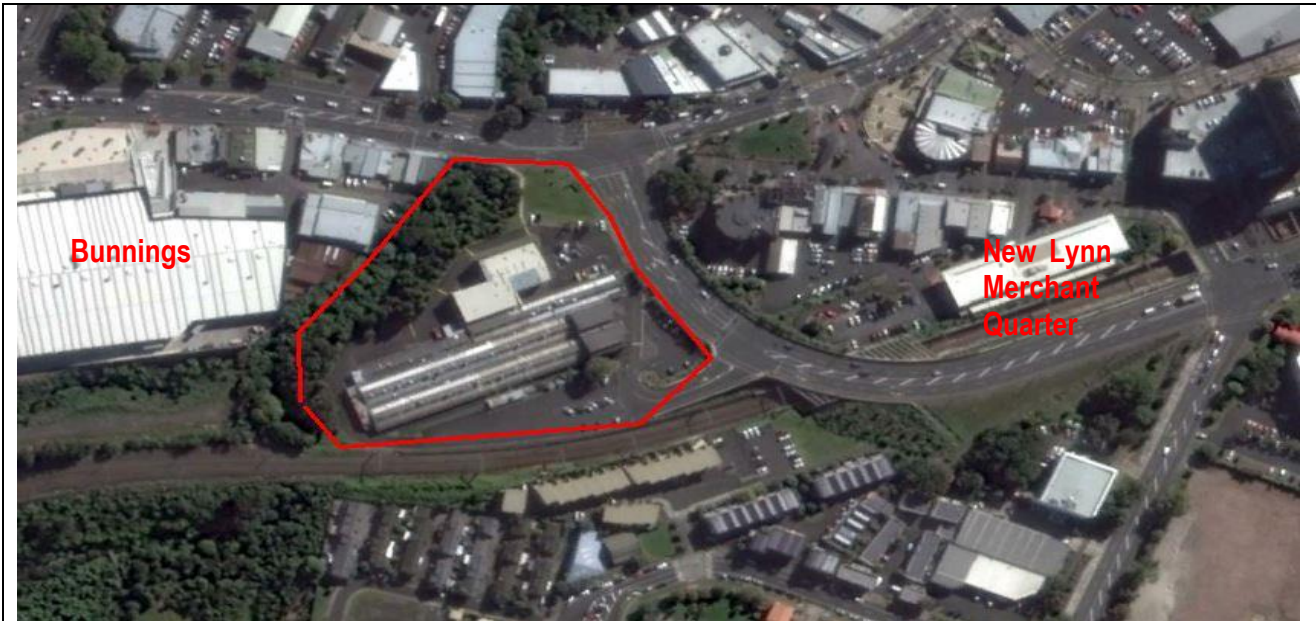
Photograph 5: Aerial photo taken in March 2016 indicating the recent road developments with the Clark Street widening and extension adjacent to the eastern boundary of the subject site.

Comparison of aerial photographs from 1959 through to 2016 reveals the following points considered relevant from a geotechnical perspective:

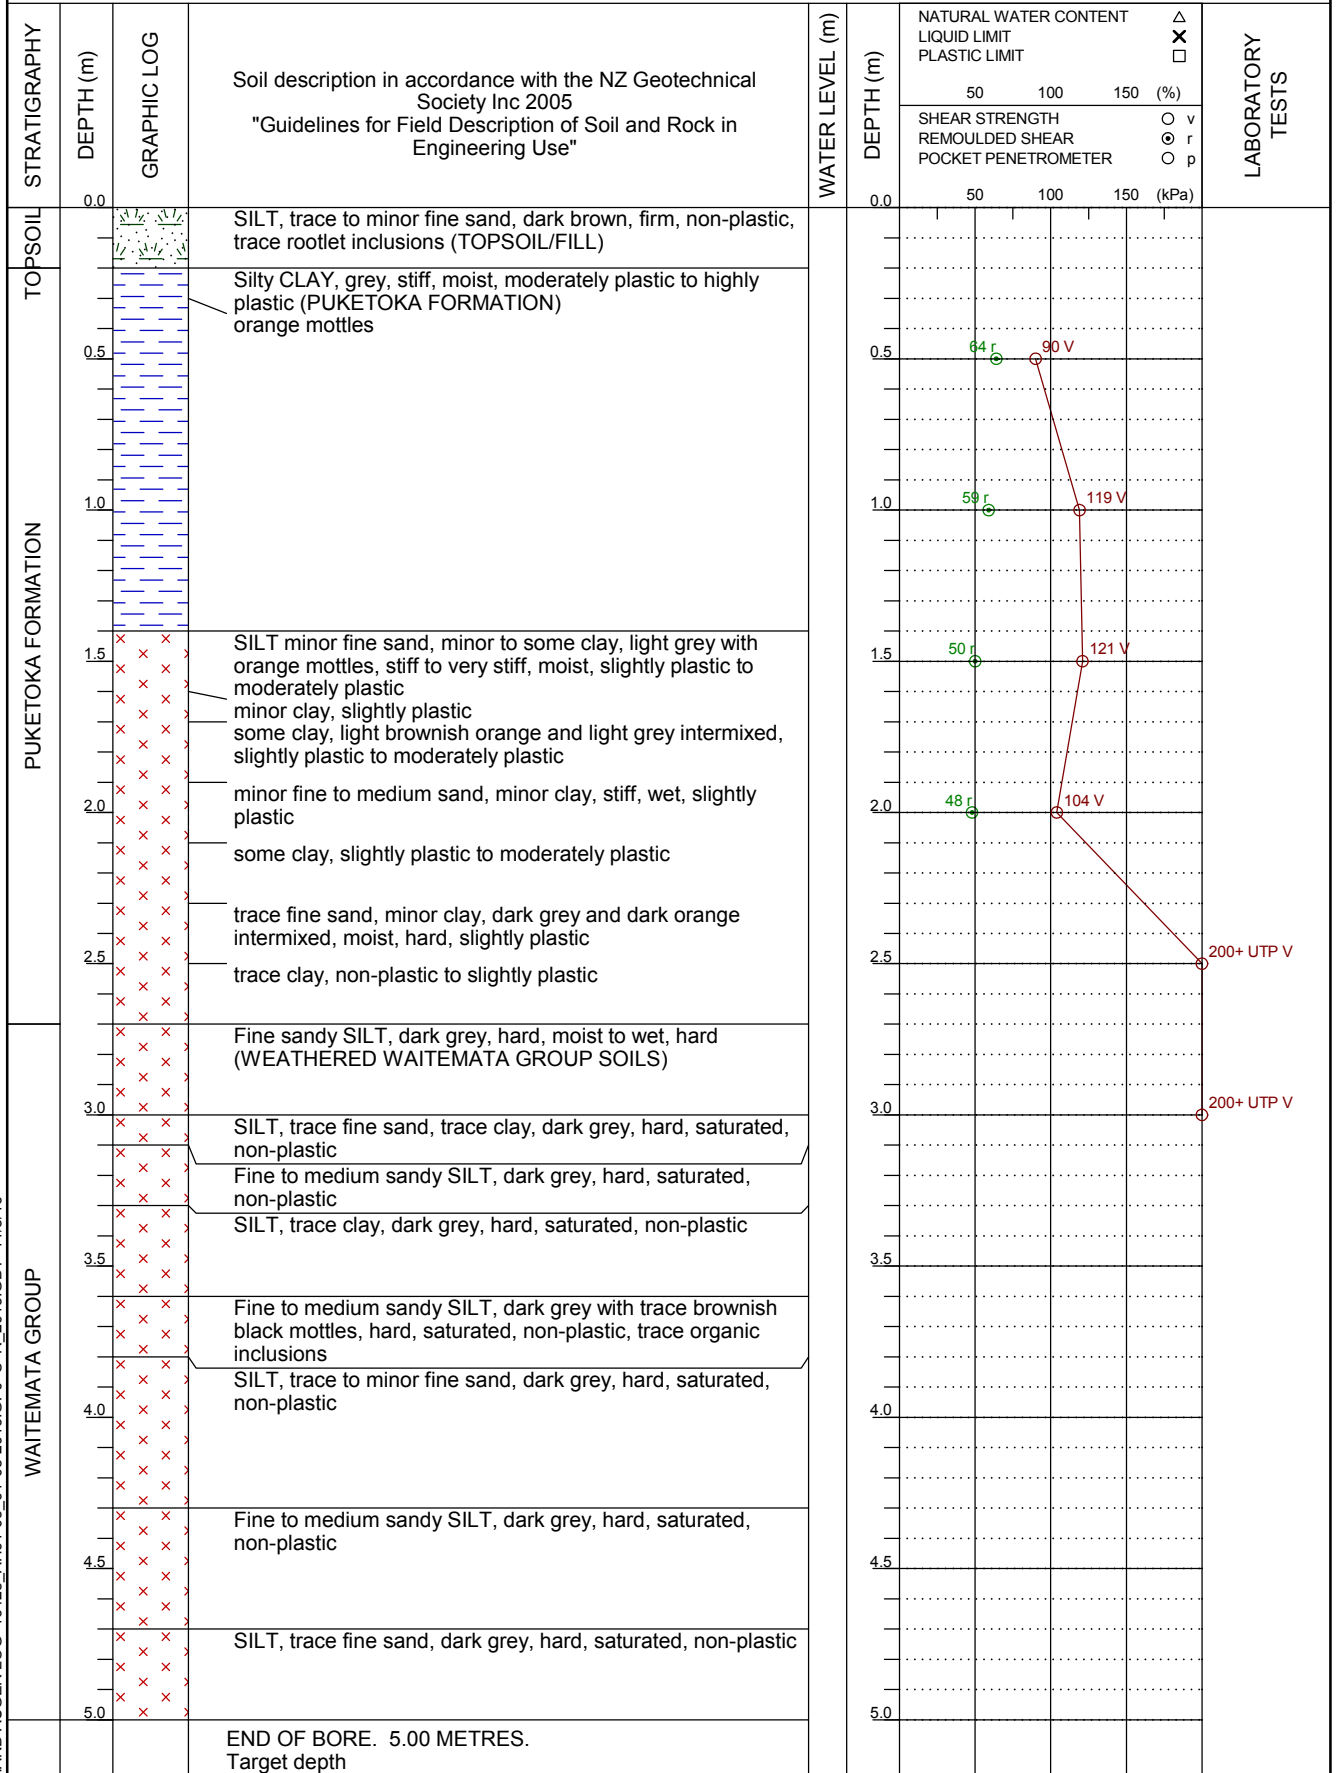
HAND AUGER LOG: 16425-AH01-03_01-08-2016.GPJ S+R_2013.GDT 11/8/16

Drill Type: Hand Auger	Project No: 16425	Logged By: JW
Drilled By: JW	Coordinates:	Shear Vane No - Calibration Date: GEO354 - 24/03/2016
Date Started: 1/8/16	Ground Elevation:	Surface Conditions: Slightly sloping grass
Date Finished: 1/8/16	Water Level: Groundwater not encountered

- Topsoil.** Topsoil was encountered from the ground surface at the locations of hand augerholes AH101, AH103, AH3, AH4, AH7, AH8, AH10, MB1, MB2 and MB3 to depths between 0.1m and 0.4m below present ground level (bpgl). Topsoil is unsuitable for the support of permanent structures (ie building foundations, floor slabs, retaining walls etc)

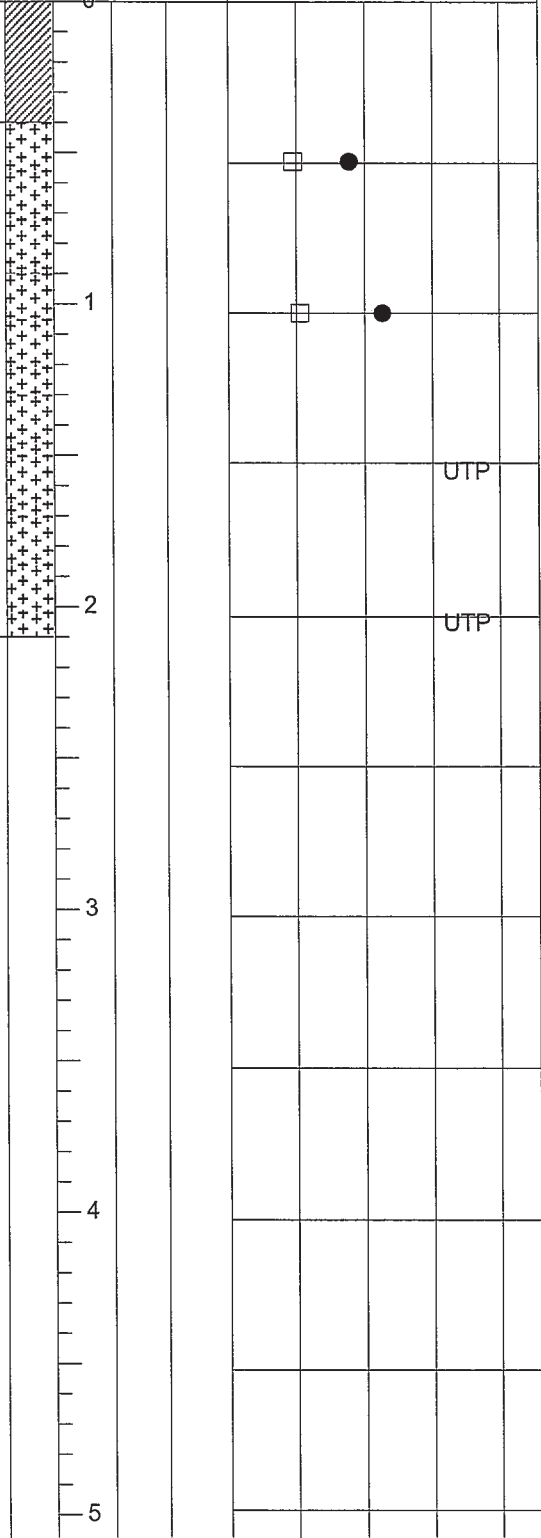
Orange SILT, some clay to clayey, stiff to very stiff, moist, moderately plastic, trace of rootlet inclusions, fine sand [WEATHERED WAITEMATA GROUP SOILS]
Greyish orange
Trace of clay, minor fine sand, slightly plastic
Sandy silt [fine], trace of clay, non to slightly plastic
Some fine sand
Brownish orange fine sandy SILT, trace of clay, non to slightly plastic
Brownish orange fine sand, dense, moist, non plastic

End of Augerhole 2.1 metres (too dense to auger)

Observations: Groundwater not encountered 1 Sept 2009

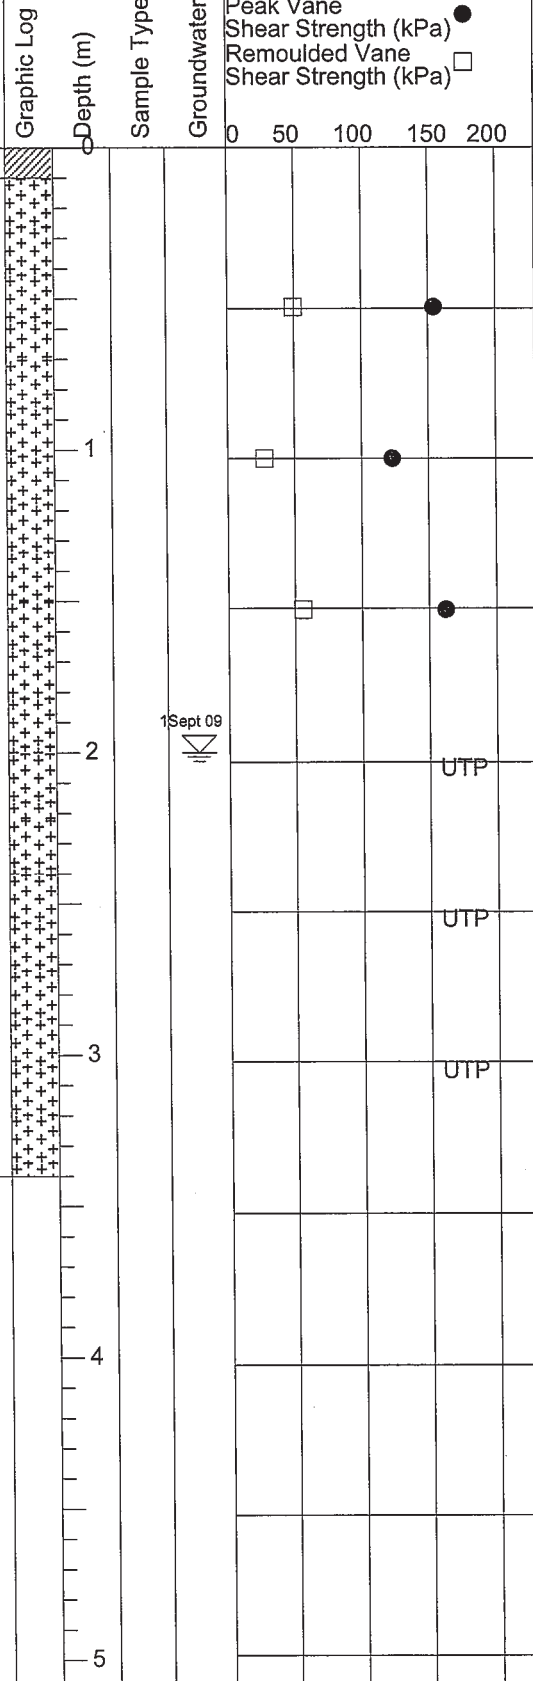
Surface Conditions: Steep, grassed

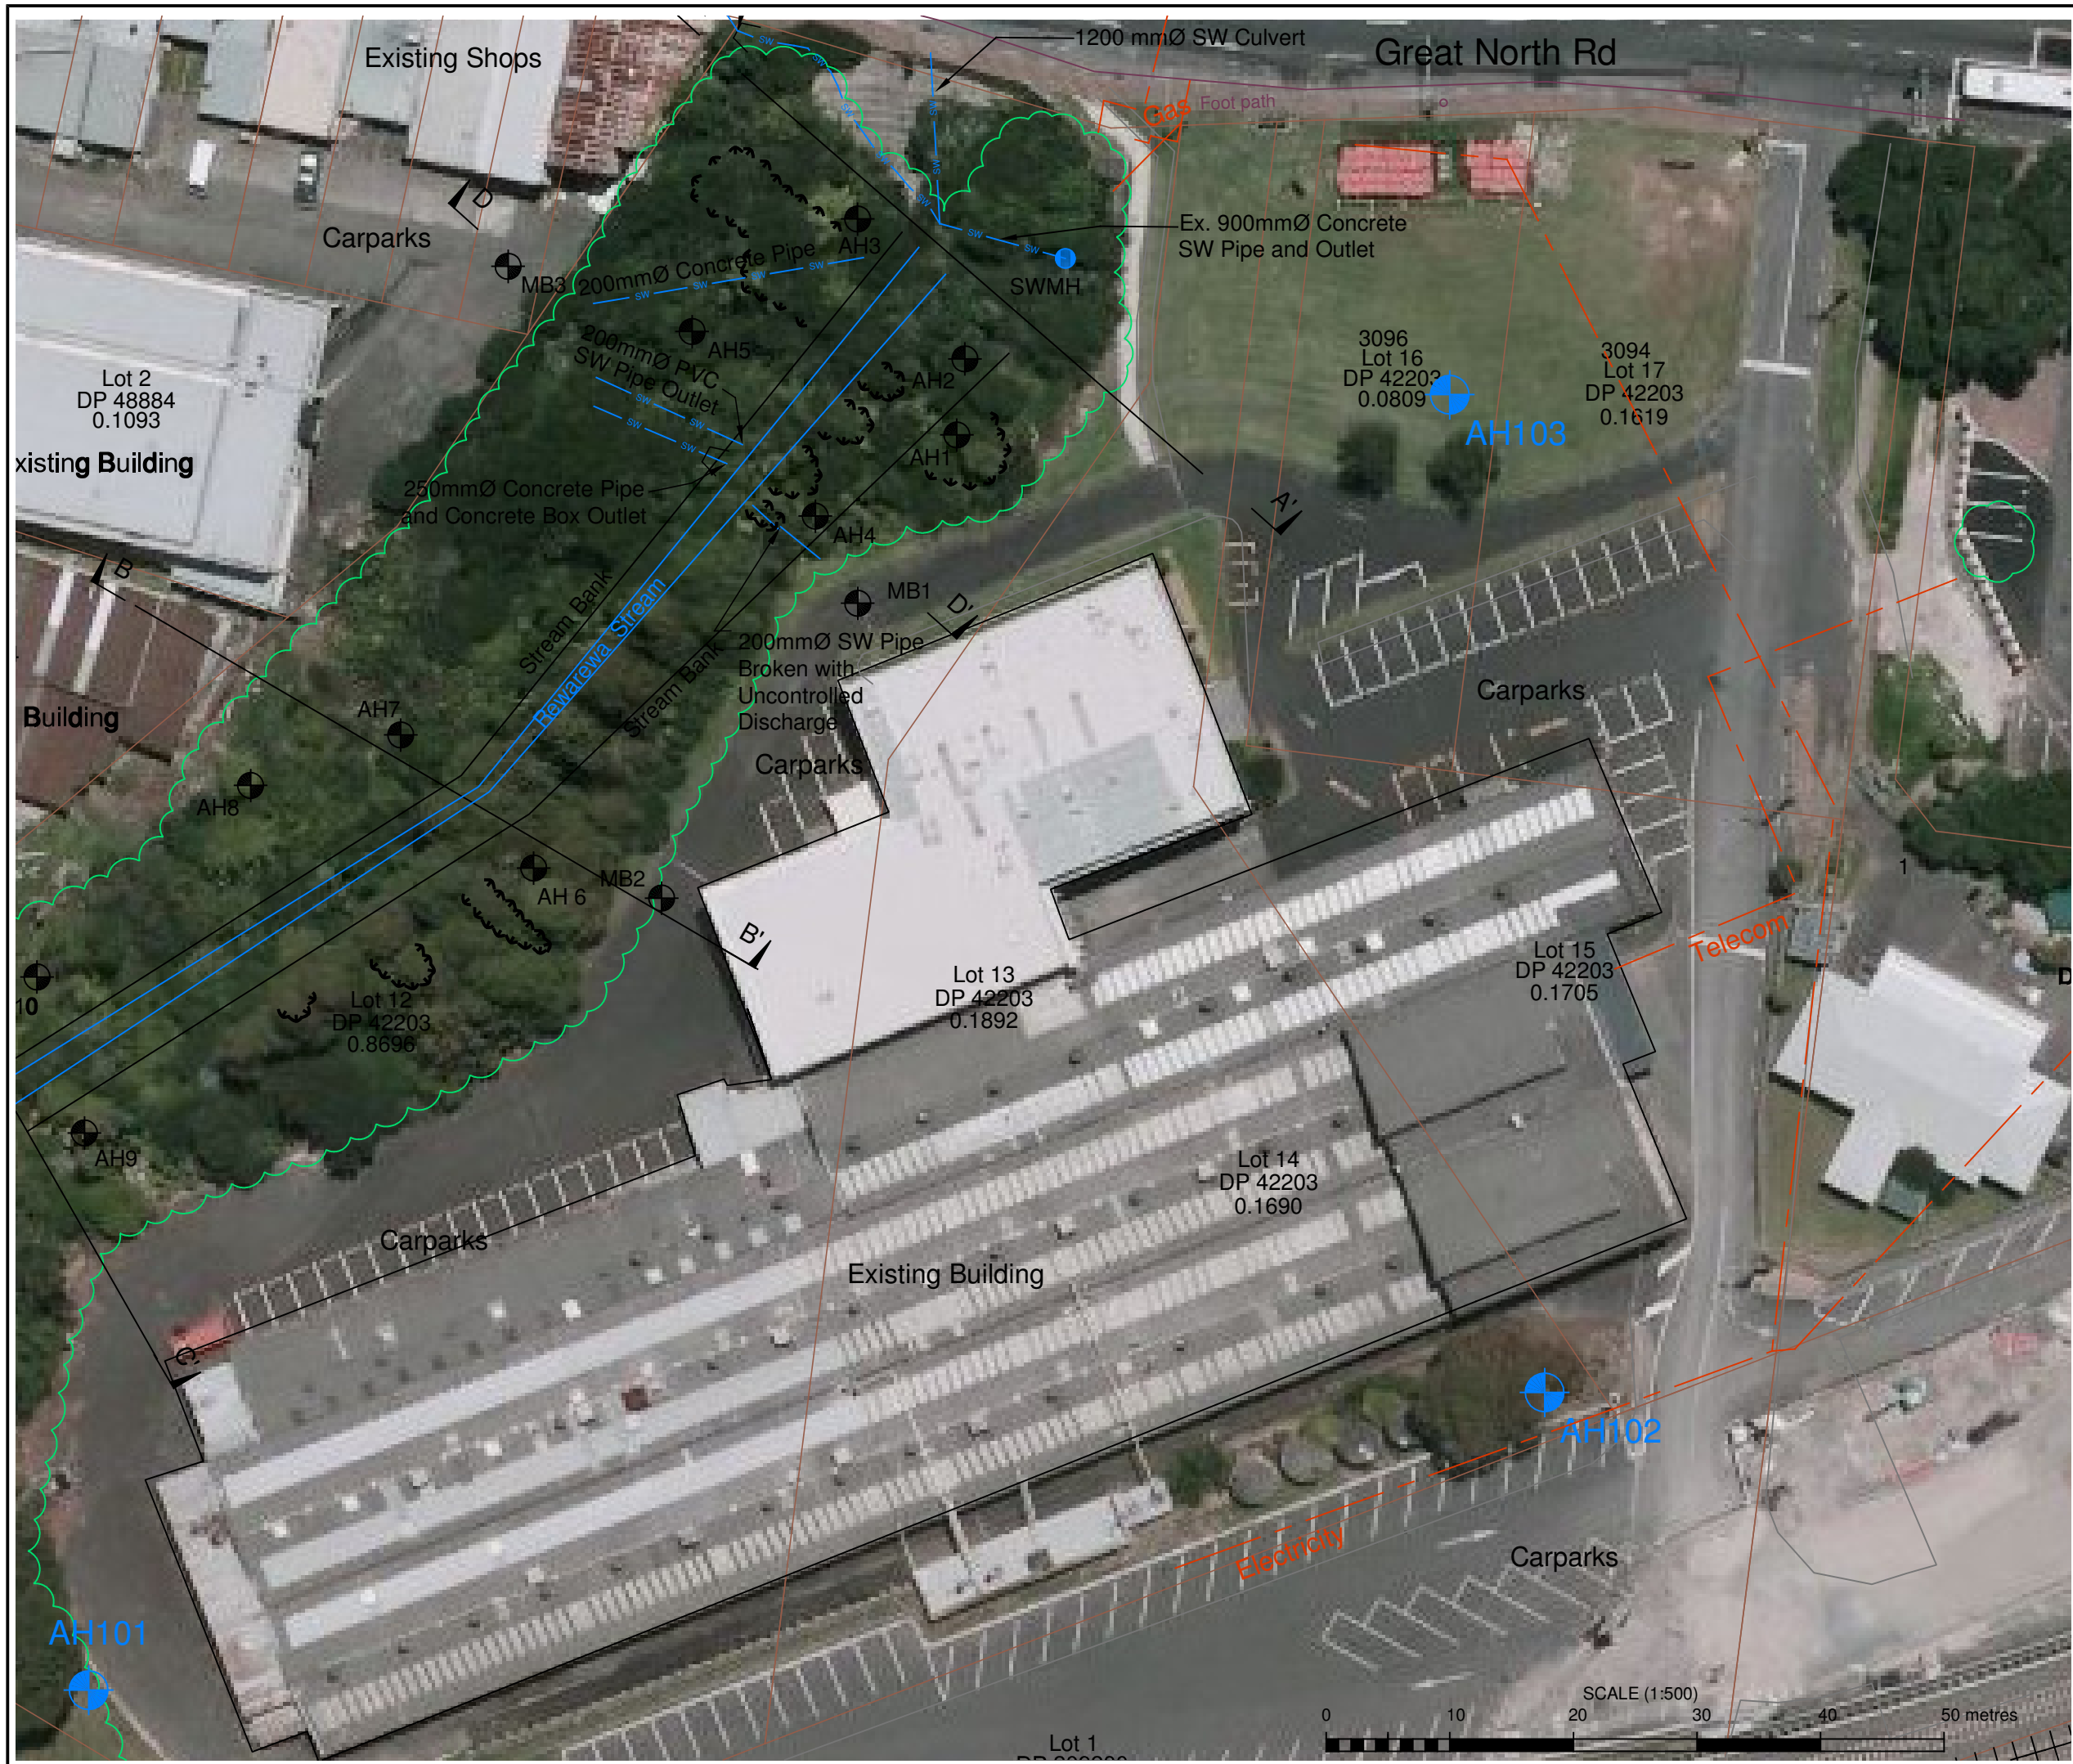
**AH101** Approximate Augerhole Locations, Soil and Rock Consultants, 1 August 2016

Table 2 below summarises the subsurface conditions encountered in hand augerholes carried out within the site as part of the current scope. Table 3 summarises subsurface conditions encountered in hand augerholes and machine boreholes carried out within the site as part of previous investigations.
