| <b>Re:</b> | <b>BUN6044955 395 Fitzgerald Rd – S92 Response</b> |

# PRELIMINARY GEOTECHNICAL INVESTIGATION REPORT

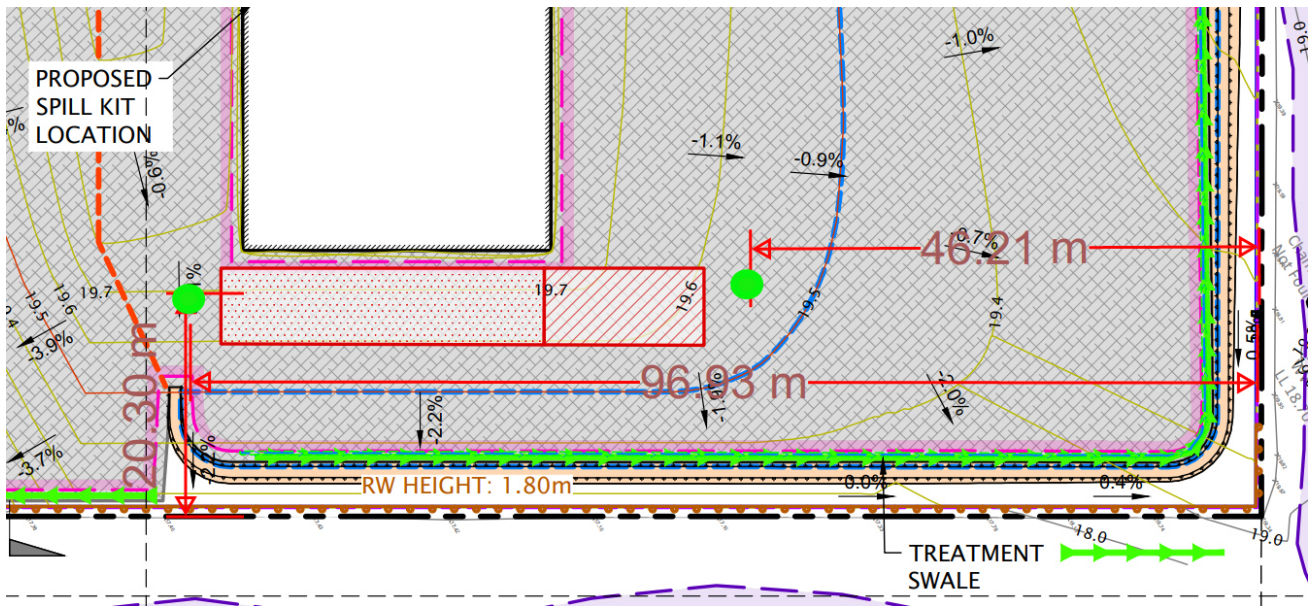
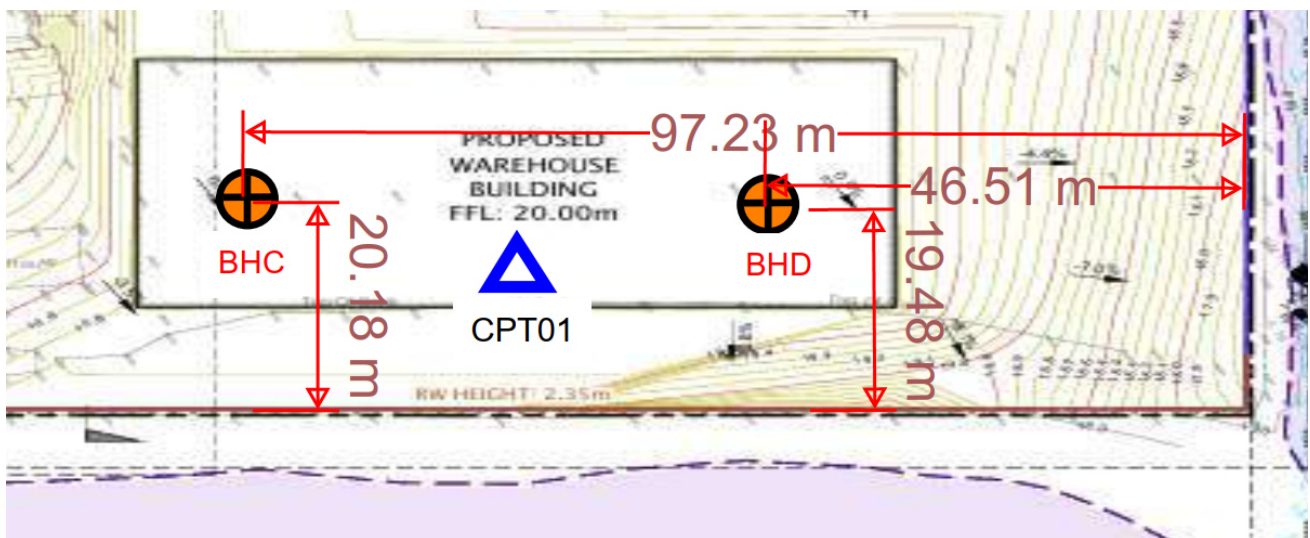
*Please see the site geotechnical report attached that shows the locations and soil descriptions at borehole locations c and d. Below is snip of these locations relative to the disposal field (green dots). We feel these locations provide sufficient confidence for the soil classification. Please note the Geotech report describes the subgrade as clayey silt and silty clay. We have conservatively assumed a clay subgrade for the entire field.*

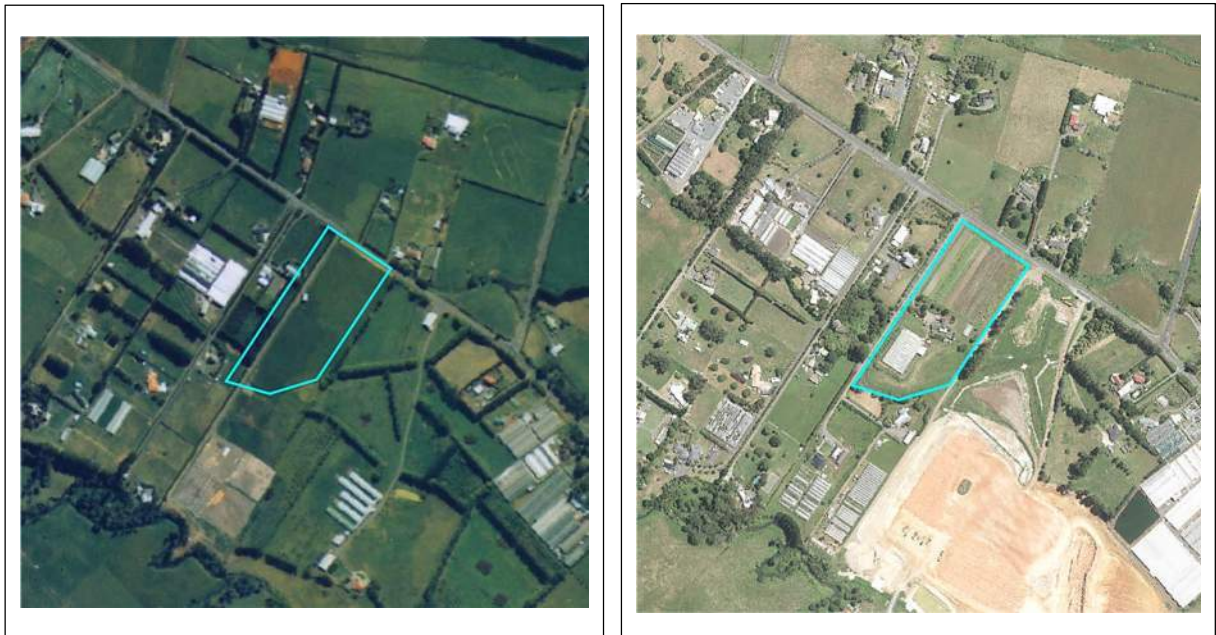
**Figure 1: Aerial Photos** (Source: 1996 & 2025 Auckland Council Geomaps, April 2025)

Figure 1 below shows aerial photos from 1996 (Left) and 2025 (Right) used in our desktop study.

Historically, the subject site appears to have been a vacant section in a rural area with some properties located in the surrounding areas in the 1990s. Since then, a few additional properties and roading networks have been constructed in the surrounding area, including the subject site. Our review of the aerial photos extracted from the Auckland Council Geomaps shows no signs of recent mass ground movements or land instability at the subject site.

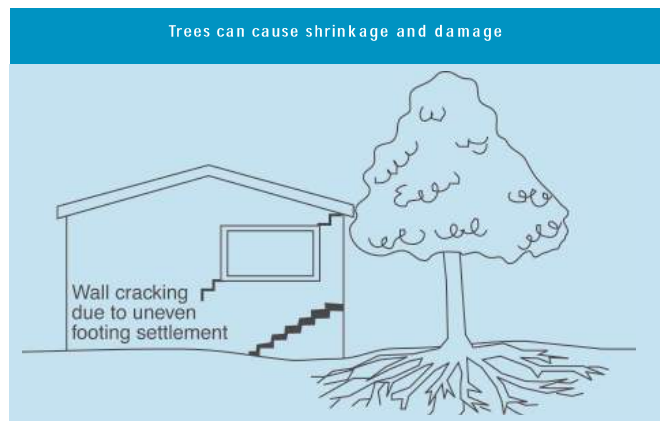
As the moisture absorption process completes its journey to the innermost areas of the building, the internal footings will rise. If the spread of moisture is roughly even, it may be that the symptoms will temporarily disappear, but it is more likely that swelling will be uneven, creating a difference rather than a disappearance in symptoms. In buildings with timber flooring supported by bearers and joists, the isolated piers will rise more easily than the strip footings or piers under walls, creating noticeable doming of flooring.

As the weather pattern changes and the soil begins to dry out, the external footings will be first affected, beginning with the locations where the sun's effect is strongest. This has the effect of lowering the external footings. The doming is accentuated and cracking reduces or disappears where it occurred because of dishing, but other cracks open up. The roof lines may become convex.
