**PROPOSED PRIVATE PLAN CHANGE**

**100 HOBSONVILLE ROAD, HOBSONVILLE**

**GEOTECHNICAL ASSESSMENT REPORT**

AKS2023-0062AB Rev 0

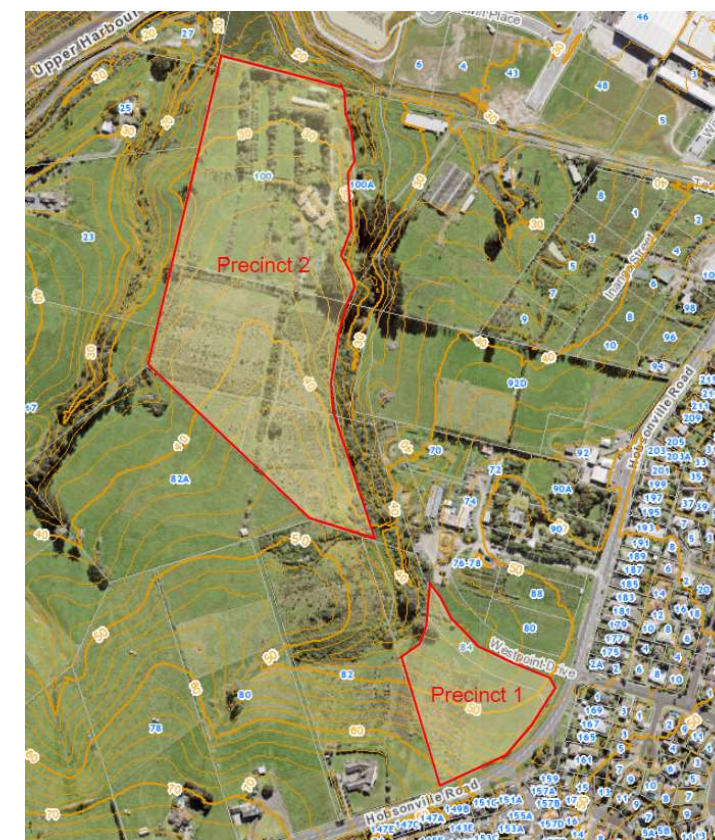
Figure 2: Site Aerial & Contours circa 2016 (Source: Auckland Council Geomaps)

The current general landform is presented on **Figure 2**.

Precinct 1 was subject to land disturbance earthworks in recent years with the contours shown in Figure 2 having been altered to some degree. Specifically, the lower-lying landform to the north, was filled as part of subdivisional earthworks the bulk of which was undertaken to the north-east of the site. Attached in Appendix C is a topographic survey showing the modified landform. The northern portion of the landform is now mostly very gently sloping apart from an approximately 8m high batter slope to the north-west, the gradient of which averages around 1V:3H. There is also a large soil stockpile which sits on the modified plateau. as well as a fill batter. The amphitheatre shaped slope in the southern portion of site is believed to be unaltered and comprises gradients of 1V:6H.
