# Eastern Busway

## EB2 and EB3 Residential

Contaminated Land Effects Assessment

Document Number: EB234-1-PL-RP-ZO-000015

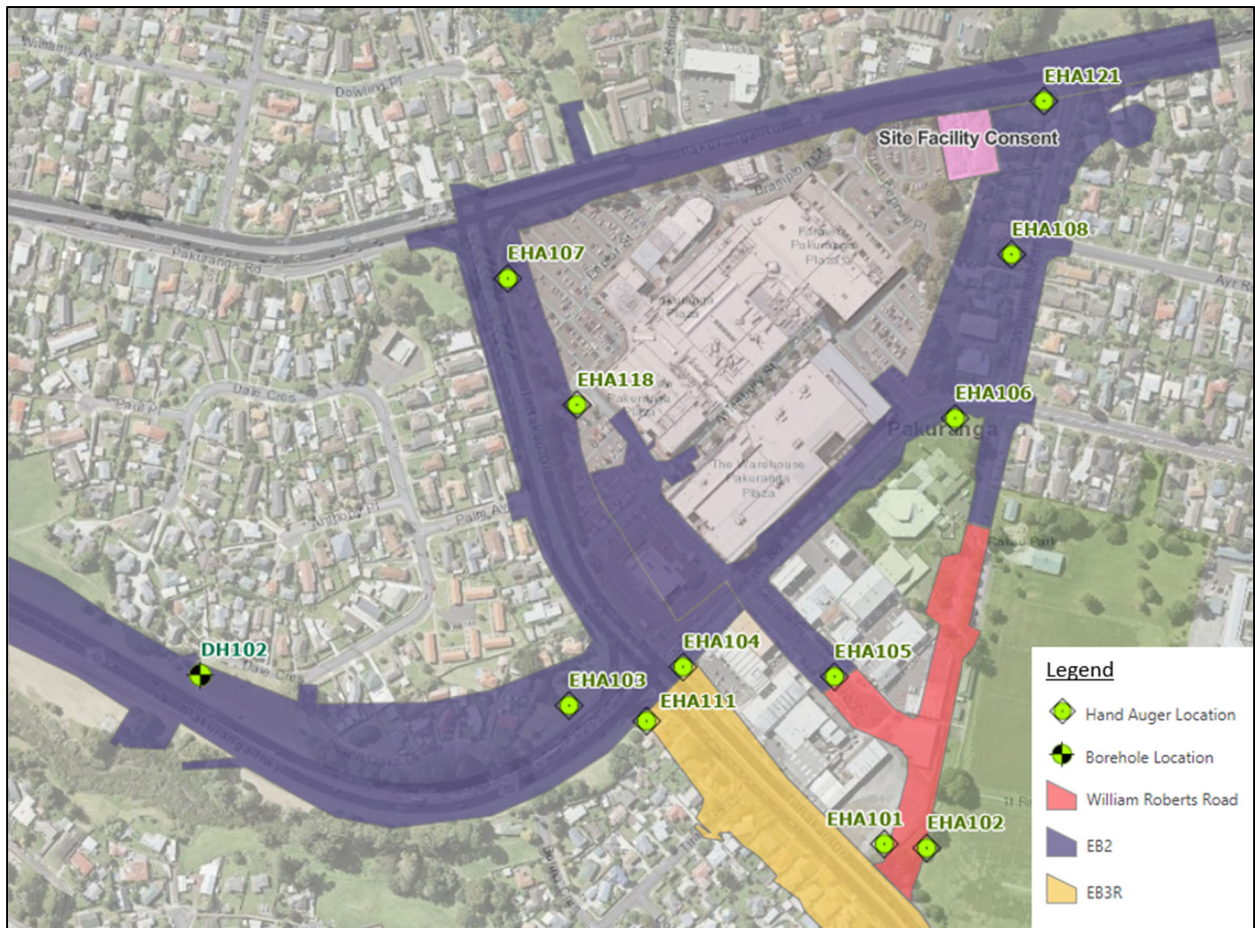
Figure 2: 2018 Environmental Investigation Locations within EB2.

The environmental assessment focussed on the collection of soil samples for laboratory analysis from materials within anticipated areas of soil disturbance. The analytical results from samples collected from locations within the EB2 package are presented in **Table A1** in **Appendix A**. Soil samples were analysed for contaminants associated with the HAIL activities at or in the vicinity of the EB2 package (listed in **Table 2** below). The investigation locations relevant to the EB2 package are presented in **Figure 2** below.

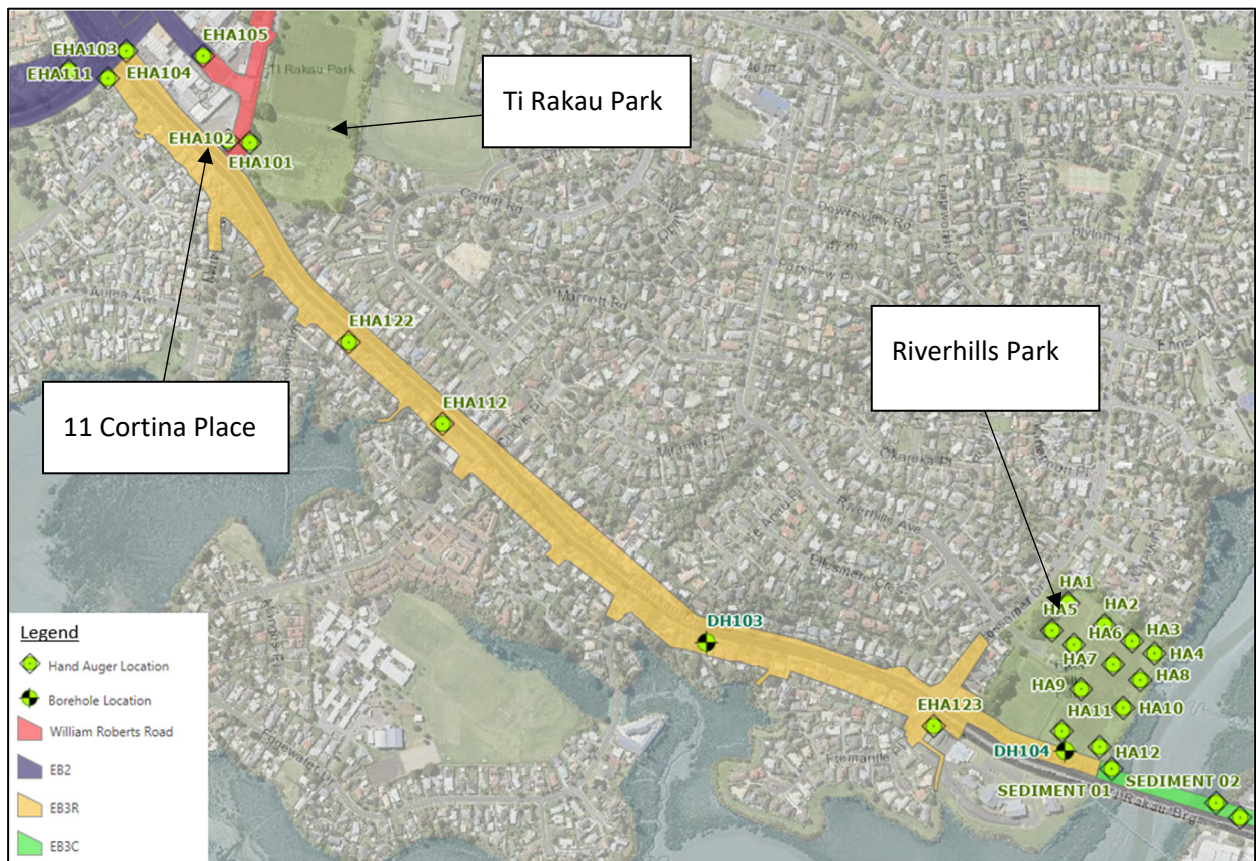
Figure 3 - 2019 Environmental Investigation Locations within EB3R, and HAIL sites in or adjacent to EB3R

The environmental assessment focused on the collection of soil samples for laboratory analysis from materials within anticipated areas of soil disturbance and Riverhills Park. The analytical results from samples collected from locations within EB3R are presented in **Table A2** in **Appendix A**. The investigation locations relevant to EB3R are presented in **Figure 3** below.

Based on the information reviewed, there were three sites identified within EB2 where HAIL activities were identified. These sites are noted in Figure 3 summarised in Table 4 - Summary of findings within EB3R Table 4 and the potential for contamination to be encountered is detailed in the following sub sections. It should be noted sites identified within the William Roberts Road extension have not been detailed in the following subsections. For further details on those sites, refer to the William Roberts Road Extension Contaminated Land Technical Report in Appendix D.
