ON SITE WASTEWATER DISPOSAL ASSESSMENT REPORT

MURIWAI DOWNS GOLF

COURSE PROJECT

PROJECT:1976

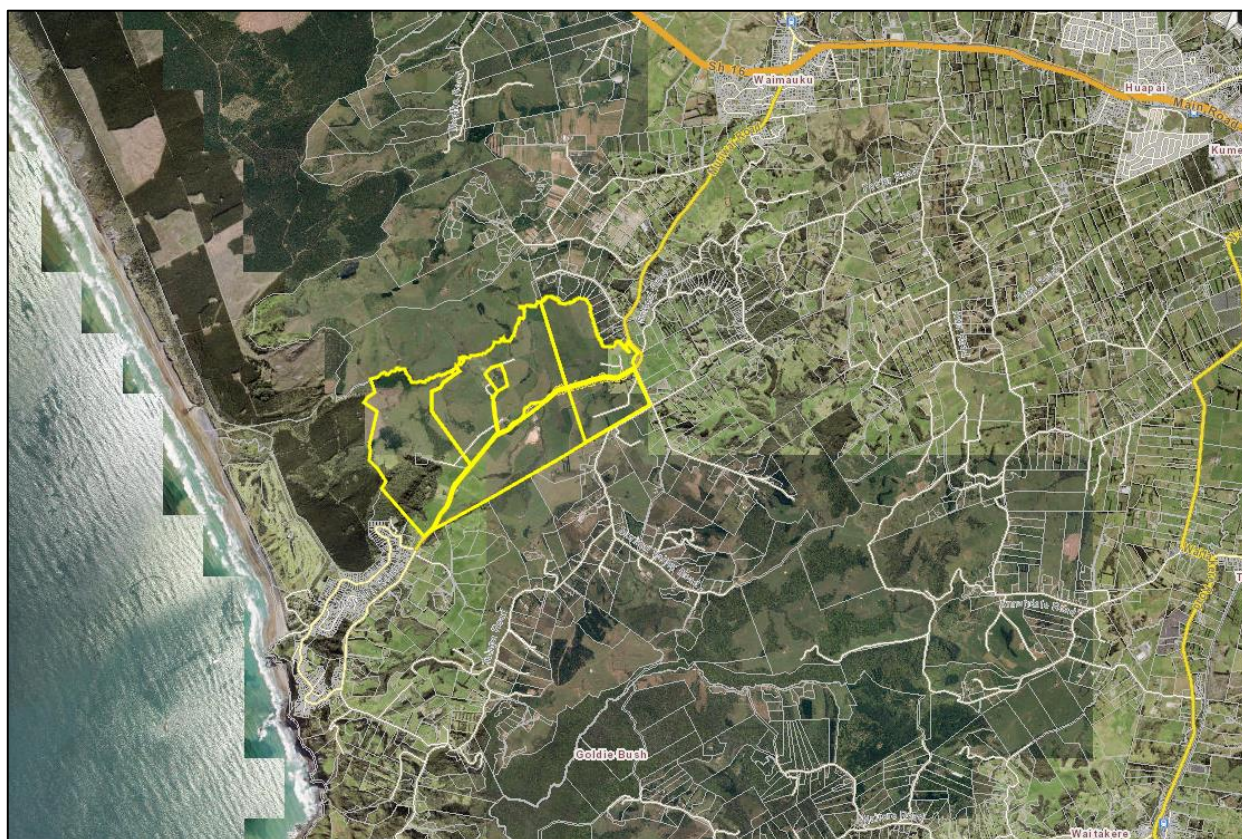
The subject property is located adjacent to Muriwai Road as shown in Figure 1 below:

Figure 1 – Property Location (courtesy of Auckland Council GeoMaps)

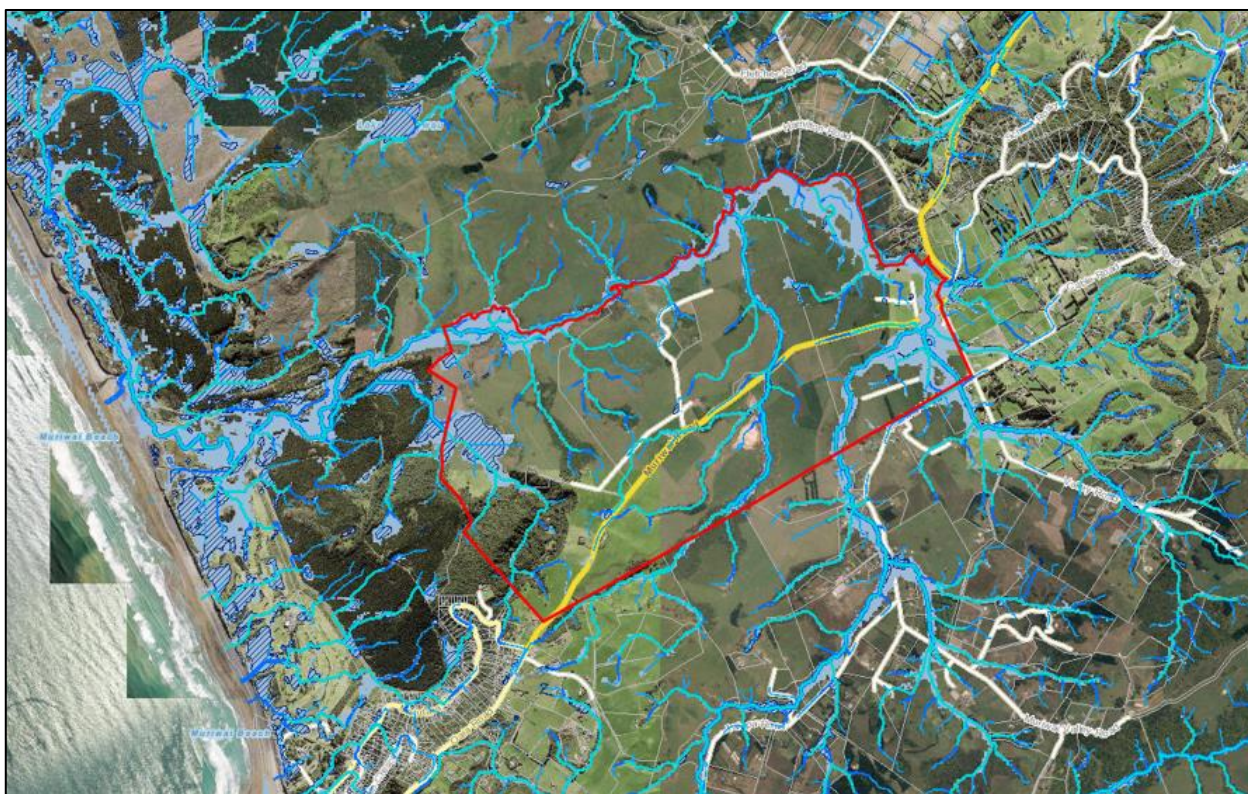
This southern portion of the property falls from Muriwai Road in a north-eastern direction into three prominent gully features which also consist of intermittent streams and associated wetland features. Two main streams traverse the east and western perimeters of the main quarry operation onsite, and both join to ultimately connect into the Ōkiritoto stream to the north via an existing culvert crossing (1500Ø under Muriwai Road. The eastern most gully feature on the southern side

of site conveys the Rarataua Stream which tributes into the Ōkiritoto Stream traversing north under an existing bridge crossing under Muriwai Road near the eastern boundary.

Figure 2 – Existing Overland Flow Paths

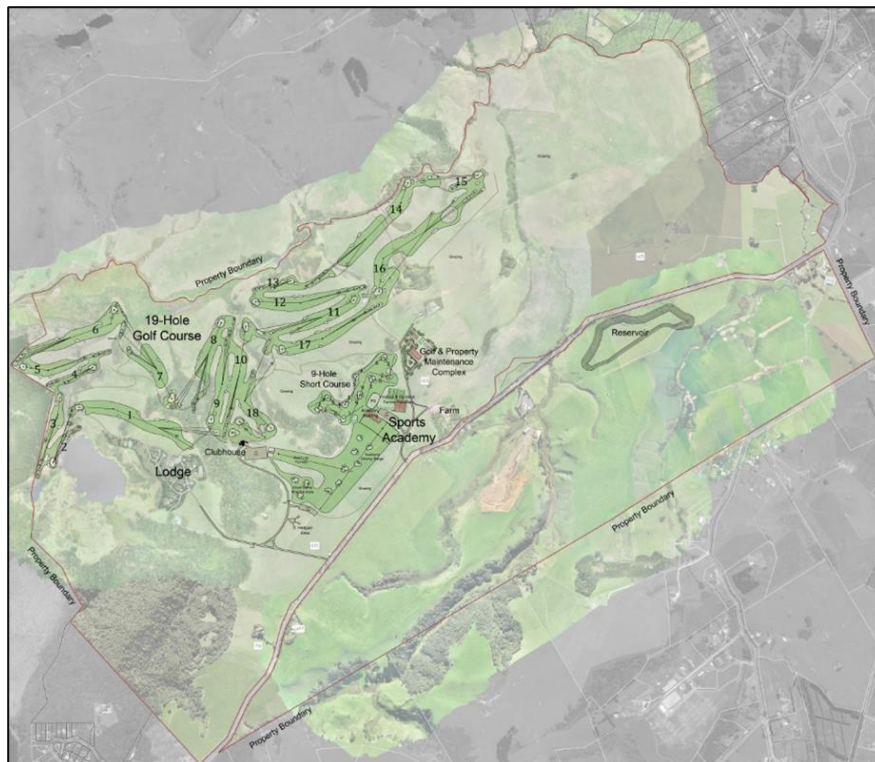
Refer to Figure 4 (below) and MCCL drawings 1976-500 (Appendix B) for details pertaining to the proposed development layout.

Figure 5 – Proposed Preliminary Master Plan Layout (Courtesy of Kyle Phillips Golf Course Design)

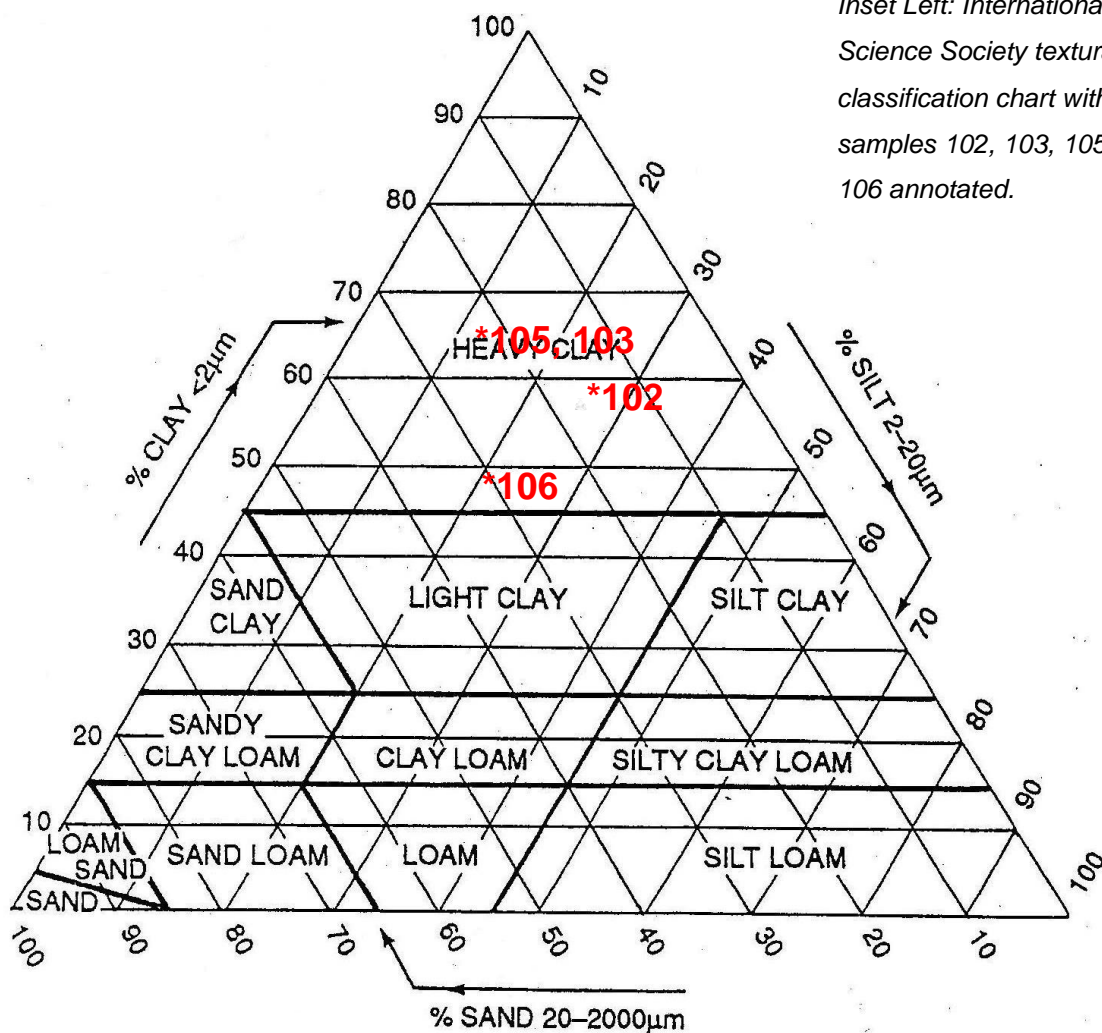
Further, based on laboratory testing, the soils samples recovered fall into the Heavy Clay category according to the International Soil Science Society textural classification chart as shown the inset below with each of samples 102, 103, 105 and 106 annotated.

Inset Left: International Soil Science Society textural classification chart with samples 102, 103, 105 and 106 annotated.

The Auckland Regional Council TR2009/0072¹ (Review of Hydrologic Properties of Soils in the Auckland Region) defines clay soils as having a coefficient of permeability of between 1 and 5 mm per hour (Table 7, Section 3.3 of TR2009/0072).

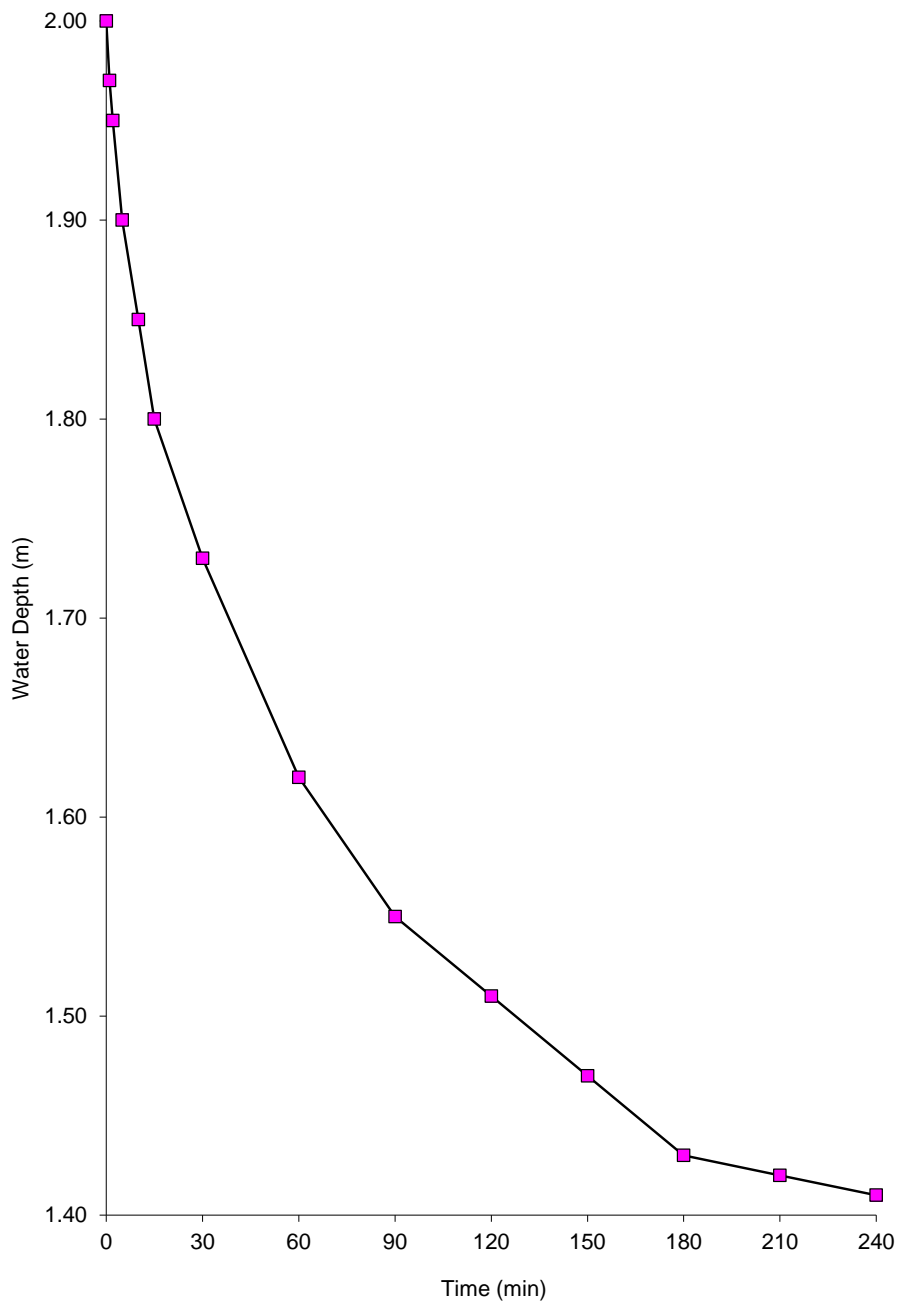
Water Depth vs Time

Location: Depth: 2.0 (m)

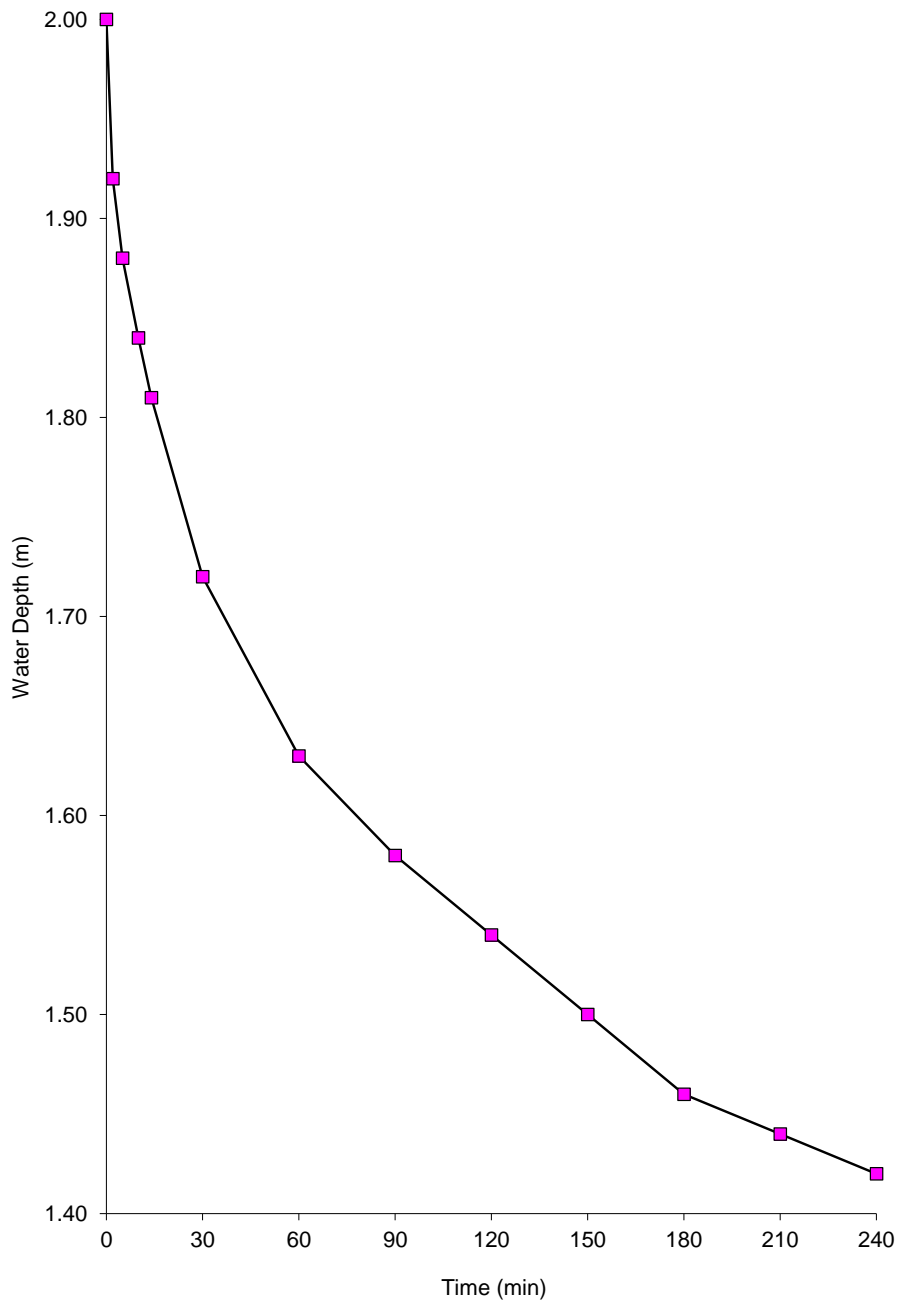
Water Depth vs Time

Location: Depth: 2.0 (m)

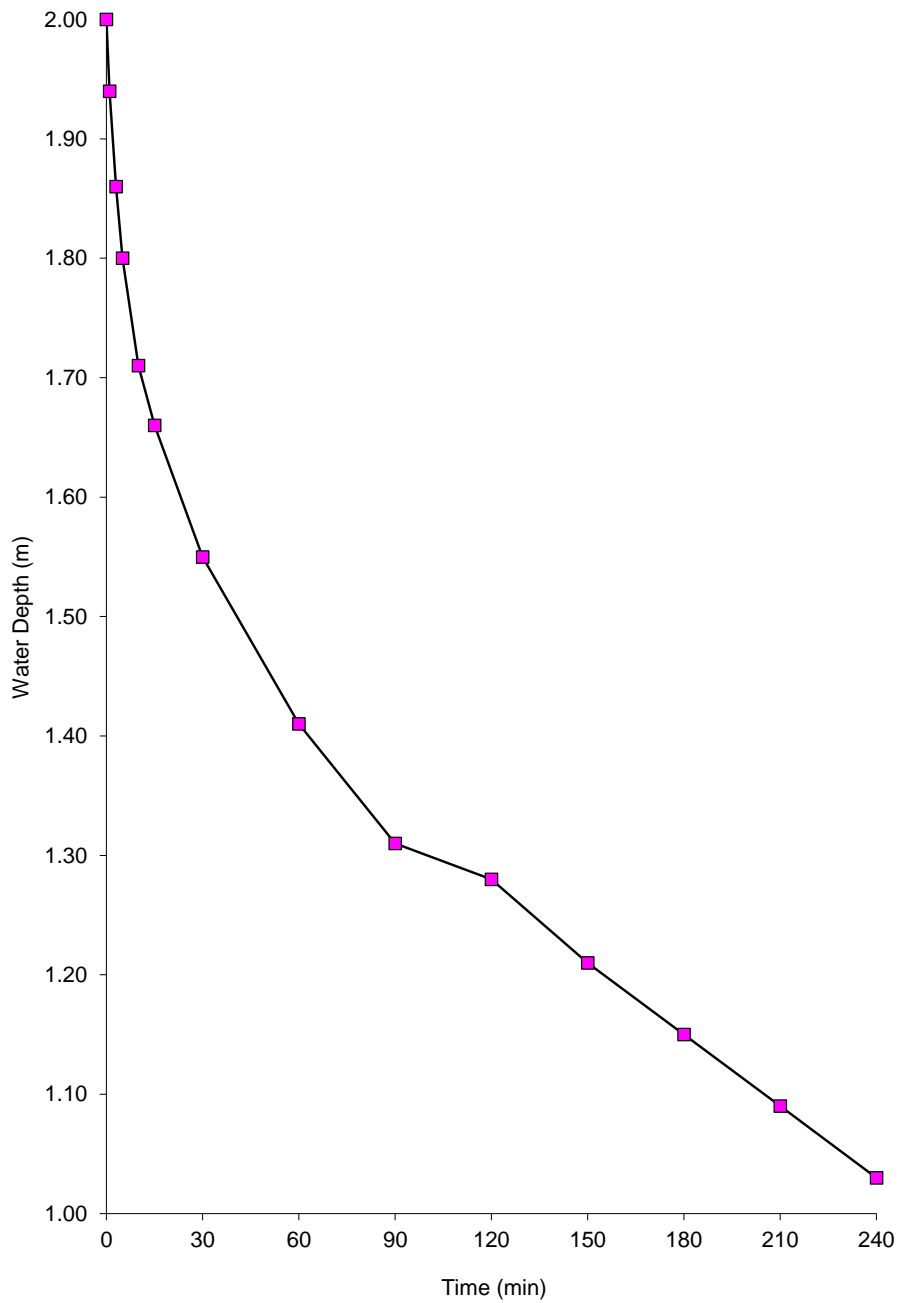
Water Depth vs Time

Location: Depth: 2.0 (m)

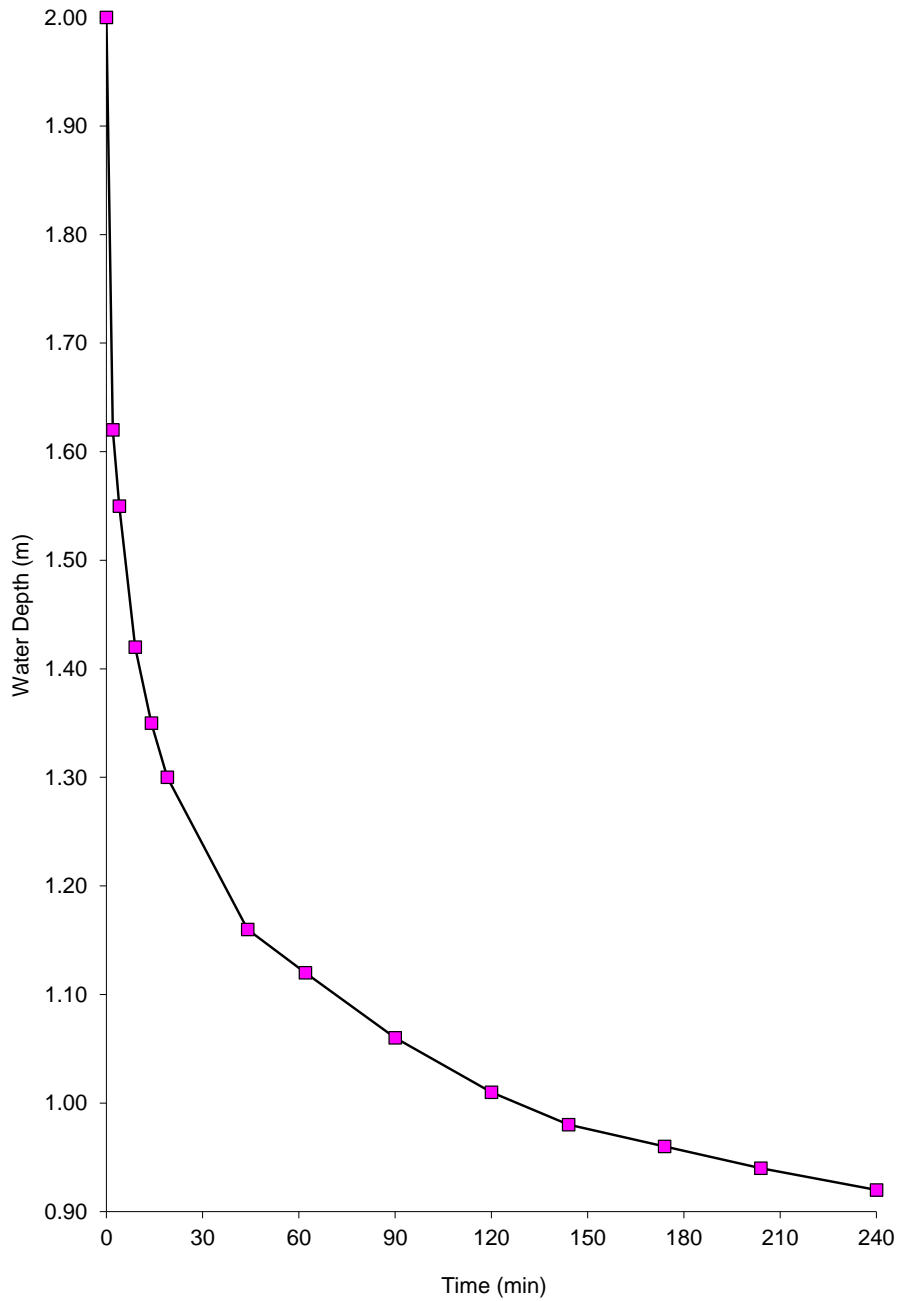
Water Depth vs Time

Client:	The Bears Home Project Management Lirr	Job No:	J01662
Location:	Muriwai Downs Golf Project	Date:	24.02.22
	0	Page:	2 of 2
Hole No:	Perc 04	Diameter:	0.1 (m)
Location:	0	Depth:	2.0 (m)

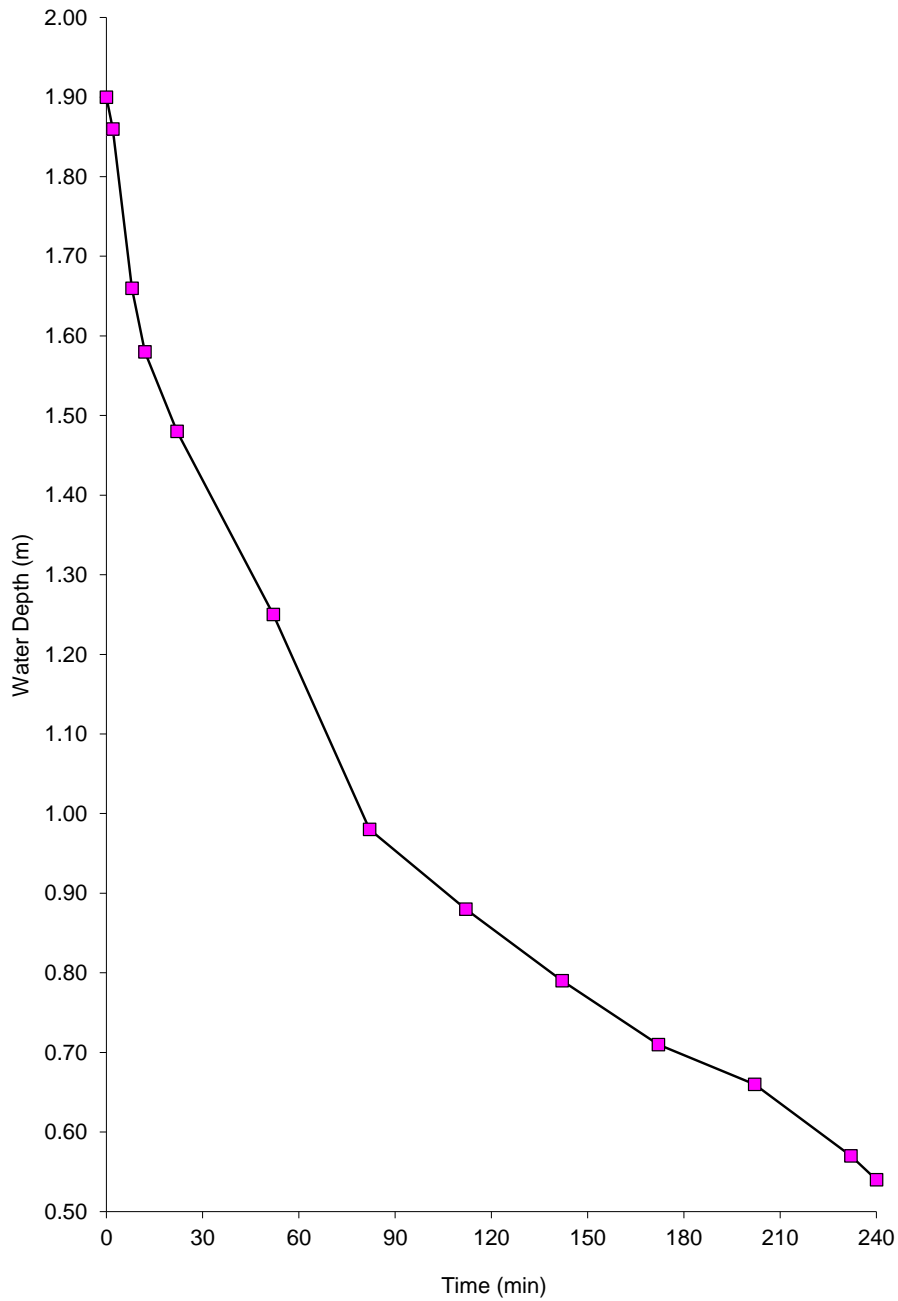
Water Depth vs Time

Hole No: Perc 05 Diameter: 0.1 (m)
Location: Depth: 2.0 (m)

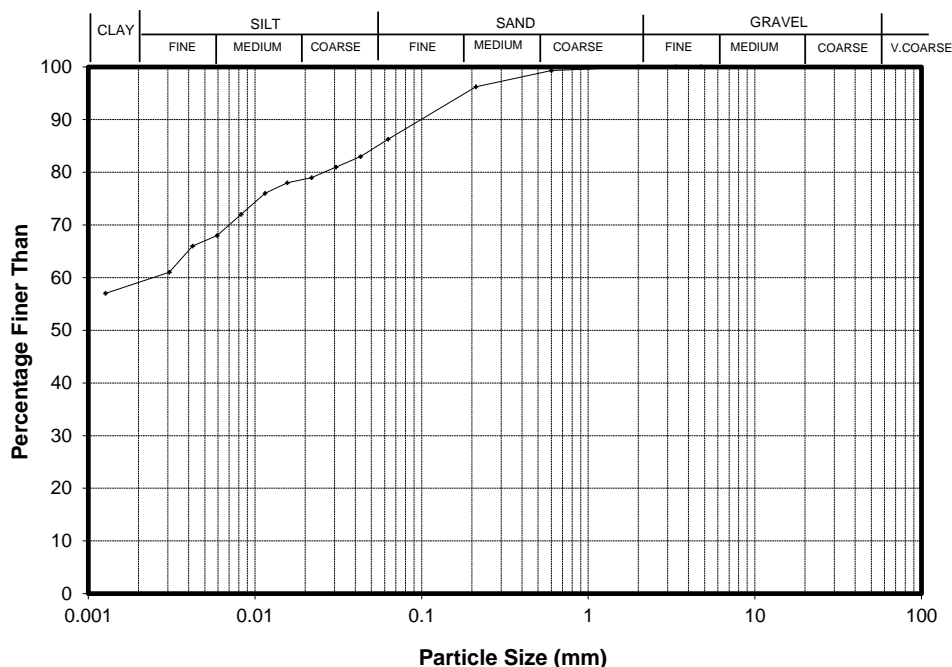
PARTICLE SIZE ANALYSIS

Test Method Used : NZS 4402:1986 Test 2.8.4 Subsidiary method for fine soils (Hydrometer)

Sieve (mm)	Total % Passing	Sieve (mm)	Total % Passing
4.75	-		
3.35	-		
2.00	100		
0.600	99		
0.212	96		
0.063	86

Equivalent Particle Diameter D (mm)	% of Particles Finer than D
0.0430	83
0.0307	81
0.0219	79
0.0156	78
0.0115	76
0.0083	72
0.0059	68
0.0042	66
0.0031	61
0.0013	57

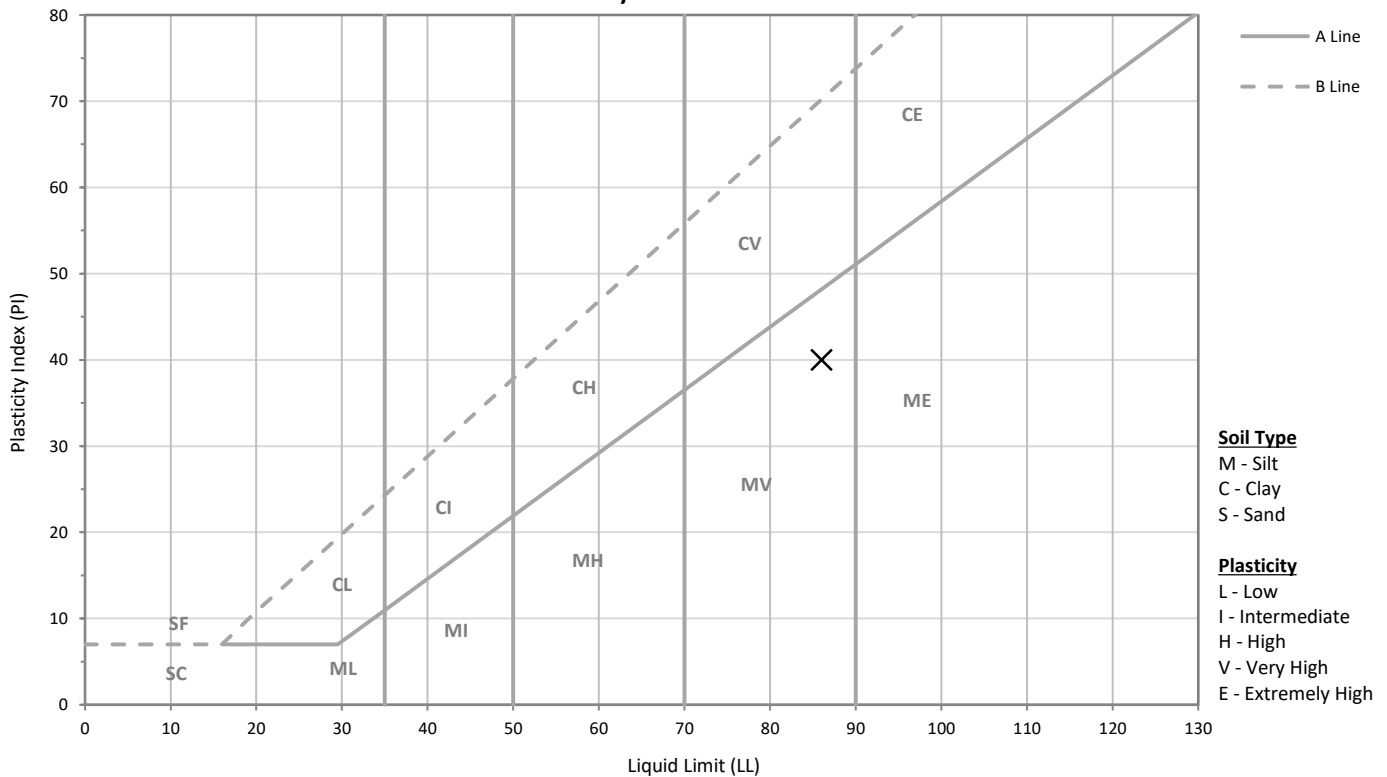
Plasticity Chart - BS 5930:1999

Liquid Limit 86
Plastic Limit 46
Plasticity Index 40

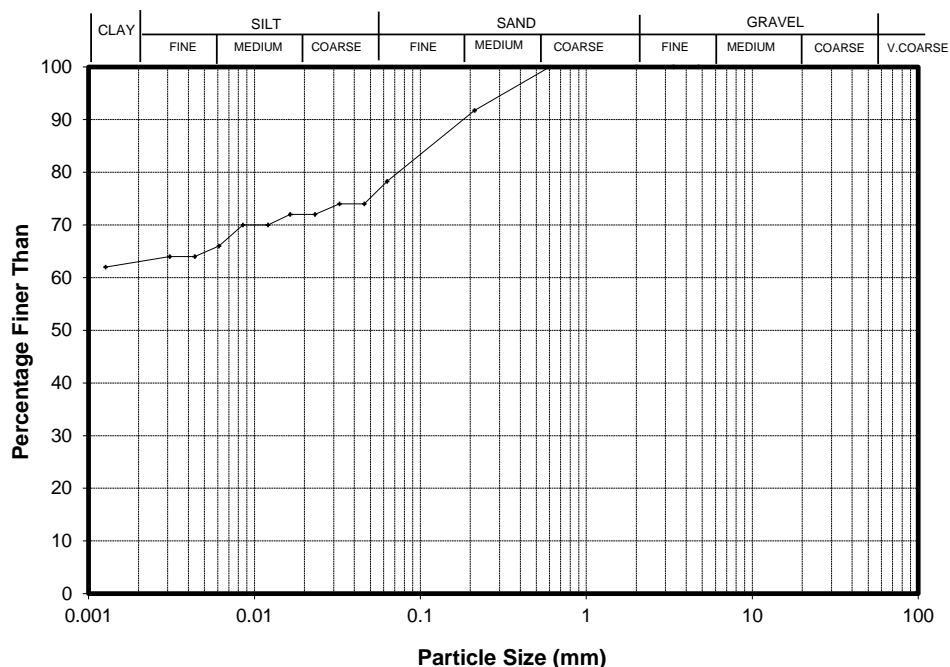
PARTICLE SIZE ANALYSIS

Site: **Muriwai Downs** Your Job N **JO1662**
BH No.: **HA103** Our Job Nc **2021000.0565**
Sample ID.: **AKL45.2** Depth: **0.3-1.5 m**
Test Method Used : NZS 4402:1986 Test 2.8.4 Subsidiary method for fine soils (Hydrometer)

Sieve (mm)	Total % Passing	Sieve (mm)	Total % Passing
4.75	-		
3.35	-		
2.00	-		
0.600	100		
0.212	92		
0.063	78

Equivalent Particle Diameter D (mm)	% of Particles Finer than D
0.0460	74
0.0325	74
0.0232	72
0.0164	72
0.0121	70
0.0085	70
0.0061	66
0.0044	64
0.0031	64
0.0013	62

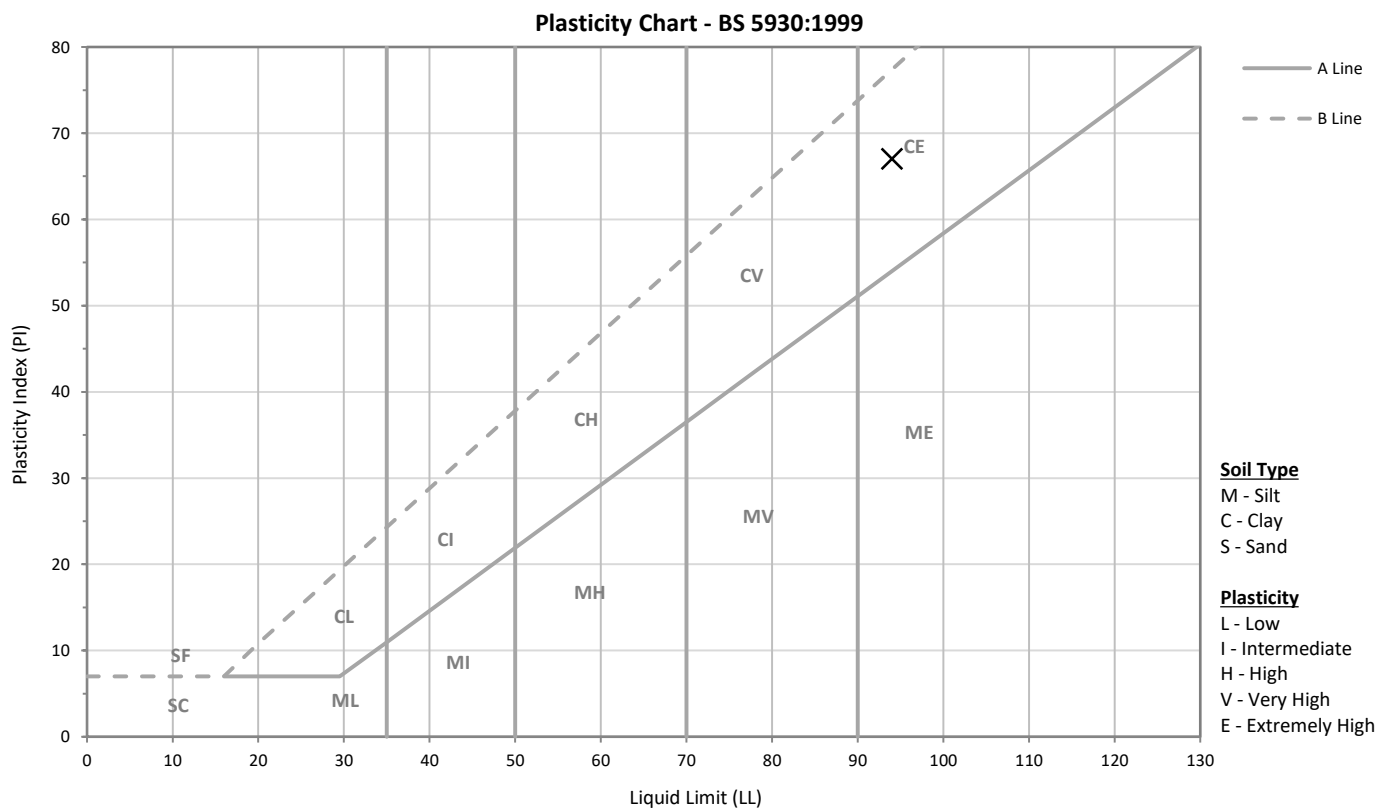
Liquid Limit 94
Plastic Limit 27
Plasticity Index 67

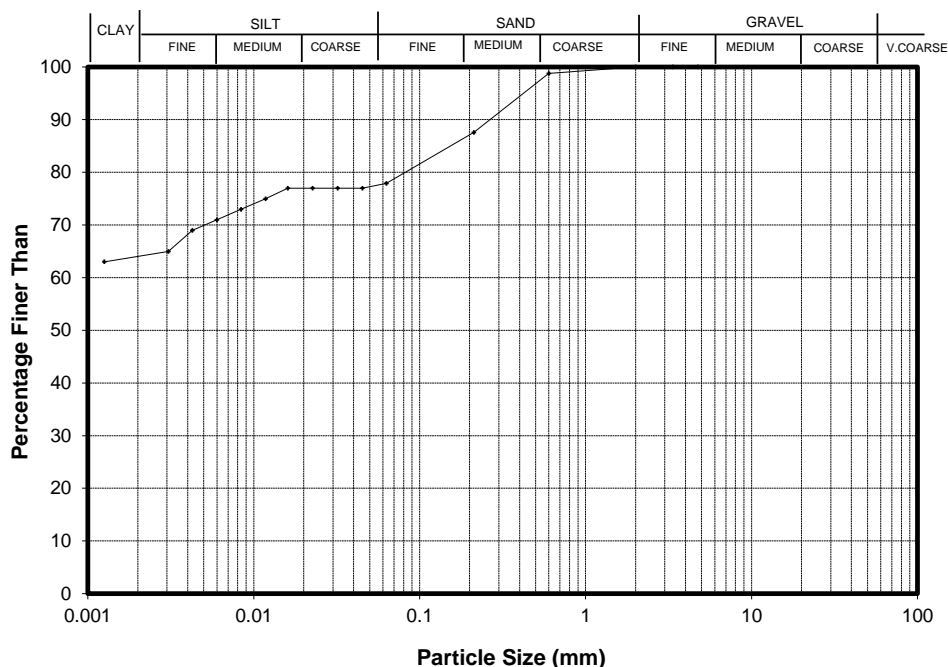
Test Method Used : NZS 4402:1986 Test 2.8.4 Subsidiary method for fine soils (Hydrometer)

Your Job No.: **JO1662**Our Job No.: **2021000.0565**Depth: **0.5-2 m****PARTICLE SIZE ANALYSIS**

Sieve (mm)	Total % Passing	Sieve (mm)	Total % Passing
4.75	-		
3.35	-		
2.00	100		
0.600	99		
0.212	88		
0.063	78

Equivalent Particle Diameter D (mm)	% of Particles Finer than D
0.0452	77
0.0320	77
0.0226	77
0.0160	77
0.0118	75
0.0084	73
0.0060	71
0.0043	69
0.0031	65
0.0013	63

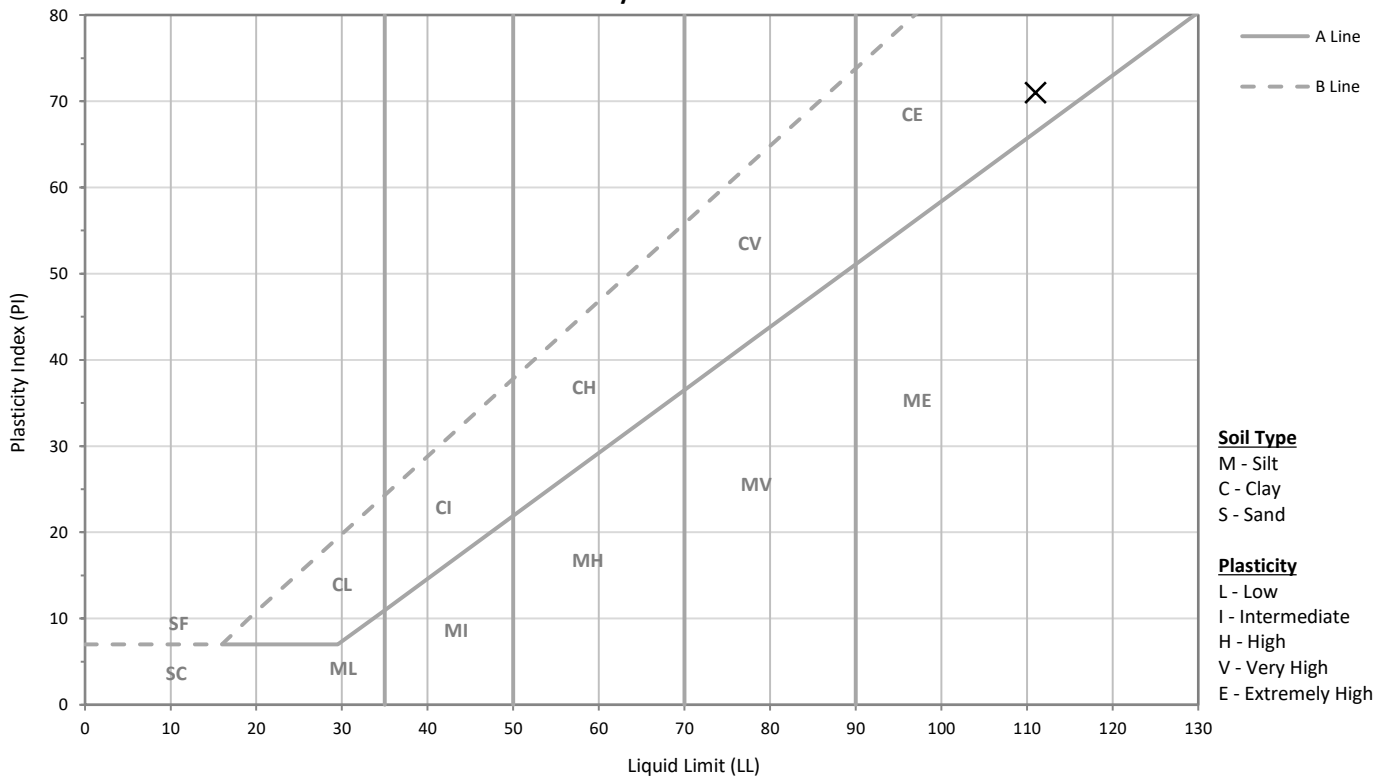
Plasticity Chart - BS 5930:1999

Liquid Limit 111
Plastic Limit 40
Plasticity Index 71

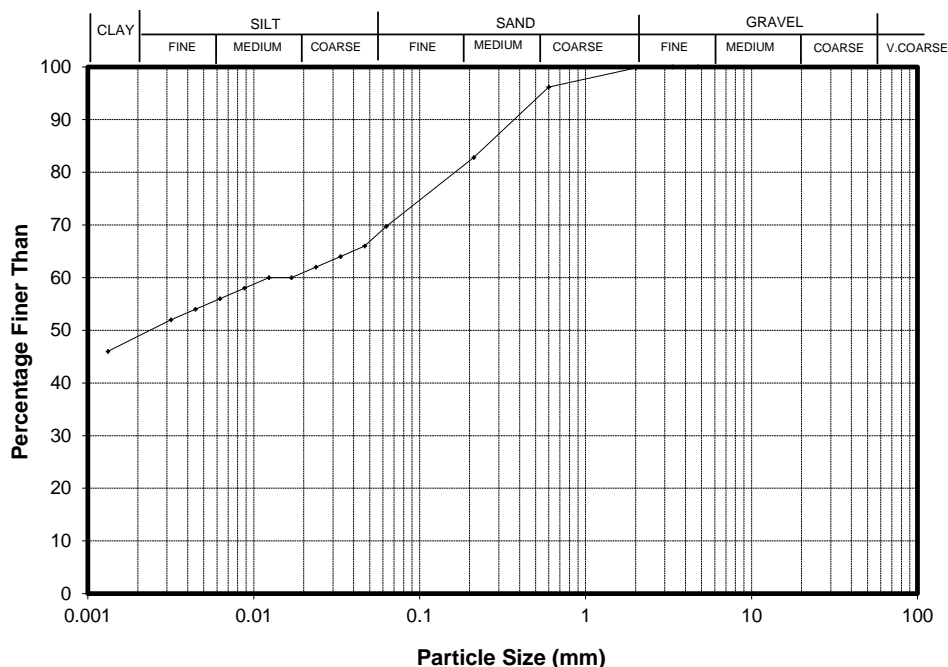
PARTICLE SIZE ANALYSIS

Site: **Muriwai Downs** Your Job No.: **JO1662**
BH No.: **HA106** Sample ID.: **AKL45.4** Our Job No.: **20212000.0565**
Test Method Used : NZS 4402:1986 Test 2.8.4 Subsidiary method for fine soils (Hydrometer) Depth: **0.3-1.2 m**

Sieve (mm)	Total % Passing	Sieve (mm)	Total % Passing
4.75	100		
3.35	100		
2.00	100		
0.600	96		
0.212	83		
0.063	70

Equivalent Particle Diameter D (mm)	% of Particles Finer than D
0.0467	66
0.0333	64
0.0237	62
0.0169	60
0.0123	60
0.0088	58
0.0063	56
0.0045	54
0.0032	52
0.0013	46

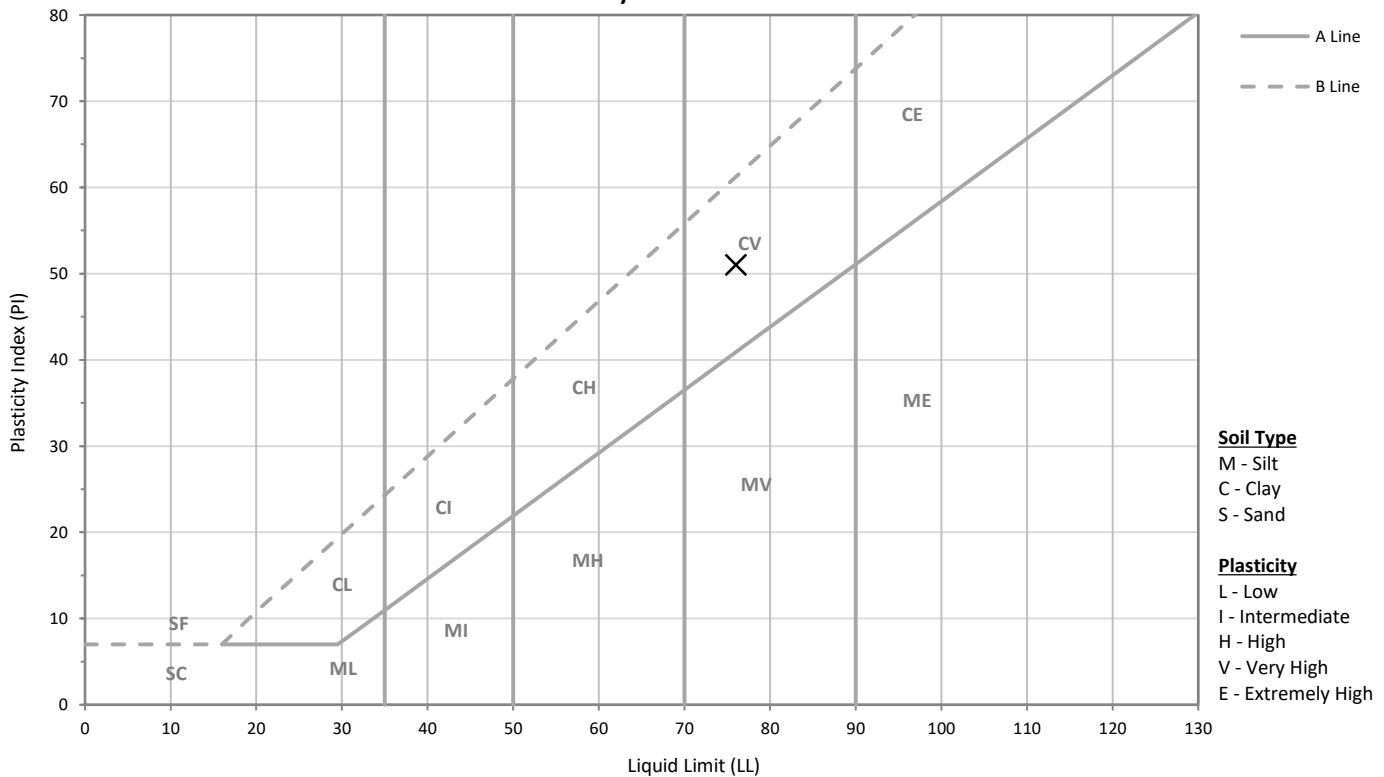
Plasticity Chart - BS 5930:1999

Liquid Limit **76**
Plastic Limit **25**
Plasticity Index **51**
