K190051-1a 7 October 2019

GEOTECHNICAL INVESTIGATION REPORT PROPOSED NEW SUBDIVISION 278 CLEVEDON-KAWAKAWA ROAD **CLEVEDON**

Geotechnical Investigation Report Proposed New Subdivision 278 Clevedon-Kawakawa Road Clevedon

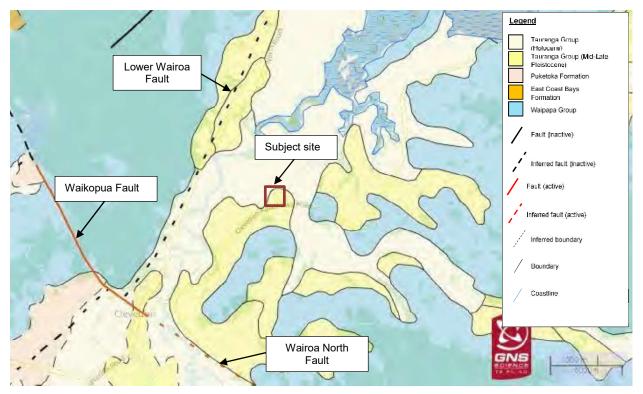
Three major published faults, the Lower Wairoa Fault, the Waikopua Fault and the Wairoa North Fault are located around the proposed development site. The Lower Wairoa Fault is located approximately 1km to the northwest of the proposed site and dips to the southeast with information provided from GNS Geoscience website indicating the fault is currently inactive. The Waikopua and Wairoa North Fault are located approximately 2.5km and 2.3km to the southwest respectively and dip to the southwest with information provided from GNS Geoscience website indicating the fault section. During our site reconnaissance, though some minor surficial surface movement of the soils were observed, no evidence of any major fault movements was observed over the proposed site development area

The regional geology of the site and its surrounding area is detailed on the Geological Map of the Auckland Area Sheet 3 of the Geological Map Series (Scale 1:250,000), published by the institute of Geological and Nuclear Sciences in 2001. This shows the site to be underlain by pumiceous sand, silt, and clay, with interbedded gravel and peat associated with the Taranga Group of Pleistocene and Holocene age. Therefore, it is anticipated that the superficial deposits will comprise predominately alluvial deposits of the Tauranga Group.

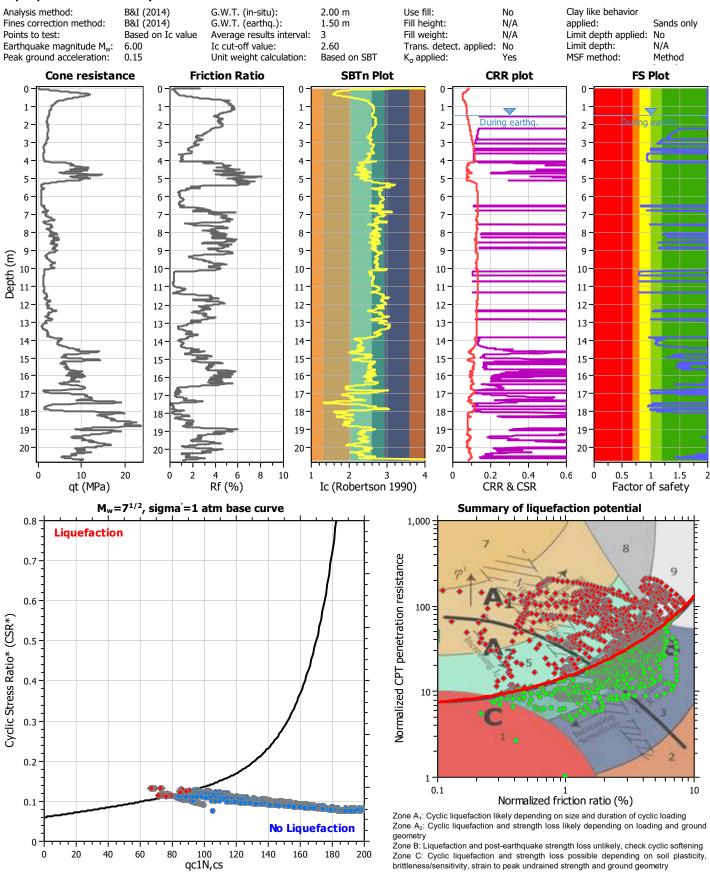
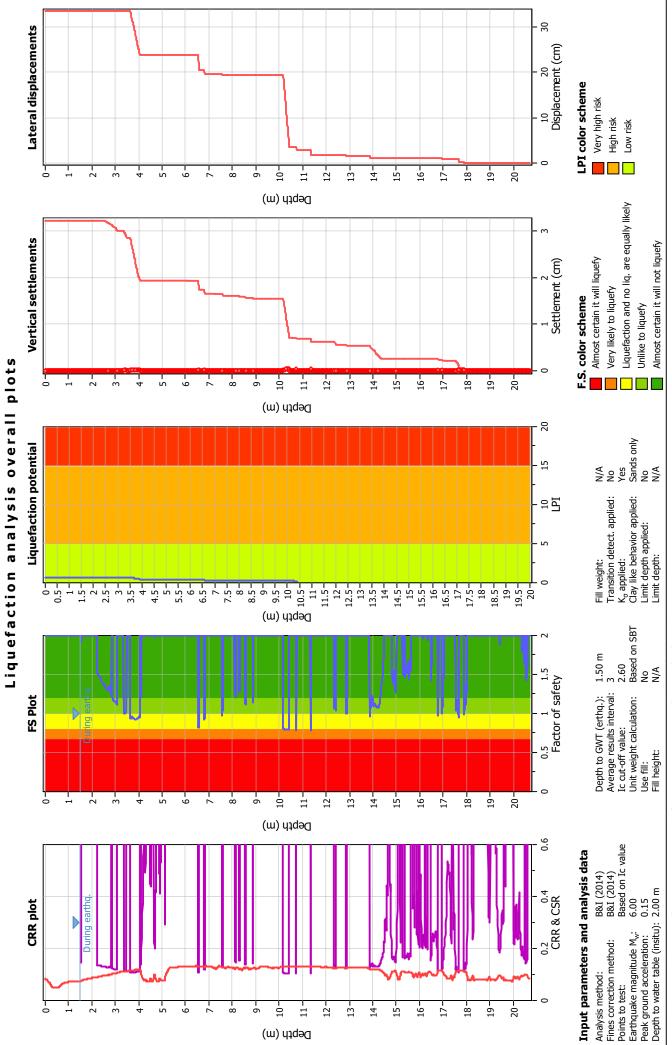
Project title : CPT file : CPT-01

Input parameters and analysis data

The triggering of liquefaction was assessed using Boulanger and Idriss (2014) procedure as suggested in NZGS Earthquake Geotechnical Engineering Practice 'Module 3: Identification and Assessment of Liquefaction Hazards'. The following design parameters are used for the determination of Peak Ground Acceleration (a_{max}):

Under ULS conditions several layers within the upper 20m returned FoS readings of 1 or below within logs CPT1 and CPT2. The estimated accumulative settlement, based on CPT1, is less than 35mm and lateral displacement is less than 350mm. The estimated accumulative settlement, based on CPT2, is less than 40mm and lateral displacement is less than 500mm. For both CPTs, no liquefaction is expected under SLS conditions. Therefore, the liquefaction potential of the Tauranga Group Alluviums at the site is negligible under SLS and low under ULS conditions. Furthermore, liquefaction in the top 10m occurs in layers of limited thickness (approximately less than 10%) and results in relatively small lateral displacements and vertical settlements. The results of the Cliq analyses are appended as Appendix D.

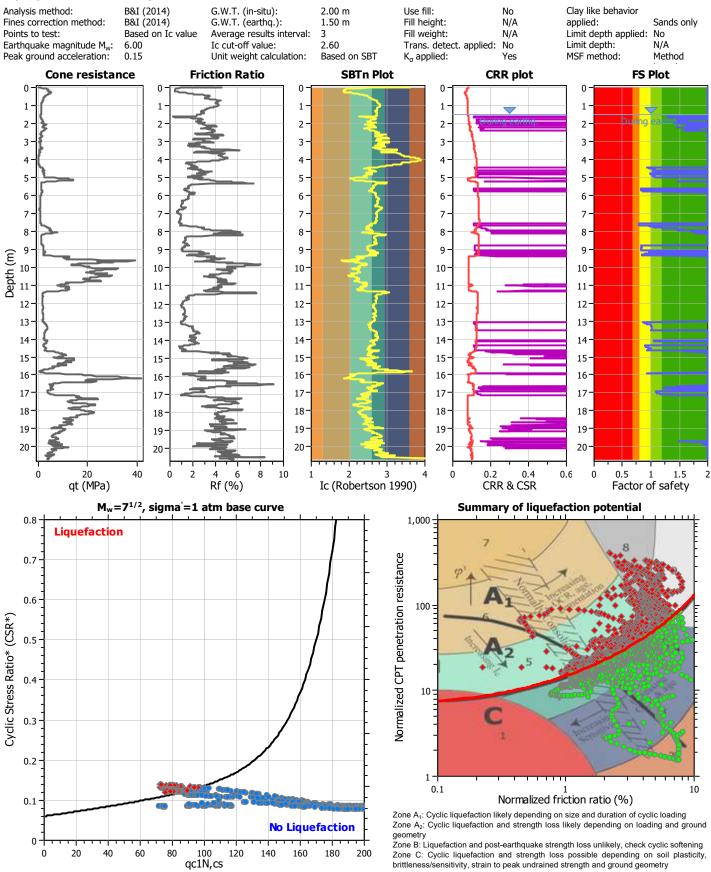
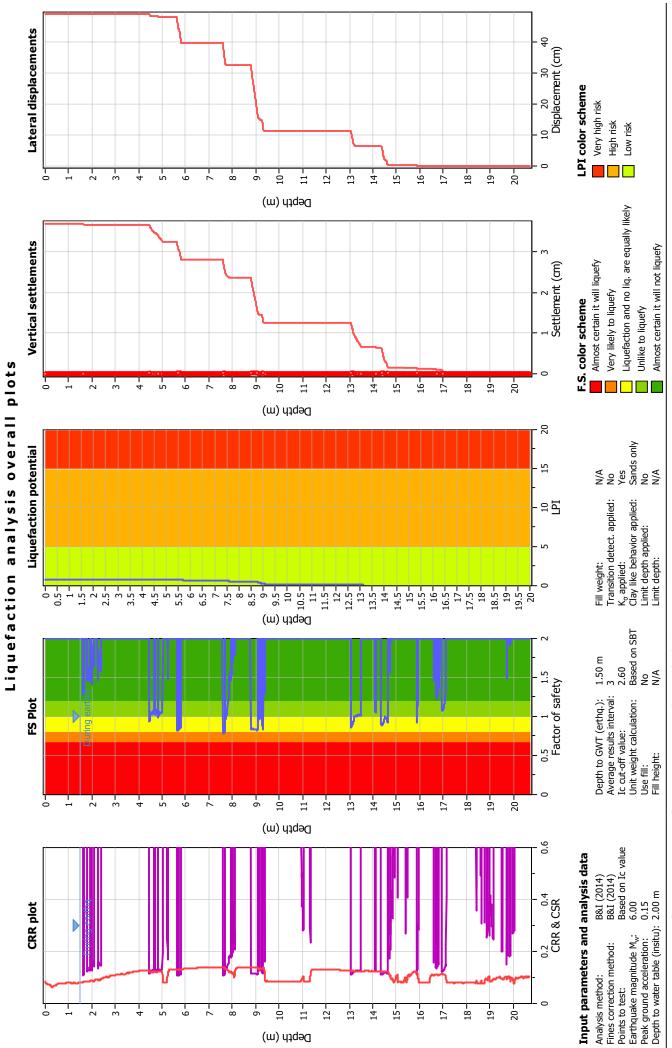
Project title : CPT file : CPT-02

Input parameters and analysis data
