DRURY ACCESS RAMP PROJECT

Appendix G – Arboricultural Assessment

Revision No: C Published Date: 13/07/2023 Author: Matthew Paul Reference: 523844-W00001-REP-EN-0002

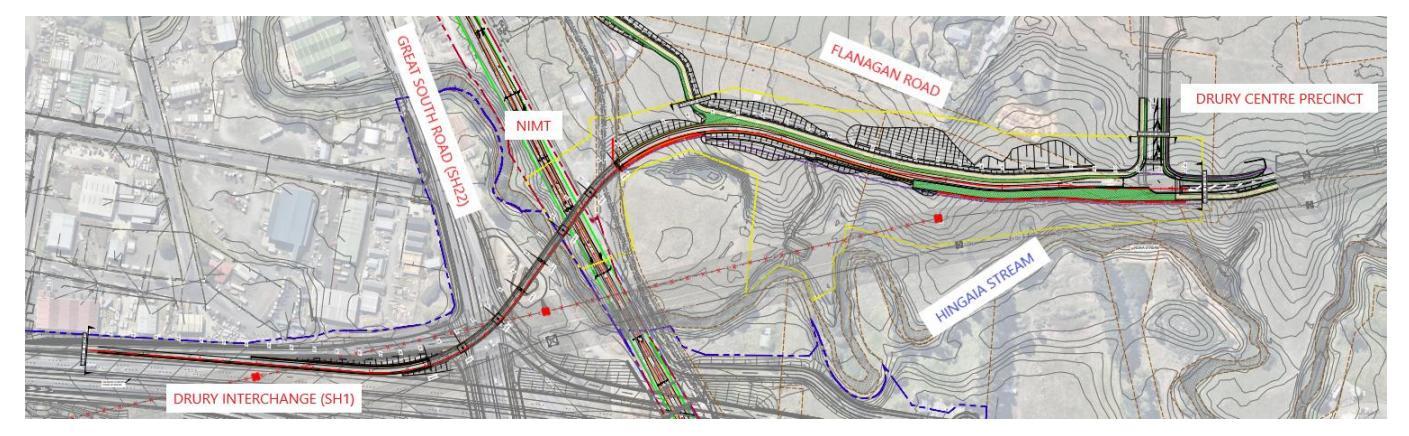
Figure 1-2: Location plan of Drury Access

The proposal is for the construction of a new southbound access ramp from SH1 to provide direct connection to future development areas in Drury Town Centre. The approximate location of the proposed off-ramp in relation to the surrounding existing and planned environment is referred to in the AEE and shown in Figure 1-1-2 below.

- Construction of a 245m long seven span structure bridge from southbound lane of SH1 to an area off Flanagan Road.
- Foundation piling works for bridge support; and
- Establishment of a left-hand shoulder lane on the bridge with a minimum width of 2m and right -hand shoulder 1m in width.

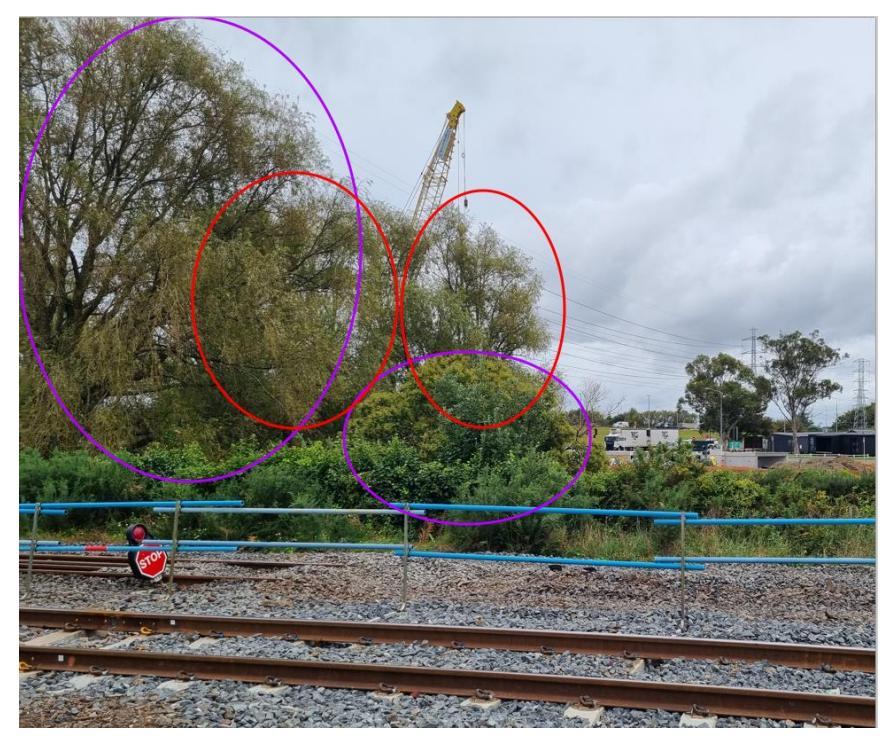
Figure 2-1: Tree 2 & Group 3 in Red, Tree 4 & 5 in Magenta

Significant vegetation within 10R Karaka Road include several groupings of Crack Willow (*Salix x fragilis*). One such cluster is growing in close proximity to the proposed bridge structure, which will include the construction of at least two (2) new piers near the subject trees (Tree 2 and Group 3at Chainage 450-500)

The subject grouping is located directly west of the proposed structure, with the trees approximately 18 metres in height. The proposed bridge structure will stand at approximately 11.0m in height from existing ground to the bridge surface. At least 30% of Tree 2 would stand within the footprint of the new bridge structure.

The Privet (Tree 4) stands directly within the footprint of Pier 5 with the Crack Willow (Tree 5) between 6-8 from the outer edge.

It is anticipated that the three (3) Crack Willows directly to the west of the Project would be removed (Tree 2 and Group 3) to enable construction and eliminate the potential risk to the future structure posed by failing limbs or structural sections, a typical trait of the species when changes occur nearby in terms of 'unaccustomed wind forces' or changes in group dynamics.

Trees 4 and 5 standing on KiwiRail land and the remaining pest plant species within the footprint of the proposed bridge piers of the Project would be required to be removed to enable construction.

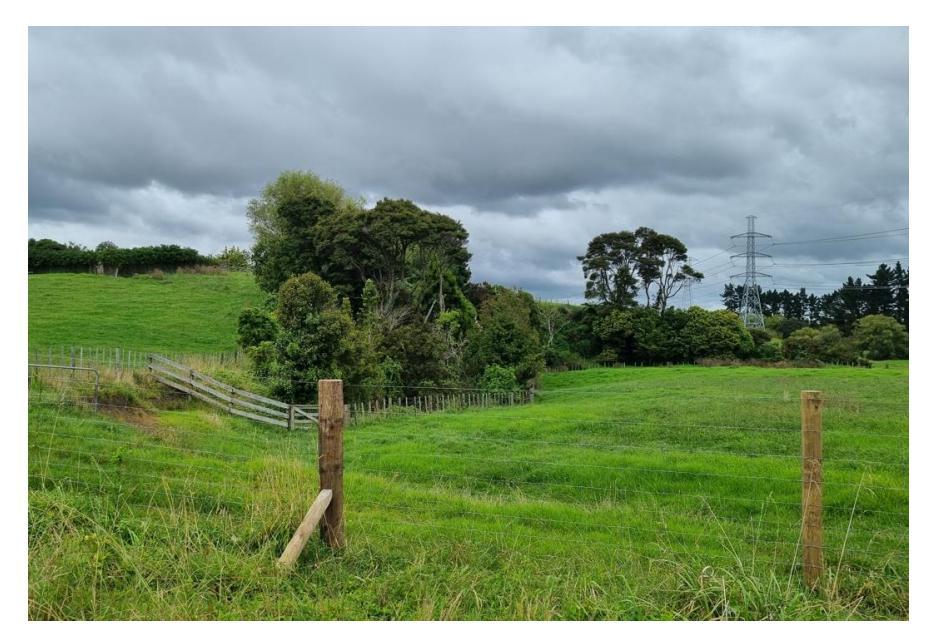
Figure 2-2: Cluster of non-protected tree grouping within 108 Flanagan Road (Group 6)

From Flanagan Road, the Project travels south through 108 Flanagan Road. While no vegetation within 108 Flanagan Road is subject to protection, the Project avoids a cluster of mixed plantings located directly to the west of the new ramp alignment.

This cluster of trees (Group 6) is a mixture of semi-mature indigenous species such as Kanuka (*Kunzea ericoides*), Totara (*Podocarpus totara*) and Kauri (*Agathus australis*) as well as a number of exotic plantings including Crack Willow and Magnolia (*Magnolia grandiflora*).

As noted in Section 2, there is no protected vegetation within 108 Flanagan Road. However, Group 6 will be retained and protected as part of the Project. As such, a tree protection methodology is provided in this report to ensure this is the case. It is recommended that all works near this grouping, and any additional tree or group to be retained, be undertaken in accordance with this methodology.

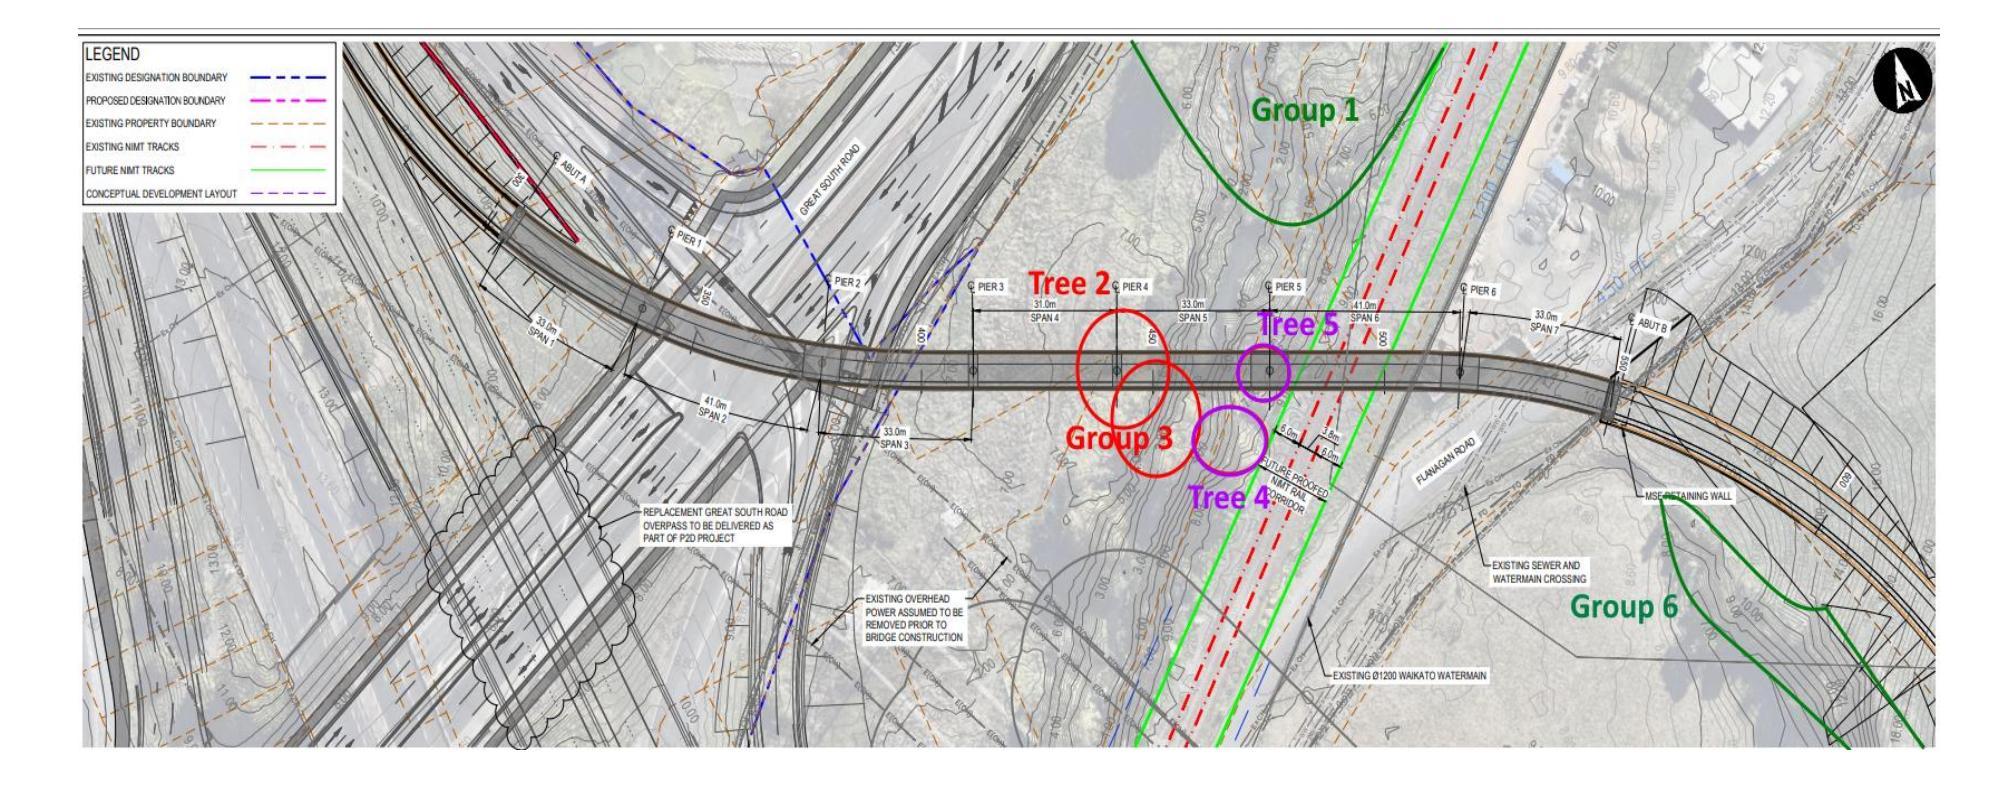
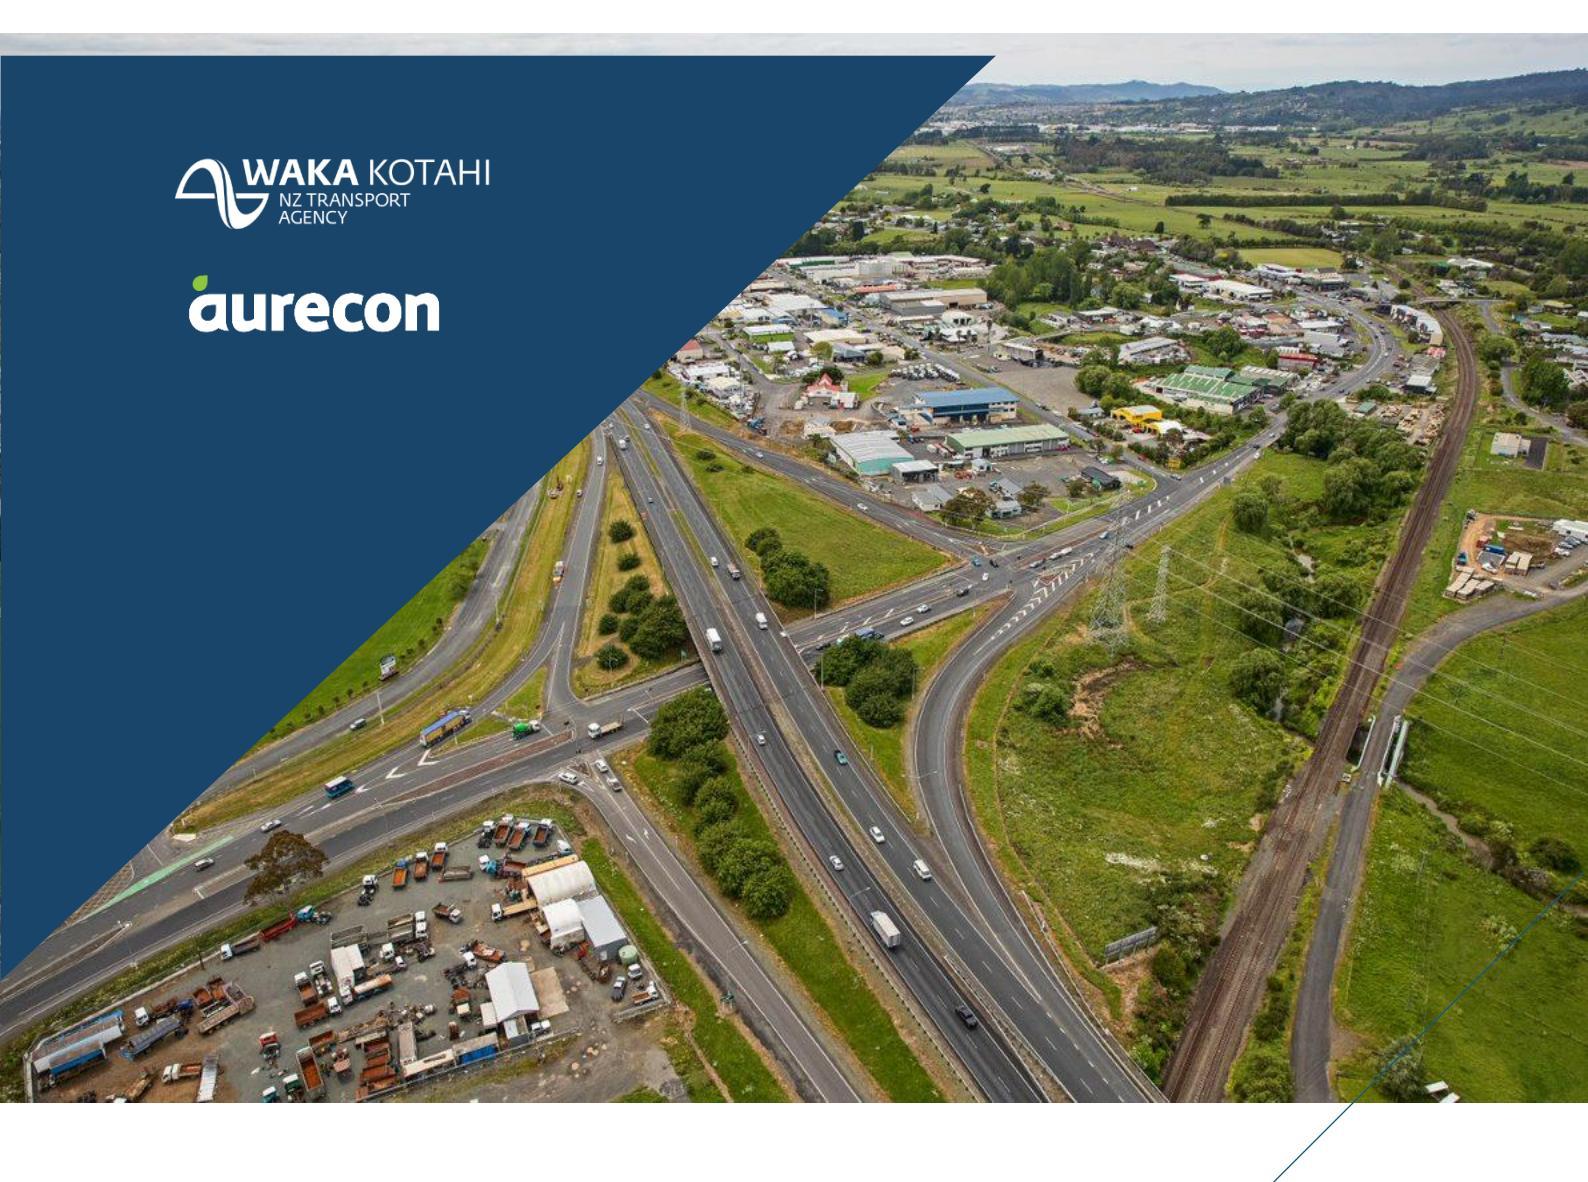
ATTACHMENT 2 – TREE PLAN

The **Attachment 1** Tree Schedule and **Appendix B** Tree Plans identify the locations of the vegetation described in the following sections.
