# Boffa Miskell Harania Flood Resilience Works - Tennessee Bridge

Landscape and Natural Character Effects Assessment Prepared for Healthy Waters 31 October 2024

Boffa Miskell Limited 2024. *Harania Flood Resilience Works - Tennessee Bridge: Landscape and Natural Character Effects Assessment.* Report prepared by Boffa Miskell Limited for Healthy Waters.

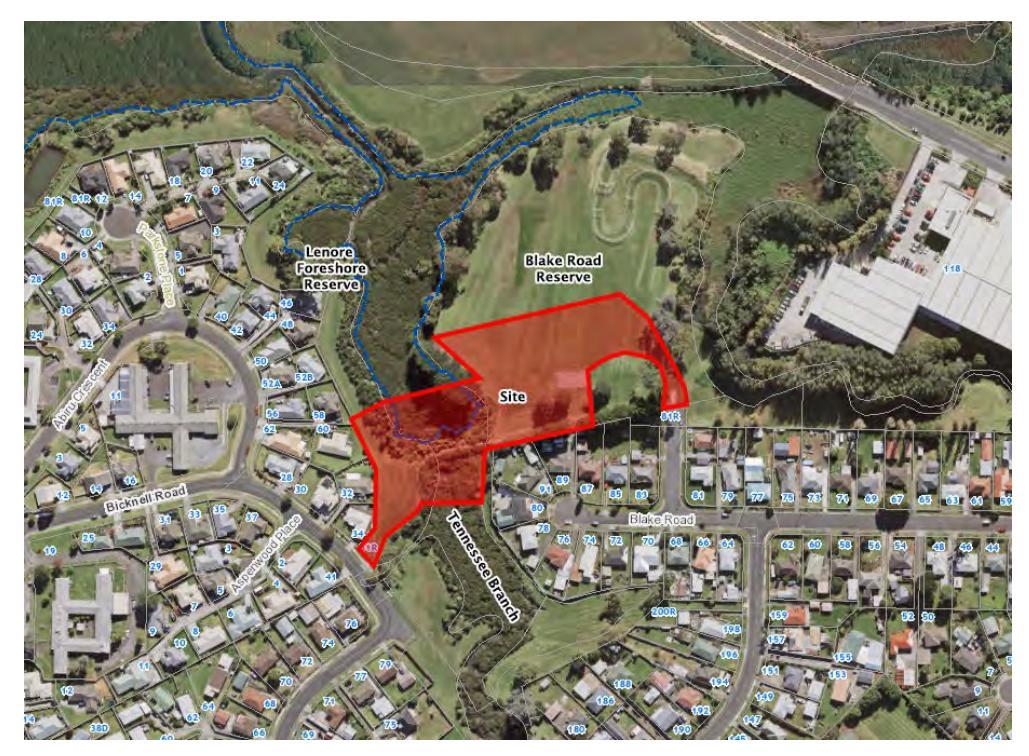
Figure 1: Site location and surrounding context

The Site is located over the Tennessee Branch, a tributary of the Harania Creek, between the Lenore Foreshore Reserve and Blake Road Reserve, accessed from Bicknell Road and Blake Road respectively (refer to Figure 1 below). The Lenore Foreshore Reserve and Blake Road Reserve are large open spaces which acts as a buffer between the Mangere East residential area and the Ōtāhuhu Industrial area.

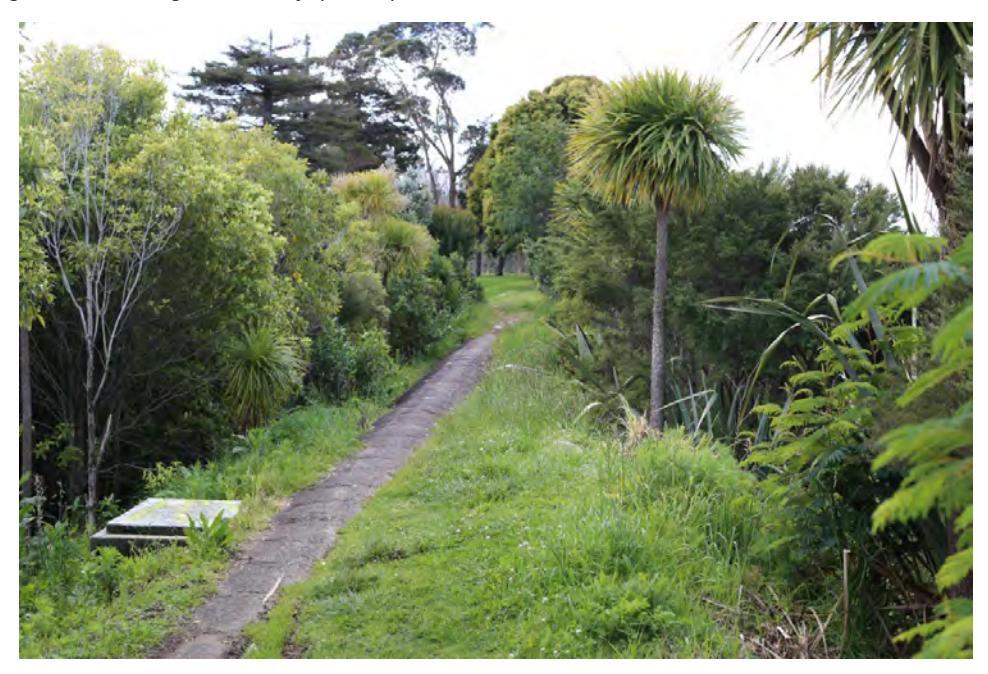
Photograph 1: View east across the existing pipe bridge embankment

The existing pipe embankment across the Tennessee Branch is approximately 44m long and 10-20m wide, has two culverts to allow water flow through the embankment, and is informally used for as a pedestrian bridge between the two reserves (refer to Photograph 1 below). Beyond the two (OS-IRZ) reserves residential development either side of the bridge comprises low density residential development zoned as a Single House (SHZ). Further to the east and north, separated from the Blake Road Reserve by another tributary of the Harania Creek are two large areas of Light Industry (B-LIZ) zoned land in the Ōtāhuhu Industrial area.

In summary, the existing stream has High/Moderate - High and Moderate natural character ratings due to the combination of modified and unmodified elements within the stream and its margins. The existing embankment across the Tennessee Branch and the two culverts are the most apparent examples of human modification (refer to Photograph 1 above).

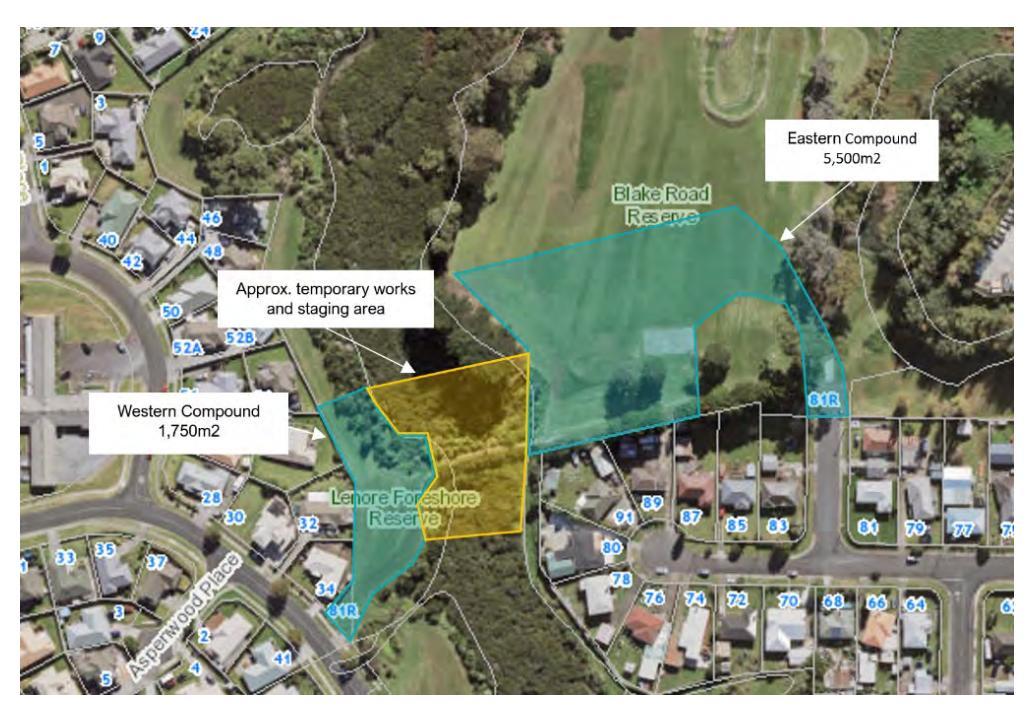
Figure 2: Indicative construction compounds and staging area which define the Site boundary.

The proposed Site boundary comprises the extent of the construction areas of the Western Compound (approximately 1,750m2) in the Lenore Foreshore Reserve, the Eastern Compound (approximately 5,500m2) in the Blake Road Reserve and the temporary works area within the Tennessee Branch corridor (refer to Figure 2 below). The Western Compound boundary extends up to the boundary of residential properties at Abiru Crescent (58 and 60) and Bicknell Road (32 and 34) and Eastern Compound abuts the residential properties at Blake Road (81, 83, 87, 89 and 91).

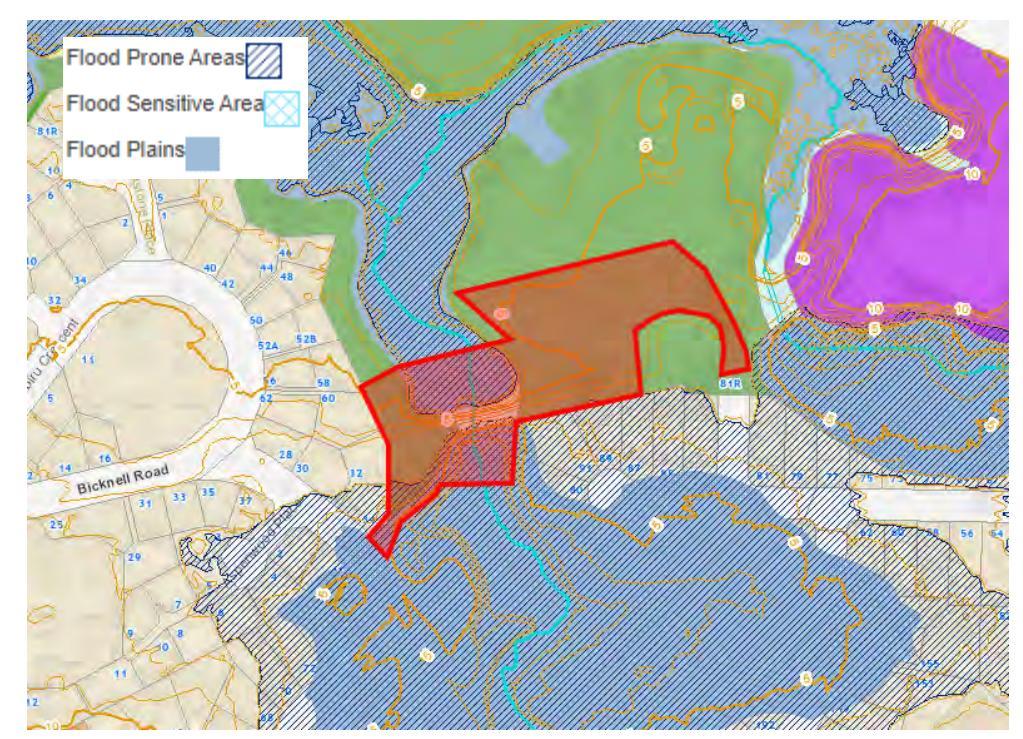
Figure 3: Flood prone areas and flood plains in the arear surrounding the Site (indicatively shown in red).

The surrounding topography is low lying to the south rising to the north with slight undulations. Earthworks mounded either side of the existing pipeline creates an embankment and an artificial high point within the two reserves. To the south of the existing embankment the low lying landform is within an identified flood plain (refer to Figure 3 below). The residential properties accessed from Blake Road and Bicknell Road are single storey dwellings and sit lower in the landscape than the existing pipe bridge embankment, the residential dwellings at Abiru Crescent have two storeys and sit slightly higher in the landscape.

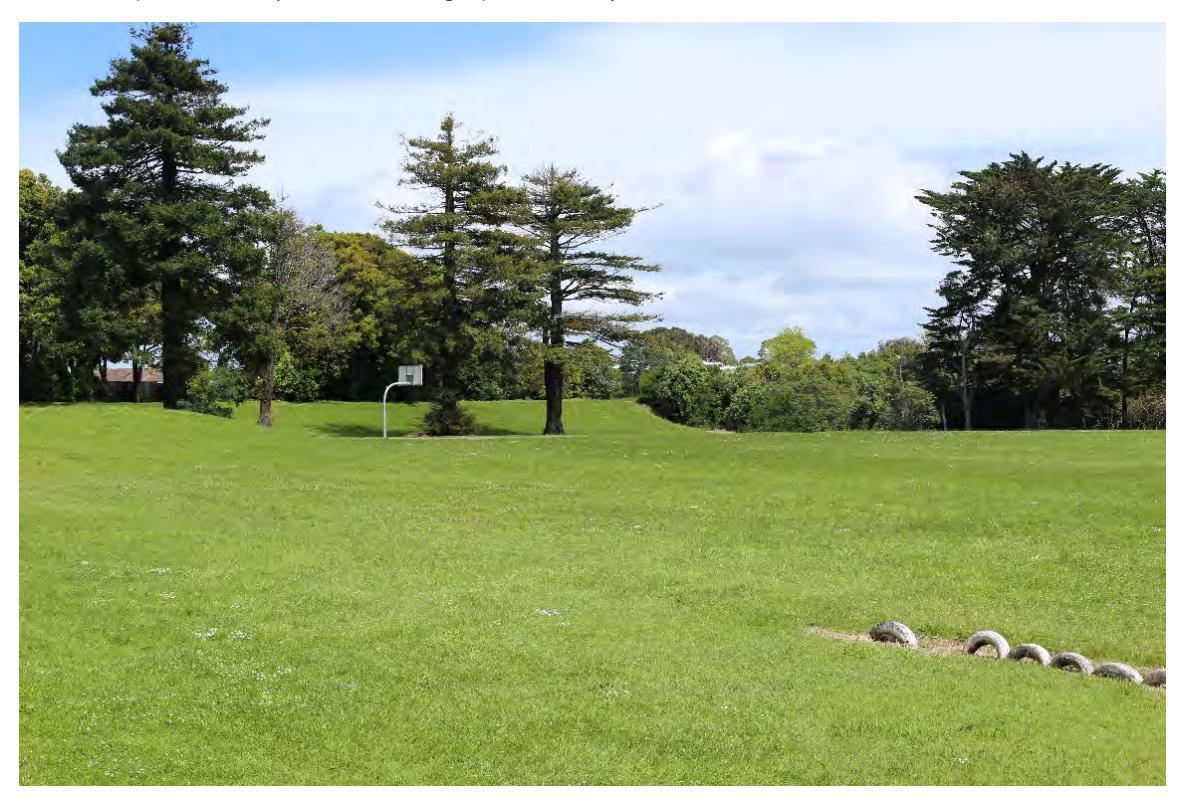
Photograph 2: View southwest from within the Blake Road Reserve.

The Lenore Foreshore Reserve is an esplanade reserve which primarily serves as a buffer between residential development and the Tennessee Branch and has very few amenity features or facilities. The Blake Road Reserve is a larger open space surrounded on three sides by a watercourse and contains community facilities including a BMX Track, basketball court and informal sports fields (refer to Photograph 2 below).

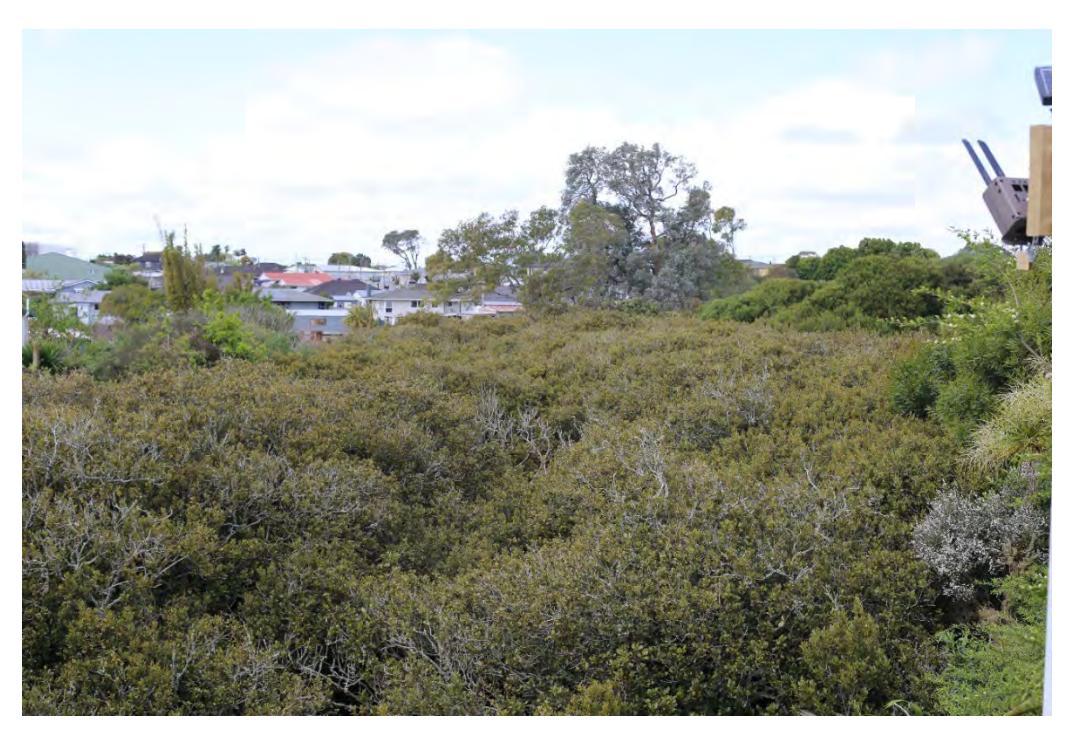
Photograph 3: View south from the existing pipe bridge over the mangrove forest.

Vegetation within the Tennessee Branch predominantly comprises Manawa / mangroves with small areas of salt marsh within the low lying areas and riparian margins of the watercourse which extend to the north and south of the embankment (refer to Photograph 3 below). The margins of the watercourse contains a combination of indigenous and exotic vegetation. Indigenous species within the margins include kānuka, mānuka, ngaio, karo, tarata/lemonwood, tī kōuka and exotic species include pampas, fennel, macrocarpa, redwood, bush wattle and tree privet.

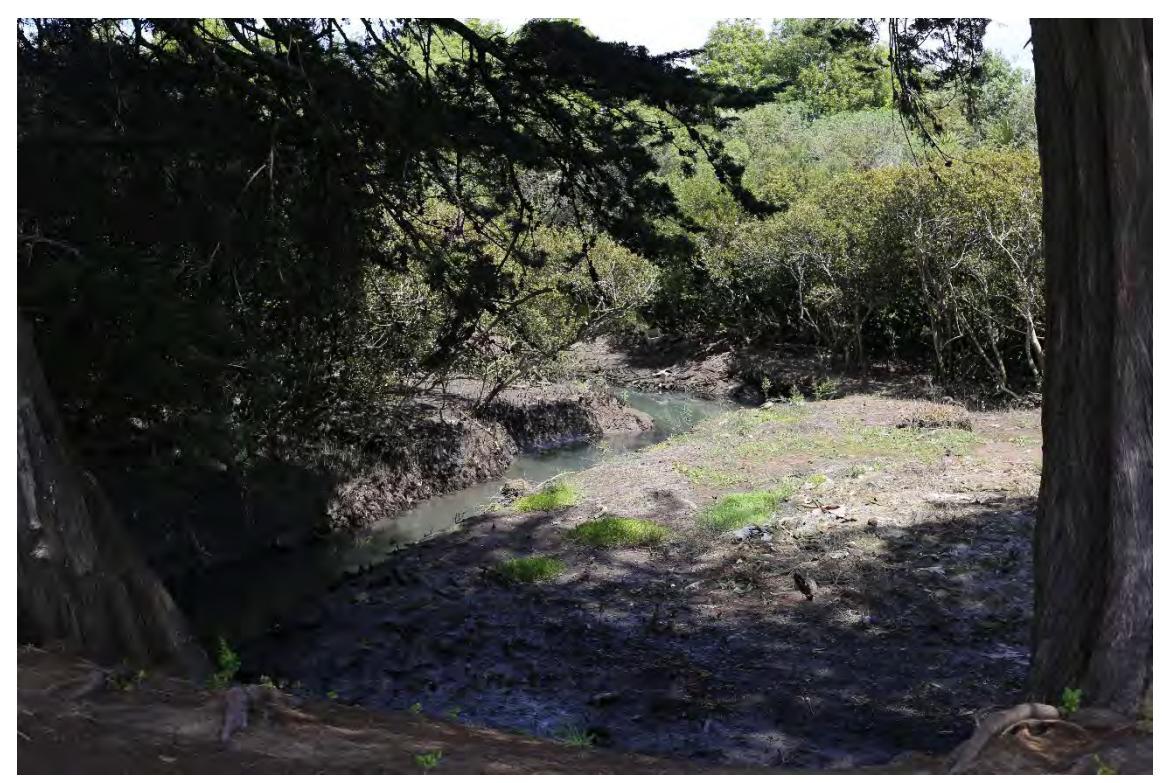
Photograph 4: Mangrove Forest within the low lying plateau of the Tennessee Branch to the north of the existing pipe bridge.

The existing embankment defines part of the "Indicative Coastline" in the AUP OiP, as such the Tennessee Branch to the north of the existing pipe bridge embankment is at the edge of the coastal marine area (CMA) and to the south of the embankment is not. The low lying plateau to the north and south of the existing embankment are dominated by mangrove (*manawa/Avicennia marina*) forests (refer to Photograph 3 above and Photograph 4 below). To the north of the existing embankment the majority of the stream is unmodified, to the south of the embankment the urbanisation of the land to the east and west of the Tennessee Branch, in the 1960s and 1970s, has resulted in modification for additional pipe crossings further upstream.

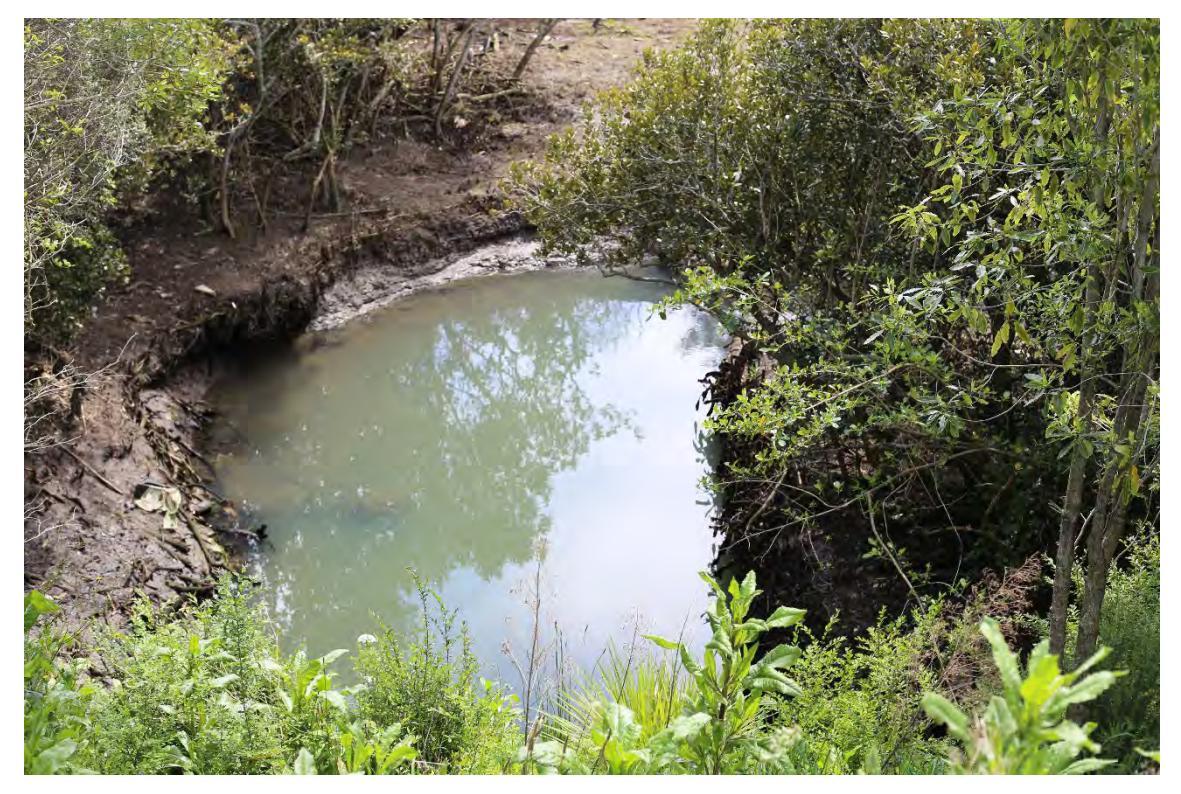
Photograph 5: Slow moving stream with suspended sediment to the north of the existing pipe bridge embankment.

The surface bed material was observed to comprise a silty sand with cohesive marine clays approximately 0.1 m below a fine silty sand layer. The wider catchment is underlain by mud, silt and clay with a dense sand layer. The flow of the stream was observed to have to be moderately slow with some visible suspended sediment (refer to Photograph 5 below). It is noted that debris including tree limbs and litter have been observed within the stream particularly after heavy rainfall. A range of aquatic fauna have been identified within the Tennessee Branch, a full list of species is provided in the Ecological Management Plan provided by Tonkin + Taylor, appended to the AEE. The notable "high value" species identified are Inanga (*Galaxias maculatus*), Longfin eel/tuna (*nguilla dieffenbachia*) and Smelt/pōrohe (*Retropinna retropinna*).

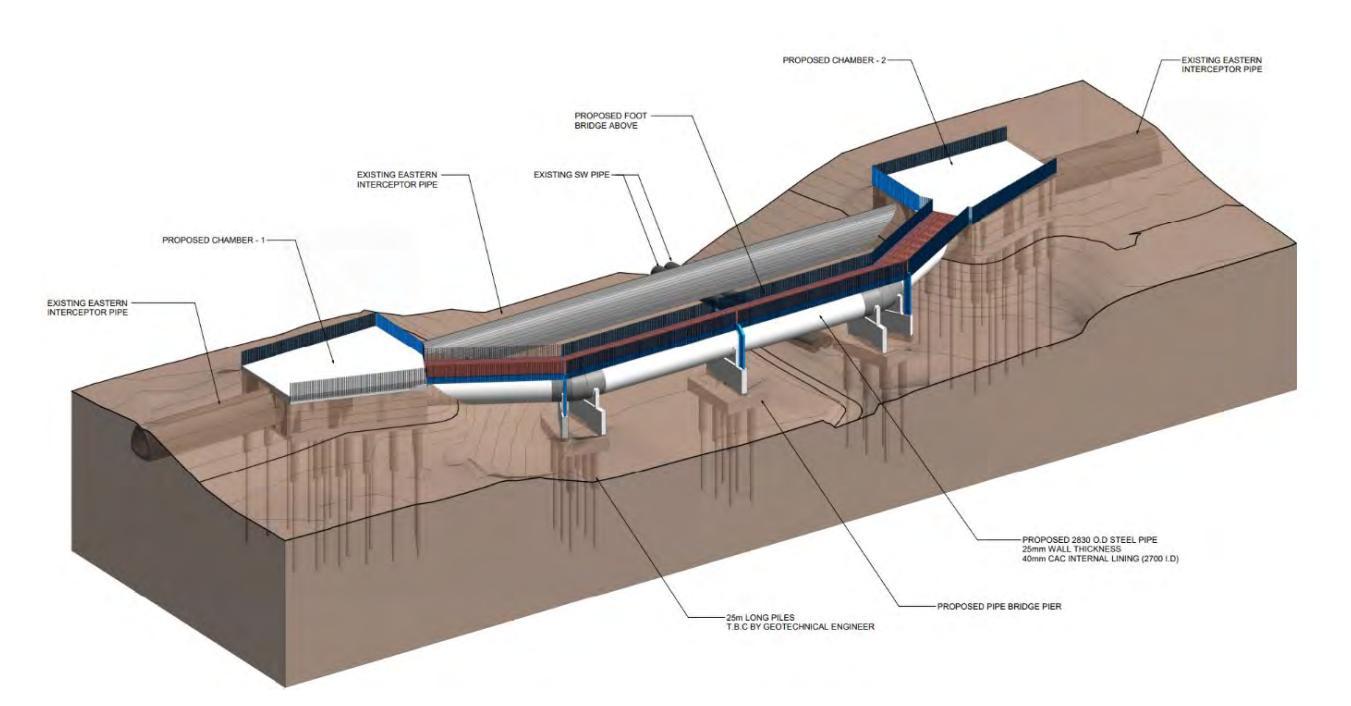
Figure 4: Tennessee Footbridge Concept Sketch

The proposed replacement footbridge is designed to provide a formalised pedestrian access across Tennessee Branch to replace the existing informal access. The proposed footbridge will sit on top of the proposed replacement pipeline. The current concept design for the bridge proposes that the northern and southern façades of the bridge deck are clad with vertical "timber" slats which will break up the bulk and scale of the bridge form (refer to Figure 4 below). The design of the bridge will continue to be developed in collaboration with iwi.

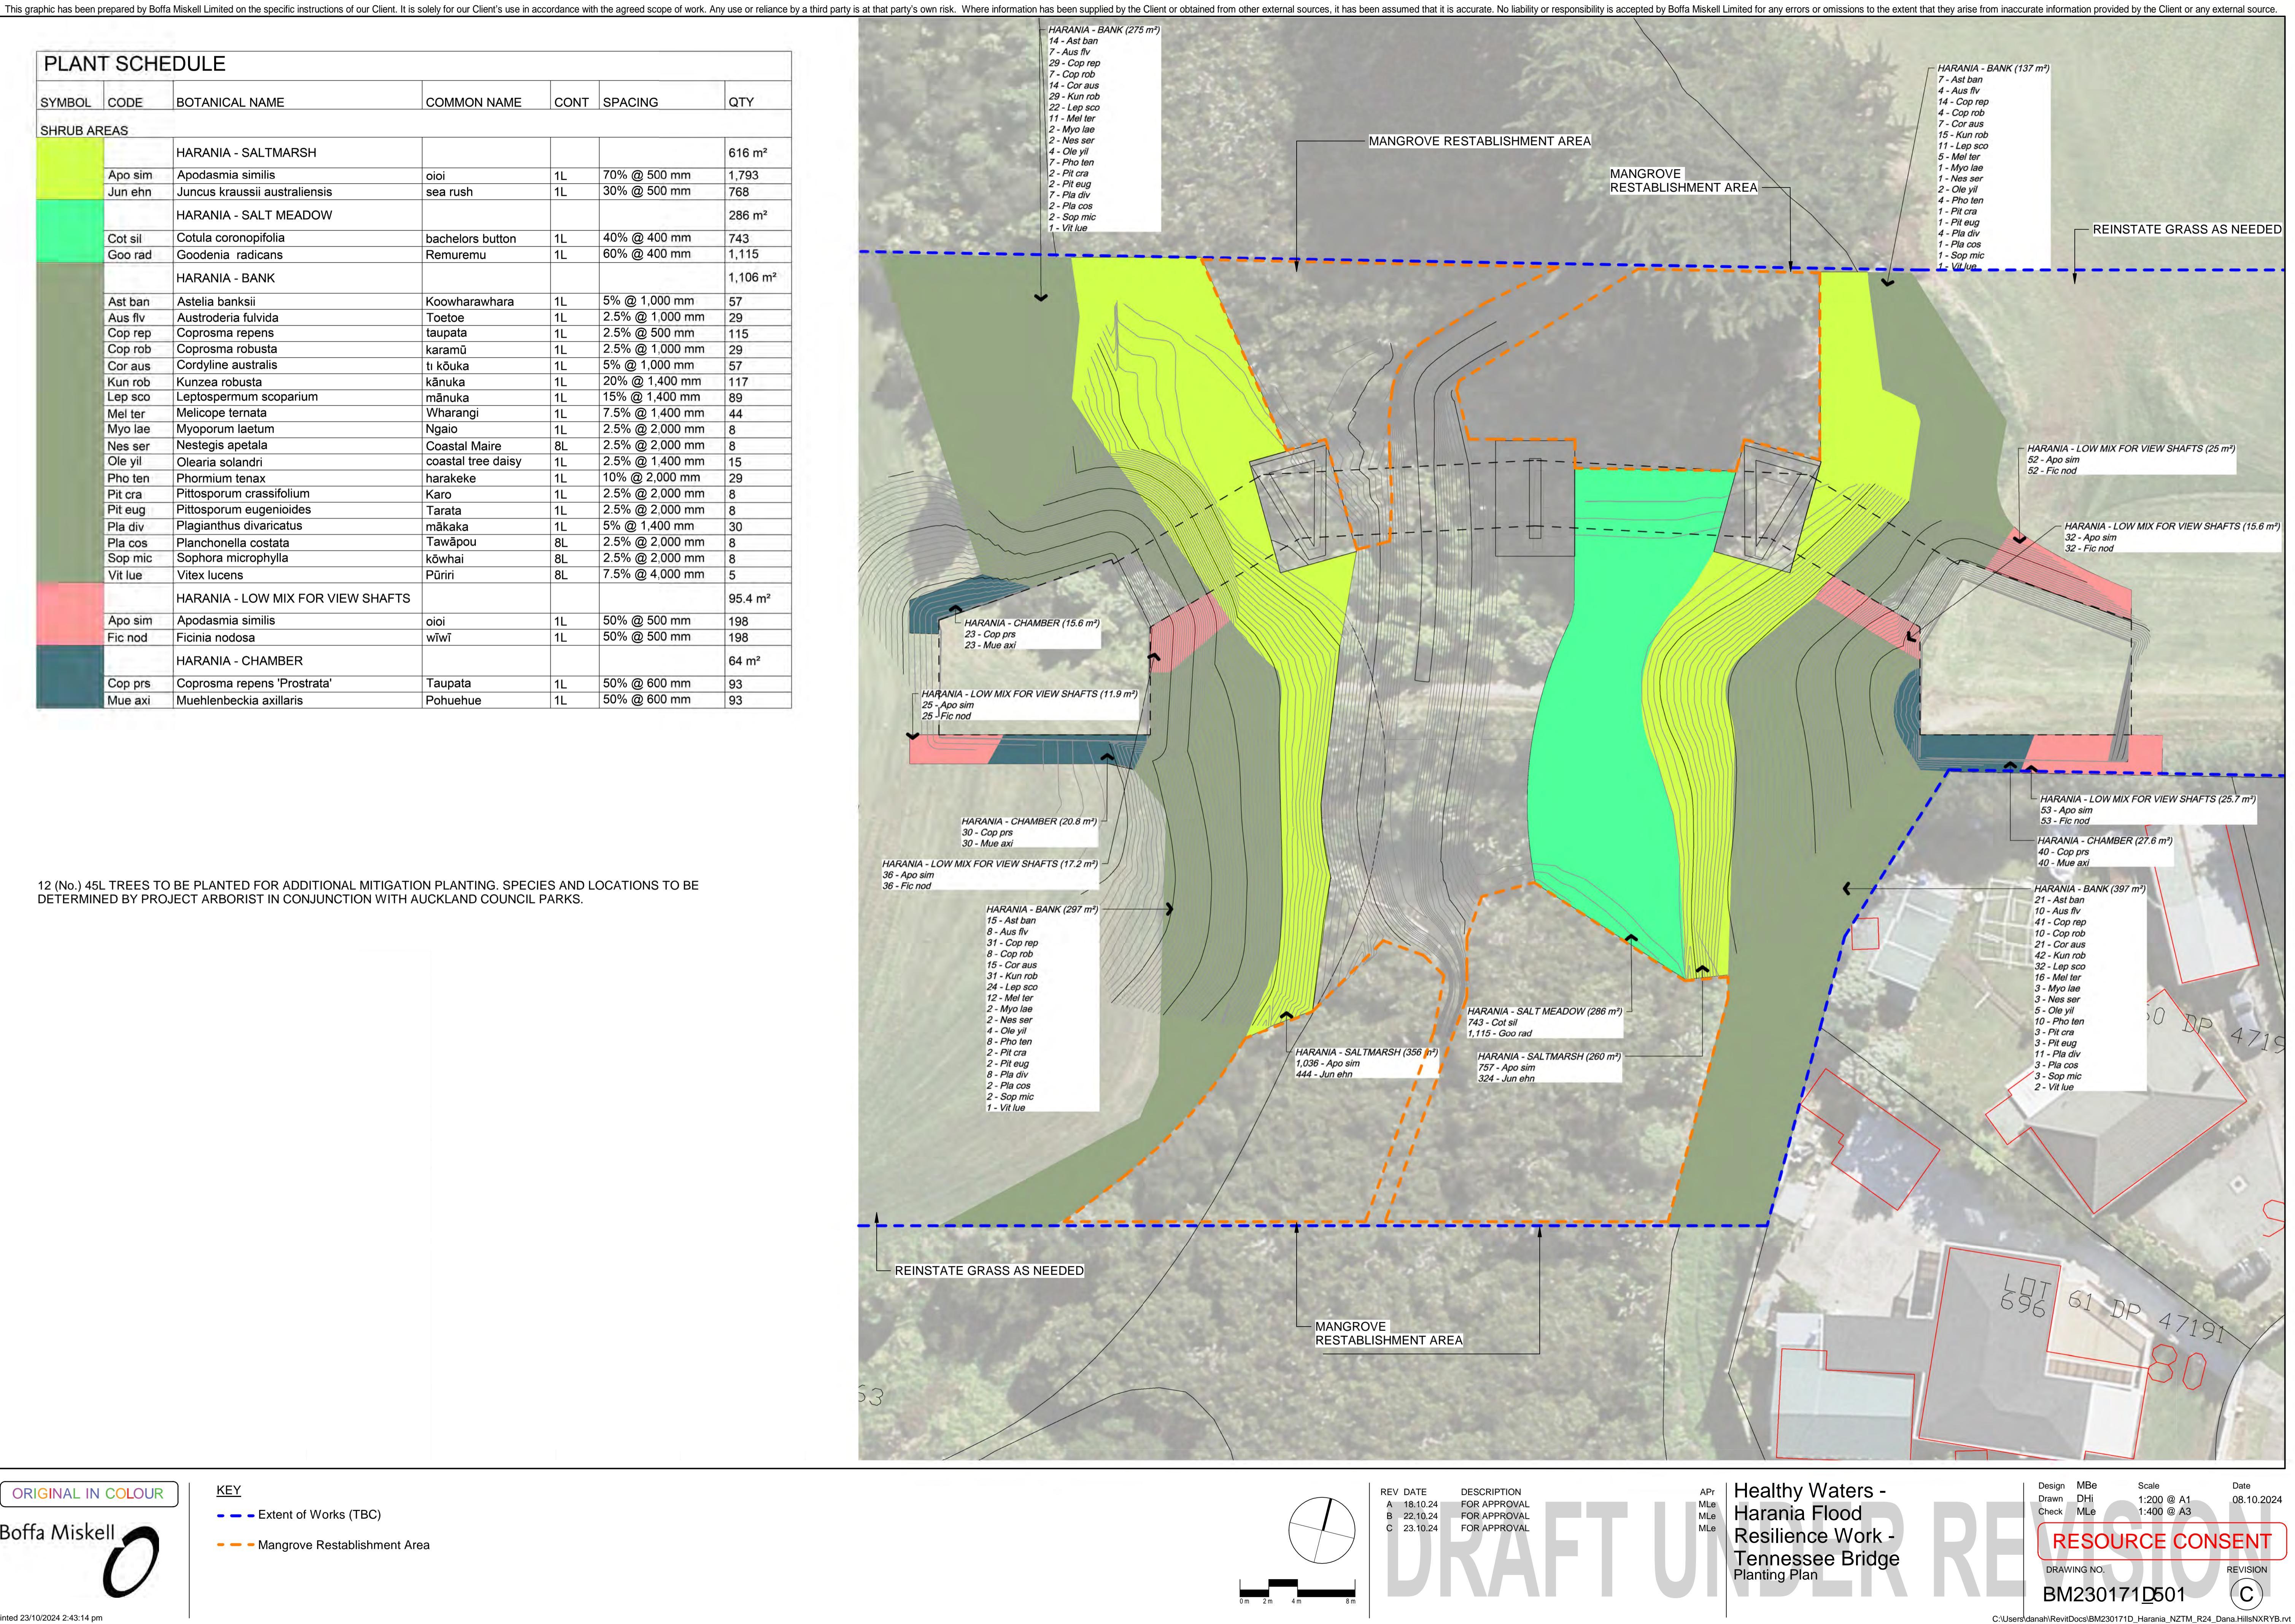
Appendix 4: Replacement Planting Plan

12 (No.) 45L TREES TO BE PLANTED FOR ADDITIONAL MITIGATION PLANTING. SPECIES AND LOCATIONS TO BE DETERMINED BY PROJECT ARBORIST IN CONJUNCTION WITH AUCKLAND COUNCIL PARKS.

– – Mangrove Restablishment Area

A proposed Replacement Planting Plan (RPP) has been developed to address the landscape and visual effects as a result of the construction of the proposed culvert and footbridge. The landscape and natural character effects have been assessed with the consideration that the proposed RPP will be implemented as part of the proposal. The RPP has been developed with consideration of the recommendations of the CVA's to ensure that the natural character (including cultural values) is maintained or enhanced. This assessment recognises that planting will take several years to provide a mitigation role and will reduce the landscape and natural character effects. Full details of the RPP are presented in Appendix 4: Replacement Planting Plan.

A total area of 2,167.4m<sup>2</sup> riparian, saltmarsh and bank vegetation plus mangrove vegetation lost will be planted to replace the vegetation lost during construction.
