Earthquake prone buildings – guidance and approaches

Auckland Council Guide

Purpose of this document

This document has focused on a particular type of building that can be earthquake prone: a two storey unreinforced clay brick masonry (URM) building. Previous earthquakes have demonstrated the vulnerabilities of URM construction. And many URM buildings have not been strengthened to resist earthquake forces and may be vulnerable in future earthquakes. Two storey URM buildings are a common sight in Auckland's urban environment. They are usually older buildings, and often have historic heritage and character value that is appreciated by the wider community.

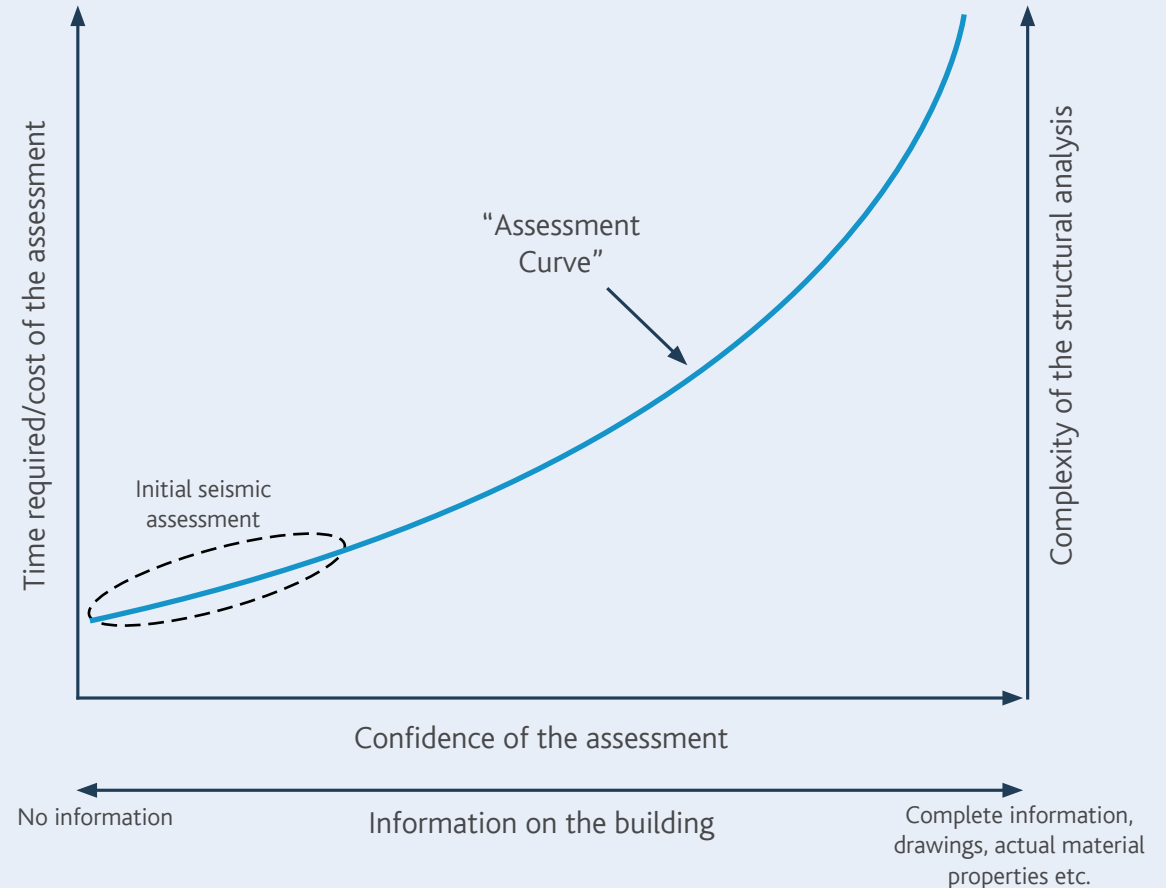
FIGURE 4: Graph illustrating the relationship between the confidence of the assessment, time/cost and complexity of the analysis

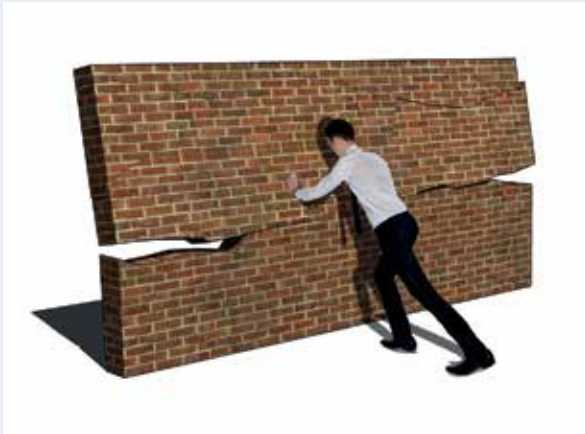
(a) Schematic of a wall responding out-of-plane

(b) Schematic of a wall responding in-plane

FIGURE 7: Illustrations of URM walls when subjected to in-plane and out-of-plane lateral forces

Geometry dictates that URM walls are much stronger and more stable when the direction of lateral force is parallel to the horizontal span of the wall (commonly referred to as the in-plane direction by engineers). When the direction of force is perpendicular to the wall (commonly referred to as the out-of-plane direction by engineers), the stability of the wall is greatly diminished. These principles are illustrated in **Figure 7**.
