**K200826-1a**

**21 July 2023**

**GEOTECHNICAL INVESTIGATION REPORT  
PROPOSED SUBDIVISION  
2127 KAIPARA COAST HIGHWAY  
MAKARAU**

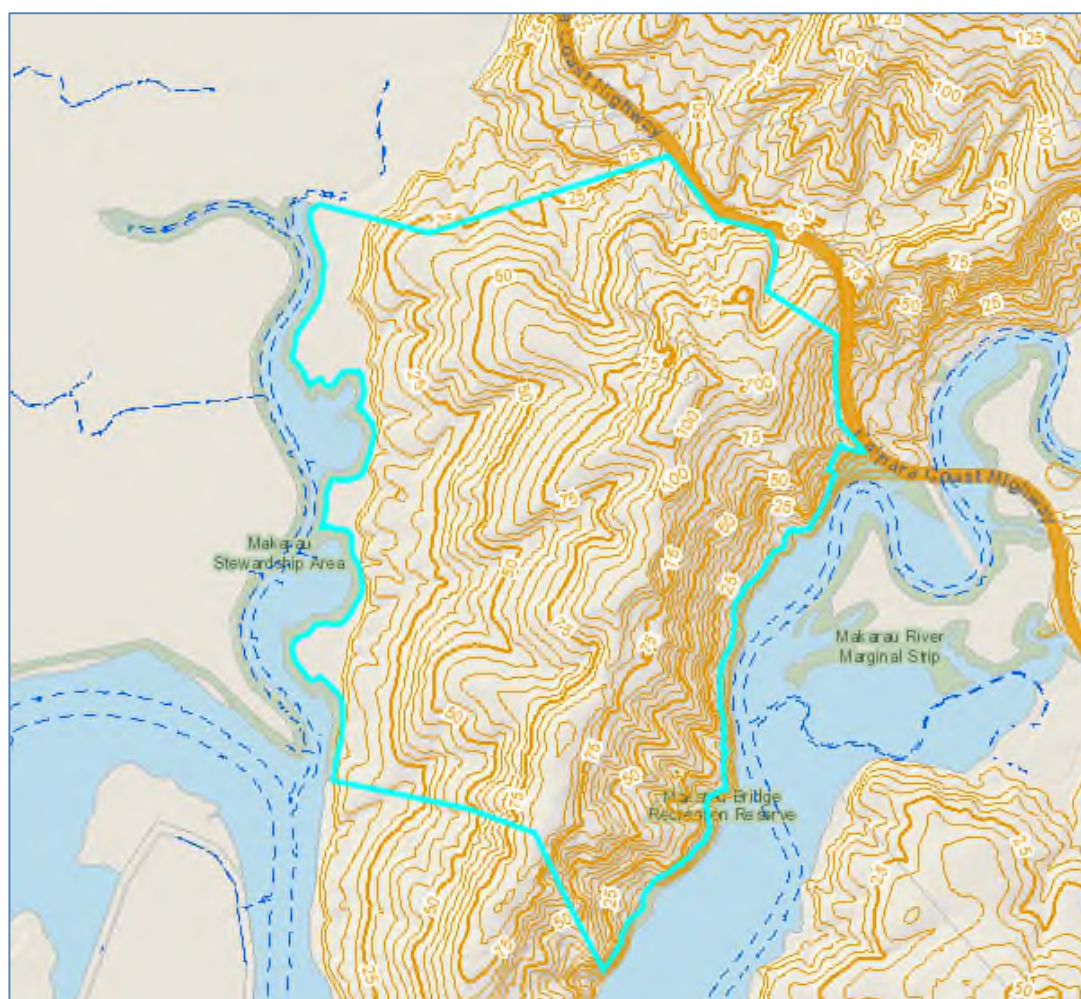
**Figure 1: Screenshot of site boundaries from Auckland Council Geomaps Website. (Not to Scale)**

The site at 2127 Kaipara Coast Highway, Makarau is legally described as 4B Block and Section 1 Survey Office Plan 328127, and Part Section 50 Block II Kaipara Survey District and has a total plan area of approximately 138.0722 Ha, and is hereinafter referred to as ‘the site’. The site is irregular in plan shape and accessed via Kaipara Coast Highway on the northeast boundary. The site is bound by rural residential properties to the north, Makarau Stewardship Area (currently used as pastoral farmland) to the west, Pareparea Burial Reserve to the south, and Makarau River/Makarau Bridge reserve to the east. An indication of the site boundaries relative to Kaipara Coast Highway is indicated in Figure 1 below, and shown on our Site Plan presented in Appendix A.

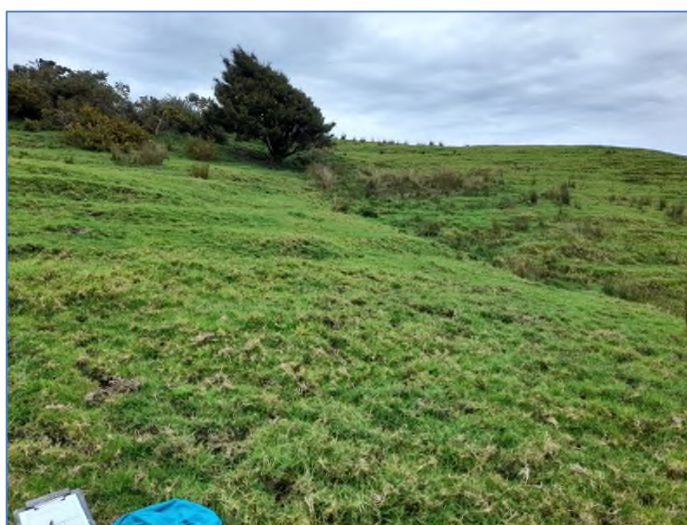
Several features of note were observed during our walkover which are reminiscent of historic shallow land-sliding morphology. Notably, we observed several amphitheatre shaped areas of land which contained a notable steep sloping portion upslope of a more gently sloping but hummocky/benched area. In many of these locations, the land downslope of the hummocky/benched areas were noted to fall steeply again. Further, in some places there was a notable 'back-slope' to some of the benches (where the surface of a bench locally falls back towards the overall slope), and also localised concentrations of hydrophilic vegetation (rushes) were observed. An example of this type of morphology can be seen in Figure 2 below.

**Figure 2: Example of observed historic landslide morphology northeast of the proposed Lot 8.**

We observed historic instability on site which typically comprised minor shallow soil creep across much of the site's sloping ground. No obvious evidence of deep-seated slope instability was identified during our site observations.

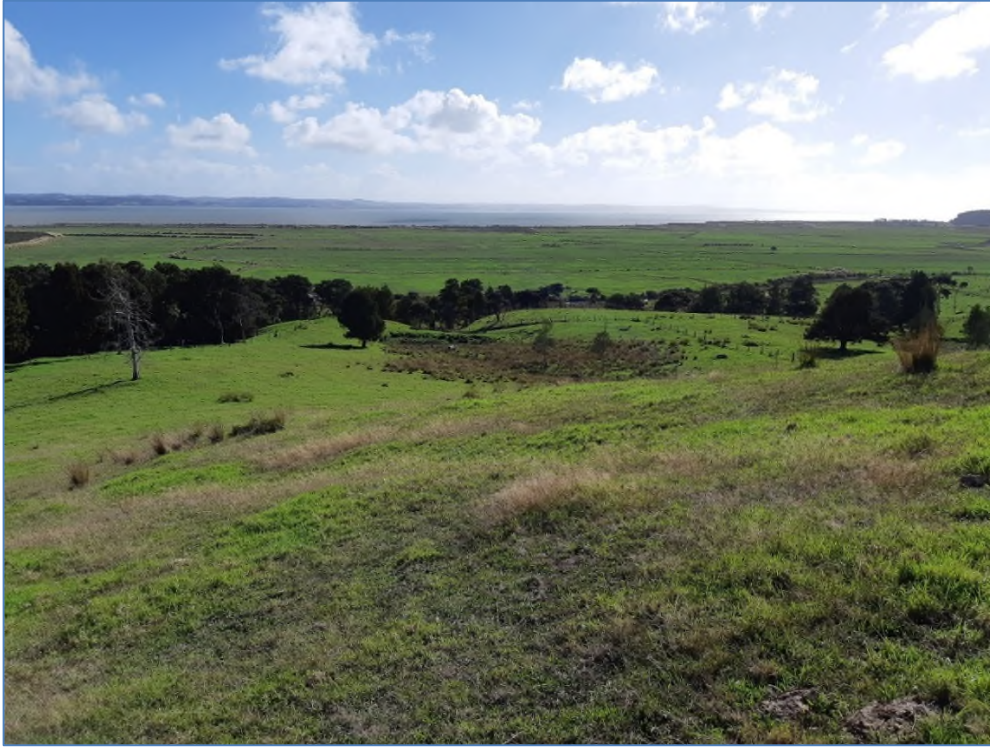
The current land-use of the site is pastoral farming and is divided into a number of paddocks. An existing dwelling is located on the northern corner of the site and a number of farm sheds and other structures are located north of the high point of the site. A gravel accessway allows vehicle access to the dwelling and the farm sheds where a turnaround bay is located. Farm tracks are spread across the site, generally along local ridge lines. The heavily used farm tracks were observed to be highly disturbed and 'boggy' from the stock movement through the wet season. Several large stands of bush, and Significant Ecological Areas (SEA) are present on the property, particularly on the more steeply sloping eastern side of the ridge, and within the larger, western sloping gully features. The gently sloping areas on the western side of ridge are noted to contain some shallow drainage channels and abundant growth of hydrophilic vegetation (rushes), as is evident in Figure 3.

**Figure 3: Gently sloping land and hydrophilic vegetation in the western part of the site proper**

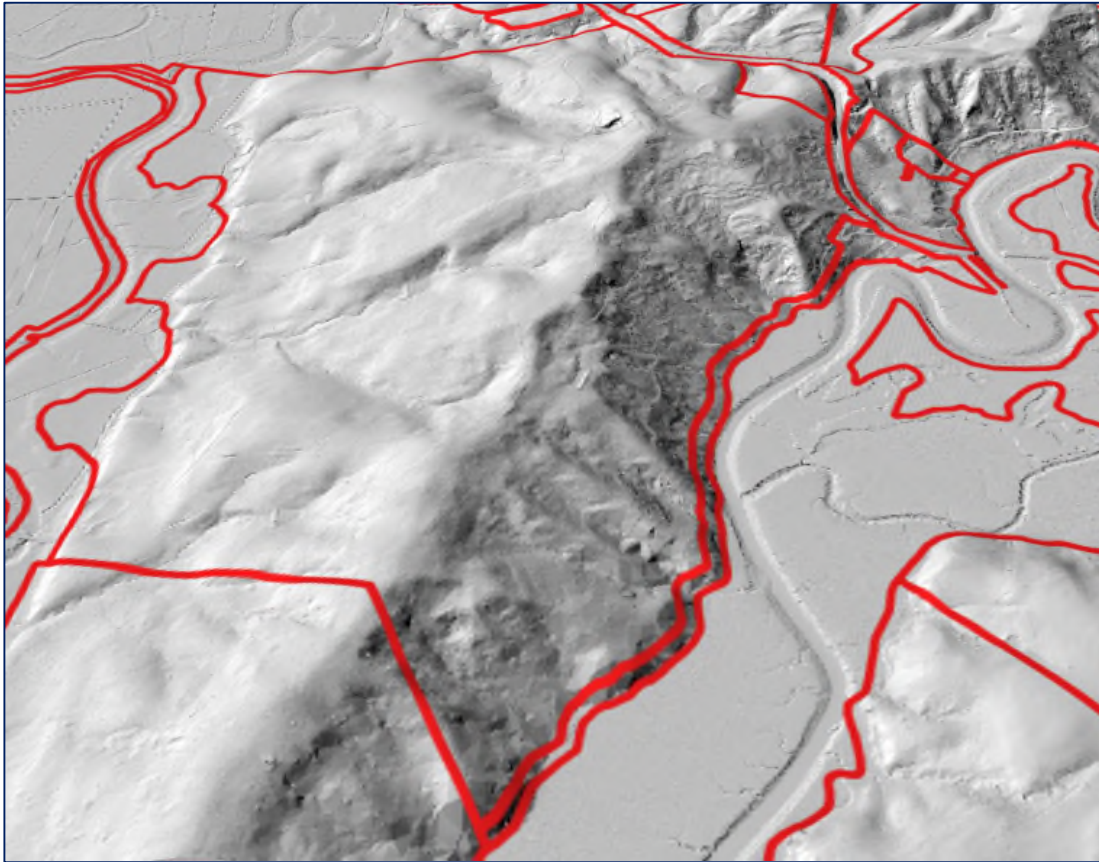
Our interpretation of the GIS information for the site generally confirmed our on-site observations. In particular, the data available helped to confirm the presence and location of historic landslide head-scarp features, including those that were otherwise obscured by vegetation, or were not readily apparent by ground surface observation while on site. A 3D perspective of the site using a hillshader algorithm applied to the Digital Elevation Model (DEM) of the site, which is publicly available LINZ data, is presented in Figure 4 below for perspective.

**Figure 4: 3D perspective of the site elevation (data from LINZ). Looking from South to North.**

Our interpretation of the hillshade model generally confirms the observations made during the reconnaissance walkover, and indicates historic land slippages across the site, particularly in the eastern portion. However, no evidence of recent or on-going, deep-seated slope instability was interpreted.

The hillshade model and aerial photograph interpretation also suggest the southern portion of the site is underlain by a mass block of Waitemata Group Formation Rock which is dipping westward. A westward tilting block would result in the eastern slopes having favourable geology and may be the reason the eastern escarpment is so steep and only exhibiting minor shallow soil failures compared to the remainder of the site. This would also explain why the drainage patterns in the western portion of the site are generally towards the west.

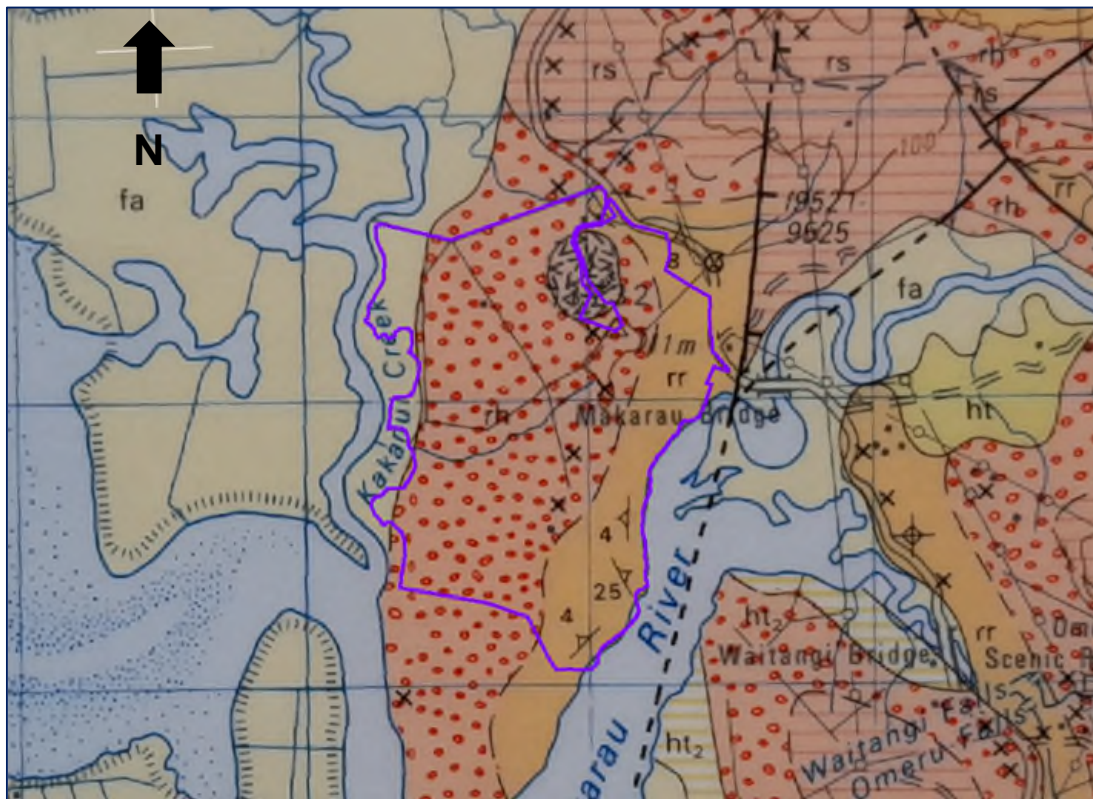
The geological map also shows an inactive fault immediately east of the site. This fault trends northeast to southwest and runs through the centre of the Makarau River mouth. The fault is dipping eastward indicating the western side (of the fault) has been uplifted.

**Figure 5 - Excerpt from Helensville Geologic Map, Sheet Q10 (not to scale). The subject site boundaries (in purple) relative to the mapped geologic units and features are indicative and approximate only.**

We point out that the geologic map used in this investigation is regional in scale and as such is only useful as an approximate indication as to the material that may underlie the site. The presence or absence of any material can only be confirmed by undertaking site specific investigation.

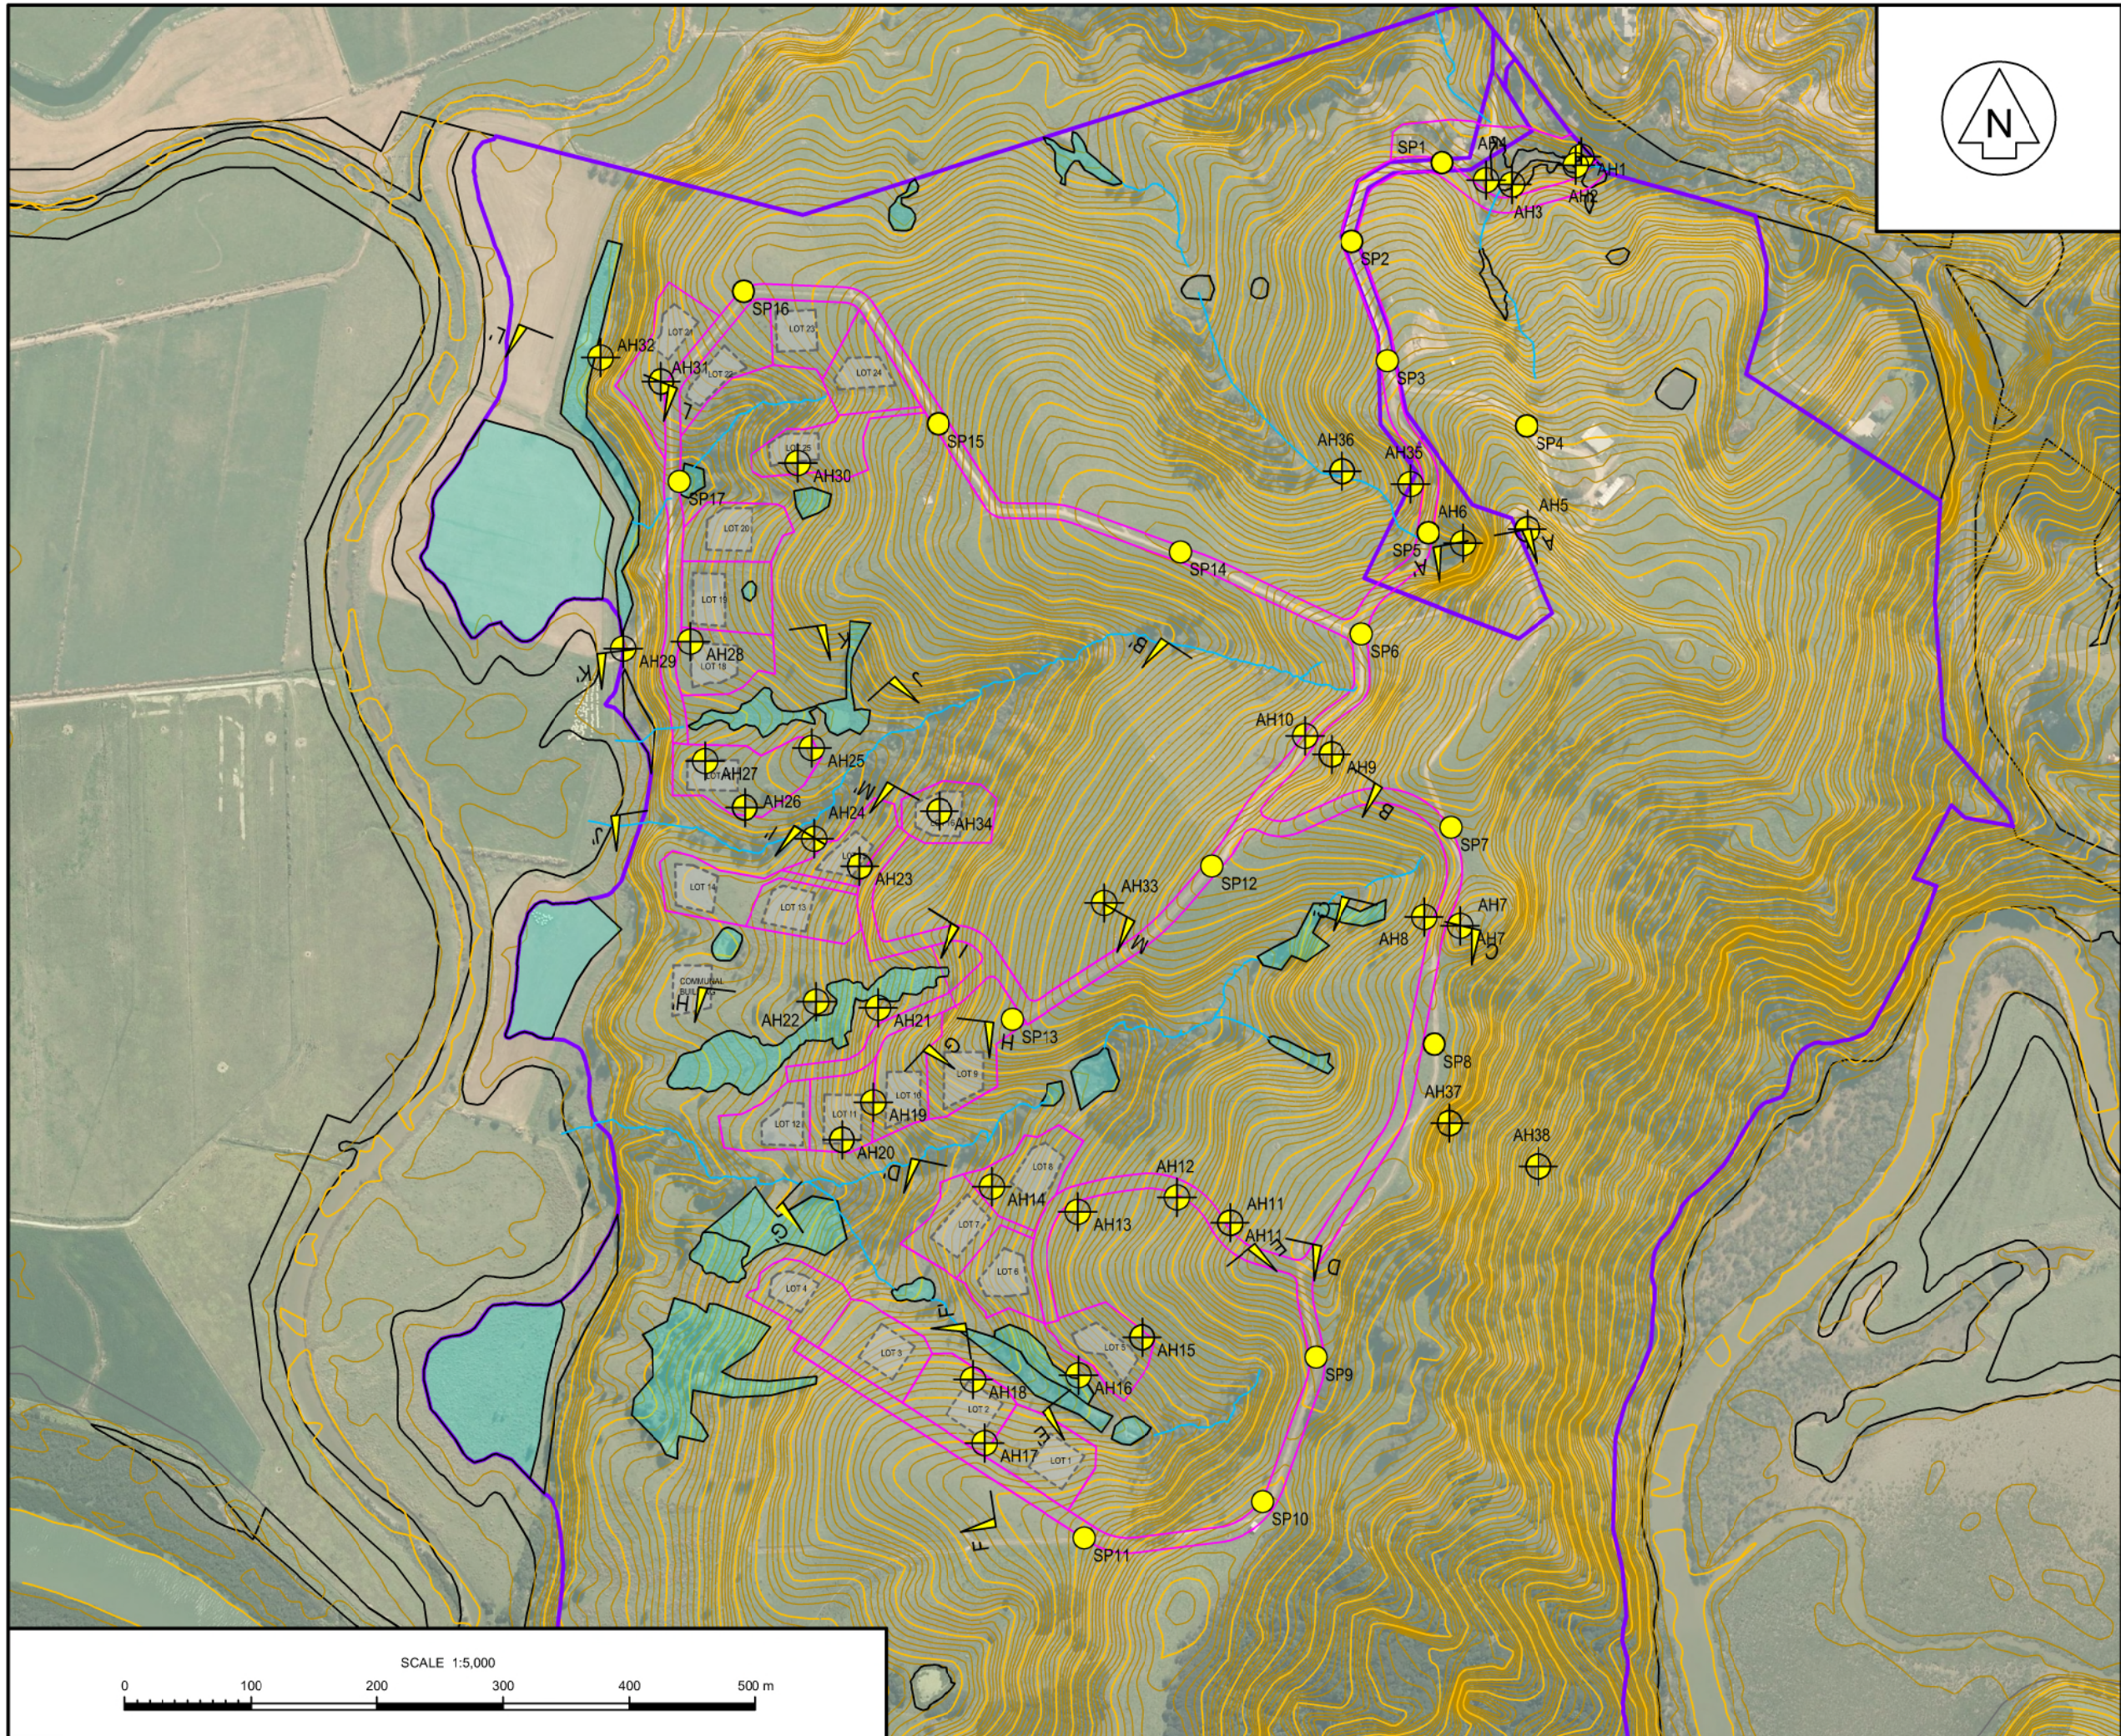
- NATURAL INLAND WETLAND AREAS
- PROPOSED BUILDING PLATFORMS
- AH1 HAND AUGER BOREHOLE
- SP1 SURFACE SCALA PENETROMETER
- SITE BOUNDARY
- NEIGHBOURING BOUNDARIES
- PROPOSED LOT BOUNDARIES
- OVERLAND FLOWPATH
- EXISTING TOPOGRAPHIC CONTOURS, MAJOR INTERVAL = 5m
- A A' CROSS SECTION

The subsurface ground conditions within the proposed Lots, accessway and sloping ground across the site were explored by drilling 38 hand-auger boreholes, AH1 to AH38. The borehole locations are shown on our Site Plan, presented in Appendix A. The borehole locations were selected to provide a representative indication of the subsurface ground conditions across the site.

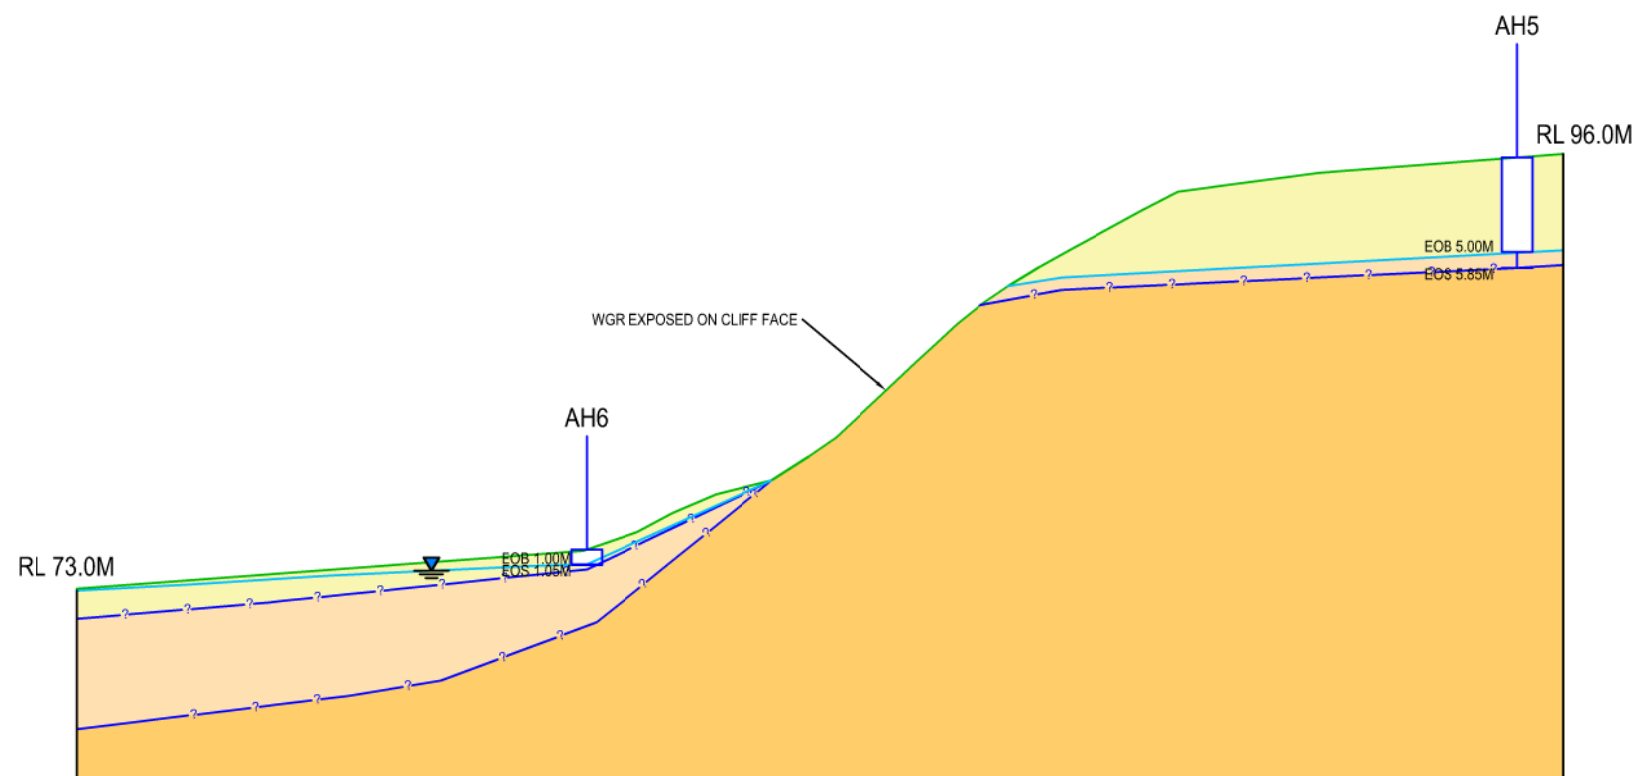
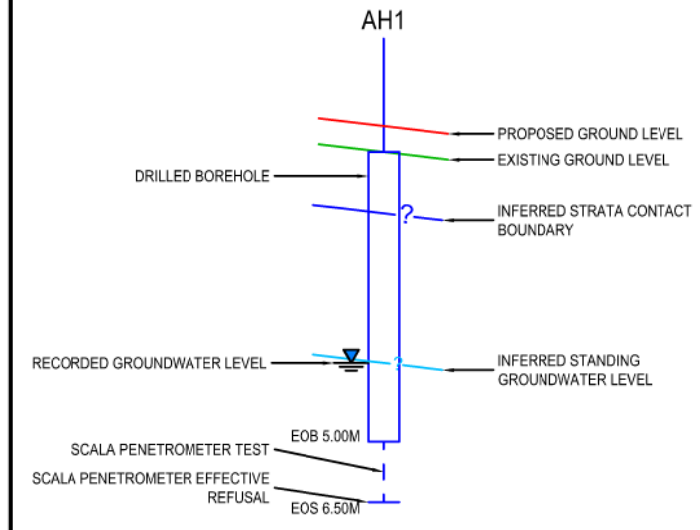
PROJECT NUMBER  
 K200826      DRAWING NUMBER  
 KGA 3      REVISION  
 A

- WAITEMATA GROUP SOILS
- WAITEMATA GROUP TRANSITIONAL MATERIAL
- WAITEMATA GROUP ROCK

The visual assessment undertaken on the sloping ground within the site identified evidence of shallow soil failures/creeps. However, no deep-seated failures were observed. In conjunction with our visual assessment, we have used 1 m contours from the Auckland Council Web application 'GeoMaps', in order to prepare a series of representative cross-sections for use in a slope stability analysis of the existing ground, see attached cross-sections A-A' to N-N'.

The subsurface conditions modelled in the analyses are based upon the results of our subsurface investigation. In addition, a bedrock layer has been inferred at 10 m below the inferred dense/transitional material for each section.
