K200826-1B

1 March 2024

**GEOTECHNICAL INVESTIGATION REPORT
PROPOSED SUBDIVISION
2127 KAIPARA COAST HIGHWAY
MAKARAU**

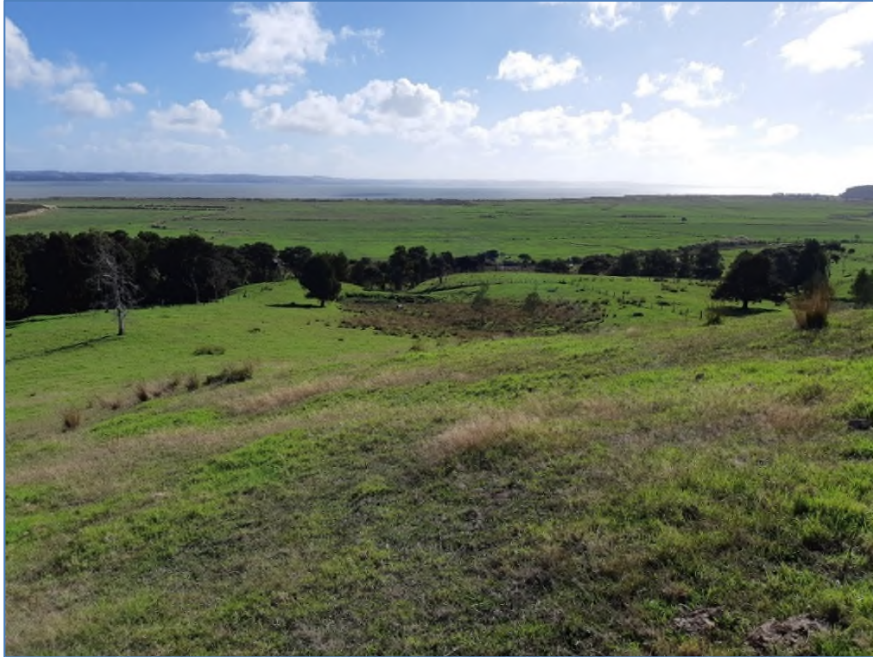
Figure 3: Gently sloping land and hydrophilic vegetation in the western part of the site proper

The current land-use of the site is pastoral farming and is divided into a number of paddocks. An existing dwelling is located on the northern corner of the site and a number of farm sheds and other structures are located north of the high point of the site. A gravel accessway allows vehicle access to the dwelling and the farm sheds where a turnaround bay is located. Farm tracks are spread across the site, generally along local ridge lines. The heavily used farm tracks were observed to be highly disturbed and 'boggy' from the stock movement through the wet season. Several large stands of bush, and Significant Ecological Areas (SEA) are present on the property, particularly on the more steeply sloping eastern side of the ridge, and within the larger, western sloping gully features. The gently sloping areas on the western side of ridge are noted to contain some shallow drainage channels and abundant growth of hydrophilic vegetation (rushes), as is evident in Figure 3.
