Harbourview-Orangihina Park Community Restoration Plan

Te Atatū Peninsula

Auckland Council

Date: 31 May 2021

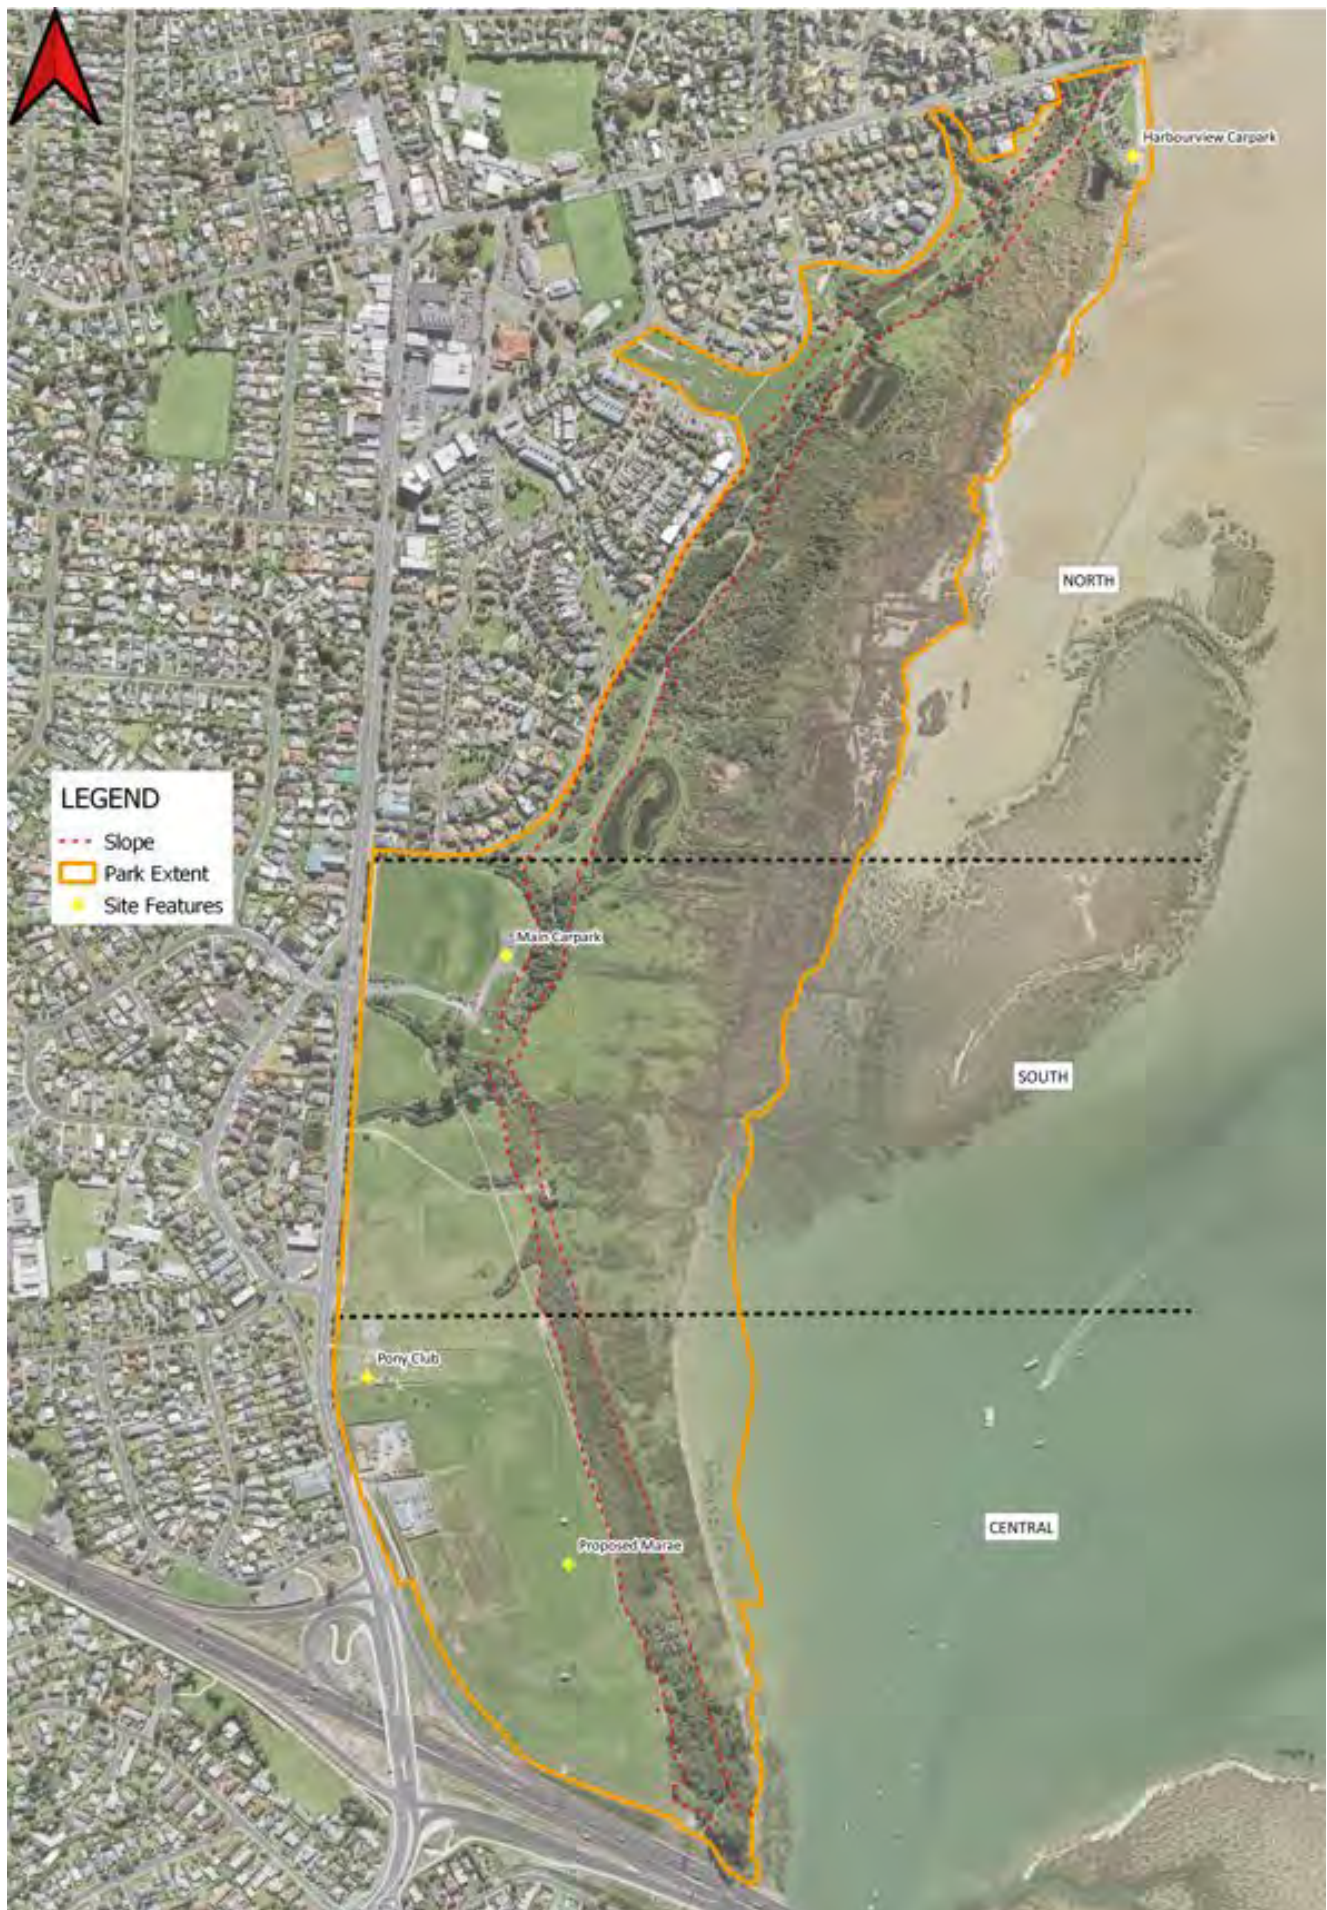
The topography of the park comprises two terraces – the upper terrace and the lower terrace – separated by a slope. For the purposes of this restoration plan, the park has been broken northern, central, and southern sections. See Harbourview-Orangihina Park Overview Plan on following page.

Harbourview-Orangihina Park is an 85-hectare, approximately 2km long area of coastal Council reserve land located on the eastern fringes of Te Atatū Peninsula, in the Henderson-Massey Local Board area (see overview map, Figure 1, next page).

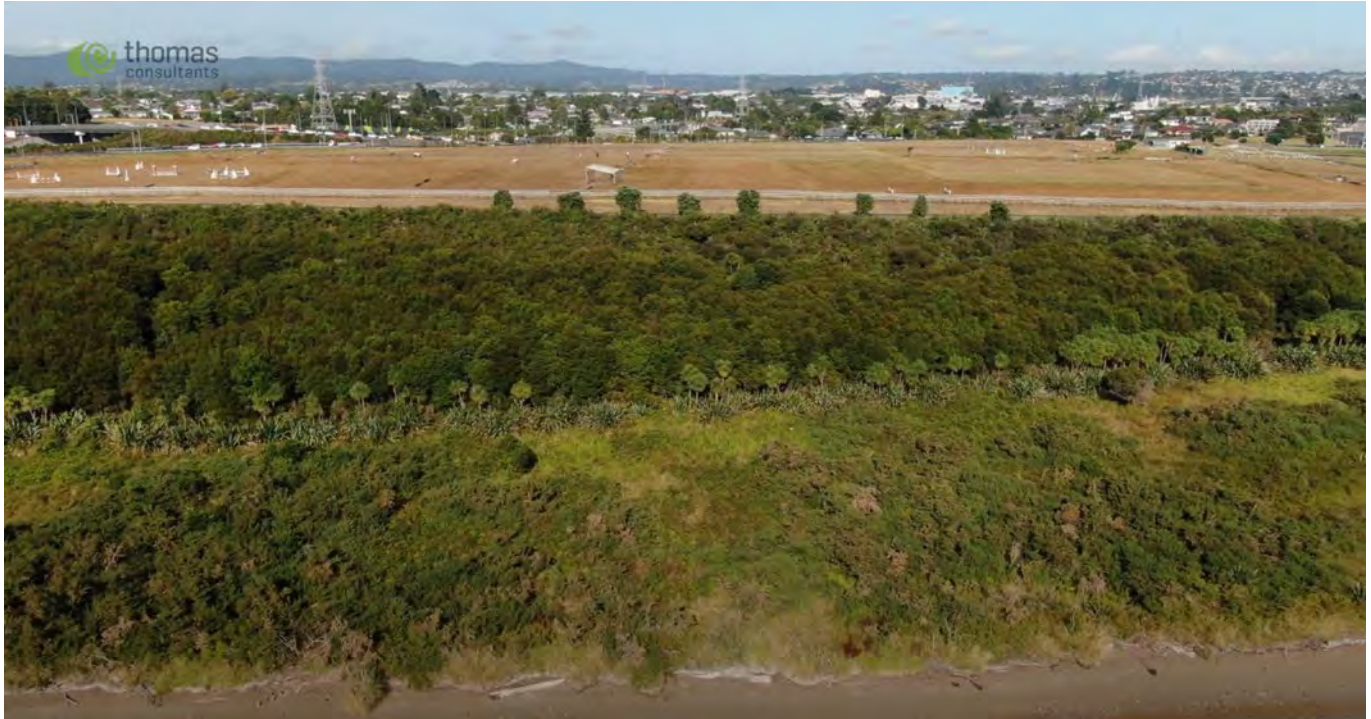
Photo 2: Aerial view of the southern end of the park (looking south) showing the gorse covered lower terrace, planted slope, and Pōhoro Club paddocks.

Lower terrace: The lower Pleistocene terrace formed as sea levels receded leaving an area of old mudflat above the new sea level. This ground lies around 1.5m to 4m above sea level and slopes gently down to the Waitematā Harbour. This former mudflat area is now comprised of salt marsh, freshwater wetland, and previous pasture areas regenerating in weeds such as gorse and blackberry.

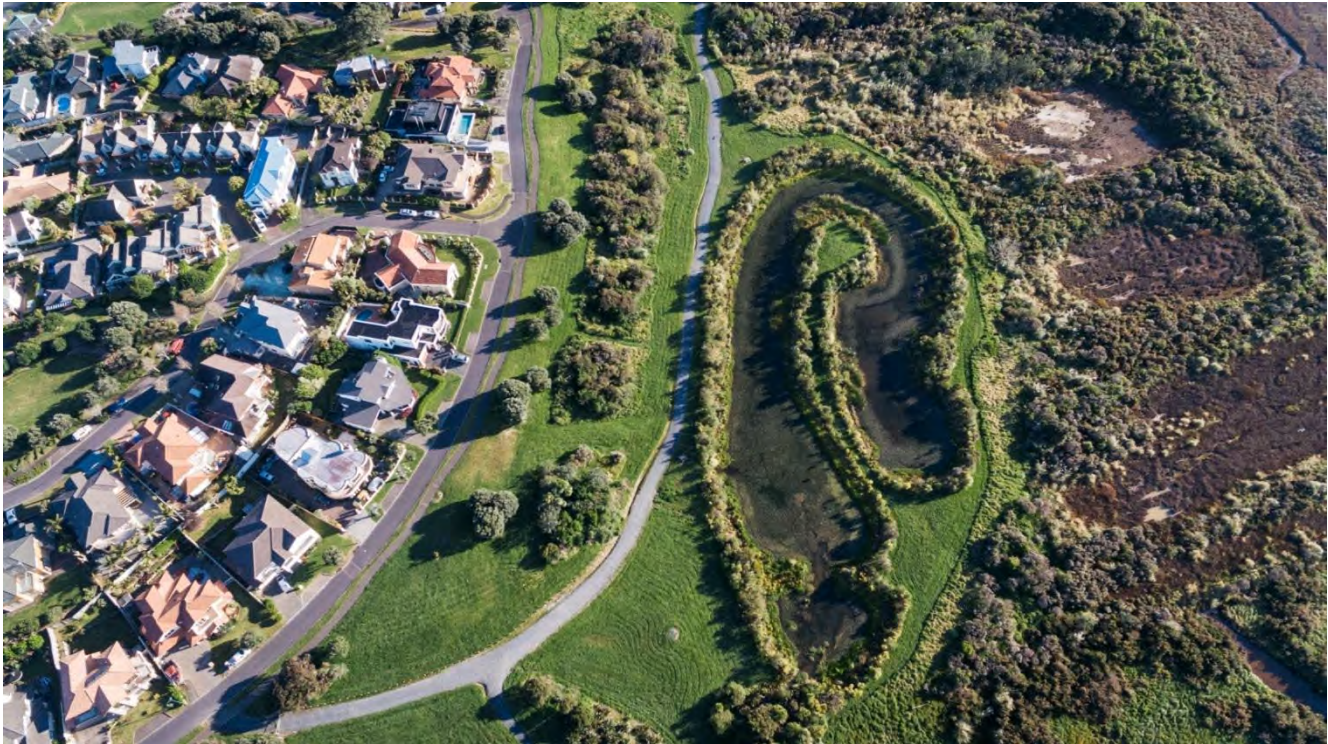
Photo 5: An aerial view of Danica Esplanade Pond, showing the scattered slope planting (between the path and the road) and extensive areas of salt marsh to the east (right of photo). Photo supplied by Auckland Council (2018).

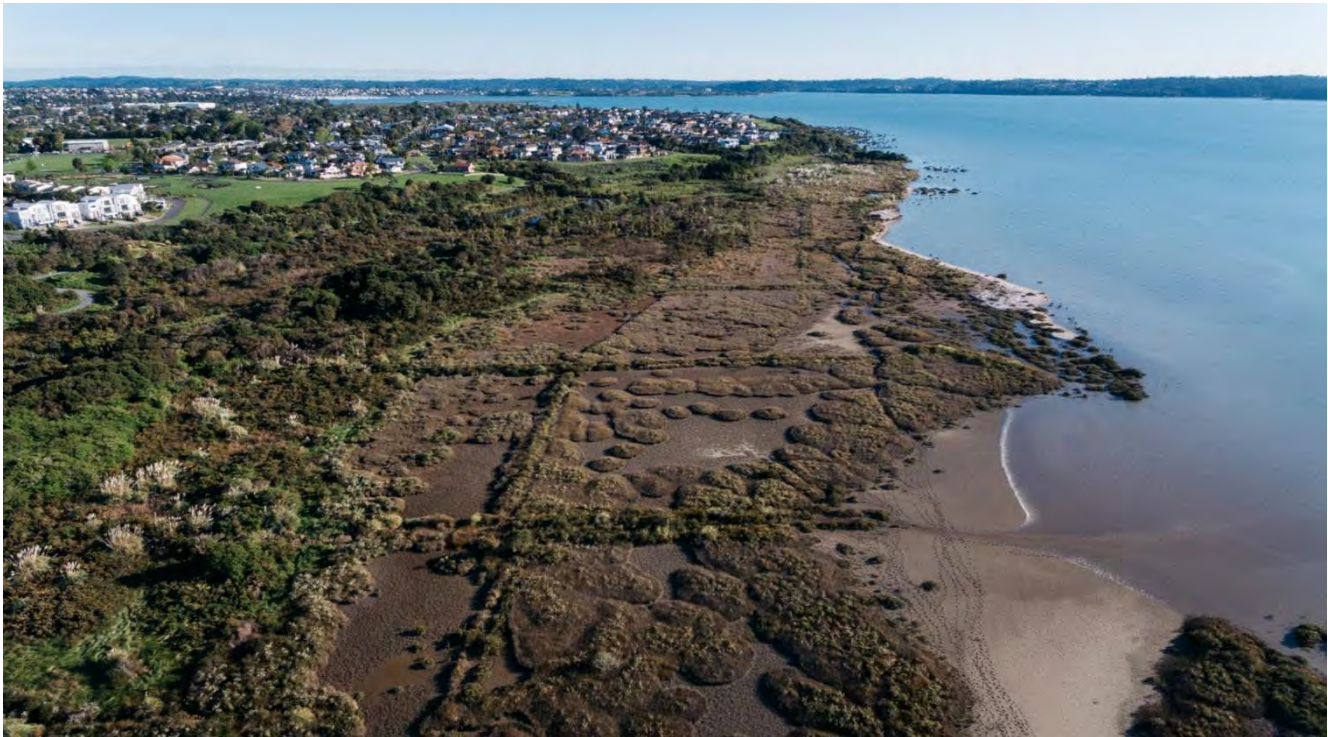
Photo 6: The northern zone, showing the criss-cross pattern of the location of historic drains. Photo supplied by Auckland Council (2017).

Photo 6 is an overview photo of this zone looking north.

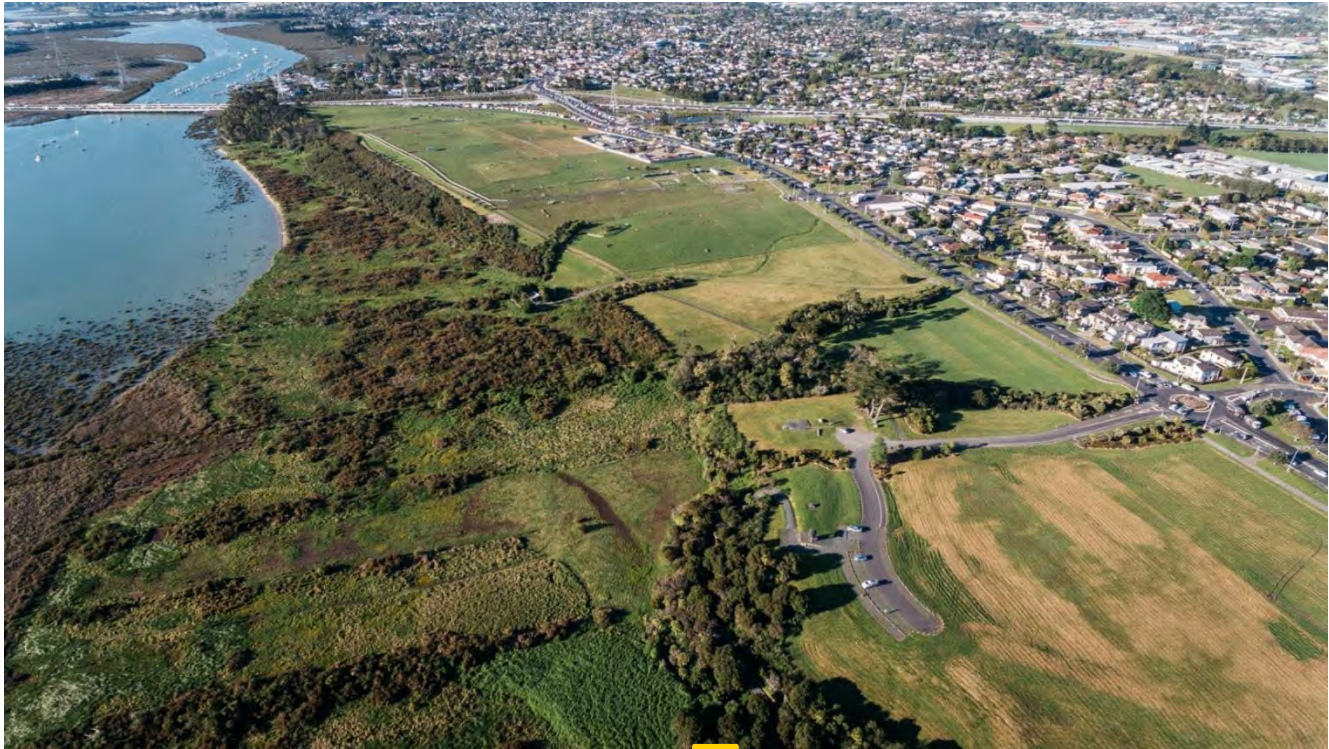
Photo 7: A 2017 drone photo of the central and southern zones, looking south, (Photo supplied by Auckland Council).

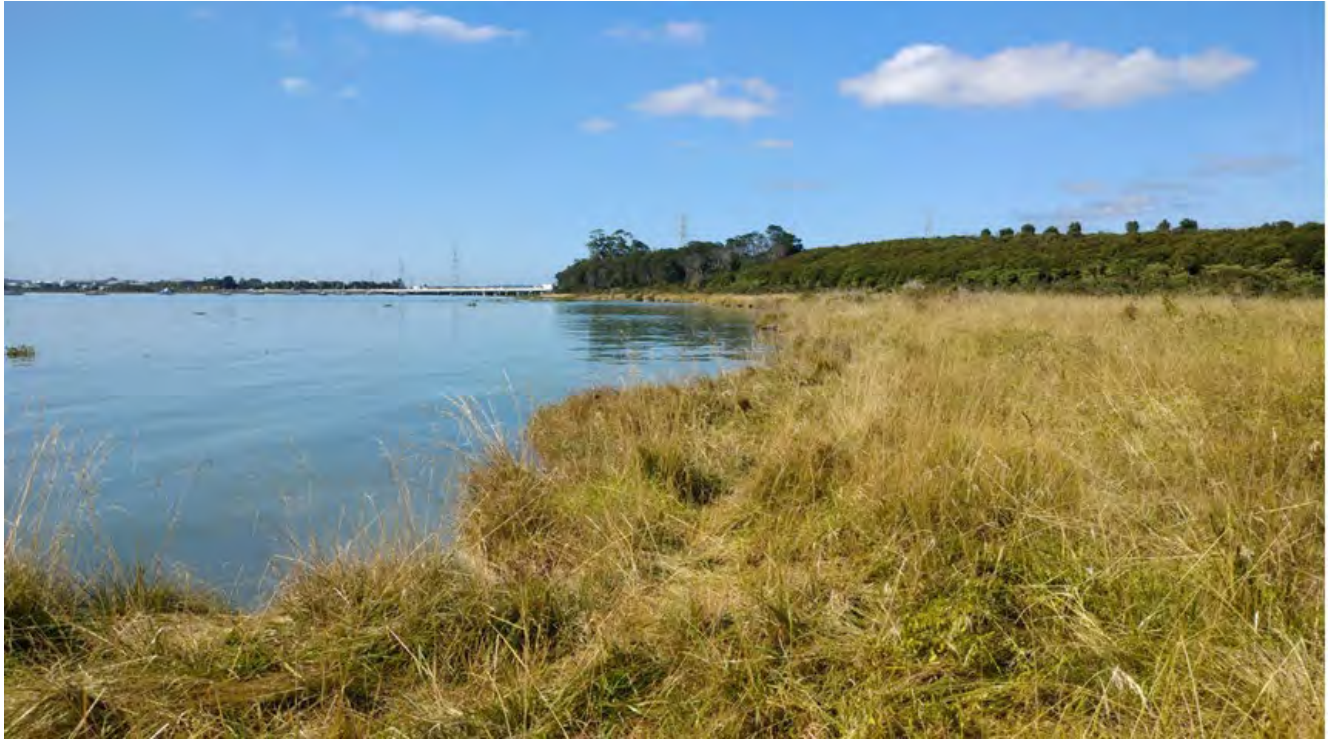
Photo 8: Looking south at high tide over the rank grass of the lower terrace towards the planted slope and black wattle and eucalyptus at the southern end of the park.

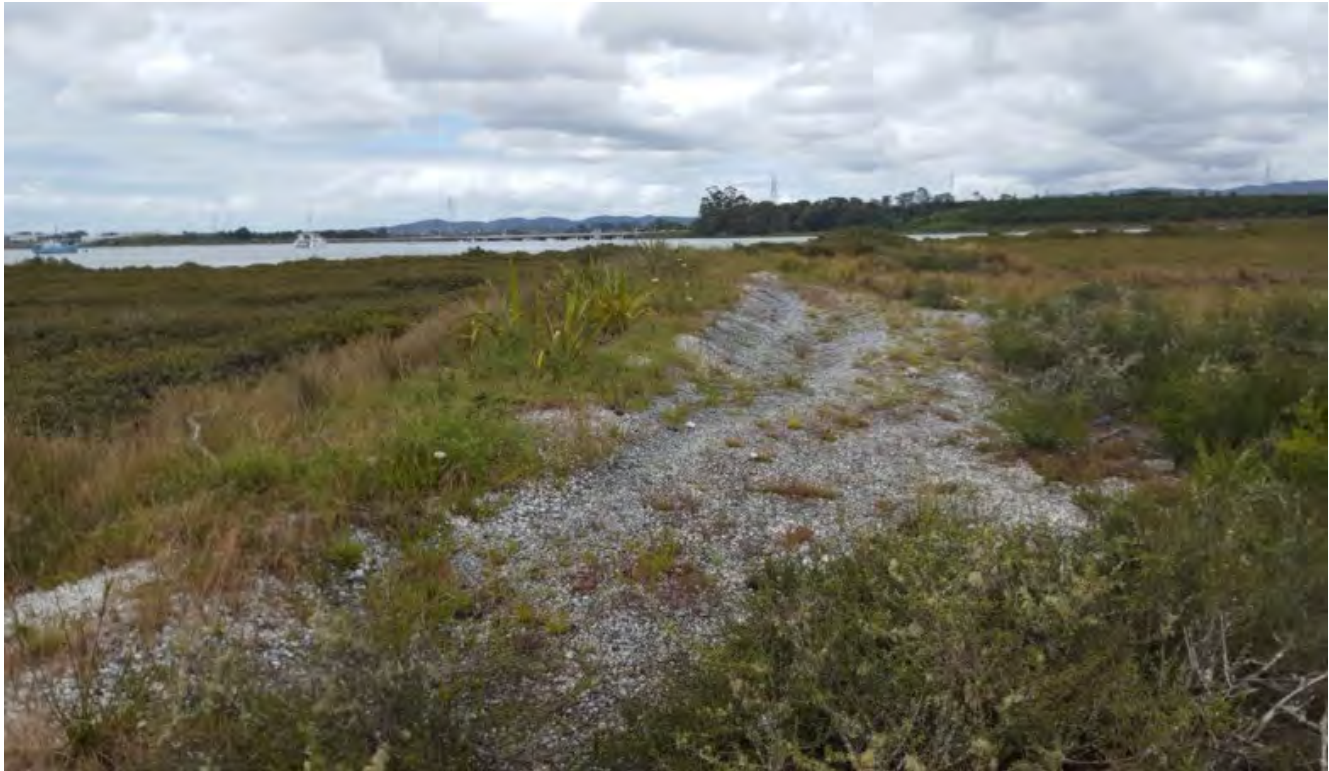
Photo 9: Looking south over the shell bank outside of the reserve (2018). Photo from iNaturalist and used with permission.

There are extensive areas of manawa (mangrove) outside of the reserve boundary. Within this area is a significant shell bank (Photo 9) 1.5 Shell-barrier Beaches (Chenier Plains) that is fringed with ureure (glasswort), mākoako (sea primrose) and remuremu, and contains needle grass (*Austrostipa stipoides*) and wīwī/knobby clubrush (*Ficinia nodosa*). Non-native plants here include buck's horn plantain (*Plantago coronopus*) and orache (*Atriplex prostrata*). Pampas grass is a threat to this area. This area is administered by the Department of Conservation and is a naturally uncommon ecosystem type⁷.

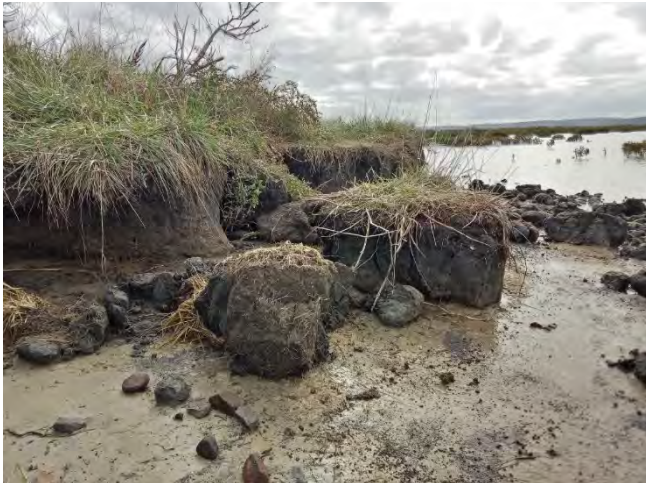
Photo 12: Active erosion in the southern zone.

The eastern shoreline of the Te Atatū Peninsula is relatively protected by its inner harbour location but is susceptible to wind generated waves during storm events when the wind blows from the north-east. The soils of the lower terrace are young, loosely bound and highly erodible (see Photo 12 and Photo 13). Where these are not protected by salt marsh they are actively eroding. Since 1959 it is estimated that erosion along parts of Harbourview-Orangihina Reserve has been in the order of 1m per year³⁶. Existing shell banks could be lost to sea level rise and erosion.

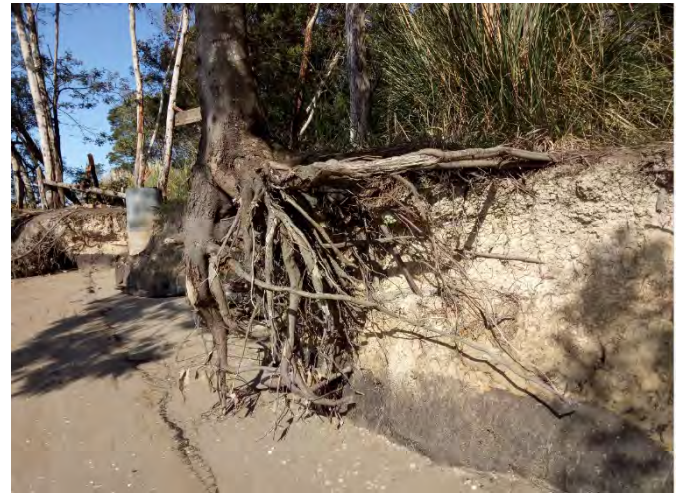
Photo 13: Erosion at the brickworks site. Planting is unlikely to slow erosion as wind-driven waves can undermine the root plate.

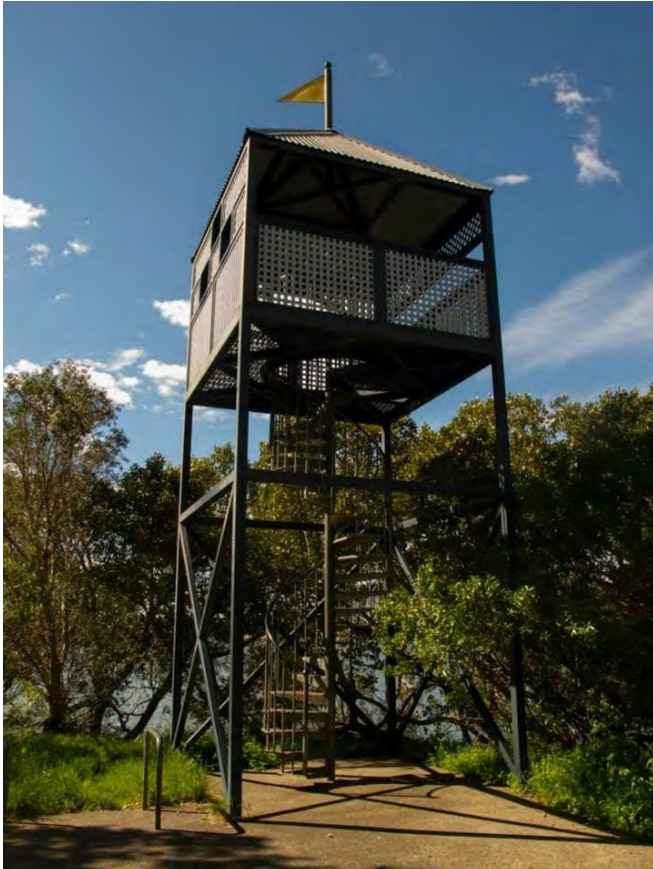
Photo 16: An example of a viewing tower from Sydney (photo supplied by Trina Smith).

The Master Plan already incorporates bird hides. In addition to this, and instead of the wetland boardwalk, it is recommended that a viewing tower and a viewing platform is created at the locations shown on the zone plans (Appendix F). These would have the additional advantage of being able to be used as part of regular shorebird monitoring. A costing for this is included in Appendix G.

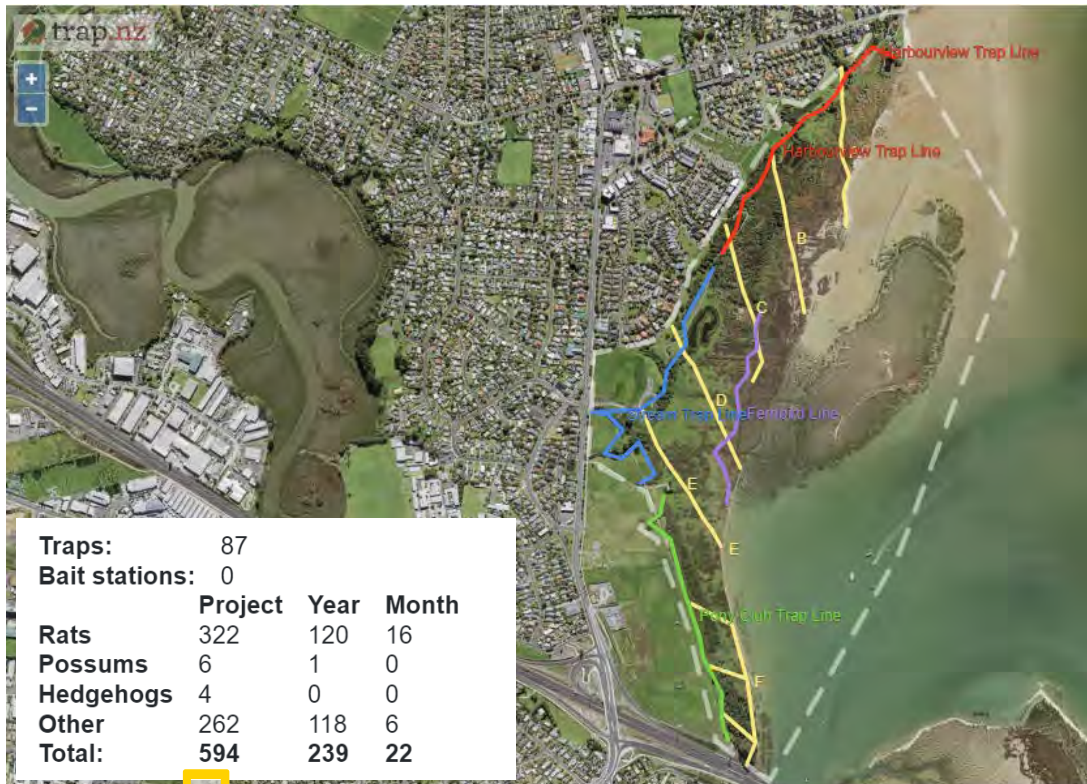
Figure 2: Screenshot from Trap.NZ showing the three rat lines and the yellow tracking tunnel monitoring lines. Taken 21 October 2020

Alongside trapping, rat numbers are monitored using tracking tunnels and birds (which should increase in response to pest control) using 5-minute bird counts as well as additional wetland and cryptic bird monitoring. These results, along with the trapping records, are recorded in TrapNZ a free online portal for recording trap, bait, monitoring and biodiversity outcome data (see Figure 2). There is strong community interest in maintaining and expanding the current programme, as capacity allows, rather than having the work done by contractors.

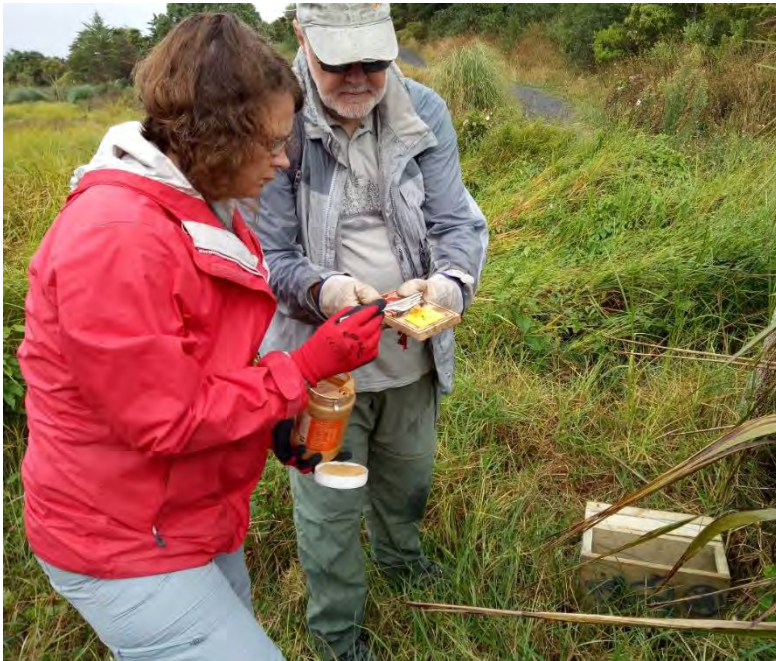
Photo 14: Harbourview-Orangihina Park Predator Control 2050 members carefully re-bait a Victor Professional rat trap with peanut butter.

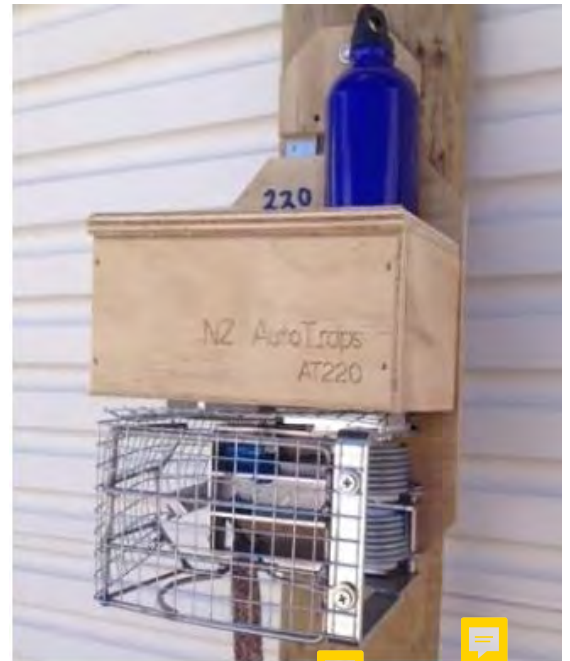
Photo 15: The AT220 only requires checking every 6 months and could be deployed near the saltmarsh interface. Photo supplied by NZ Auto Traps.
