Jubilee Bridge Structural Condition Assessment Report (Post Auckland Extreme Weather Events)

Panmure Basin, Lagoon Drive,
Panmure

Job No. 21785

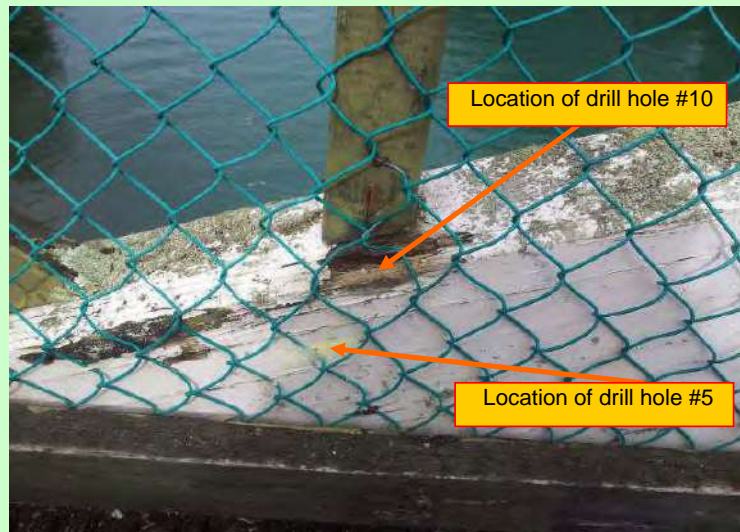
Probe # 10(drilled on an angle appr. 10 Degrees from vertical above the original #5 drill hole)

The sample indicates surface decay at the entry point to a depth of approximately 10mm with sound timber after that.

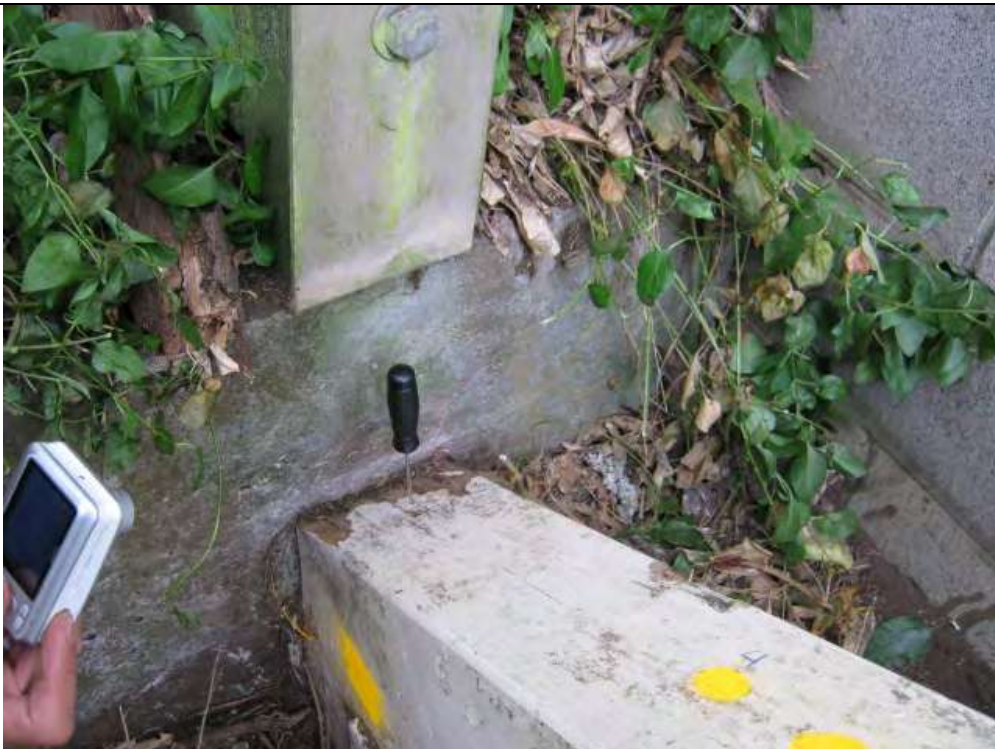
Photo showing Beam "B" with manual probe pushed into decayed wood.

As above

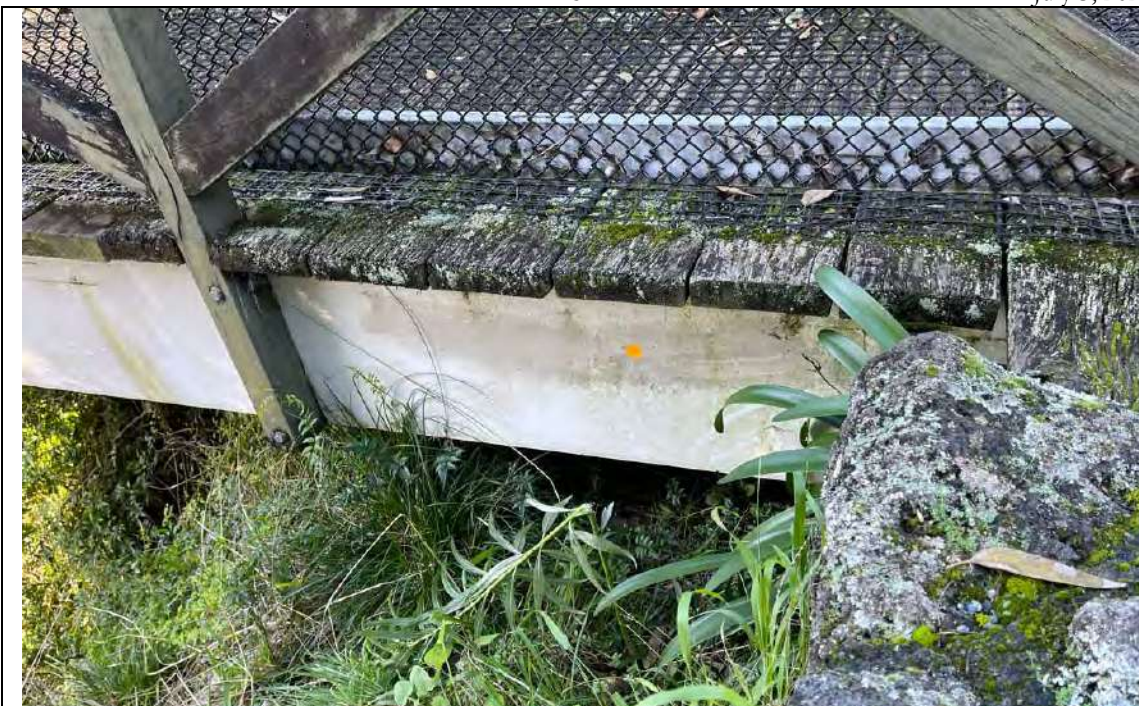
Photo showing the location of the calibration drilling "A"

As per above

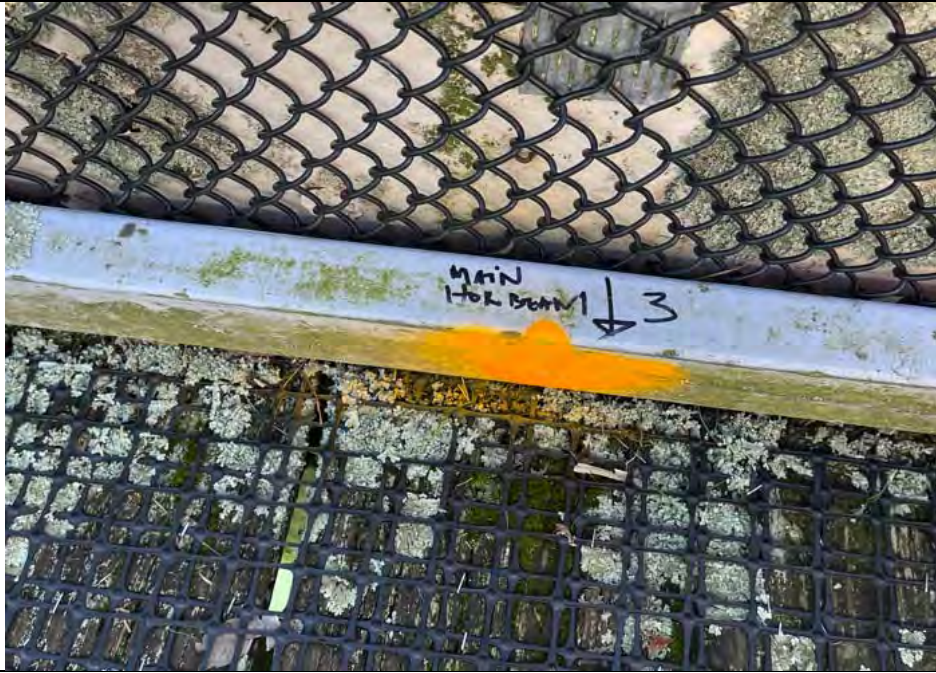
Photo showing the location of test drilling #3 The red arrow(s) depict the approximate drilling angle(s) Drilling was undertaken near vertical through the deck into horizontal beam

As per above
