Watercourse Assessment Report

Ngakoroa Catchment

Prepared for Auckland Council by Morphum Environmental Ltd

Client Name:	Auckland Council
Project Name:	Ngakoroa Catchment
Project Number:	P01644
Document:	Ngakoroa Watercourse Assessment Report

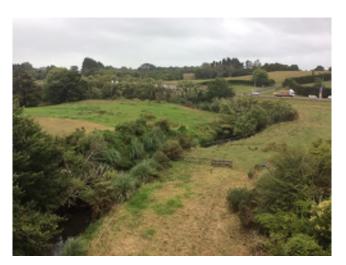
The stream is wide, run dominant, and largely maintains its natural morphology and extent of meander. The stream is dominated by mature willows which provide bank stability however in some areas, these have formed large debris jams and creating back-waters and pools. In these areas, the willow canopy extends across the full width of the channel.

Figure 4: Lower Ngakoroa Stream (NGA_MAIN_2-3)

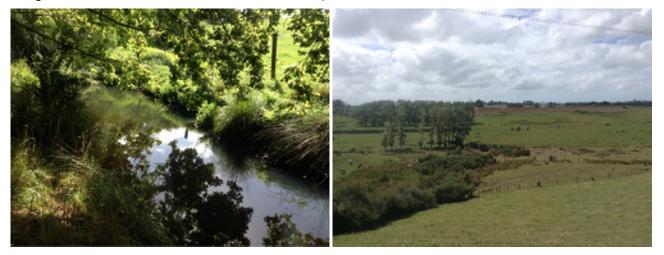
Ngakoroa Stream Tributary 8 extends south from the main Ngakoroa Stream, intersecting properties dominated by residential and agricultural land use. The main channel has been historically straightened. This main channel flows from south to north and outside of the future urban area is referred to as NGAWEST (the main western sub-catchment of Ngakoroa).

Tributary 8b extends west from the main channel. This area has been extensively drained with a series of straightened farm drains, however an extensive floodplain covers this area.

Figure 5: Right - Tributary 8. Left – Overview of landscape of Tributary 8b showing network of drainage

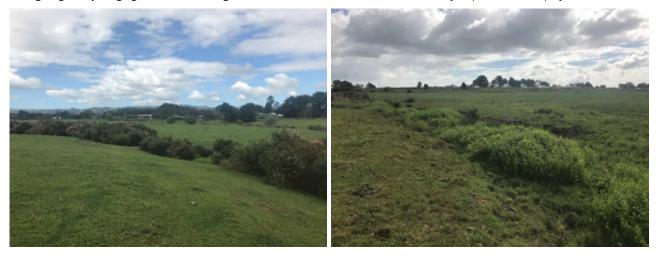
Ngakoroa Stream Tributary 3 is situated between the railway tracks and Burtt Road, west of the main Ngakoroa Stream. These reaches are characterised by incised channels, with high levels of exotic macrophyte cover and a dense gorse (*Ulex europaeus*) understory. The stream narrows in the upper reaches between NGA_TRIB3_4 and NGA_TRIB3_5. The mid-reaches were heavily modified by pugging which resulted in a poorly defined channel with an average wetted width of 1.8 m, with clear evidence of the full width of the constrained gully being regularly engaged to an average width of 4 m. This was dominated by aquatic macrophytes.

Figure 6: Representative reaches of Tributary 3

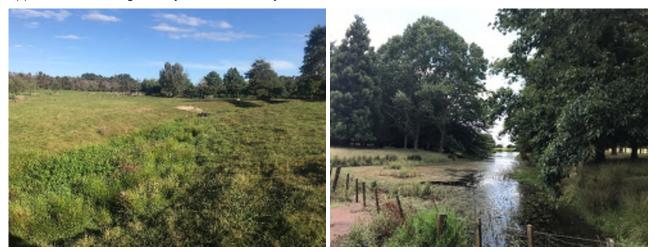
The lower reaches have open stock access and were generally characterised by sparse canopy cover and exotic understory and groundcover, with some willow dominated reaches. A series of artificial farm ponds are located in the mid-reaches of the tributary. Sections of the tributary lack clearly-defined banks due to pugging. The upper reaches were generally characterised by incised channels.

Figure 7: Representative reaches of Pahurehure Inlet Tributary

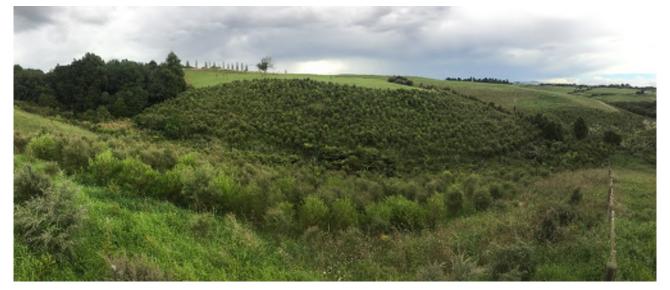
Figure 12: Riparian planting connecting remnant forest fragments at NGAWEST_23.

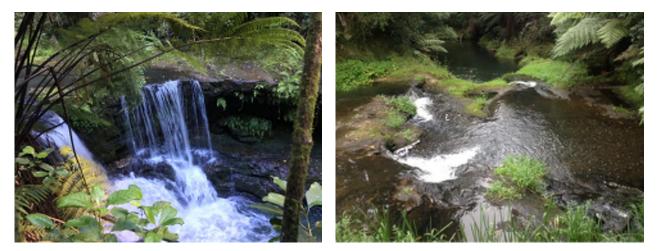
One of the largest waterfalls within the Ngakoroa catchment is located in this section in a very steep part of the gully on reach NGA_MAIN_29, and has been formed where the stream flows over the edge of a massive overhanging bedrock slab that extends the full width of the gully (Figure 13).

A large cascade sequence is located approximately 1.1 km downstream on NGA_MAIN_24 and is associated with deep plunge pools that have been carved out of the bedrock (Figure 13).

Figure 13: Waterfall flowing over bedrock slab, approx. 7 m in height, on NGA_MAIN_29 (left) and large cascade sequence on NGA_MAIN_24 (right)

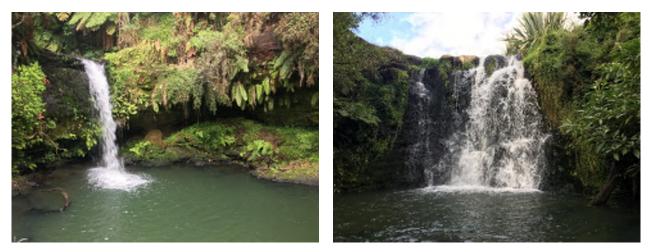
The lower section of TRIB17 also has a high concentration of significant natural structures, with three waterfalls and two cascades within a distance of 0.8 km. One of these waterfalls is located on TRIB17_70, near the confluence with the main stem of the Ngakoroa Stream, and is also associated with a large bedrock slab that has become undercut (Figure 14).

The largest waterfall in the Ngakoroa catchment, estimated at 10 m in height, is located 0.5 km further upstream at TRIB17_1 (Figure 14).

Figure 14: Waterfall, approx. 7m high, on TRIB17_70 (left) and approx. 10m high waterfall on TRIB17_1 (right)

Only one waterfall, located on TRIB17_70, was assessed as a complete barrier to all fish species, due to it flowing over an overhanging bedrock slab (see Figure 14). Despite this there are records of shortfin and longfin eels upstream on TRIB17_42, TRIB17_56 and TRIB17_57, so some must still be able to negotiate this obstacle when migrating upstream (see Map 6, Appendix 1).

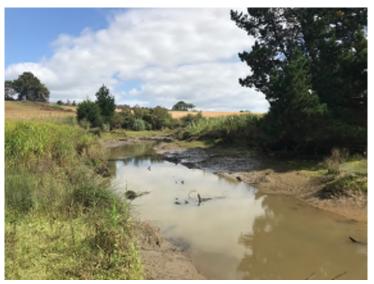
The Ngakoroa catchment drains into the Pahurehure Inlet, which flows into the Manukau Harbour. The upper boundary of the stream mouth was dominated by the native wetland species raupō, with the sedge family *Bolboschoenus* also dominant on both banks (Figure 16). The low-gradient (<10° slope) stream banks and dense ground cover on both banks was noted as suitable spawning habitat for the native freshwater fish inanga. Due to the large extent of the Pahurehure Inlet, the lower boundary of the stream mouth was not assessed.

The Ngakoroa stream mouth was recorded as a low-energy environment. Sediment load modelling by Green (2008), indicated that sediment loads are largely deposited within these low energy 'settling zones' in the upper sections of the Ngakoroa stream mouth. In combination with the nearby Slippery Creek catchment, the Ngakoroa catchment is the primary source of sediment to the harbour (approximately contributing 65% of total) (Green, 2008). These values have the potential to increase with future urban development proposed in the catchment.

Figure 16: The Ngakoroa catchment stream mouth, note the raupō wetland in the right upper corner.

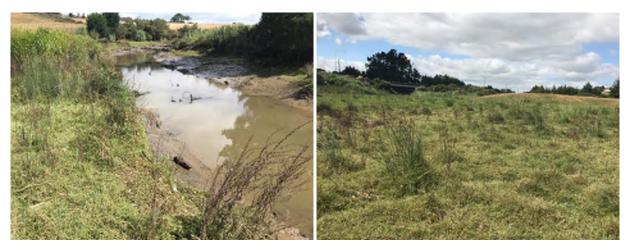
One potential inanga spawning area was located near the mouth of the Ngakoroa Stream on the true left bank (NGA_MAIN_1). The spawning area identified is 0.85 ha in size with a low bank gradient, and is currently in a pasture (Figure 17). Due to its position at the bottom of the catchment and the flat topography of the area, this site is able to be inundated by spring tides, which are a critical component in inanga spawning. The site has therefore been identified as having potential for enhancement to improve its potential as an inanga spawning location (see Enhancement Opportunity EO03 in Section 6.0).

Figure 17: Potential inanga spawning area in a pasture area adjacent to the Ngakoroa Stream (NGA_MAIN_1) with potential for enhancement.

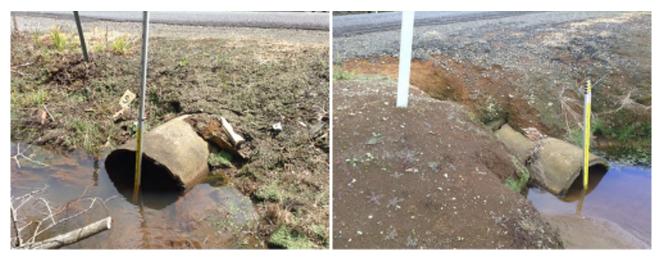
- The intersection of McPherson and Burtt Rd (Future urban) where the road culverts appear to be buried and broken (NGAPR_053) however moderate to severe erosion issues were also observed resulting in exposed cables (Figure 23).
- Inlets and outlets associated with a culvert and roadside drains at Beaver Rd where this had slumped and was partially obstructed with fine sediment.
 An inlet to a culvert Norfolk King Drive (NGAR_084) was noted to be submerged presenting a risk of flooding and subsequent damage of the road; and,
- The inlet under SH1 due to dense obstruction of gorse (NGAR_001).

Figure 24: Left - Inlet (NGAR_047) and Right - outlet (NGAR_067) at Beaver Rd

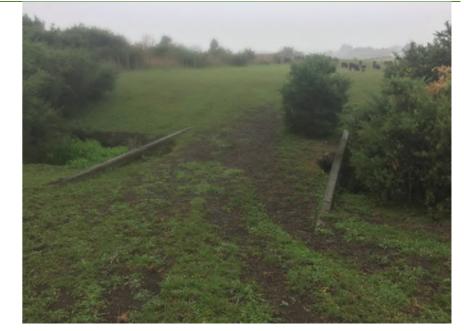
Poor condition crossing with erosion issues

Severe pugging

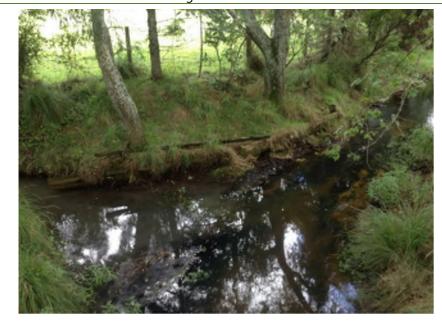
Confluence with slight erosion and short section of bank lining

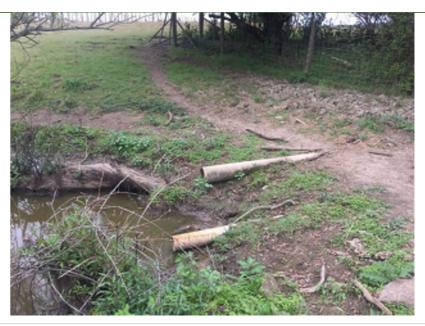
Typical dam and pipe between ponds

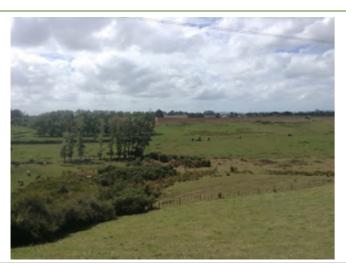
Facing downstream (east) on southern tributary

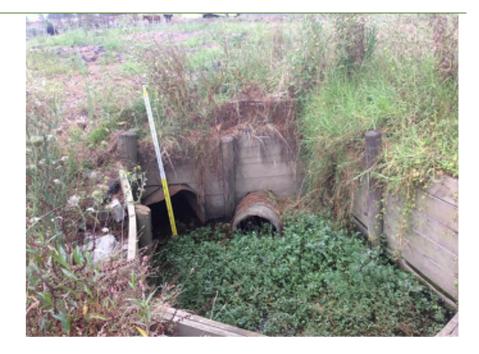
5 m length timber lining with cross beam reinforcing at culvert outlet

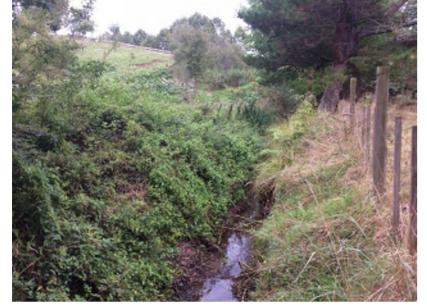
Straightened channel dominated by blackberry

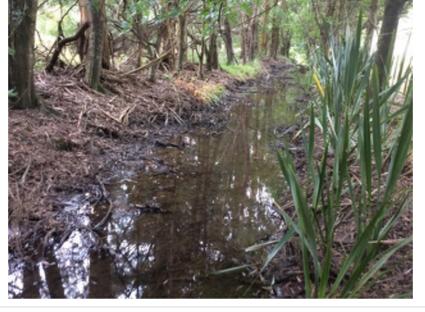
Straightened channel with shelter belt

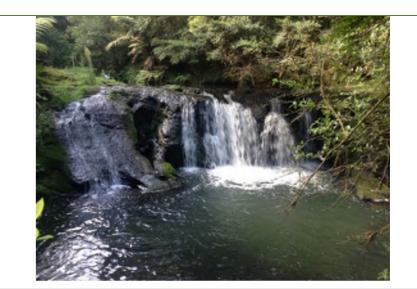
Waterfall and plunge pool

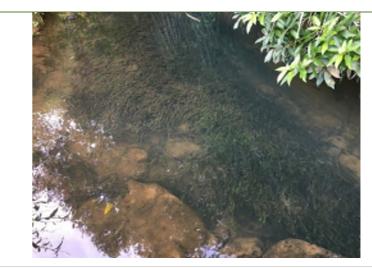
Extensive beds of Egeria densa present in stream channel, suggestive of low Opportunity to undertake weed control and revegetate stream banks to stream shading and higher nutrient inputs.

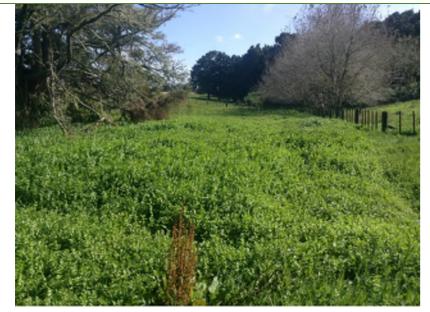
Extensive aquatic weed cover over channel.

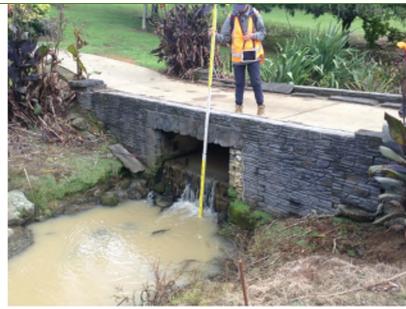
Box culvert at golf course at Ingram Rd (NGAF_033)

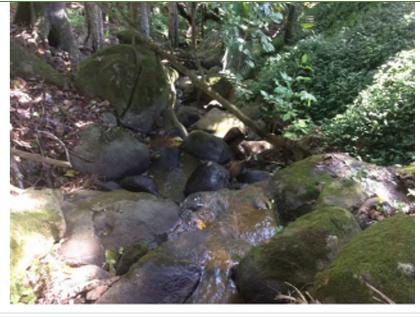
Cobble and boulder dominant upstream reach (TRIB17_27)

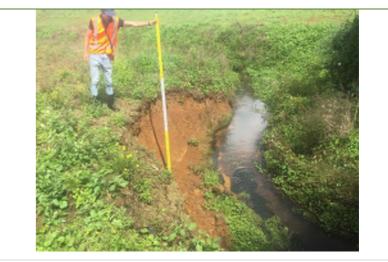
Erosion hotspot 30 m downstream of motorway outlet

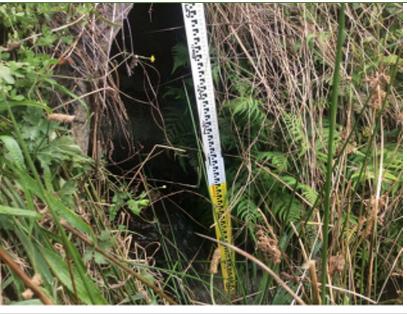
Perched culvert NGAF_130

Series of perched culverts limiting access of climbing species to prime wetland and stream habitat upstream. Culvert is perched by 0.8m and, although it appears to be a complete barrier, one adult banded kokopu was observed upstream. Upstream has good fish habitat, with wide shallow stream containing deep sediment running underneath native canopy. Good spawning habitat for banded kokopu in vegetation on floodplain adjacent to

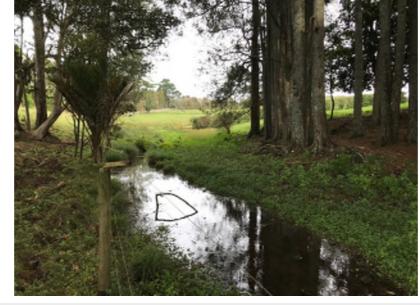
Straightened channel through remnant forest TRIB17_49
